Exmoor National Park
Historic Environment Report Series No 11

PORLOCK WEIR CONSERVATION AREA: APPRAISAL DOCUMENT

Adopted July 2022

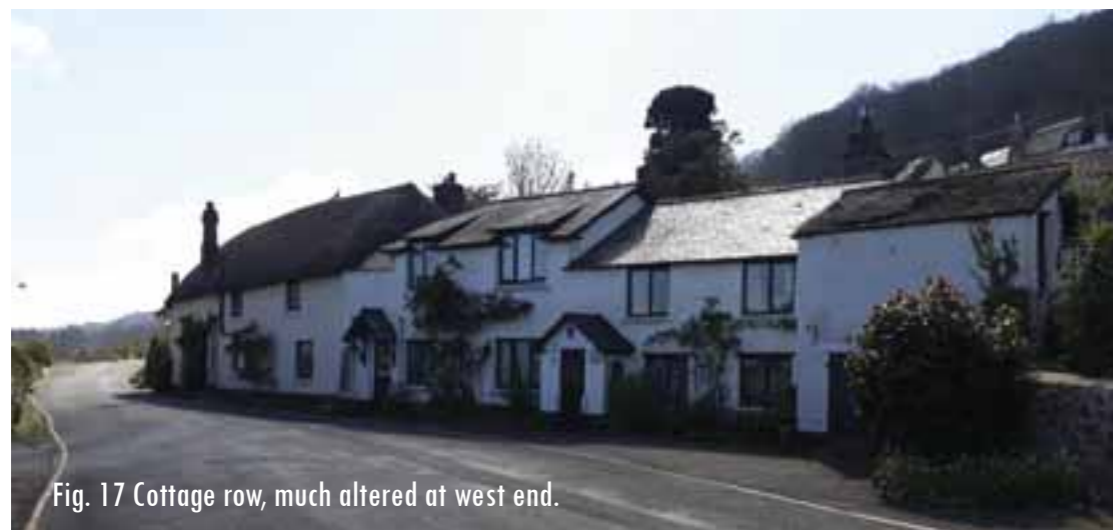
Opposite the car park entrance is another cottage row (Fig. 17), probably of 18th century origin with later modifications much in evidence. The row is now two cottages, the eastern end, **The Old Reading Rooms**, is thatched with tall brick stack and formerly incorporated a Reading Room. The west end, known as **Seaview Cottage** is of two distinct builds of painted rubblestone under slate roofs and with large modern picture windows.

Fig. 17 Cottage row, much altered at west end.

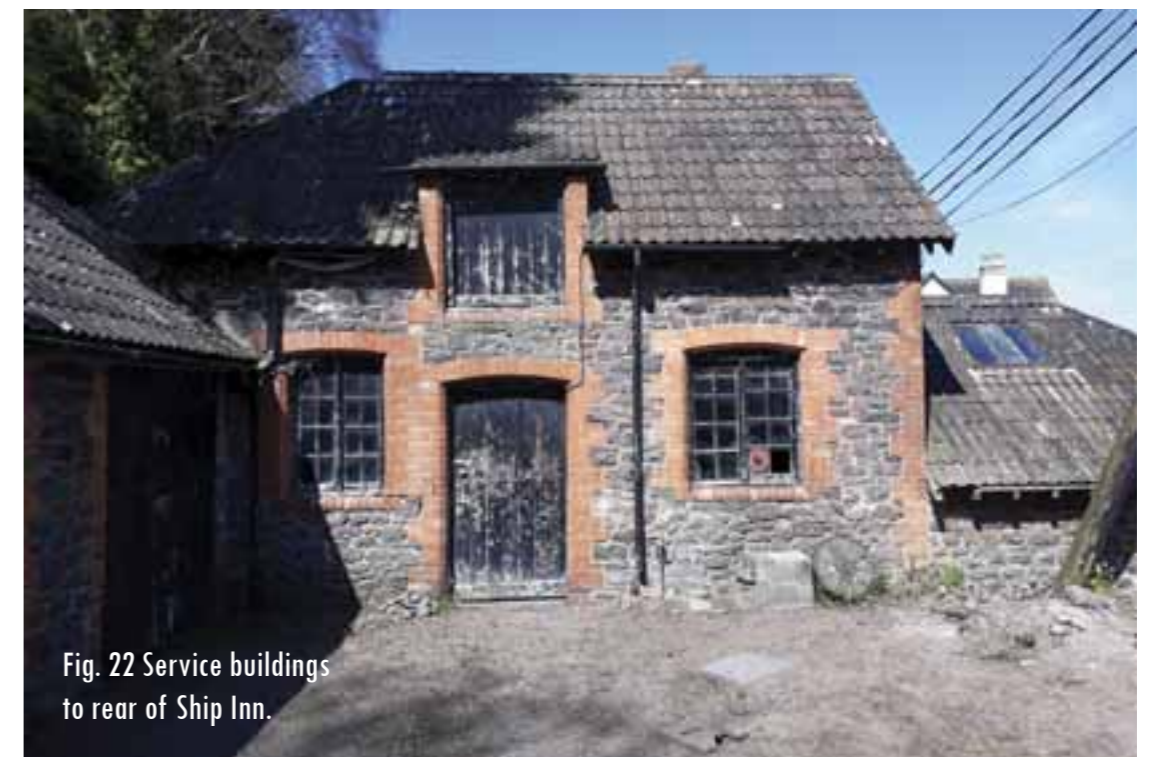
Fig. 22 Service buildings to rear of Ship Inn.

Most historic buildings, both listed and unlisted, are well maintained, and appear to be sound in terms of their maintenance and structural condition. There are, however, some examples where cottages, listed and unlisted, have been over restored and have lost much of their historic patina. For the most part, PVCu replacement windows have made no significant inroads into the Conservation Area in part due to the use class of many of the building which would require planning permission for the change of windows. Lane Head Cottage are vulnerable and an Article 4 Direction should be considered. Some localised deterioration of stonework is noted, especially the condition and structural integrity of some boundary walls. The only buildings identified as underutilised and not well maintained are the outbuildings rear of the Ship Inn (Fig. 22).

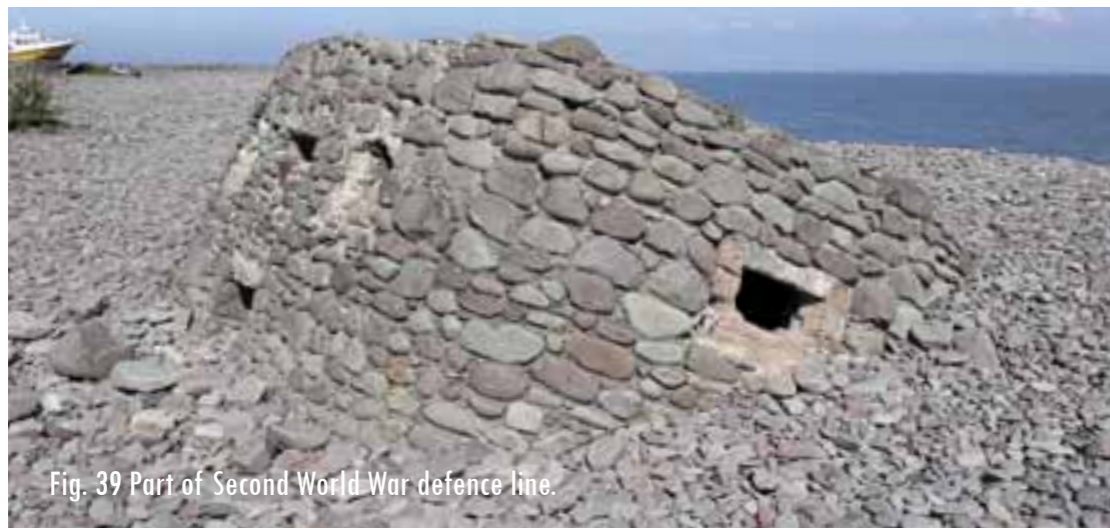
There are two Second World War 'Type 24' pillboxes on the beach immediately east of the quay. The southern pillbox (Fig. 39) is suffering from subsidence and has tipped down towards the sea.

Fig. 39 Part of Second World War defence line.

Aside from the ever present threat of coastal erosion, there are two features that are currently directly affected, the southern pillbox (Fig. 39) and the timber groynes (Fig. 45) on the east side of Turkey Island. Given their position, it is unlikely that conservation measures alone would be able to preserve these features in situ. The predicted rise in sea levels due to the climate emergency will likely cause some significant damage in the coming decade.

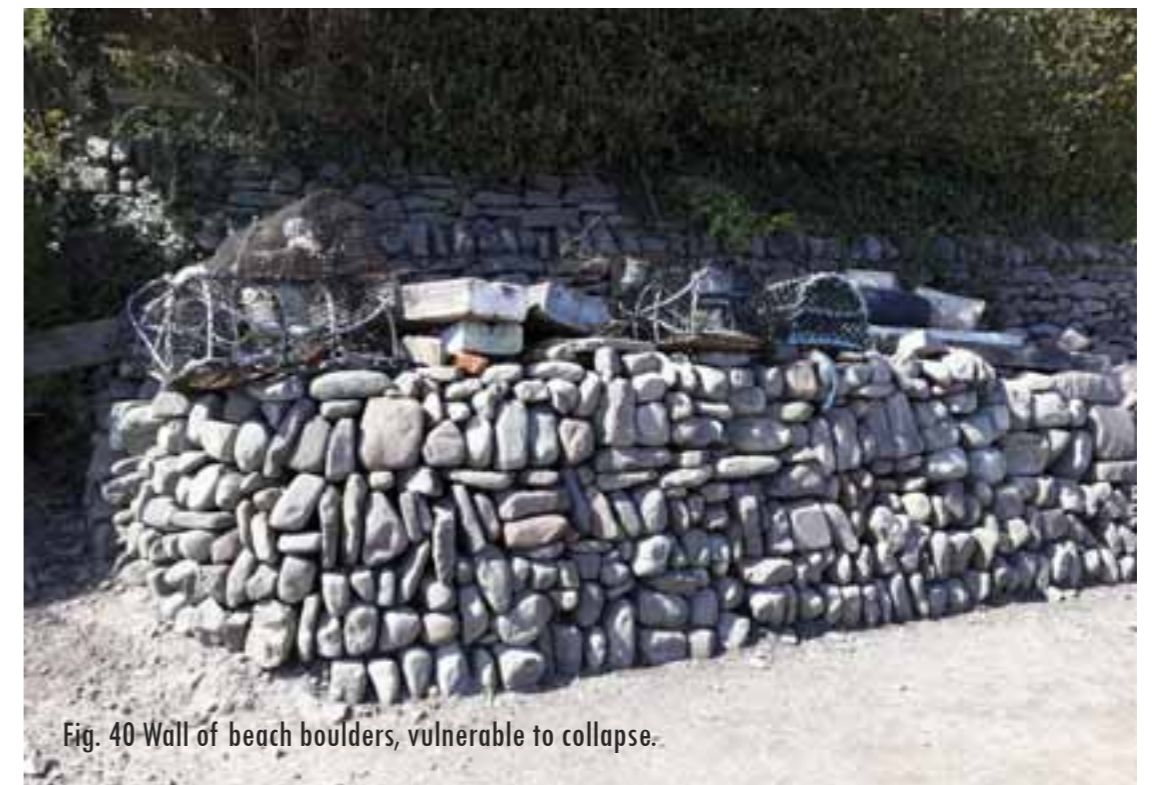
Fig. 40 Wall of beach boulders, vulnerable to collapse.

- The conservation, and where necessary, the repair of walls and/or historic railings, and timber fencing is considered important. Where appropriate consider using additional timber or ironwork that reflects the local craft traditions.

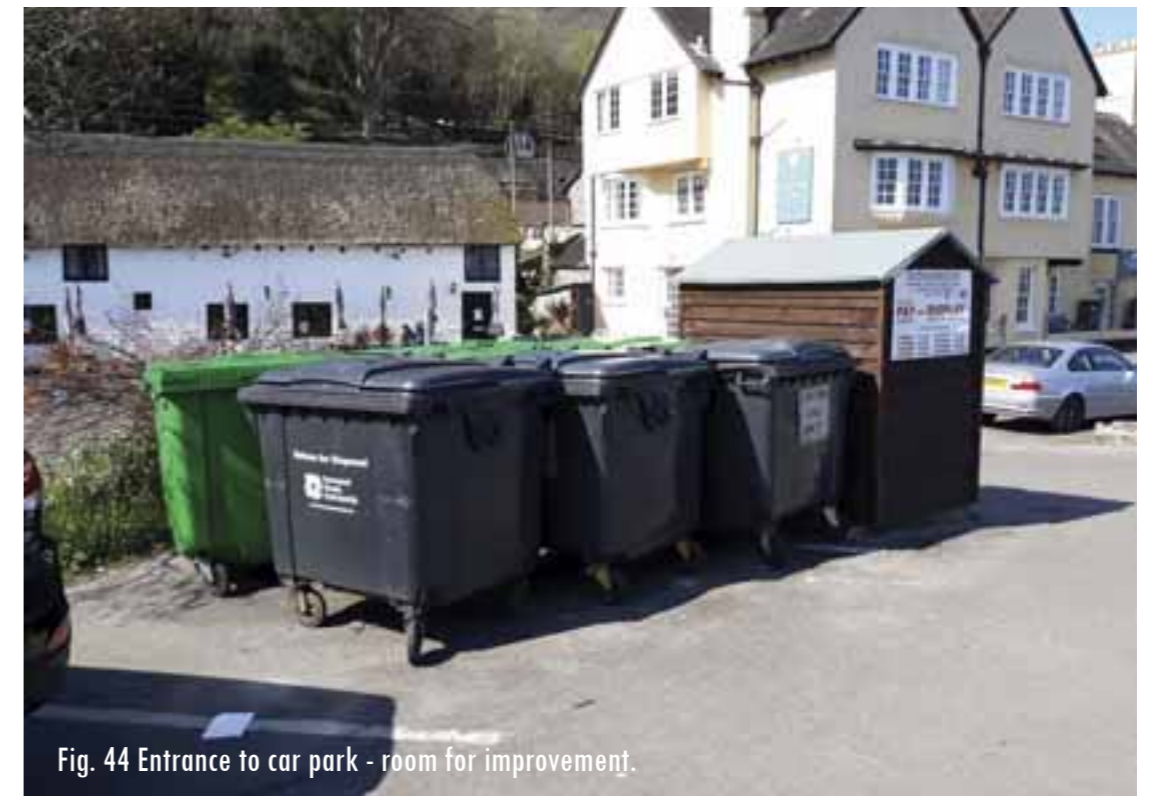
As noted in 2004, the main public car park could benefit from further hard and soft landscaping and the entrance is currently unsatisfactory (Fig. 44). Other areas of the Conservation Area would benefit from resurfacing, using natural materials where possible. Some relatively minor evidence of salt water erosion could be rectified. Overhead wires are present but not overly intrusive.

Fig. 44 Entrance to car park - room for improvement.

Porlock Weir experiences a considerable volume of visitors, especially during the main holiday season. This raises the potential for some enhancement, especially of ground surfaces where disrepair and badly worn or uneven surfaces are evident. It is important to maintain this aspect of character, and any potential for ground surfaces using local natural stone or paving materials to be restored or extended should be investigated.

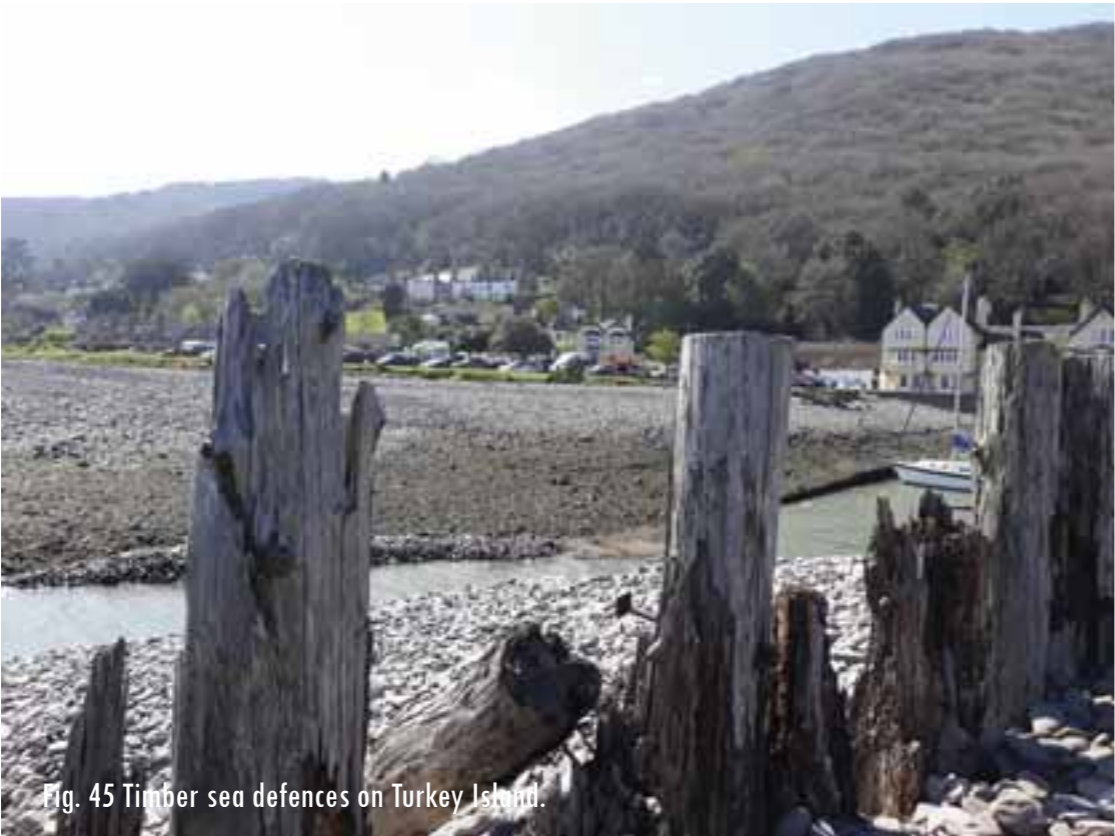
Fig. 45 Timber sea defences on Turkey Island.

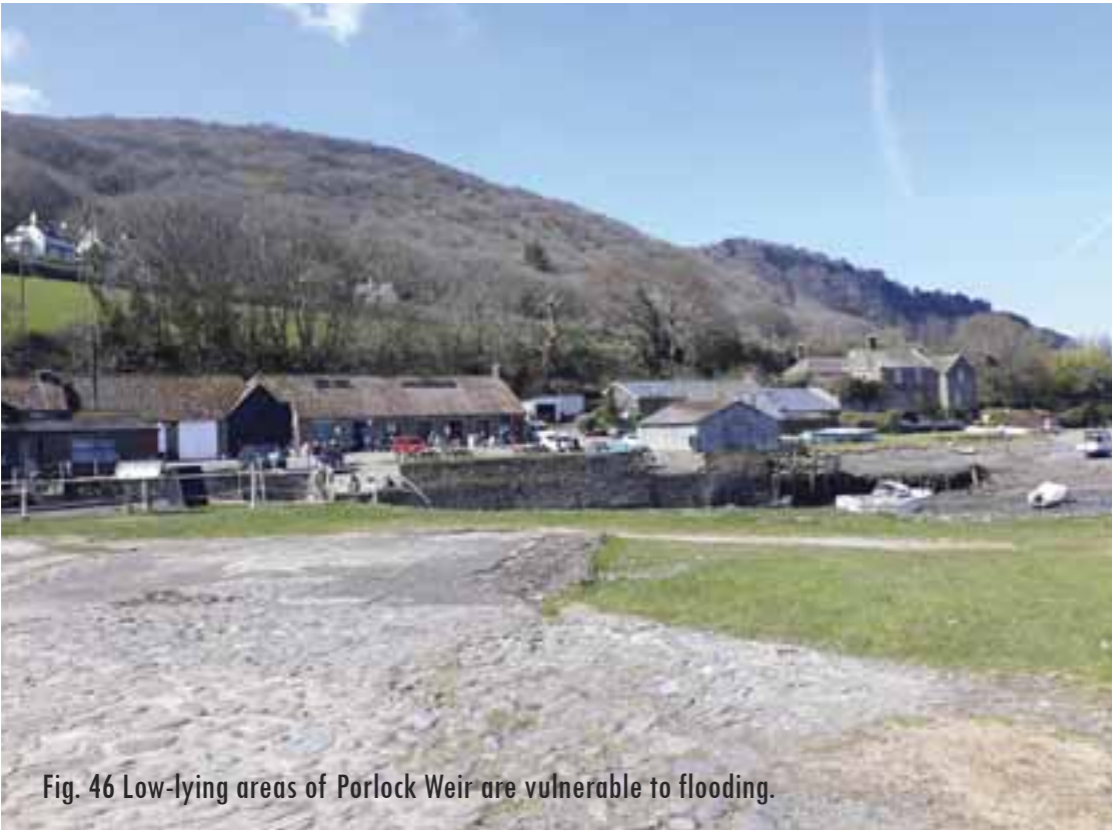
Fig. 46 Low-lying areas of Porlock Weir are vulnerable to flooding.

Porlock Weir has experienced severe flooding in the past, most recently in 1996, and longer term, the risk of inundation caused by coastal erosion and sea level changes is, due to climate change, likely to increase. This, and measures to mitigate it, are likely to significantly impact on the historic built environment and wider Conservation Area, particularly those parts closest to the sea and it is inevitable that some degree of adaptation will be required. There have been two recent reports which have specifically addressed this issue - see Appendix D.
