Exmoor National Park
Historic Environment Report Series No 8

PORLOCK CONSERVATION AREA: APPRAISAL DOCUMENT

Adopted July 2022

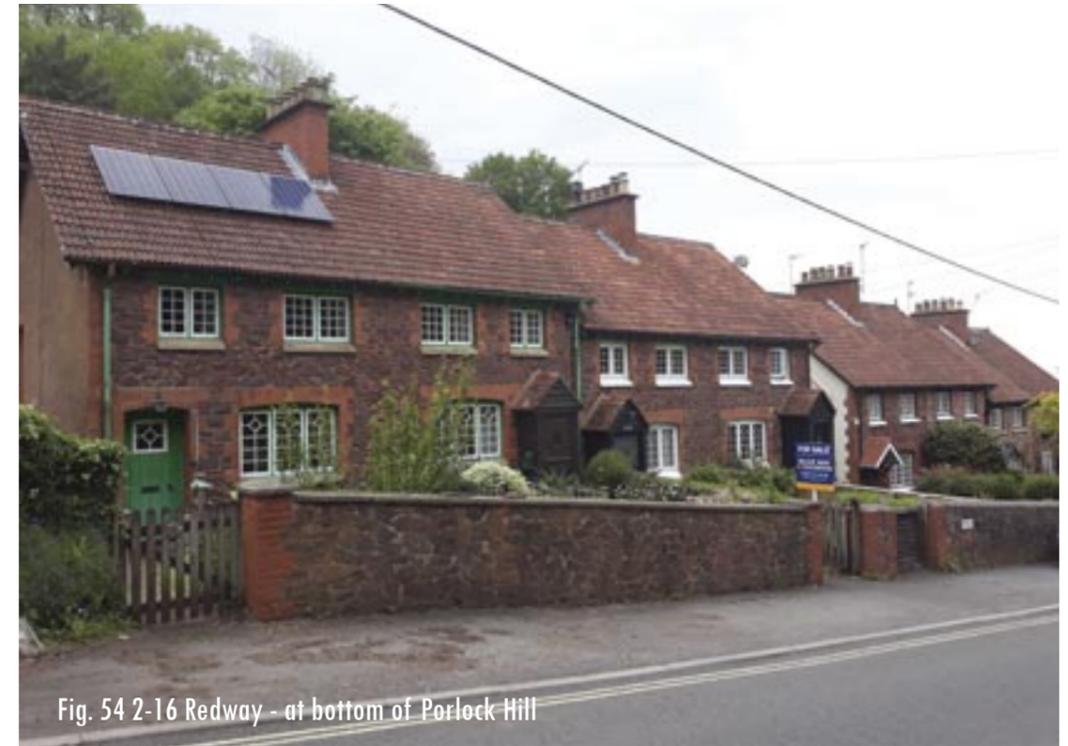
At the bottom of Porlock Hill, **Nos 2-16 Redway** (Fig. 54) is a stepped terrace comprising two blocks of four cottages built of local sandstone with brick dressings. The cottages are likely to date to the 1920s and largely retain their original fenestration including the distinctive glazing bars to the ground floor windows (also see The Poplars, Hawkcombe Fig.67). There are however a number of upvc replacements and a poorly placed solar PV panel which have degraded the appearance of the row since the last appraisal.

Fig. 54 2-16 Redway - at bottom of Porlock Hill

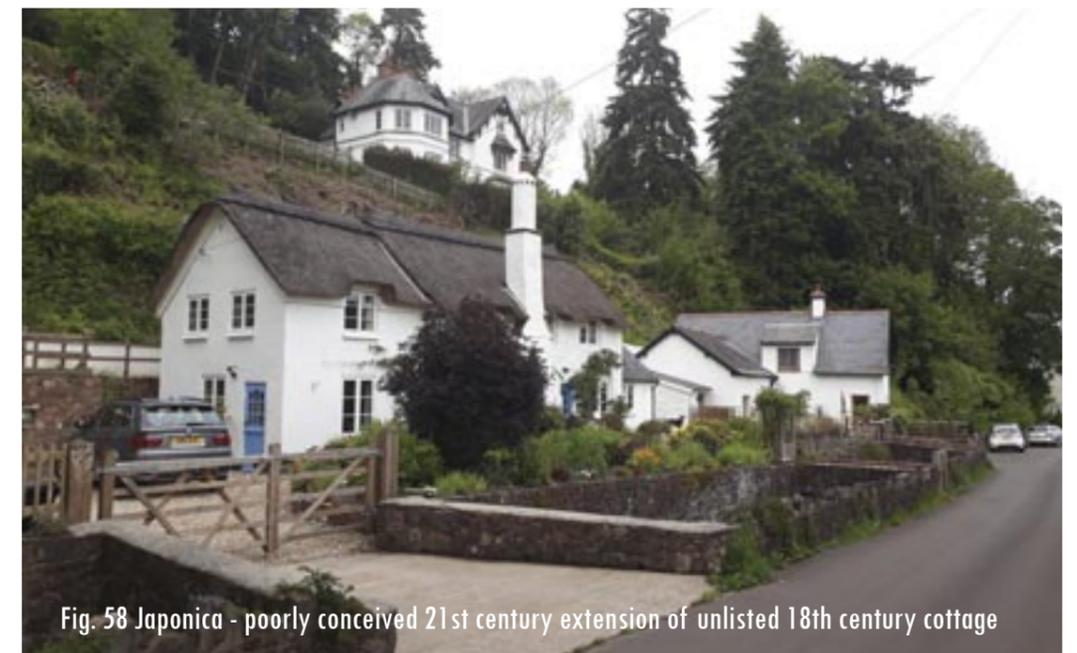
Fig. 58 Japonica - poorly conceived 21st century extension of unlisted 18th century cottage

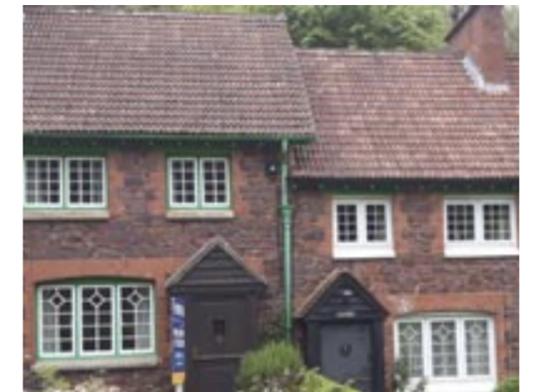
Fig. 67 uPVC windows to Redway. Piecemeal changes negatively impact these rows

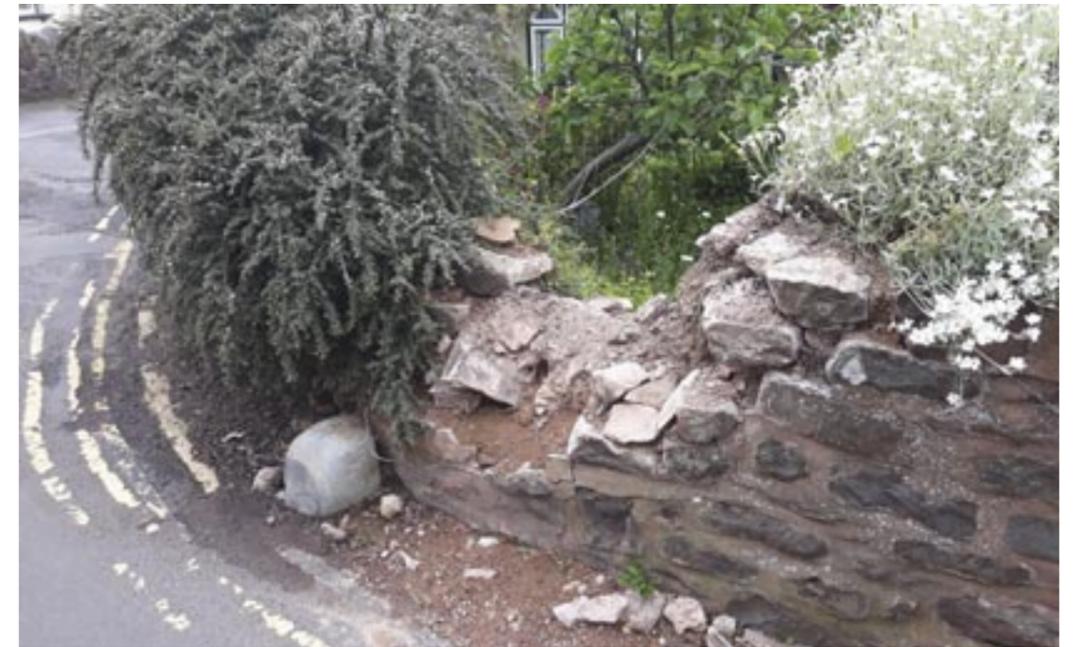
No instances of serious structural deterioration of street frontage elevations were noted and there does not appear to have been a significant change since the last appraisal (2013) however, it is apparent that vehicle damage may be becoming more frequent with damage to shop front and walls where roads narrow.

Fig. 78 Damage to wall presumably cause by vehicles

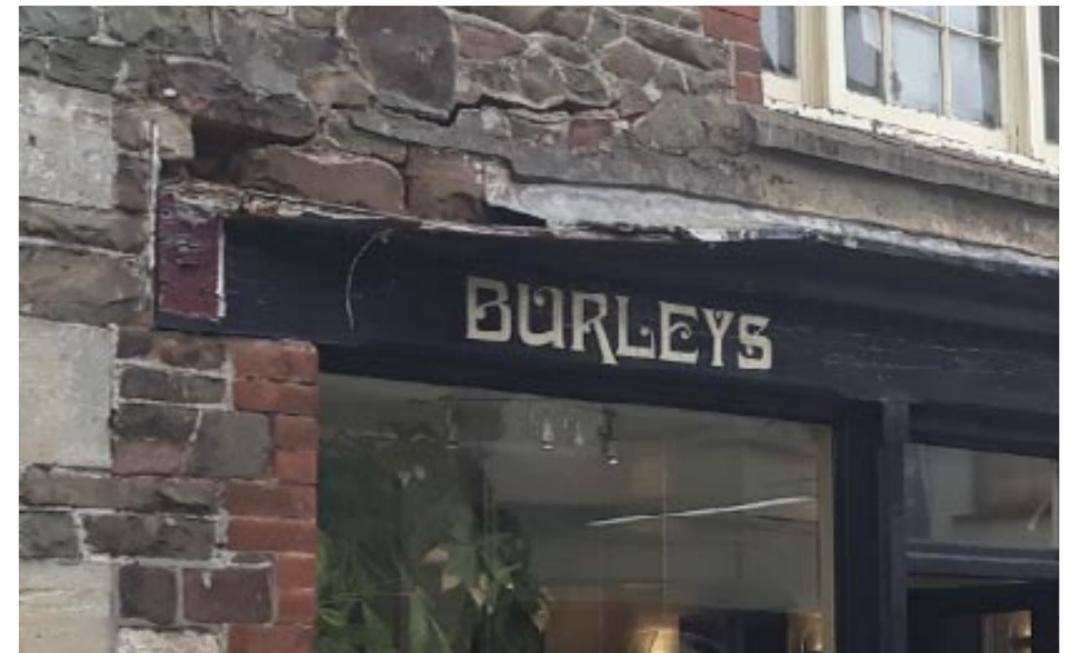
Fig. 79 Damage to shop front caused by vehicle

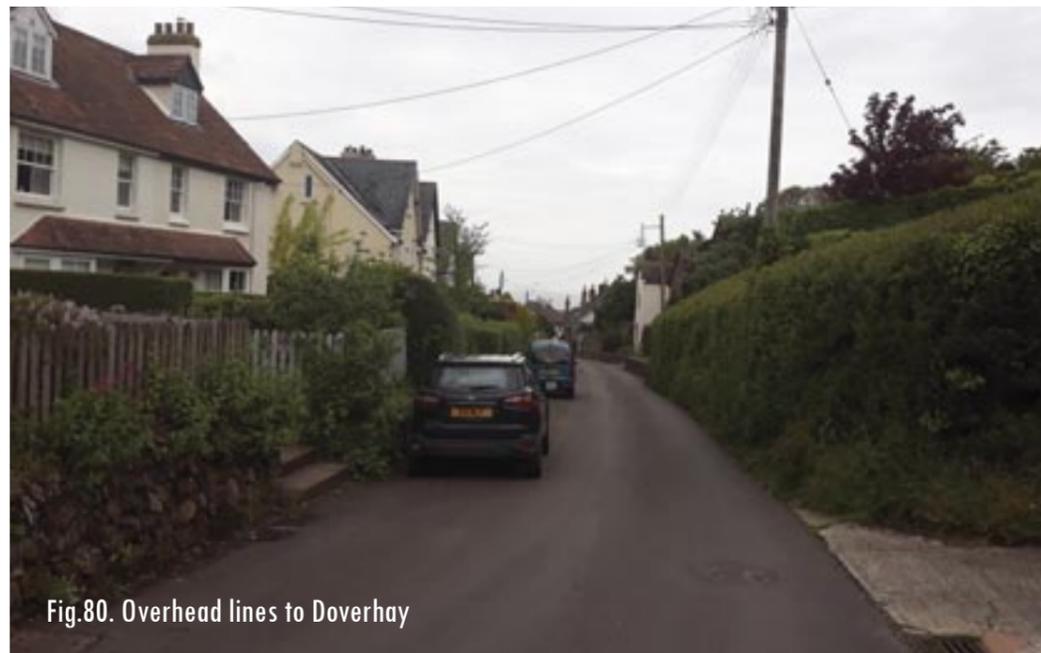
Fig.80. Overhead lines to Doverhay
