Exmoor National Park  
Historic Environment Report Series No 9

# ALLERFORD CONSERVATION AREA: APPRAISAL DOCUMENT

Adopted March 2017

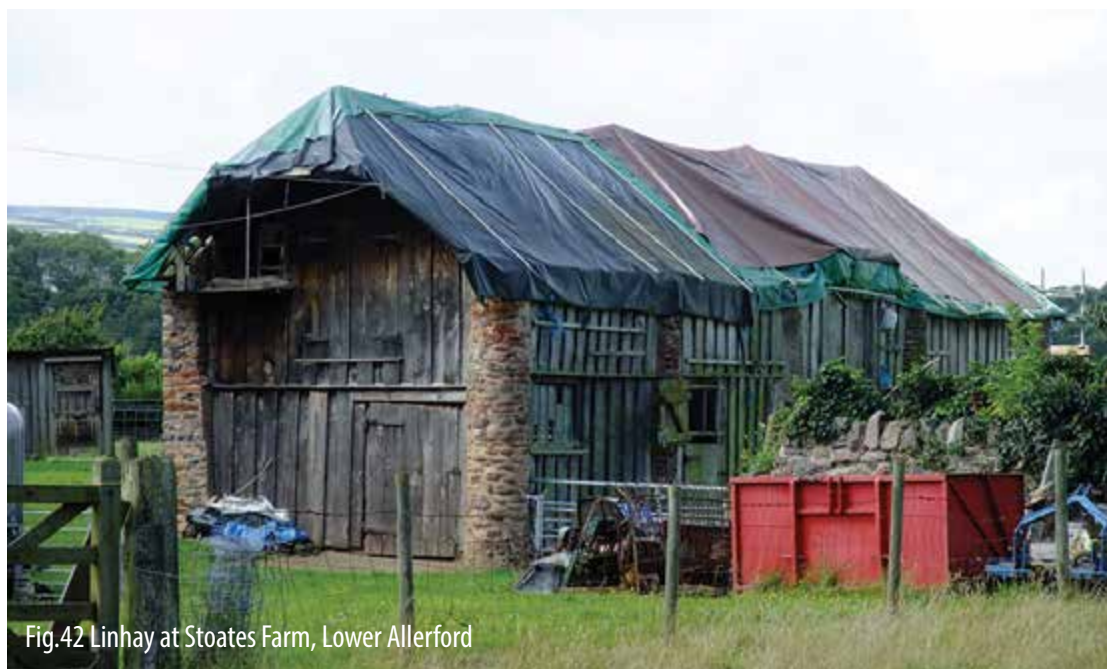
Fig.42 Linhay at Stoates Farm, Lower Allerford

To the north of the farm is a thatched **linhay** (Fig.42). This probably dates from the 18th century. Construction is a mix of stone-rubble and cob with weatherboard infill, and a half-hipped thatch roof. There are three bays with circular stone piers; a typical local feature. At the time of survey this building was in poor condition.

There are outbuildings at Lower and Higher Allerford that appear to be redundant in terms of their original agricultural use. The thatched linnhay at Stoates Farm, Lower Allerford (Fig.42), at the time of survey, has some roof damage and a temporary tarpaulin cover. This building is regarded as being 'at risk'. The farm buildings south of Hillside, Higher Allerford (Fig.43) look underused but appear to be in fair structural condition although they are undoubtedly in need of some repair. This situation is unchanged from the 2004 Appraisal.

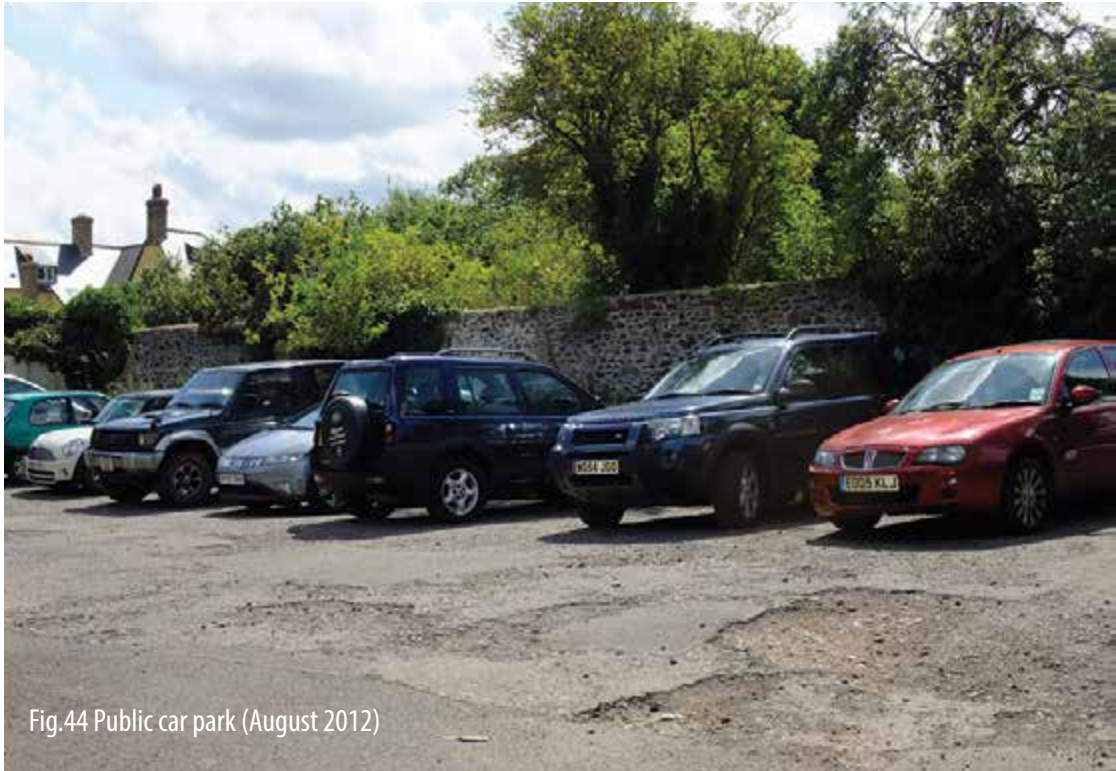
In the main part of the village, the car park (Fig.44) and its surroundings could benefit from some minor enhancement, for example signage, ground surface treatment, and improved boundary features. Elsewhere, for example at Stoates Farm, and at Higher Allerford are some outbuildings which appear to be redundant in terms of agricultural use and in need of repair (see 6.1).
