Exmoor National Park  
Historic Environment Report Series No 16

# EXMOOR FARMSTEADS CONSERVATION AREA: APPRAISAL DOCUMENT

Adopted 2018

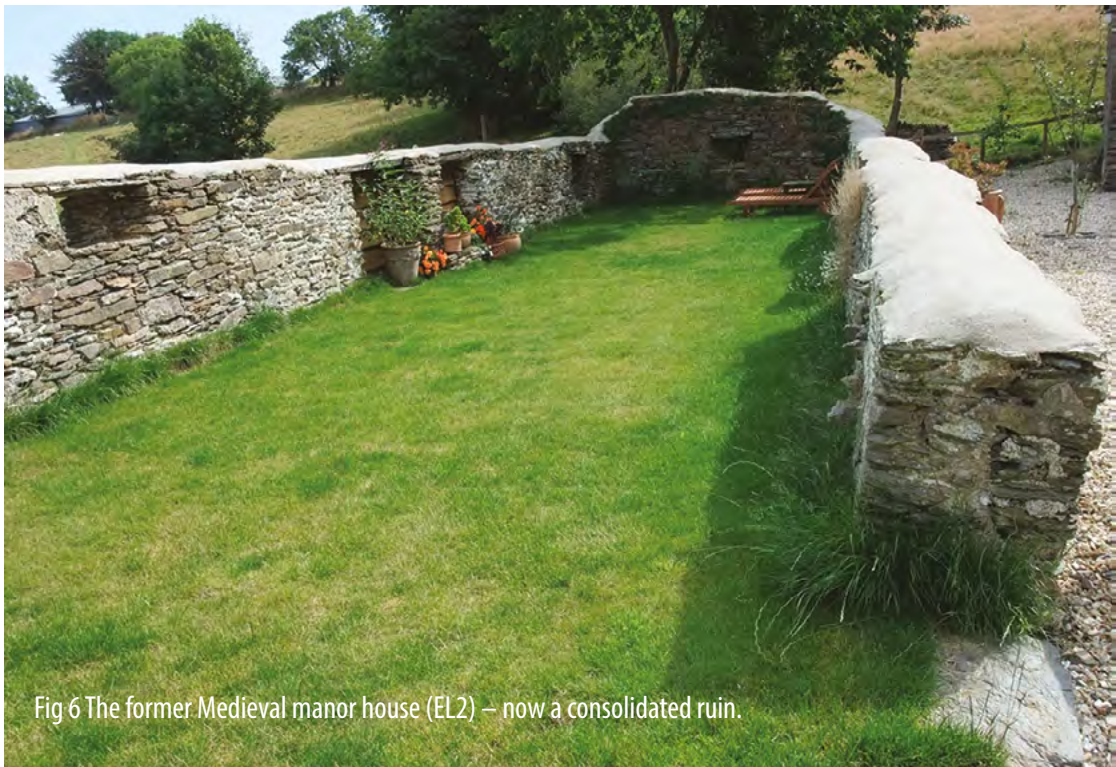
Some 11m north-east of the farmhouse and aligned east-west is what is believed to be the remains of a **Medieval manor house** (EL2). It seems likely that the majority of its life has, however, been spent in agricultural use and that it was abandoned as domestic accommodation in the late 16th century when the new house was built. Until 2013 most of the walls stood to close to full height but these have recently been reduced and consolidated following structural concerns.

Fig 6 The former Medieval manor house (EL2) – now a consolidated ruin.

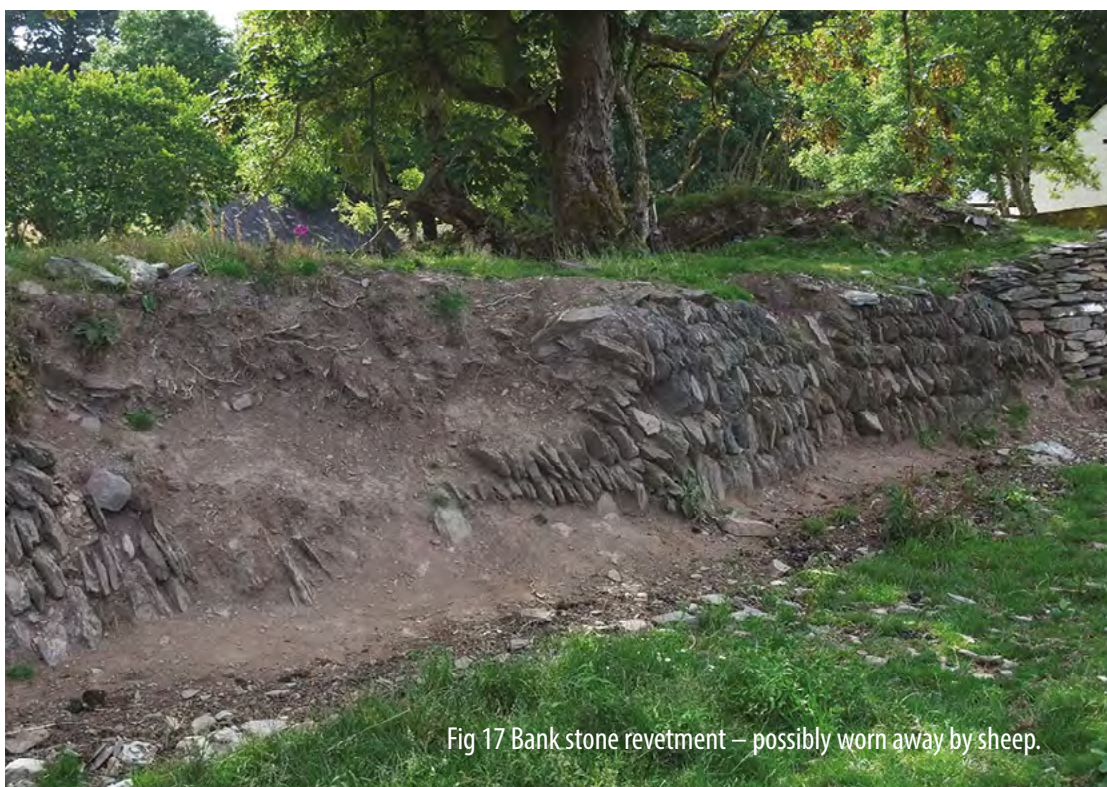
Fig 17 Bank stone revetment – possibly worn away by sheep.

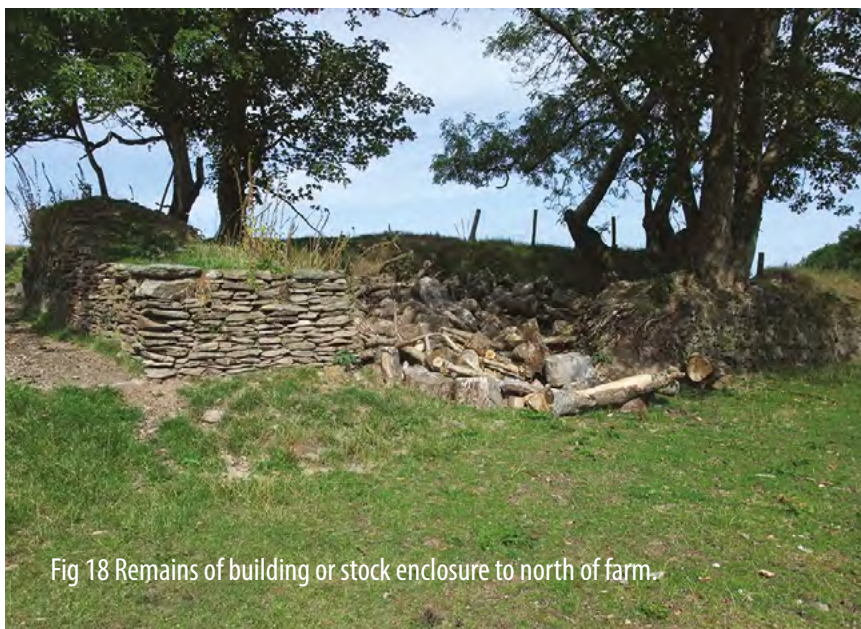
Fig 18 Remains of building or stock enclosure to north of farm.

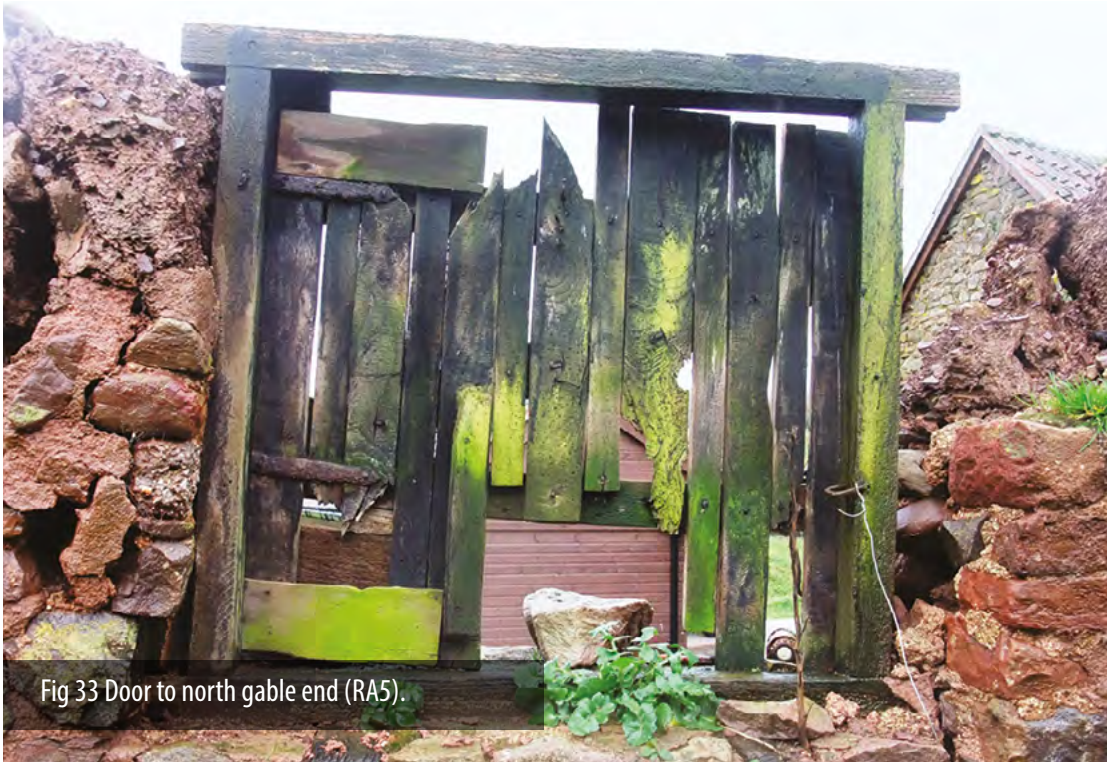
At the time of this current survey the condition of some curtilage listed buildings was of concern. Principally, the western building (RA5) is now derelict and with exception of the north gable is beyond repair. The south wall of wagon shed (RA8) has racked, caused by the spread of the roof, but could be effectively repaired.

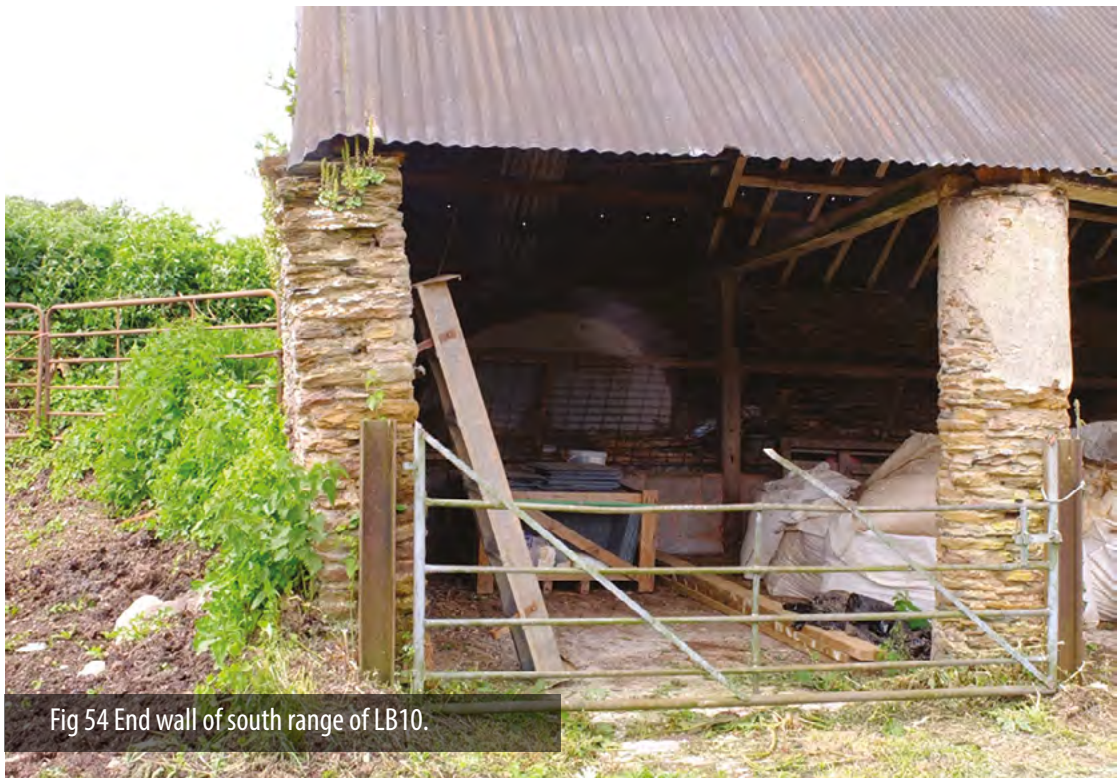
All the buildings listed in their own right are in good condition aside from some minor maintenance issues. The curtilage listed buildings are used mainly for storage and unsurprisingly the condition is variable, although none are critical and all appear mainly weathertight with essential maintenance being carried out where necessary.

Fig 54 End wall of south range of LB10.

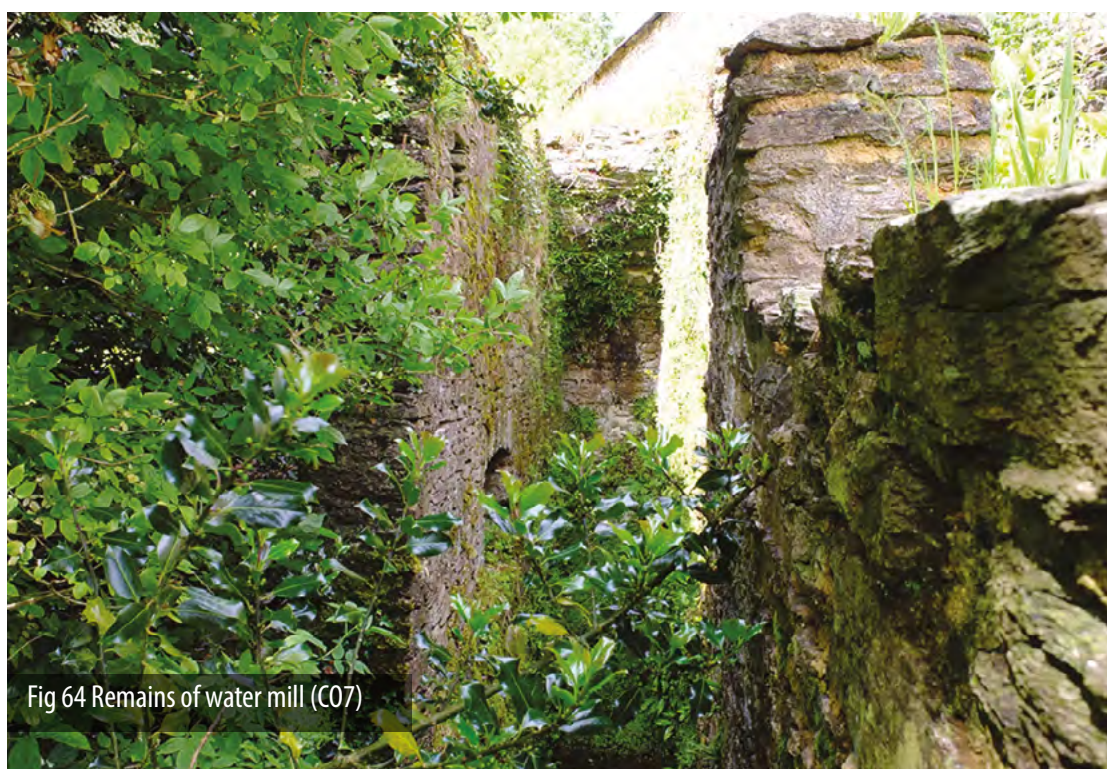
Fig 64 Remains of water mill (C07)

The condition of the buildings at Colton is generally good although there have been some losses, such as the cottages south of the eastern range of buildings, the former mill (CO7) and the outlying barn (CO12) which are ruins. The other buildings appear largely weathertight although most would benefit from some maintenance and are underused. Of more concern is the Linhay (CO10) which is built on a slope with resultant structural pressures.

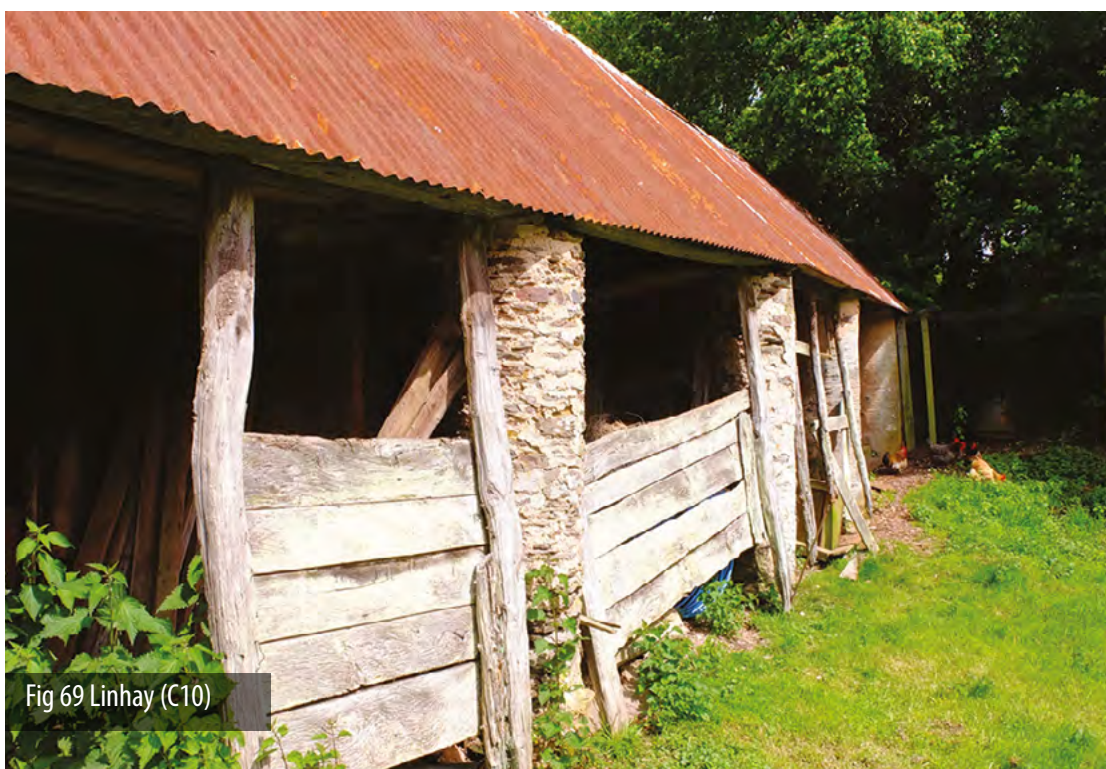
Fig 69 Linhay (C10)
