Exmoor National Park
Historic Environment Report Series No 13

DUNSTER CONSERVATION AREA: APPRAISAL DOCUMENT

Adopted 2018

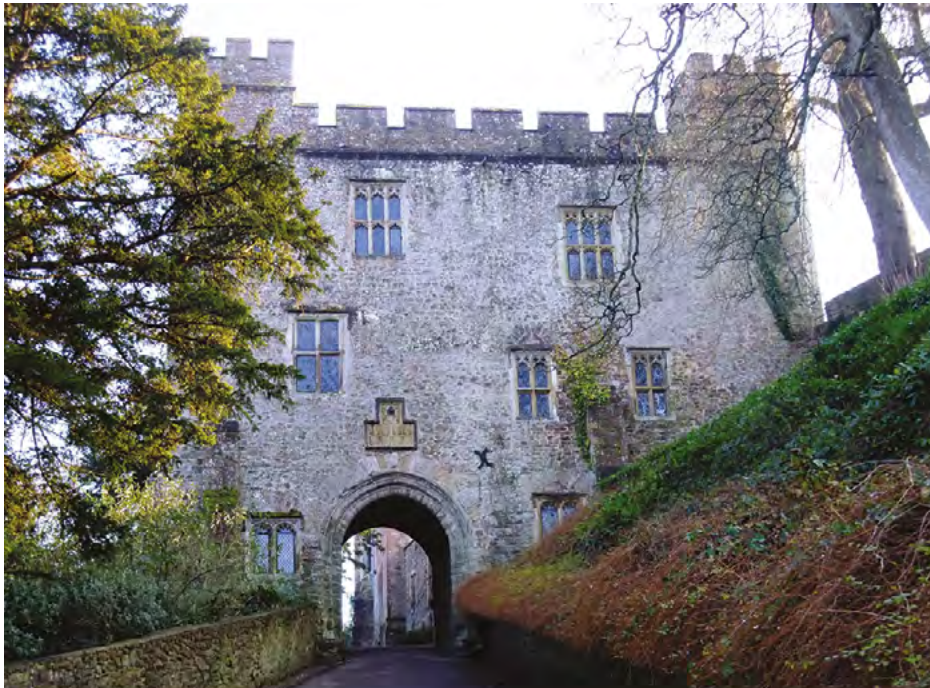
**Fig.2 Imposing
15th century
gatehouse to
Dunster Castle.**

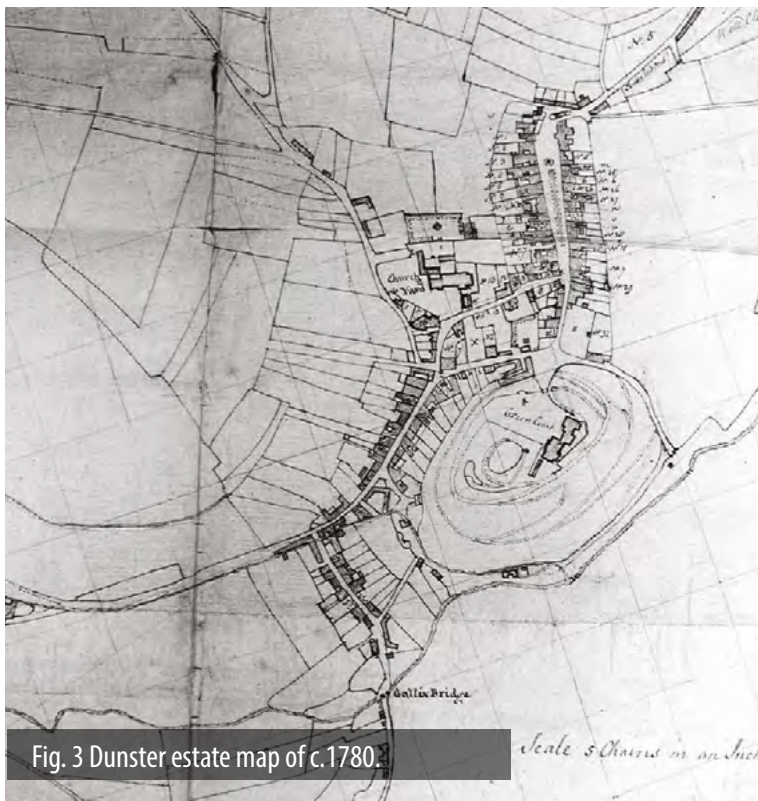
Fig. 3 Dunster estate map of c.1780.

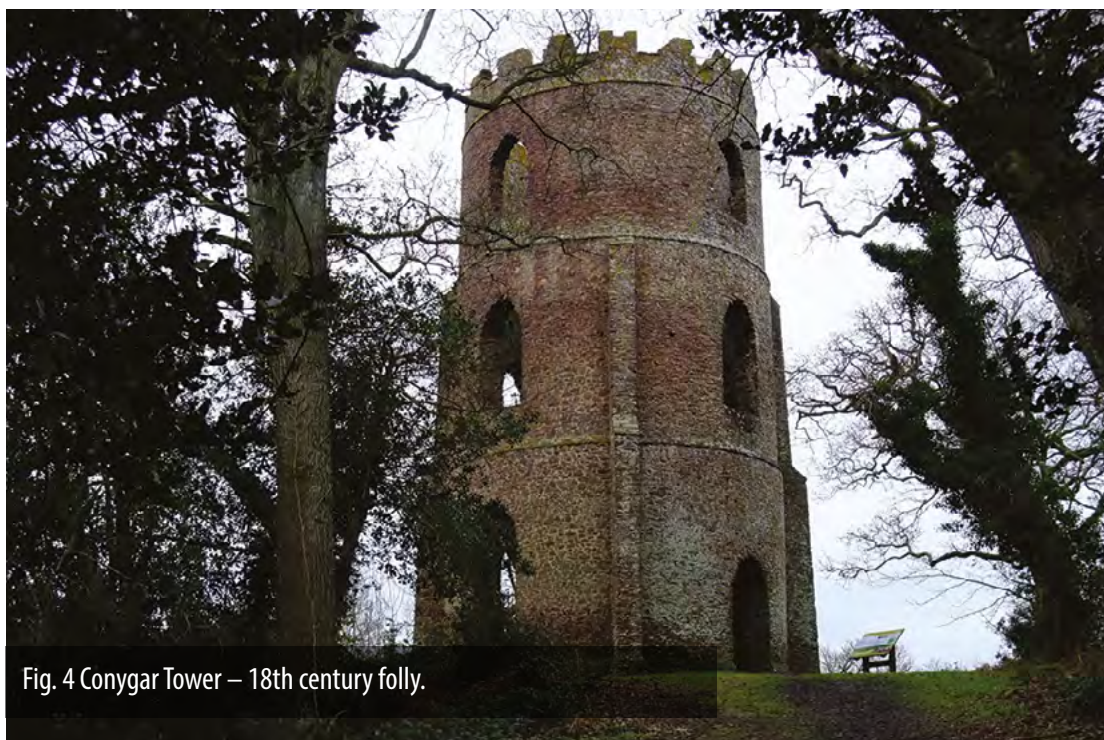
Fig. 4 Conygar Tower – 18th century folly.

There were substantial changes to the castle park which was remodelled in 1755. This work extended to Conygar Hill, the site of a medieval rabbit warren, which became a pleasure garden containing a number of follies including the tower (Fig 4) and gateway (Fig 84) which survive.

Immediately to the west is Conygar Hill, encircled by woodland and formerly part of a designed late 18th century landscape by Richard Phelps for H F Luttrell, the owner of Dunster Castle. **Conygar Tower** (Fig 4) on the east side was conceived as an 'eye catcher' and retains its role as a prominent landmark. The tower is a tall circular shell of red sandstone pierced by pointed arched openings. To the west of the tower is the only other surviving element of the former pleasure grounds, a gatehouse 'ruin' known as **the arches** (Fig 84). It comprises a length of curtain stone wall, two towers, one at the angle and the other at the western end of the wall.

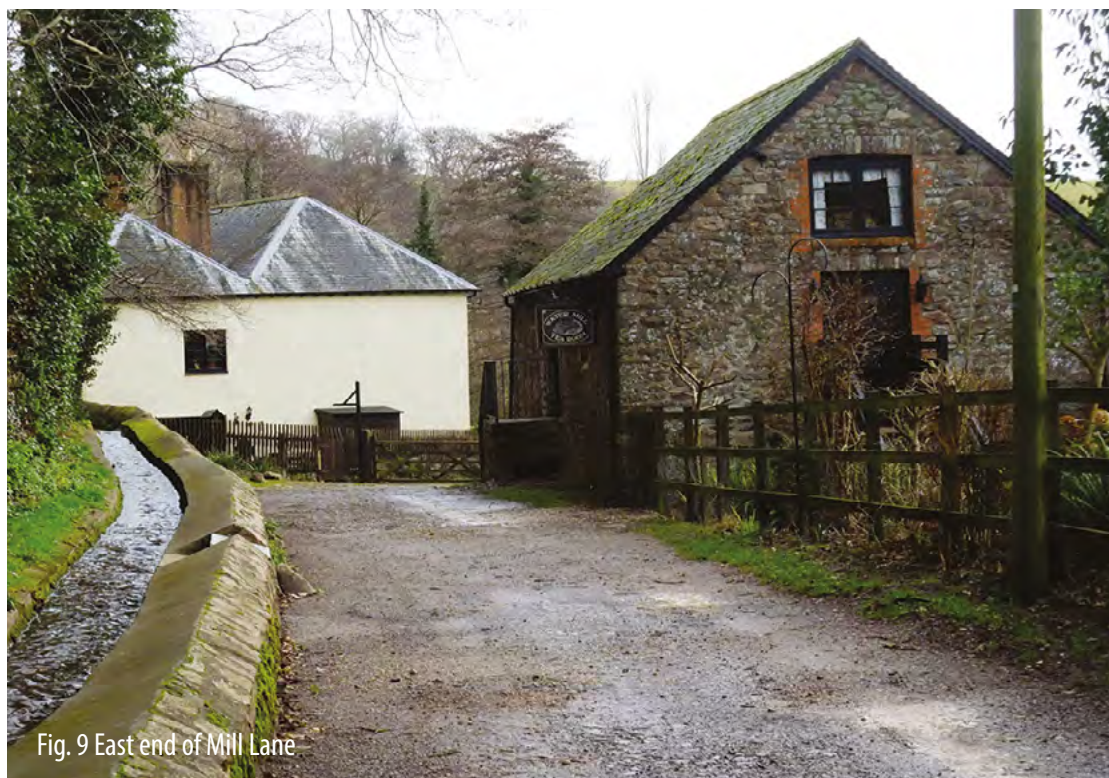
Fig. 9 East end of Mill Lane

Dunster Watermill is thought to date from the late 17th century and was rebuilt between 1779-1782. Records indicate it replaced two earlier mills and worked as a corn mill until the early 20th century. It originally had an overshot and an undershot wheel working side by side and was re-opened during the Second World War finally closing in 1962 before being fully restored to working condition in 1980. The present buildings are two-storey plus attics with two slate-hung dormer windows. The windows, several of which are arched, are mainly three-light casements with leaded lights, and the entrance is a plain stable-type boarded door. There is another at first floor-level with hoist. Attached is an arched gateway and wrought iron gates (Fig 42). The mill-lead is an attractive feature following the lower part of Mill Lane above road level (Fig 9).

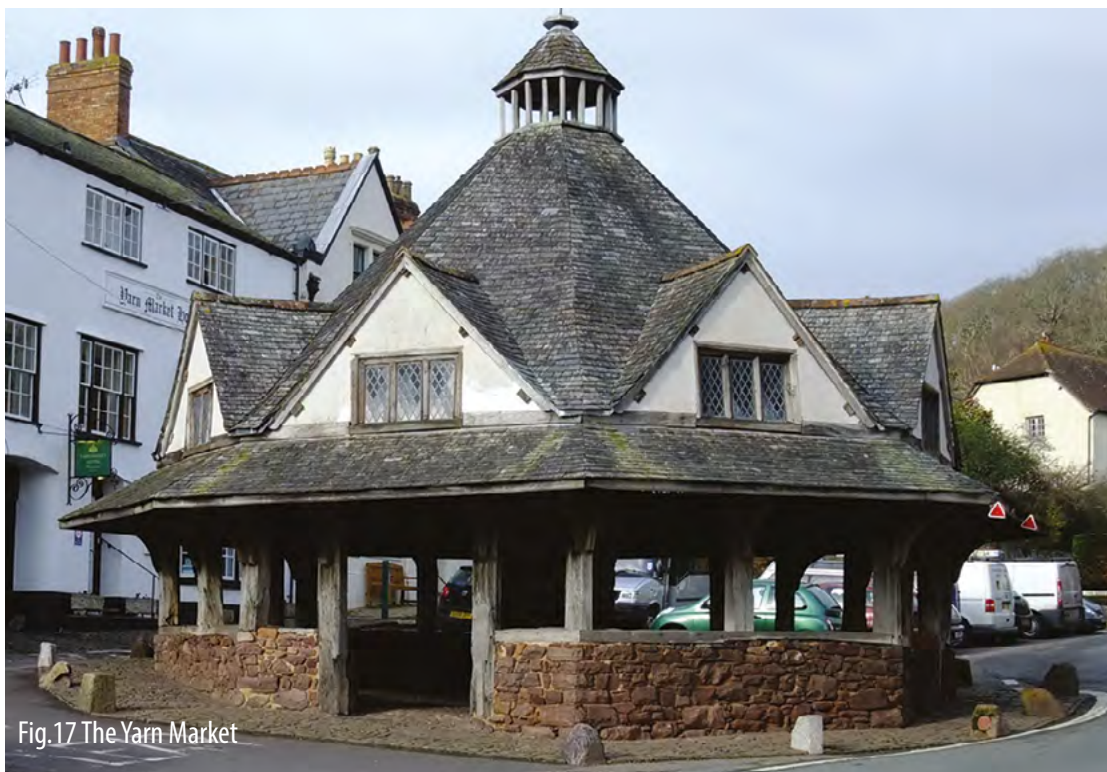
At the north end of the High Street, **The Yarn Market** (Fig 17) is tangible evidence of Dunster's once flourishing cloth trade. The exact build date is unknown but it is likely to date to the decades either side of 1600. It is octagonal in plan with a massive central stone pier supporting a timber frame structure with vertical posts sprung from an enclosing low stone rubble wall. The slate roof has a timber lantern and weathervane with the initials 'GL' (George Luttrell) and date 1647 – the date of the post-civil war repairs. On each face is a gabled dormer with three-light timber casement window with moulded mullions.

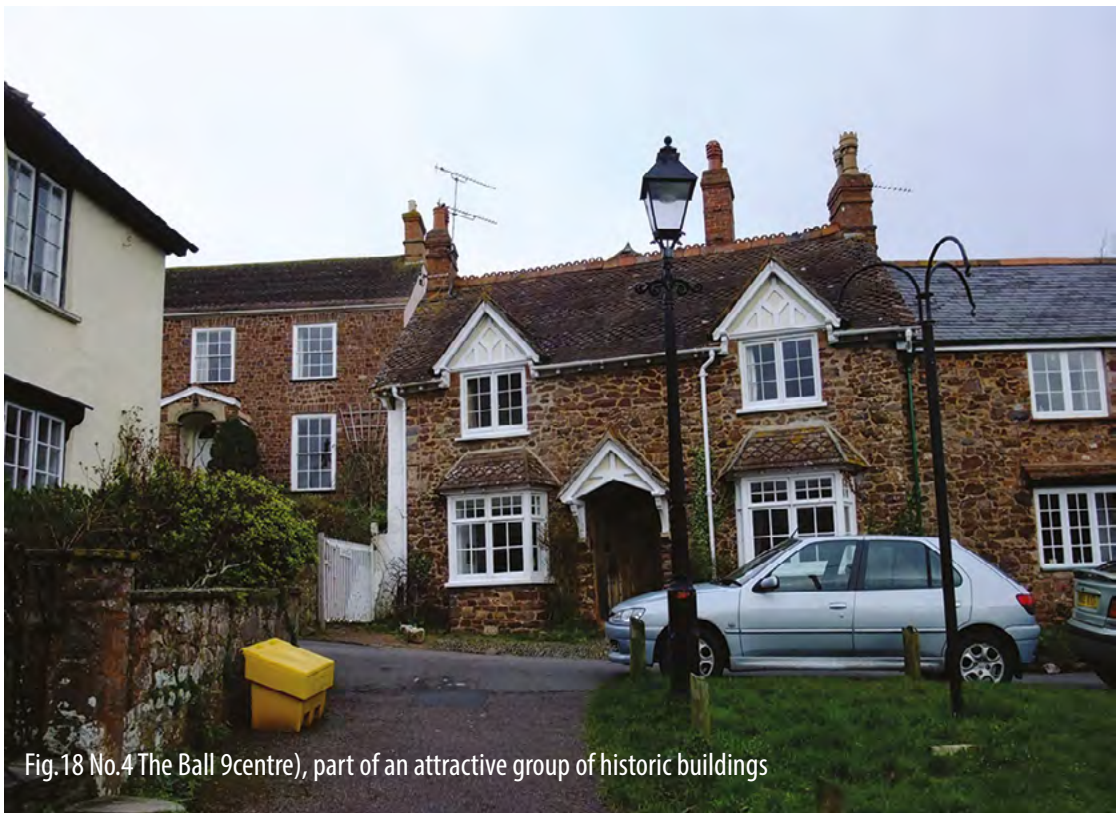
Fig.18 No.4 The Ball (centre), part of an attractive group of historic buildings

Just north of the Yarn Market a path leads up to The Ball – a group of houses clustered around a tiny triangle of grass. Nos. **5-10 The Ball**, are modest in scale and form a continuous row of early 19th century cottages in random sandstone with slate roofs. At the end of the terrace, no. **4 Priory Gate House** (Fig 18) has a 17th century core but with a 19th century patterned tiled roof, two gabled semi-dormers with barge boards and mock timbering above two canted bays each side of a decorative porch. No. **3** is of mid 19th century date detached and set back from the terrace.

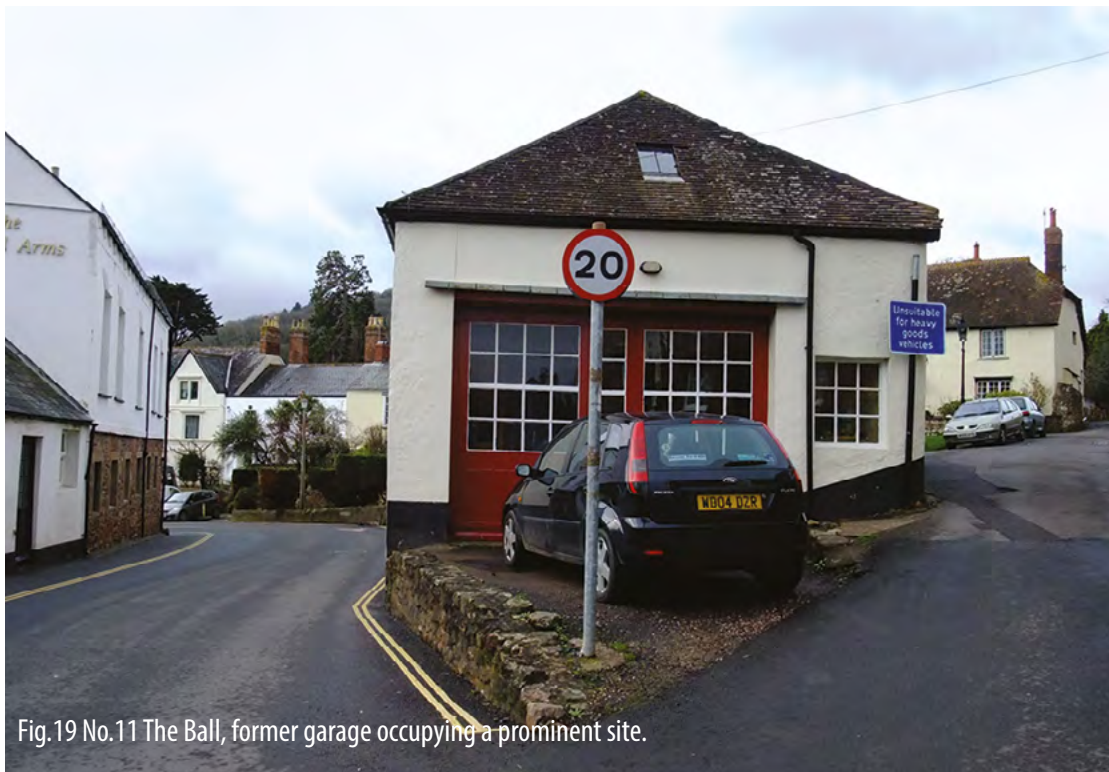
Fig.19 No.11 The Ball, former garage occupying a prominent site.

To the south west of the row, **2 The Ball** is a late 18th century or early 19th century two storey rendered house with a half hipped roof and single storey **former Smithy** built of local sandstone rubble to the rear. Other evidence of commercial activity in this now residential part of the town survives in the former garage at the east end of **11 The Ball**, a visually unadorned early 19th century or earlier building of plain tile and render occupying a key place in the street scene on an 'island' site between High Street and The Ball.

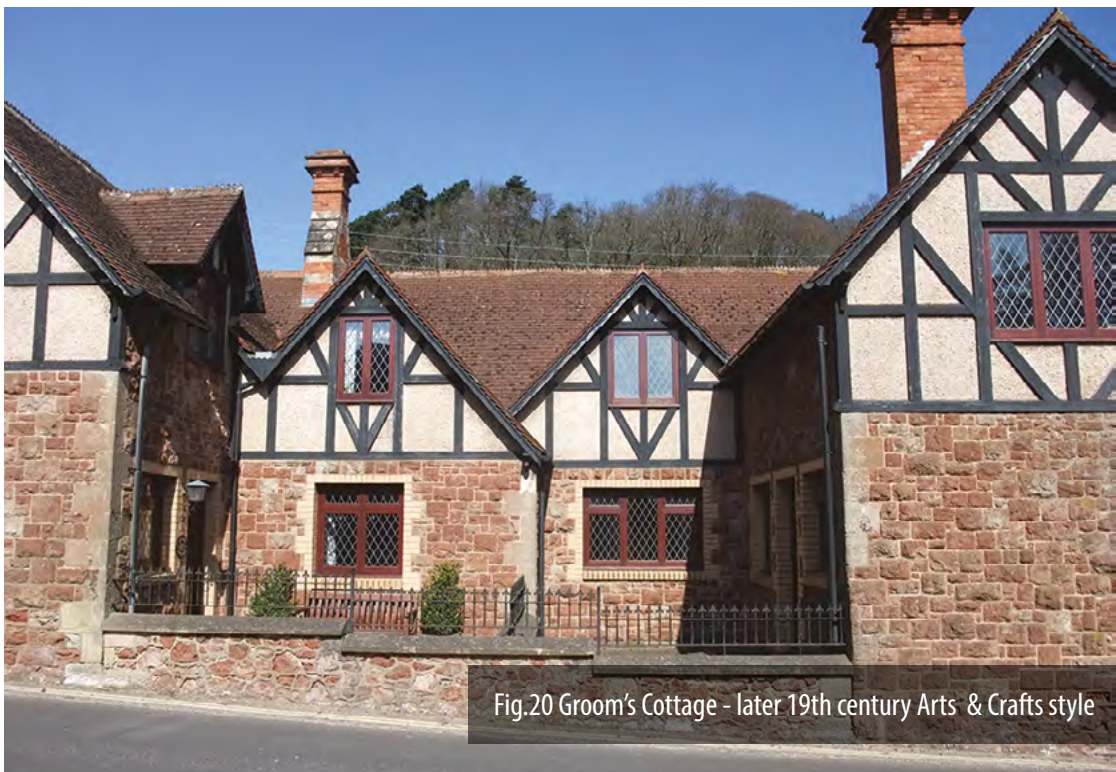
Fig.20 Groom's Cottage - later 19th century Arts & Crafts style

At the junction of The Ball, St Thomas Street and Dunster Steep, and also prominent in the street scene, is **Groom's Cottage** (Fig 20), a late 19th century Arts and Crafts style eclectic mix of stone, brick dressings, and render with a tiled roof, applied timber decoration to the gables, and ornate brick stacks. Lower down Dunster Steep and opposite the car park, is **The Archers**, originally two Georgian houses of the late 18th century, built of stucco with slate roof and brick stacks. There is a six light front of sash windows with narrow glazing bars, and two entrances, each with reeded pilasters and elliptical fanlights with tracery, and further pilasters at the quoins.

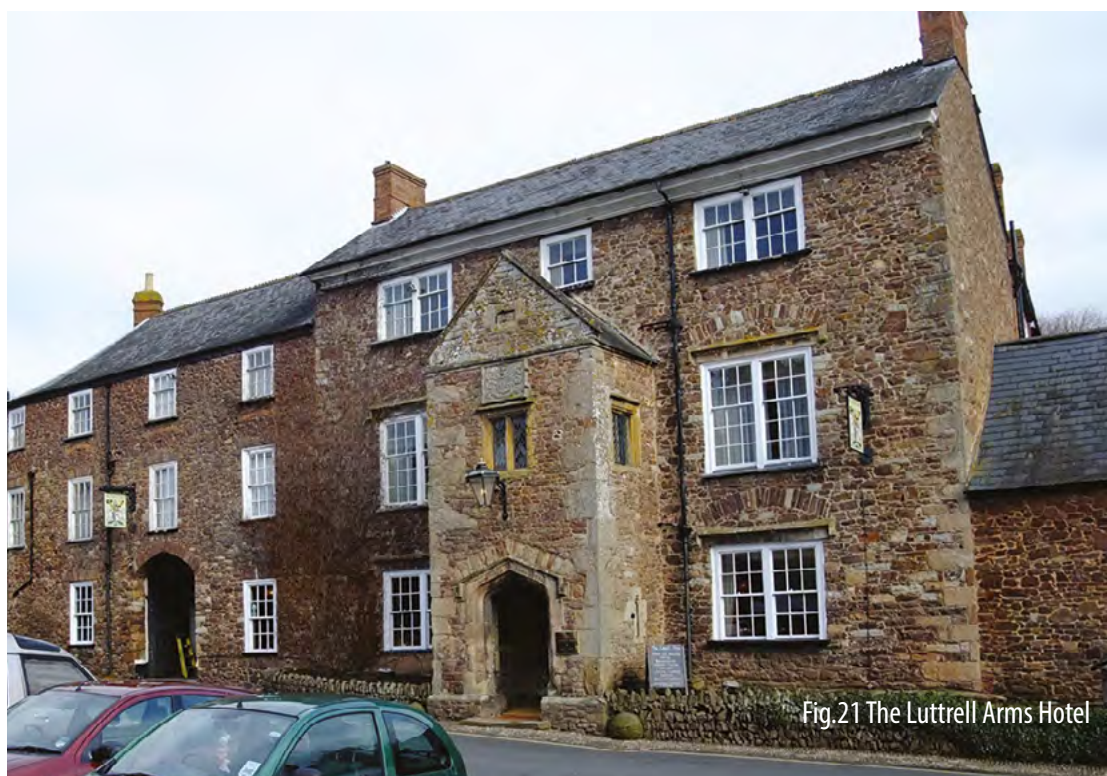
Fig.21 The Luttrell Arms Hotel

Back on the High Street, opposite the Yarn Market is the **Luttrell Arms Hotel** (Fig 21) - another of Dunster's landmark buildings. It appears to have been an inn dating back to its construction in the late 15th-early 16th century, with significant alterations in the 17th and 18th century. It is a substantial building of stone rubble with a two-storey gabled porch with four-centred arch entrance, and inner pointed arch with carved spandrels. A rear wing has a fine carved oak window extending through both floors with cusped heads (Fig 22) and a first floor hall with an open timber roof displaying moulded arch braces, purlins and curved wind braces. There are many other interior features of note, including heavy moulded oak ceiling beams, and decorative plasterwork of the early 17th century. An adjoining former carriage entrance gives access to a cobbled courtyard and leads to a former stable range to the north which curves around to the top of Dunster Steep into High Street and is built of local red sandstone with dressed openings, some of which are segmental arched.

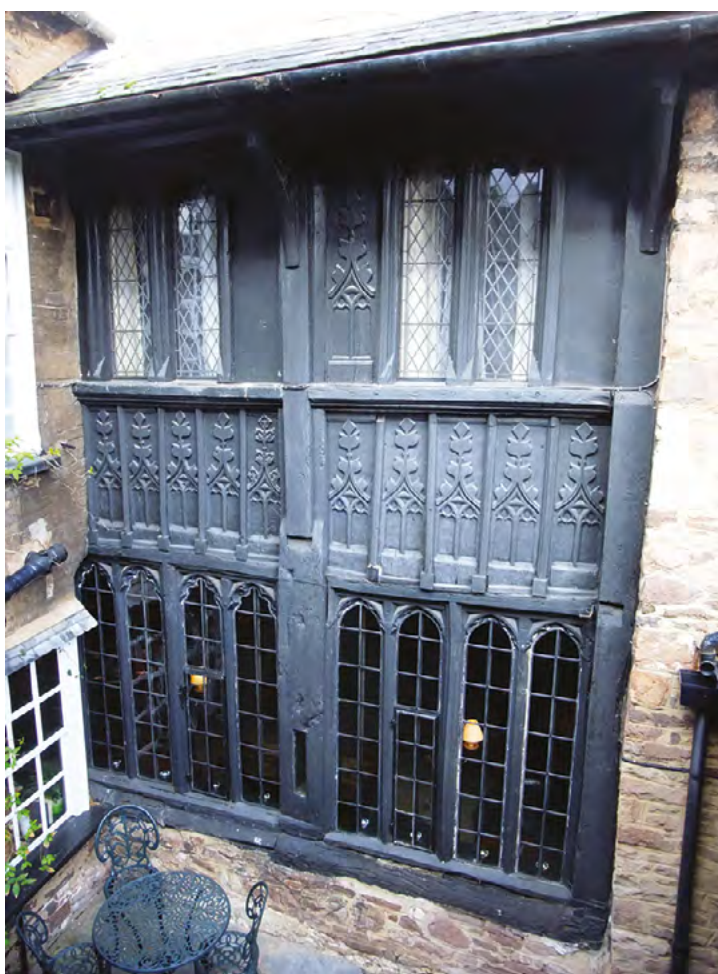
Fig. 22 Window to rear wing of the Luttrell Arms.

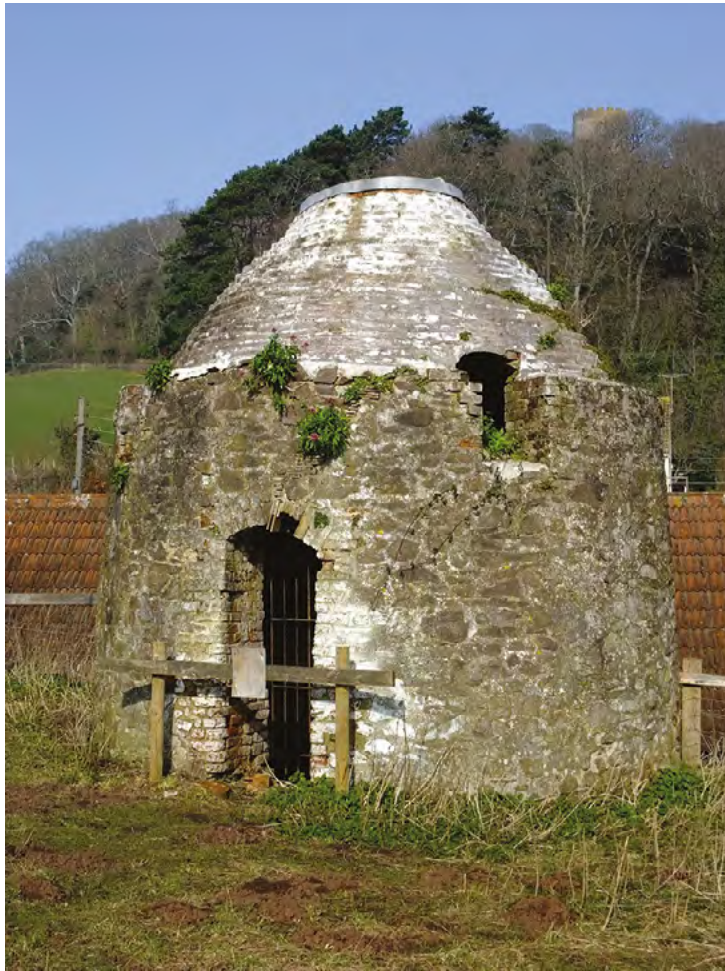
Fig. 23 Mid 18th century Pottery kiln now in the Park.

To the rear of the Luttrell Arms, but now within the park, is a **pottery kiln** (Fig 23) the only surviving structure of the pottery run in conjunction with the Luttrell Estate Brickworks, and established around 1750. It is a circular stone building of local red sandstone with brick jambs and brick linings and a shallow-domed brick roof.

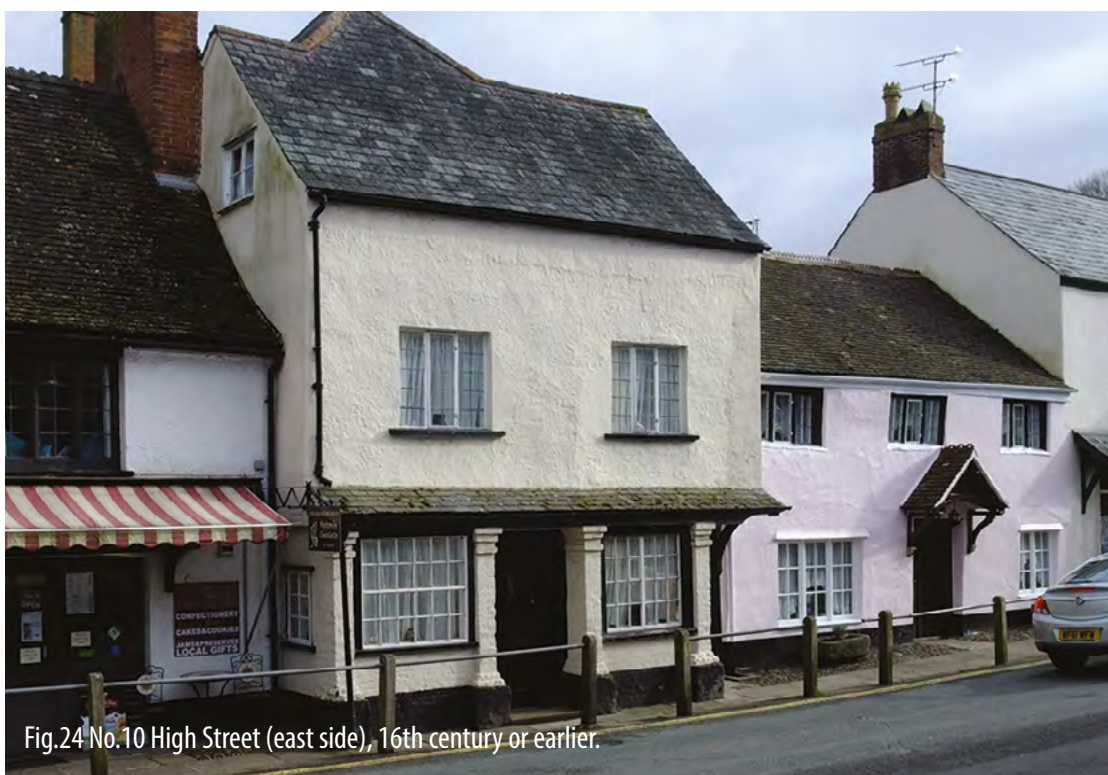
Fig.24 No.10 High Street (east side), 16th century or earlier.

The rest of the east side of the High Street, has mainly two storey rendered frontages with slate or plain tile roofs, although the few three-storey frontages introduce contrasts in height. Among the earliest cottages is **10 High Street** (Fig 24). Based on external inspection it dates from the 16th century, and breaks forward of the building line. There are ground floor square bays with small-paned windows and first floor three-light leded metal casements. Other buildings date either from the 17th century (**6, 12, & 14**); or the 18th century (**2, 8, & 16**); and the early 19th century (**4, 26-28** a pair dated 1825, and **30**). The remainder date from the mid 19th century.

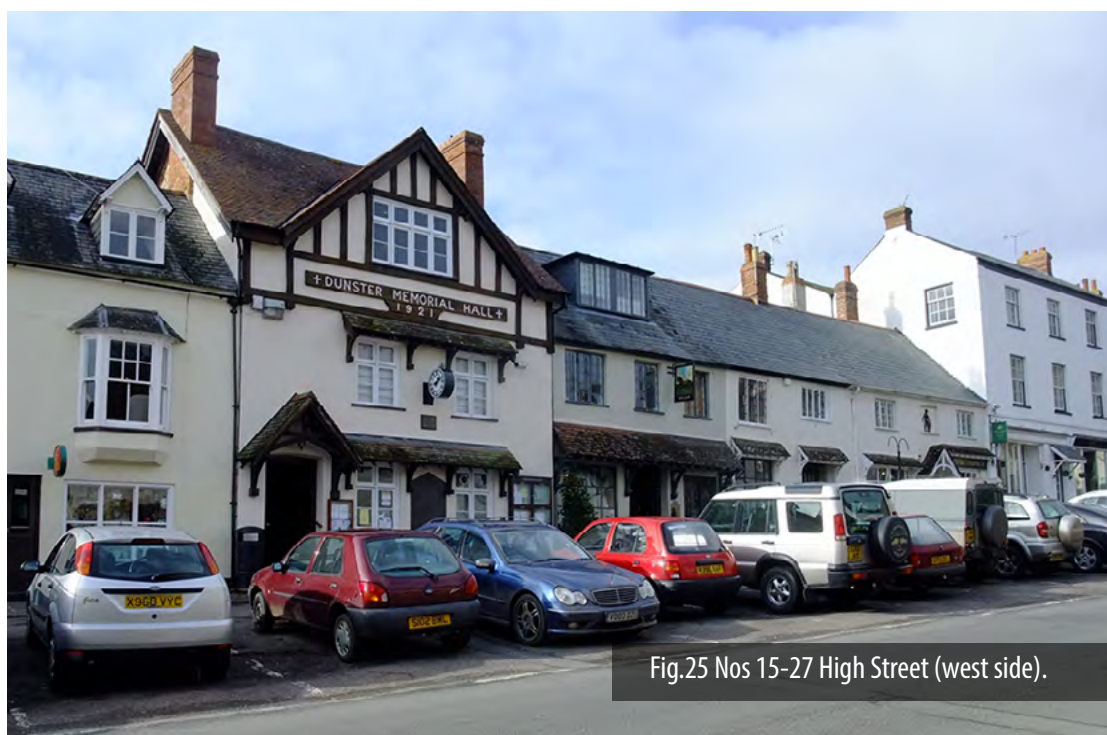
Fig.25 Nos 15-27 High Street (west side).

On the west side, **19, 21 & 23** are 17th century; **3, 5, 7, 15 & 33** are 18th century, and **13, 25, 27, 29, 31 & 35** are early 19th century. **The Dunster Memorial Hall**, built 1921, is a rare later insertion with Arts and Crafts features including mock timber framed gable with deep eaves, and gabled porch with carved brackets but integrates well in the street scene. Elsewhere frontages vary considerably in scale and detail but are fairly consistently rendered. Only no. **3** (Fig 26) has a later red brick front to the earlier building, and a rear wing which according to the list description has a 17th century two-light window with ovolo-moulded frame.

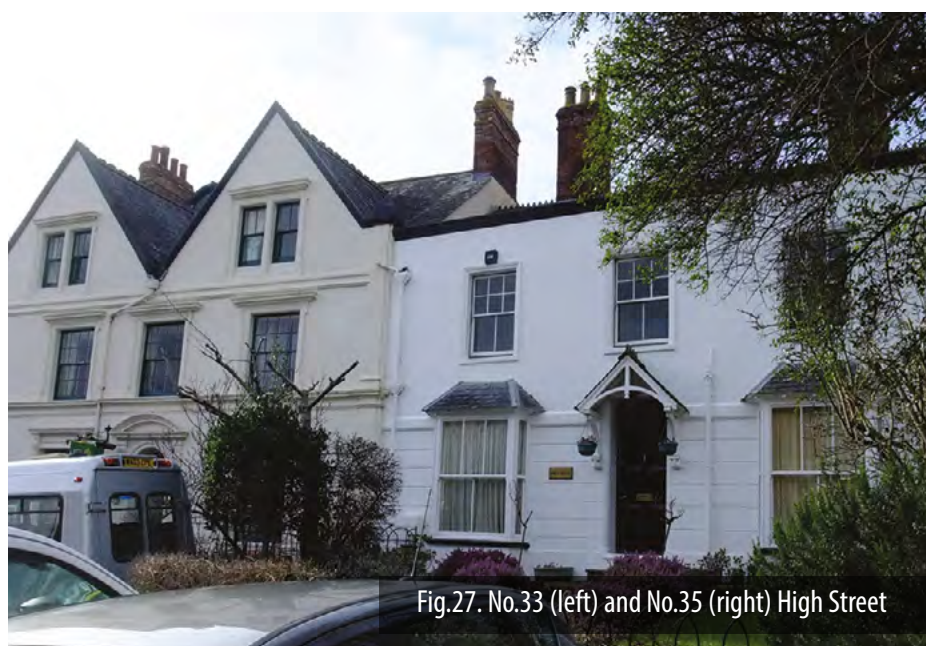
Nos **33** & **35 High Street** (Fig 27) have good frontages; the former is stuccoed having gables with moulded copings, pilasters and moulded string courses, the latter has moulded coping to the parapet, sash windows in moulded architraves, one each side of a central panelled door with a late 19th century hood. It should be noted that there is strong evidence to suggest that behind many of these frontages of all dates the core of earlier buildings may survive.

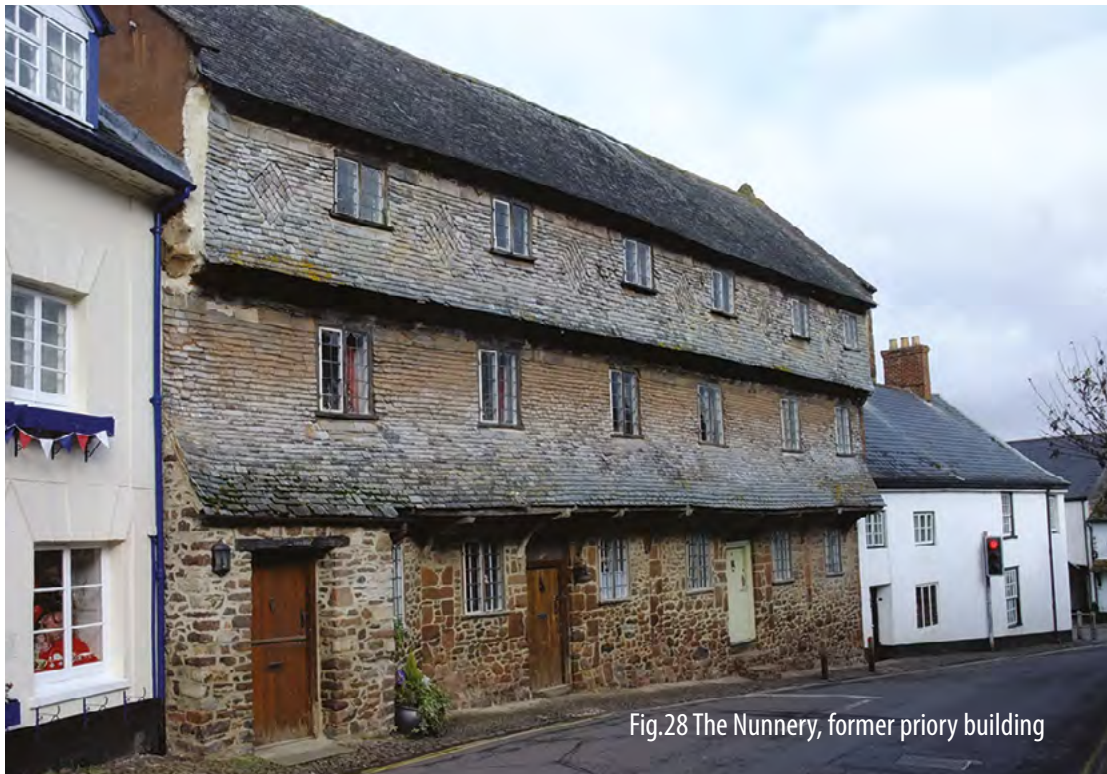
Fig.28 The Nunnery, former priory building

At the south end of the High Street, the road turns sharply into Church Street, with the High Street frontages continuing on the north side but ending abruptly near the church. The narrow street is dominated by **The Nunnery (Nos 4-8 Church Street)** (Fig 28), a long three storey six bay gabled house with tiled roof and slate-hung projecting upper floors, divided into three cottages. It probably dates from the late 14th to early 15th century and was originally attached to the priory. After the Dissolution, it was sold in 1620 to Robert Quirke of Minehead and in 1781 is recorded as being in use as a malthouse. The windows have leaded-light iron casements in timber frames, and there are stable-type vertical plank doors. The east end elevation has a 15th century opening with moulded surround and cusped head.

On West Street and High Street the frontages are generally rendered, in keeping with the 'polite' makeover that these earlier medieval buildings underwent in the mid 18th – early 19th century. Some of these may be of timber frame construction on the upper floors, such as the jettied Nunnery, which has splendid slate hanging (Fig 63), the Yarn Market, Dovecote (Figs 52 & 64) and, although altered during 19th century restoration, the Priest's House. Jointed cruck framing is a local feature that is relatively widespread in 17th century or earlier houses, and some roofs will undoubtedly contain early timber.

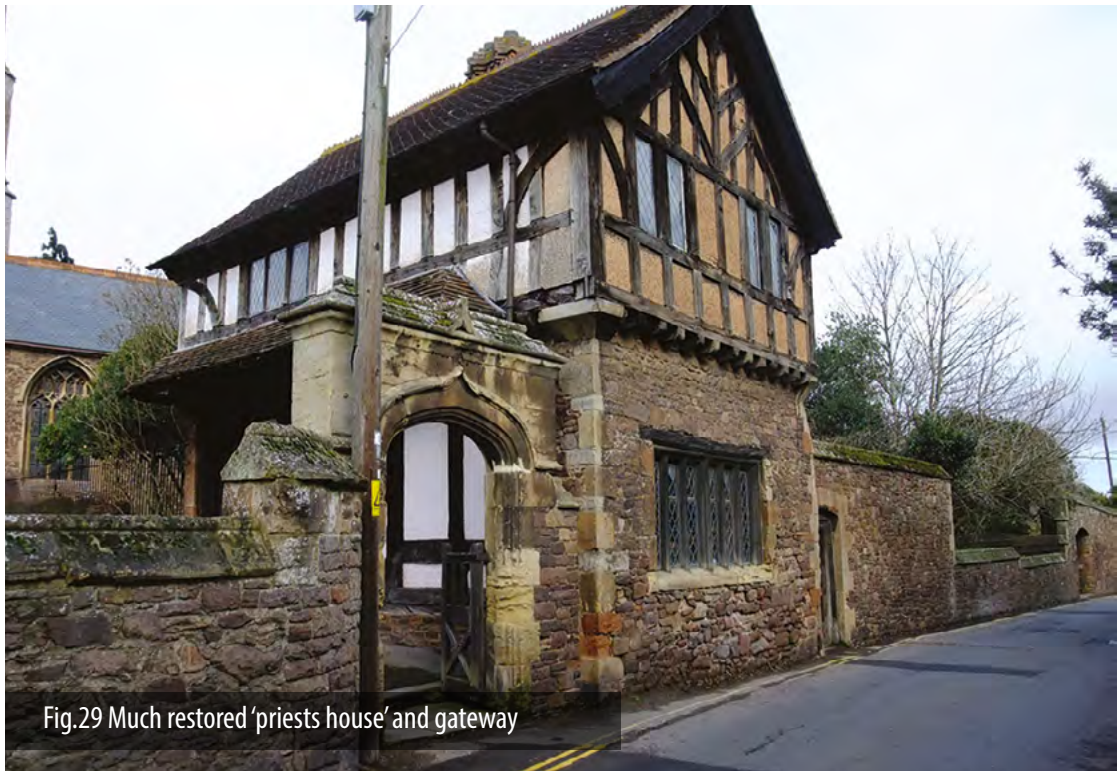
Also connected with the priory is the former priest's house (**18 Church Street**) (Fig 29), with tall Tudor style brick stacks, mullioned casements with diamond-lead panes and a four-centred entrance door. It is late medieval in origin but virtually unrecognisable as such following GE Street's heavy restoration of 1877.

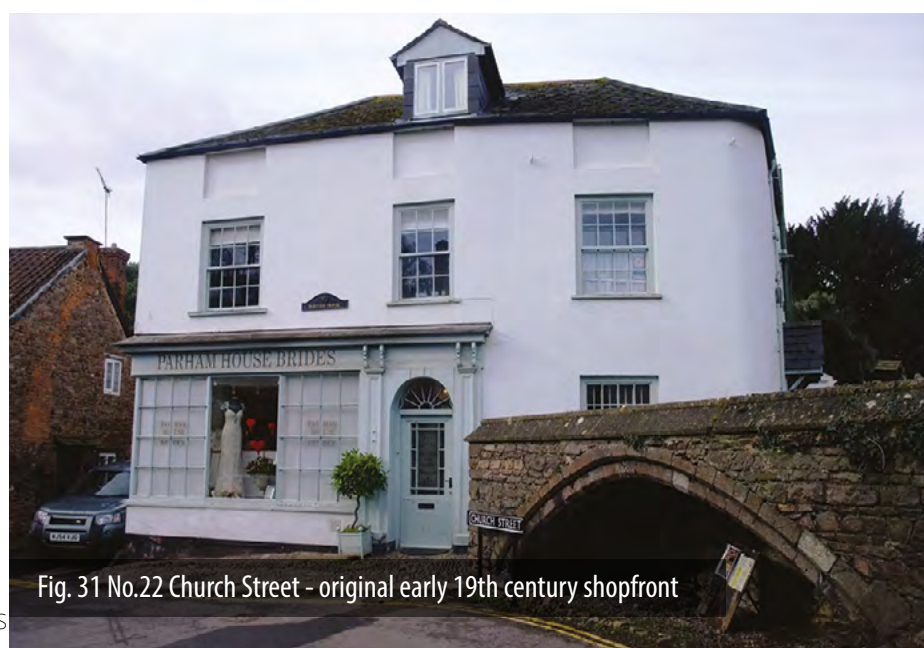
Fig. 31 No.22 Church Street - original early 19th century shopfront

colour washed render, the latter described as brick fronted in the listing details but is now rendered. No.22 (Fig 31) has a 19th century shop front with narrow glazing bars and a semi-circular headed door opening with engraved glass lettering (reading 'Guest, Boot Factor and General Warehouseman') and an arched fanlight above. Nos **26 & 28** (Fig 32) are 17th century, of stone rubble with pantile roof with brick end stack and a tall, square, stone rubble front stack. The windows, like many in Dunster, are mainly leaded iron casements in timber frames.

Many Dunster shop-fronts are traditional in style, with such features as sign-written fascia boards with cornice, flanking pilasters, console brackets, and recessed doorways. There are numerous good examples along the main streets, with the early 19th shop front at 22 Church Street, which includes late 19th /early 20th century etched glass to the door and an ornate fanlight, being of particular note (Figs 31 & 70).

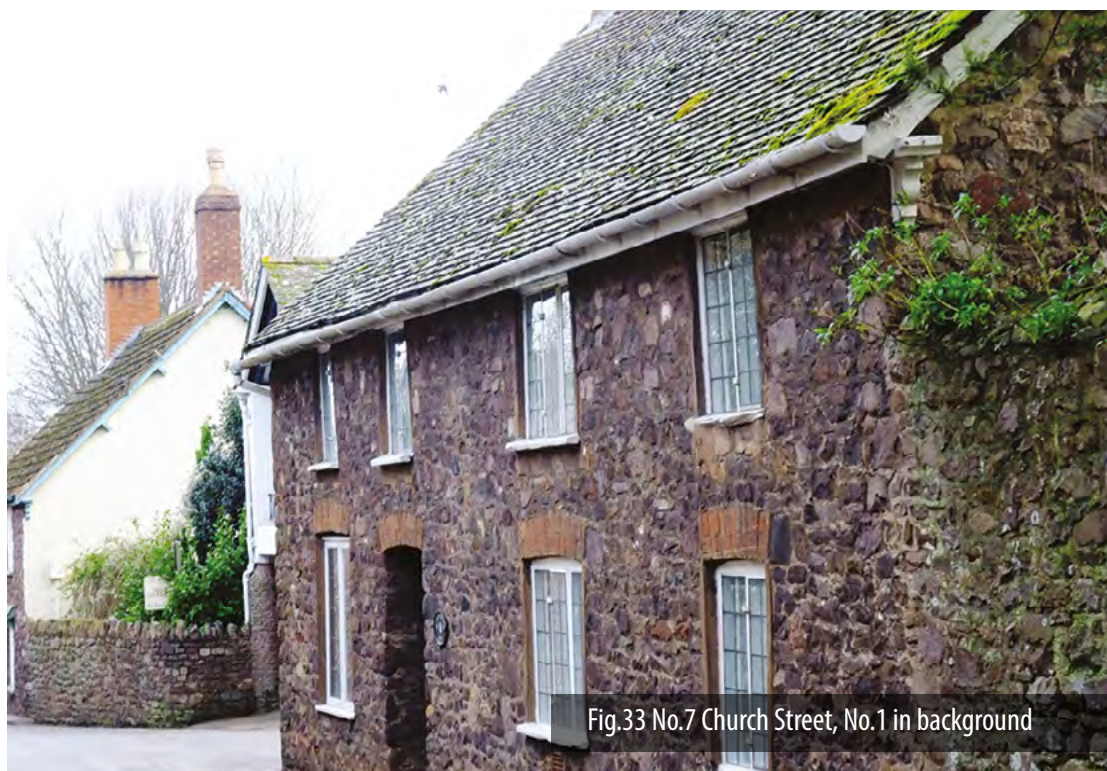
Fig.33 No.7 Church Street, No.1 in background

Nos **1, 7 (Castle Cottage)** (Fig 33) and **8**, are three cottages on the south side of Church Street - all early 19th century or earlier. They are in local vernacular style with mainly sandstone or rendered elevations and plain tiled roofs. No. 7 has brick segmental arch openings, and timber casement windows. Between nos. 7 and 8 is a shallow ogee-head arched door frame and ribbed and studded door which appears to be 18th century or earlier.

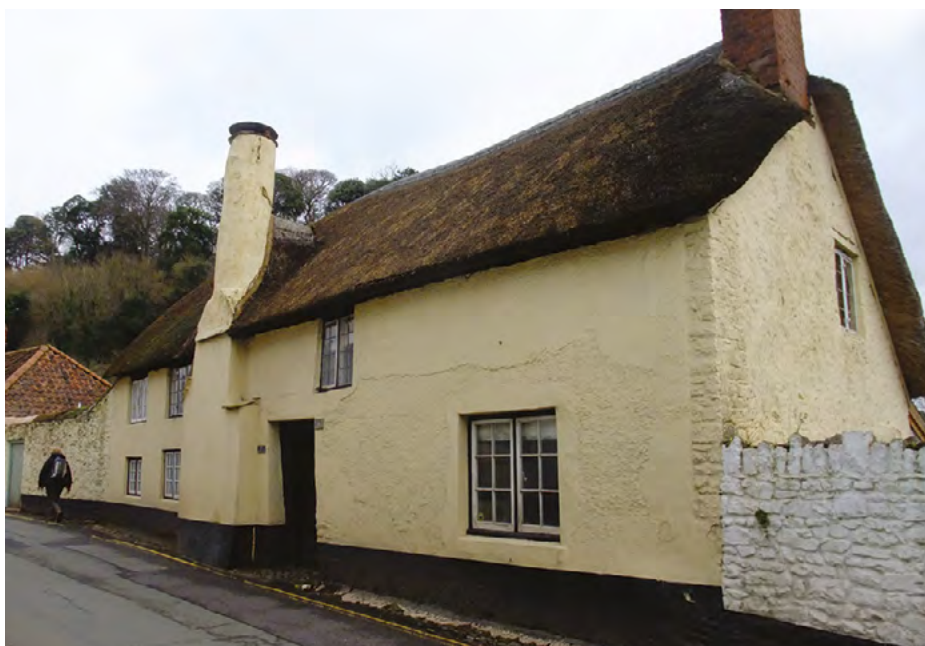
Fig.35
27-29 West Street

On the east side, No. **17** is mainly 17th century with four first floor windows having leaded iron casements in wooden frames. The door opening is under a timber lintel with a recessed heavy chamfered oak door-frame. Nos **27-29** (Fig 35) make up a 17th century house typical of the local vernacular style with rendered and colour-washed stone-rubble, a front stack with tall rounded shaft, leaded iron casement windows in timber frames, and a timber plank door in a heavy chamfered oak frame. The listing details refer to this house as a 'picturesque feature in the street scene.' No. **1** is late 17th-early 18th century whilst **7, 9, 11 & 13** are all 18th century, as are **19, 21, 23 & 31**, making a remarkably complete sequence on this side of the street. No. **15** (Westleigh), and **25** (Woodville House) are both early 19th century with typical features of the period including colour-washed rendering, panelled central door with semi-circular fanlight, and sash windows with narrow glazing bars.

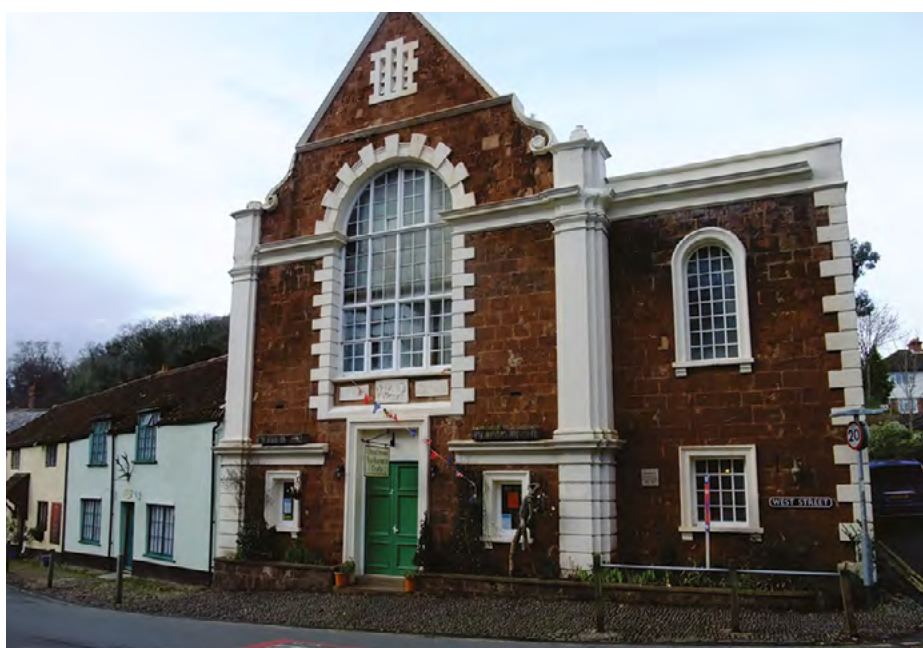
Fig. 36 Former
Methodist Church
of 1878

On the opposite side of West Street, the former Methodist Church (Fig 36), built 1878 by Samuel Shewbrooks of Taunton, is a dominant feature built of coursed red sandstone with dressings to windows and some frontage rendering. Other detail includes an ornate Dutch style gable with scrolls and spiked ball finial, a large central window with rusticated voussoirs. The Chapel house adjoins to the right.

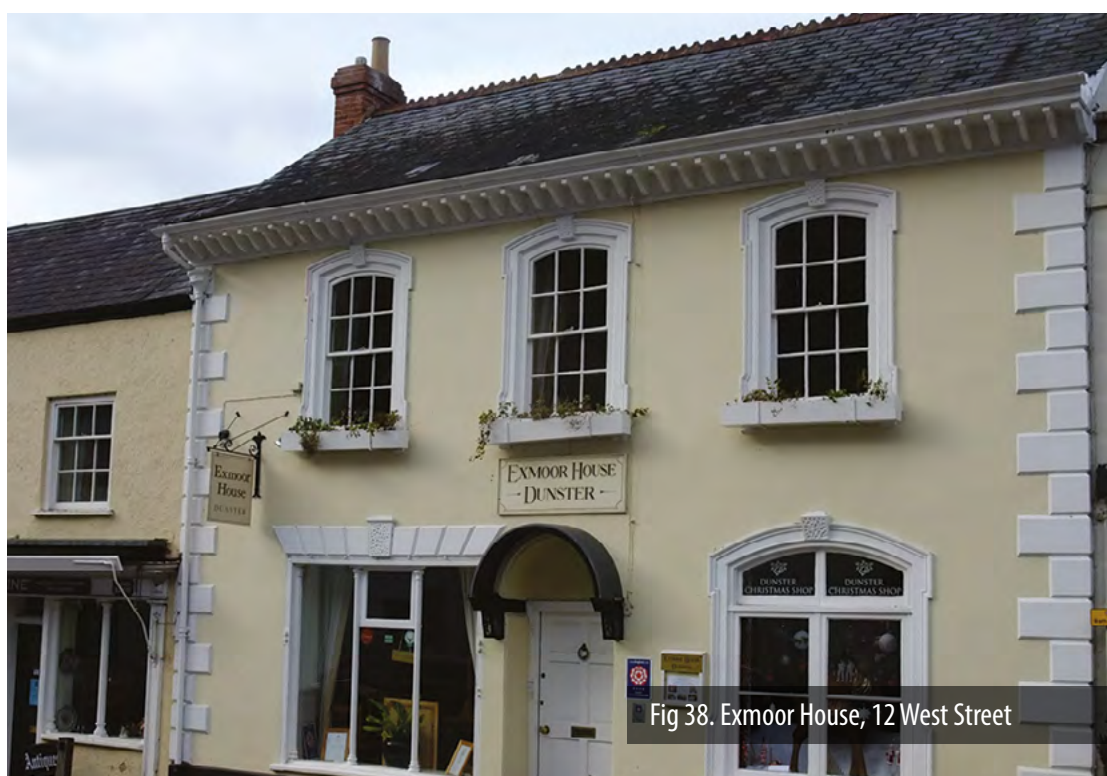
Fig 38. Exmoor House, 12 West Street

The Stags Head Inn (No. 10) is an early 19th century rendered frontage to a possibly earlier structure with end pilasters, recessed door, four wooden casement windows in flat-headed openings with stepped voussoirs. Adjoining, and also early 19th century, **Exmoor House Hotel (No. 12)** (Fig 38), has a much stronger period frontage with ornate stucco detail, including rusticated quoins, moulded architraves, cills on brackets, stepped voussoirs and wide bracketed eaves. There is a semicircular arched doorway with panelled door. **Nos. 14 -22, 26** and **34a & 34b**, all have early-mid 19th century frontages, though with possible earlier fabric. Most are rendered with slate roofs, and have sash windows with narrow glazing bars and central doors, the latter often recessed within flat, elliptical or semicircular heads. Nos. 34a & 34b have a thatched hipped roof.

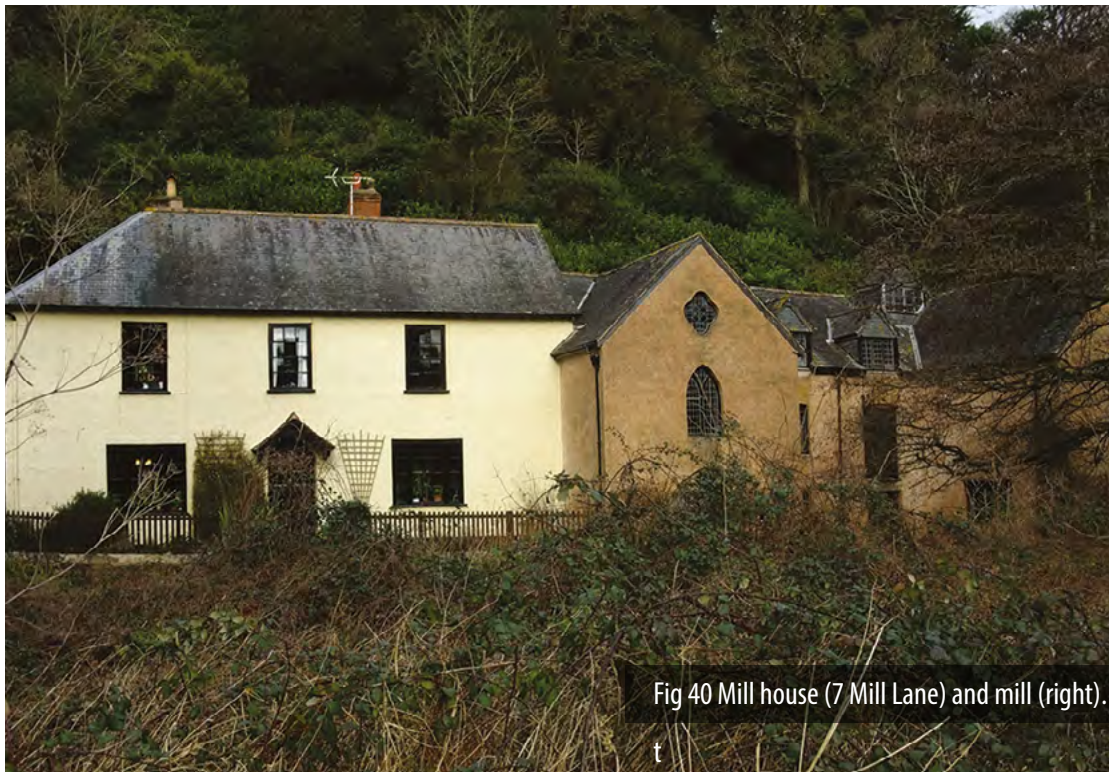
Fig 40 Mill house (7 Mill Lane) and mill (right).

No. 7 Mill Lane (Fig 40) adjoins the mill with typical late 18th century frontage of arched fanlight and panelled door, sash windows with glazing bars, including a tri-partite window on the ground floor. The tiled door hood on timber brackets is probably a later 19th century addition. Close by, and set slightly above the river, are a range of sandstone outbuildings with slate roofs dating from c.1800, probably originally a **Stable and cart shed** (Fig 41) with lean-to additions in the first half of the 19th century. These buildings, owned by the National Trust, stood empty for some years but have recently become a café and gift shop.

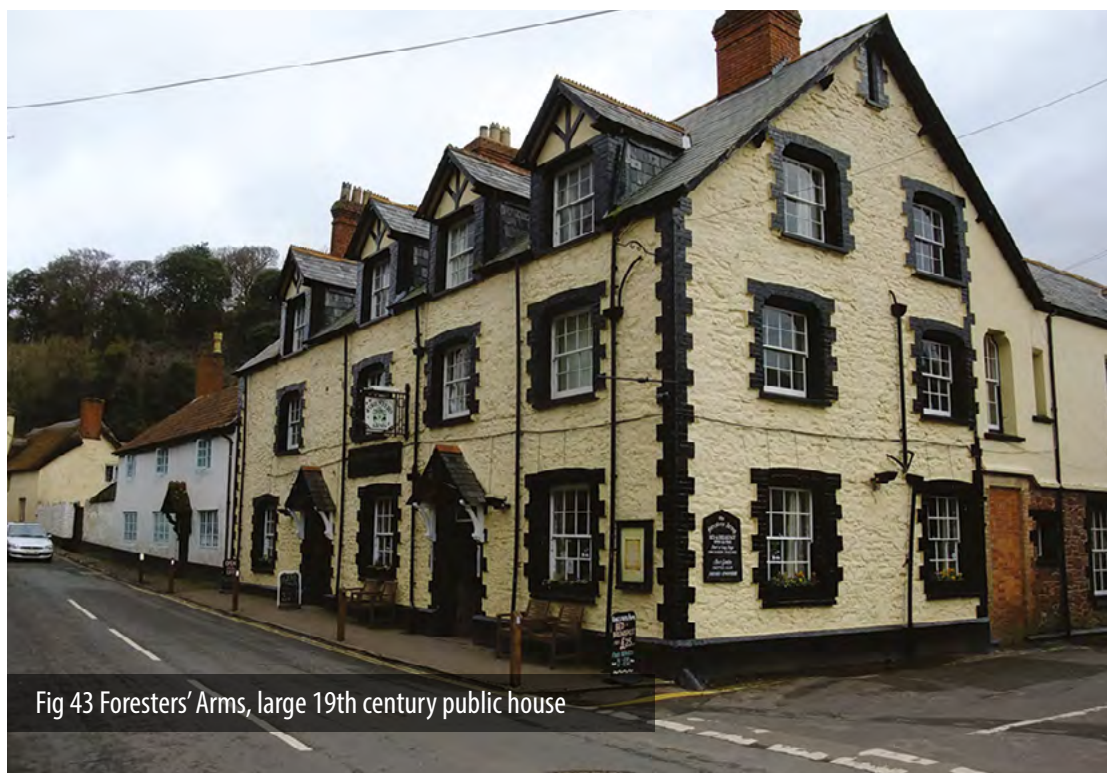
Fig 43 Foresters' Arms, large 19th century public house

At the western end of West Street, and into Park Street, are further unlisted groups of cottages, including several outbuildings, making a significant contribution to the street scene. Although there may be few distinguishing features, they are mostly early 19th century or earlier, and are an integral and important part of the historic environment. **The Foresters' Arms** (Fig 43) occupying a corner position and taller, is a later 19th century updating of earlier buildings.
