Exmoor National Park
Historic Environment Report Series No 13

DUNSTER CONSERVATION AREA: APPRAISAL DOCUMENT

Adopted 2018

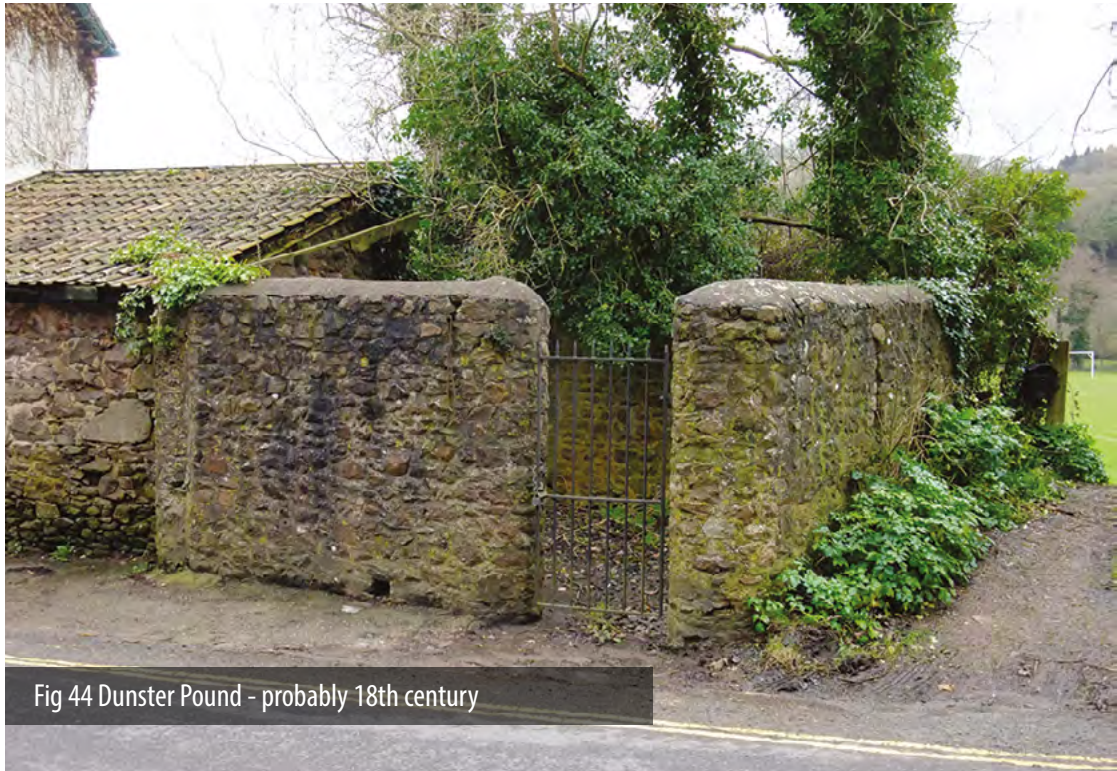
Fig 44 Dunster Pound - probably 18th century

To the west is the **former livestock pound** (Fig 44) probably dating from the 18th century, stone built and of rectangular plan with rounded angles toward the road. There is a slit opening in the end wall.

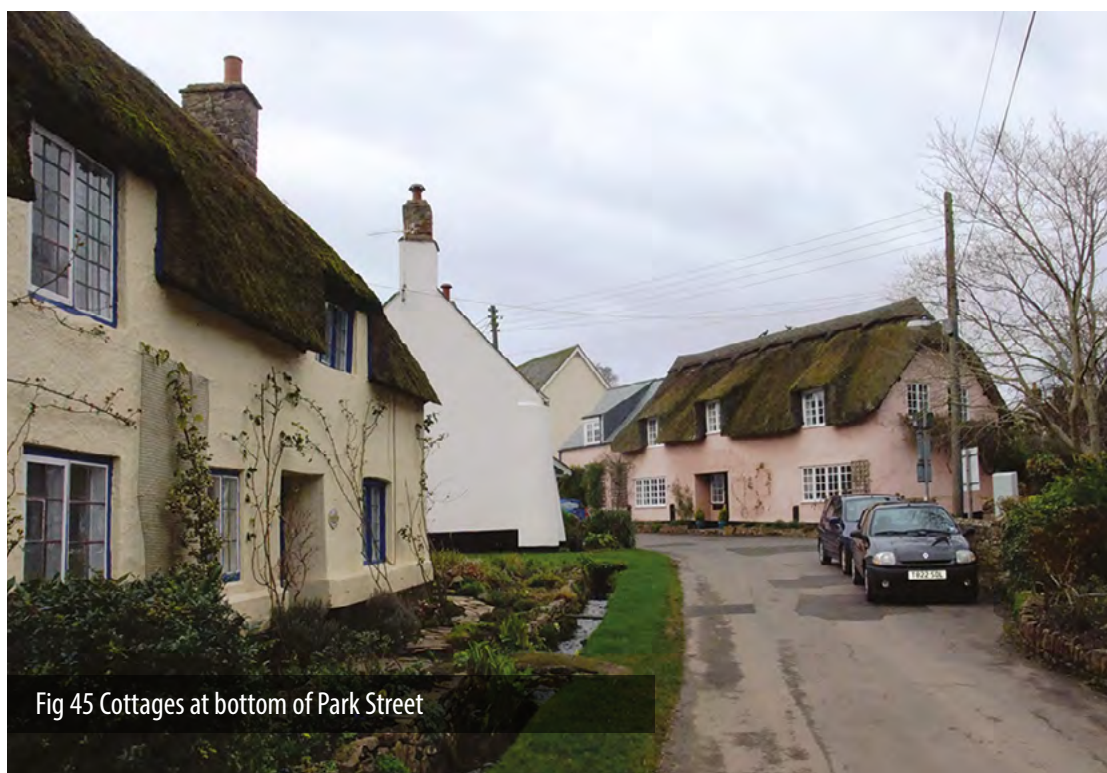
Fig 45 Cottages at bottom of Park Street

The majority of the houses in Park Street are rendered with slate or Bridgwater tile- roofs, and are loosely linked visually with several listed thatched cottages at the lower end of the road (Fig 45). Of the thatched cottages, **Nos 15, 24 & 26** all date from the 17th century and are colour-washed roughcast over cob or stone rubble. The majority have leaded light metal casements and 15 and 24 have eyebrow dormer windows. Also of note is **no. 22** which is 18th century but with a pantile roof. They form a picturesque group of cottages leading down to the River Avill and Gallox Bridge.

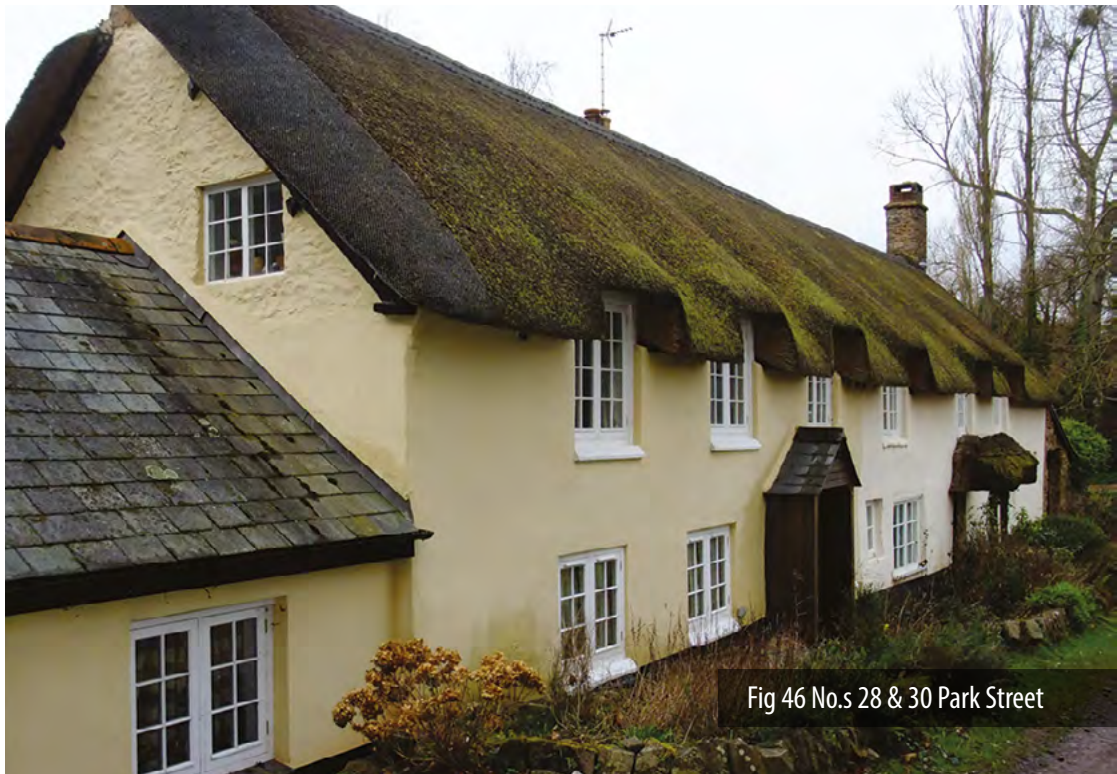
Beyond the bridge, **28 & 30 Park Street** (Fig 46) stand in an isolated position against a wooded backdrop. They too probably have 17th century origins with thatch, eyebrow dormers, colour-washed render, plank doors, and one has a gabled timber porch. The windows to the front elevation of No 30 are modern replacements with trickle vents.

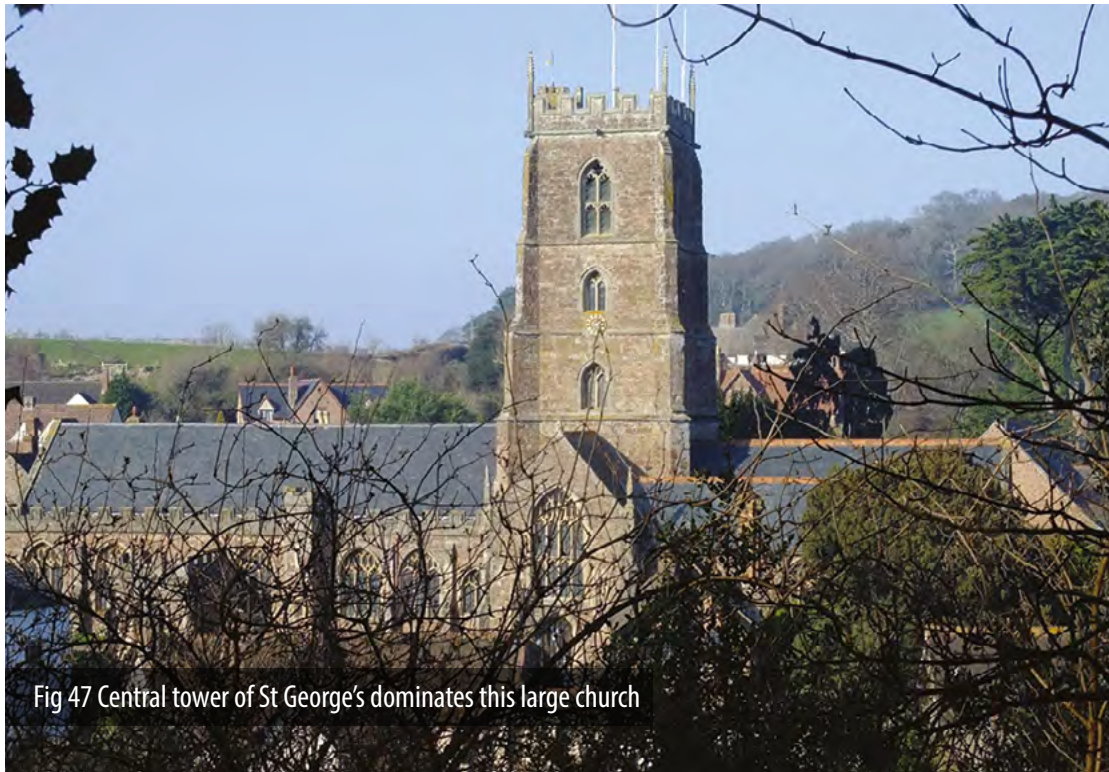
Fig 47 Central tower of St George's dominates this large church

The **Parish Church of St. George** (Fig 47) was the church of the Benedictine priory and is at the centre of a group of former ecclesiastical buildings. The church is cruciform in plan, the monastic choir dates from the 13th century, with other parts of the church from the 12th and 15th century and there was a major restoration in 1875-7 by G.E. Street. Internally, the original wagon roofs have over 150 finely carved bosses of roses, quatrefoils and heads. Other important features are the 15th century oak rood screen with 14 openings and a finely carved canopy, and an important group of monuments of the 14th to 16th century , notably to the Luttrells. In the church yard are the remains of a 15th century stone cross (Fig 48), comprising a stump with round shaft in octagonal socket on a round base of three steps.

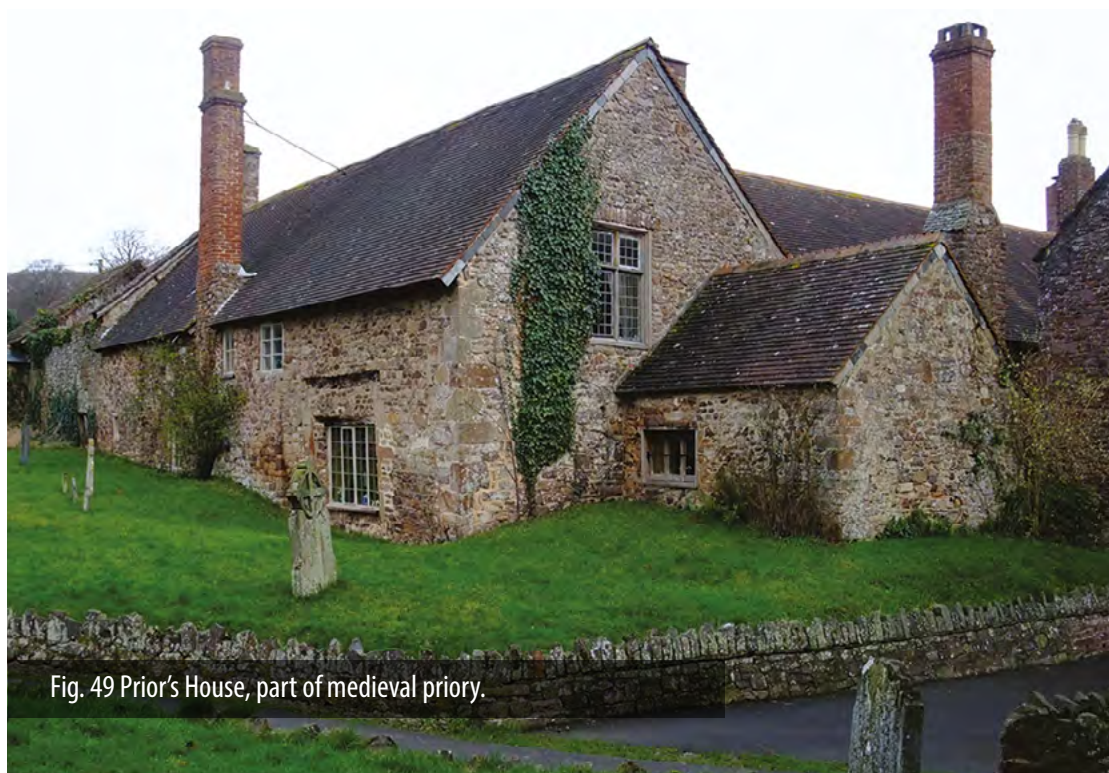
Fig. 49 Prior's House, part of medieval priory.

The **Priors' House** (nos. 5-7 Priory Green) (Fig 49) is sited immediately north-west of the church and almost certainly has medieval origins but in its current guise mainly dates to the 16th century with 19th century remodelling. The plan is L-shaped and there is a three-light stone mullion window with a cusped head, a 17th century mullioned and transomed window and a stop-moulded door frame with ribbed door.

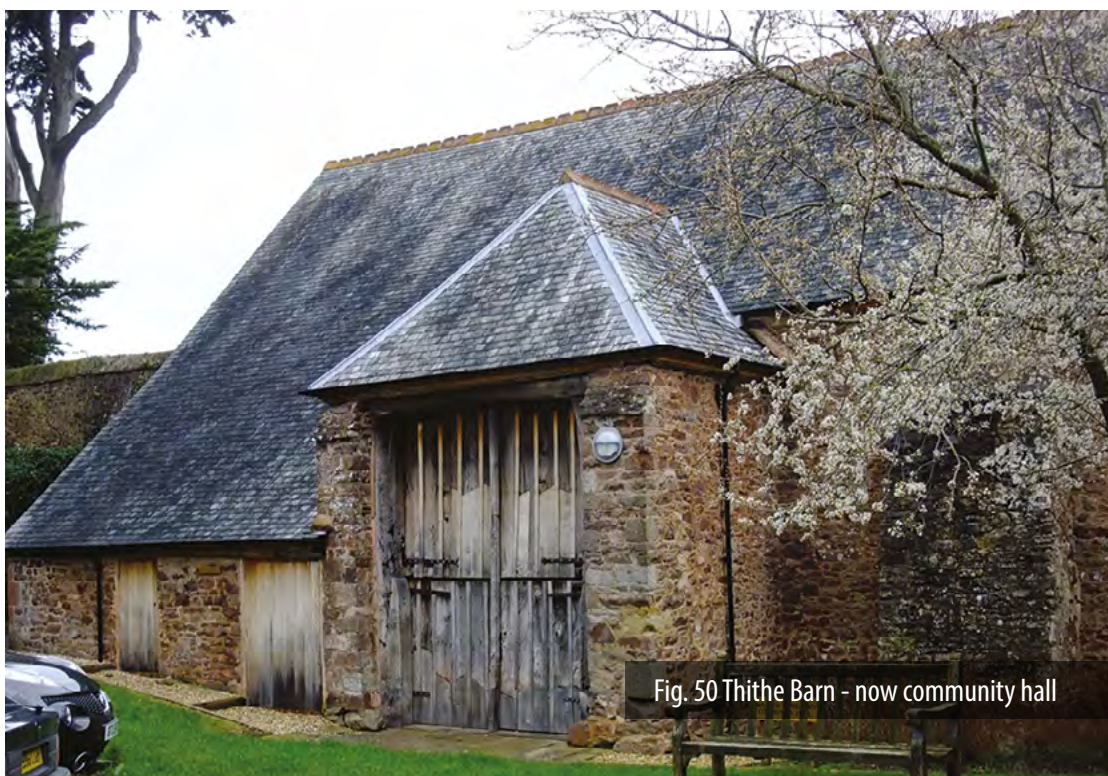
Fig. 50 Thithe Barn - now community hall

The **Tithe Barn** (Fig 50) also has early origins, and the present building probably has some 16th century fabric, but is thought to mainly date from a 19th century rebuilding including the roof structure. It was restored in 2002 for use as a community hall. On each side, there are central double timber doors in a heavy oak chamfered frame, and slit windows to the gable ends. The west elevation has three buttresses. Adjoining the barn, are several separately listed sections of wall, including two archways across Priory Green, which enhance the sense of seclusion. These are probably mainly early 19th century, and range in height from 3-4m. Attached to the west arch is the single-storey former **limehouse** (Fig 51) which has two timber mullioned windows of probable 17th century date on its roadside elevation.

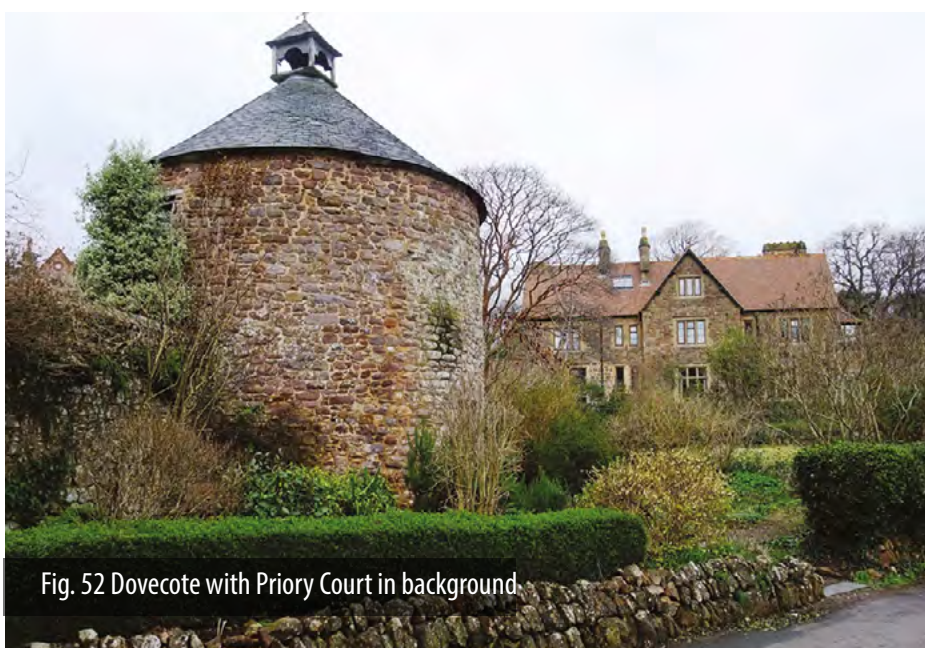
Fig. 52 Dovecote with Priory Court in background

The **Dovecote** (Fig 52) is a notable survival, probably of 15th century date or earlier. Originally used by the priory, it was taken over and used by the Luttrells until c.1870. The walls accommodated some 500 nests accessible by a revolving ladder, and it is still in full working order using a 400 year-old bearing.

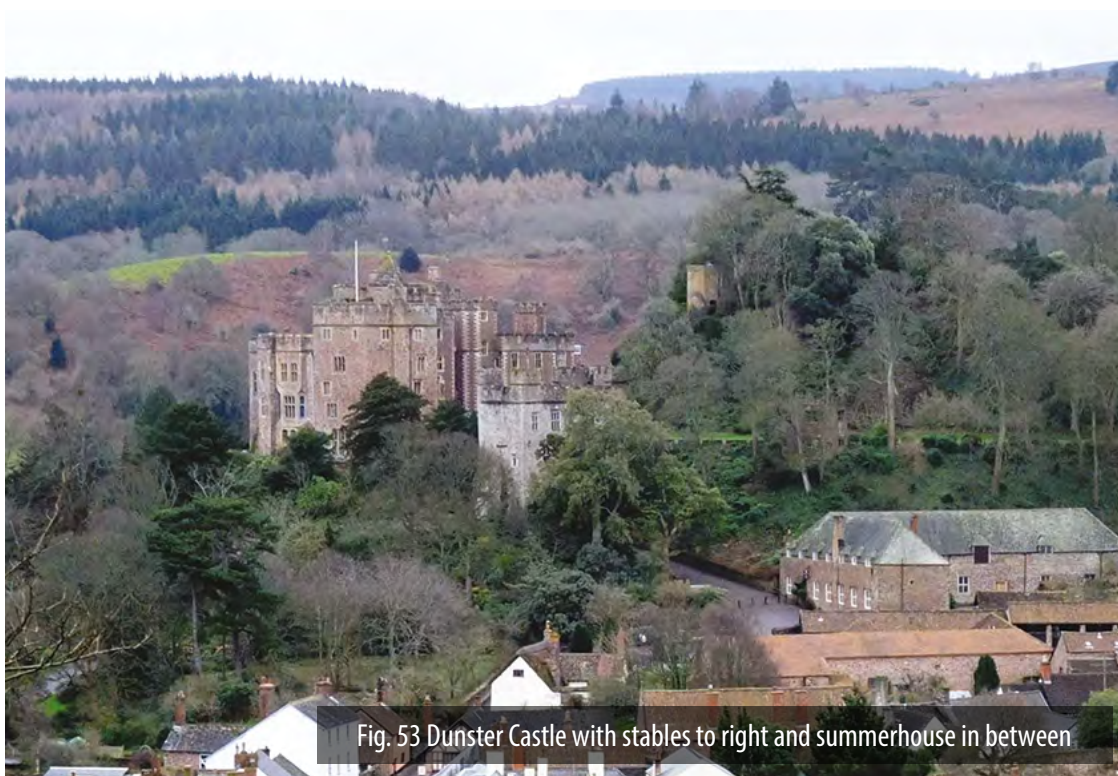
Fig. 53 Dunster Castle with stables to right and summerhouse in between

The silhouette of the castle, which forms the backdrop to the town, is to a large extent a product of the late 19th century work of the architect Anthony Salvin. The history of **Dunster Castle** (Fig 53), however, goes back much further. Above ground, the earliest surviving part is the 13th century gateway built by Reginald de Mohun. It is flanked each side by semi-circular towers with ground floor vaulted chambers and arrow loop openings. Adjoining is the Gatehouse built c.1420 by Sir Hugh Luttrell and added to up to the 1760's. Between c.1589-1620, the present castle was largely rebuilt by William Arnold. It was refurnished in the 18th century and enlarged 1869-72 by Salvin. It is largely built of local red sandstone with Douling stone dressings. The three-storey H-shape plan of the Jacobean phase was altered to a largely L-shaped plan in the 19th century. There are fine 17th and 18th century interior features, including oak staircases and panelling, and decorative plasterwork.

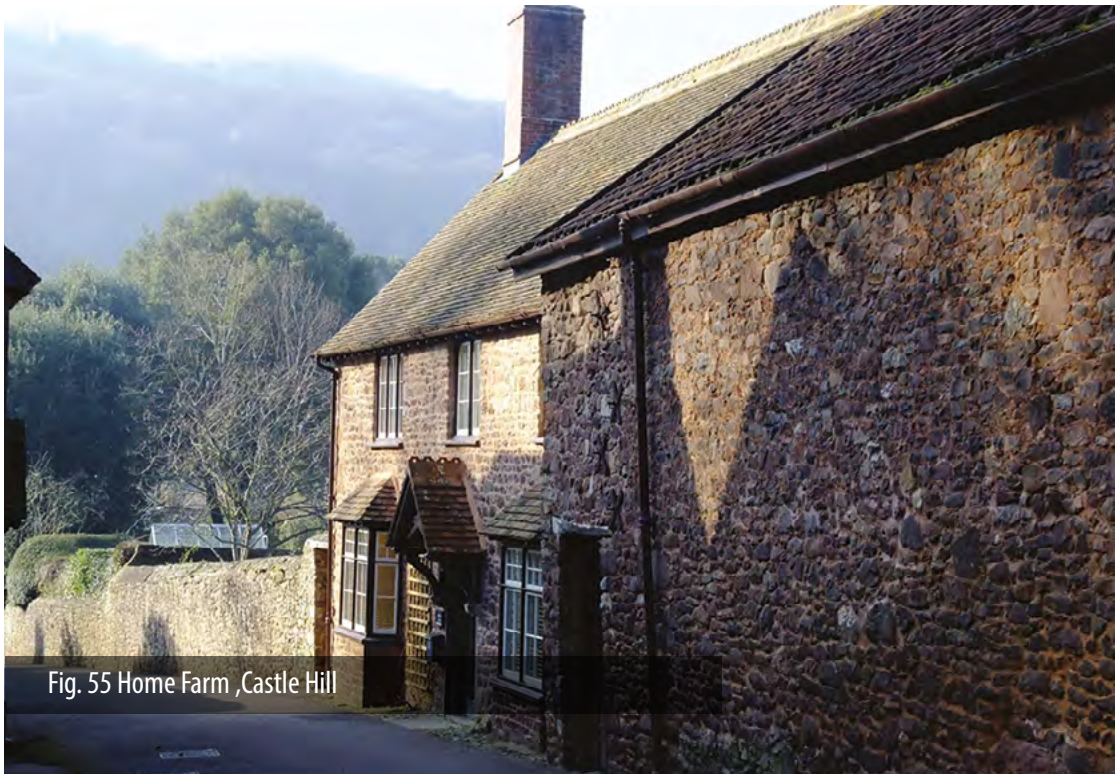
No.14 (the former Castle Home Farmhouse) (Fig 55) is also 18th century, of red sandstone with a plain tile roof, and a central door with gabled hood on timber brackets and has a good collection of farm buildings, including a stone built range of former hay barn and linhay, kennels, and a brick granary.

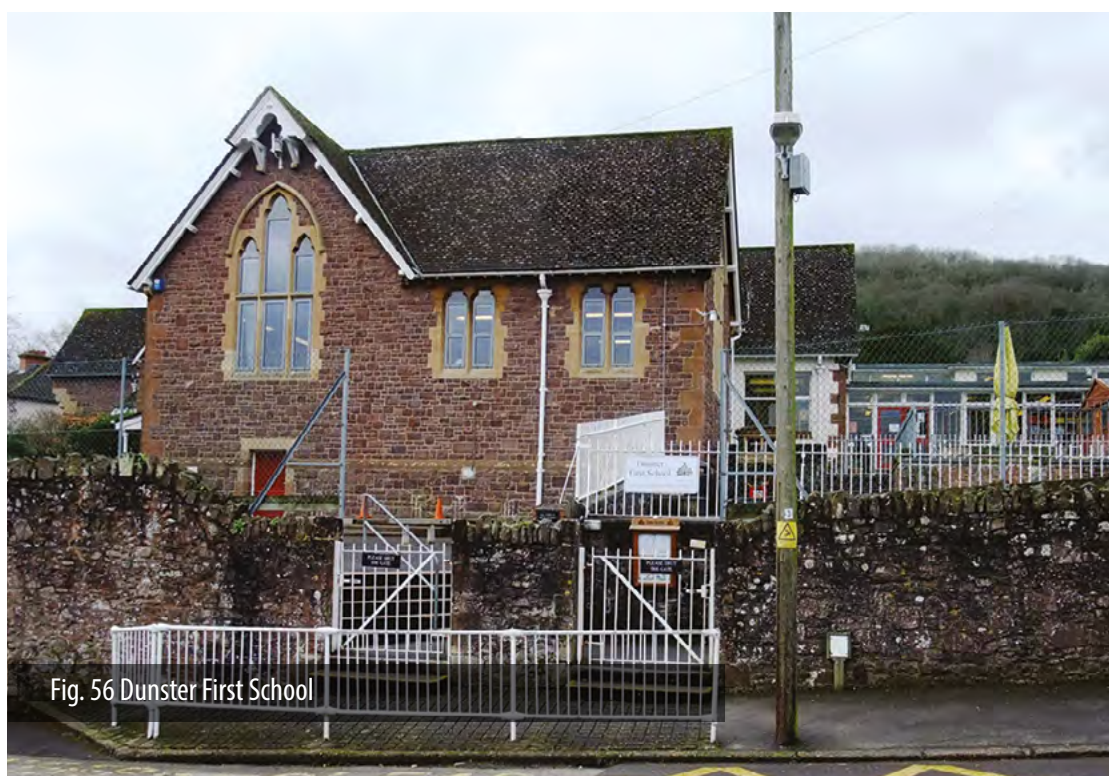
Fig. 56 Dunster First School

St George's Street has a cluster of listed buildings close to the junction with Priory Green. **The Primary School** (Fig 56) dates from 1871. The original building is ornately built of red sandstone with ashlar quoins and dressings under a tiled roof, there are triple lancet windows under relieving arches, moulded bargeboards, and a small belfry is housed under the east gable. The architect, James Piers St. Aubyn, was based in London, but worked extensively in the West Country where he had family connections.

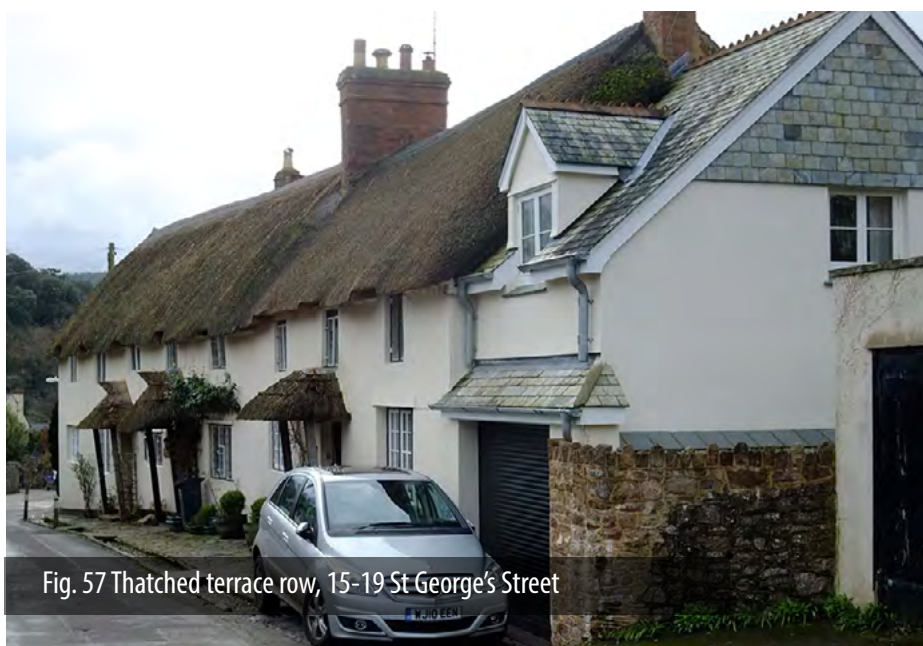
Fig. 57 Thatched terrace row, 15-19 St George's Street

Immediately to the north, **Nos 15-19** (Fig 57) form a 17th century colour-washed and rendered range under thatch with leaded light iron casement windows. The thatched porches are probably 19th century additions. Opposite, **Nos 14 and 18** (Fig 58), at right angles to the street, is built of red sandstone rubble under a plain tiled roof. No.18 has a date-stone of 1833. Other 19th century features include, segmental arched brick voussoirs, casement windows with patterned glazing bars, a panelled door with tracery fanlight, and a timber trellised porch. Also included in the listing are a **gate and iron railings** alongside the highway.

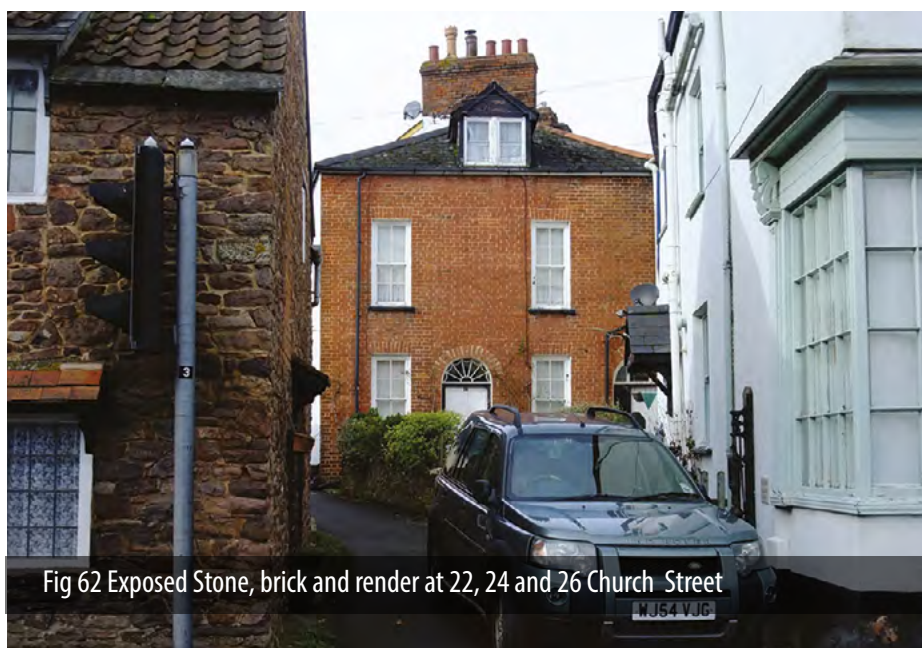
Fig 62 Exposed Stone, brick and render at 22, 24 and 26 Church Street

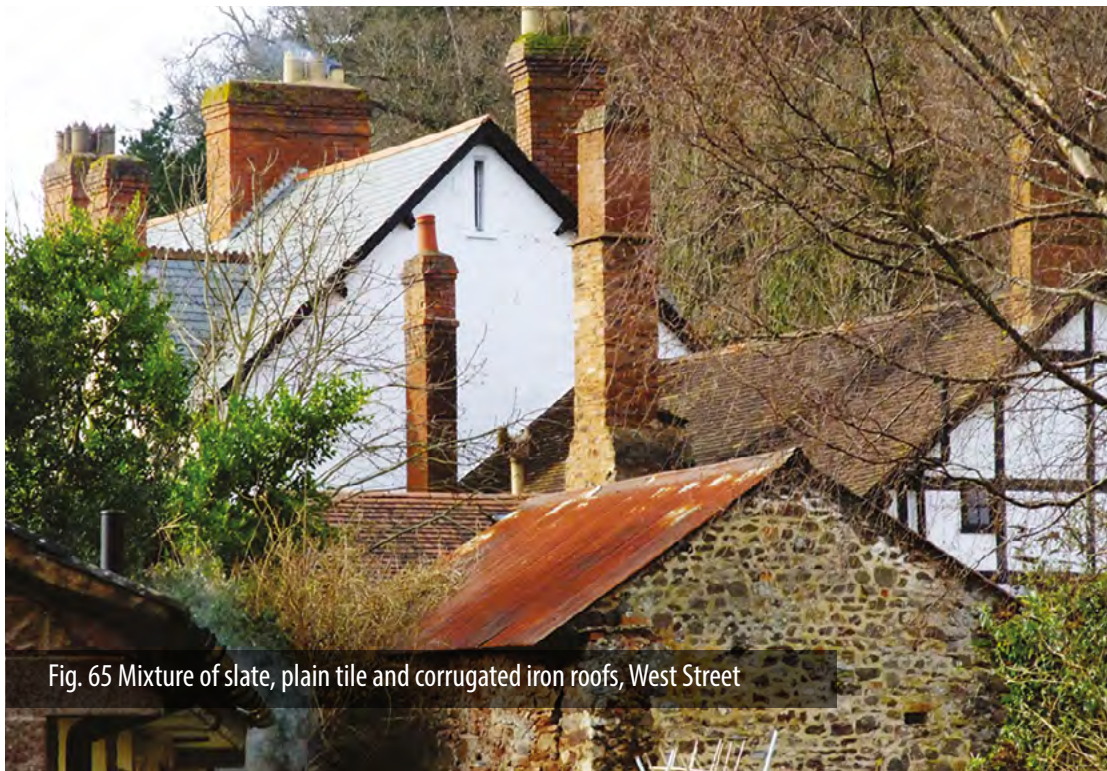
Roofs are generally quite steeply-pitched and predominately of slate, although Bridgwater double Roman and plain clay tiles are also present. Up until the mid 19th century, when transportation costs started to fall, many of these buildings would have been thatched, although the ever present risk of fire in the more densely populated High Street and West Street would have seen it disappear quite early. Away from the main urban streets, thatch does survive in isolated pockets, notably in Park Street and St George's Street.

Fig. 65 Mixture of slate, plain tile and corrugated iron roofs, West Street

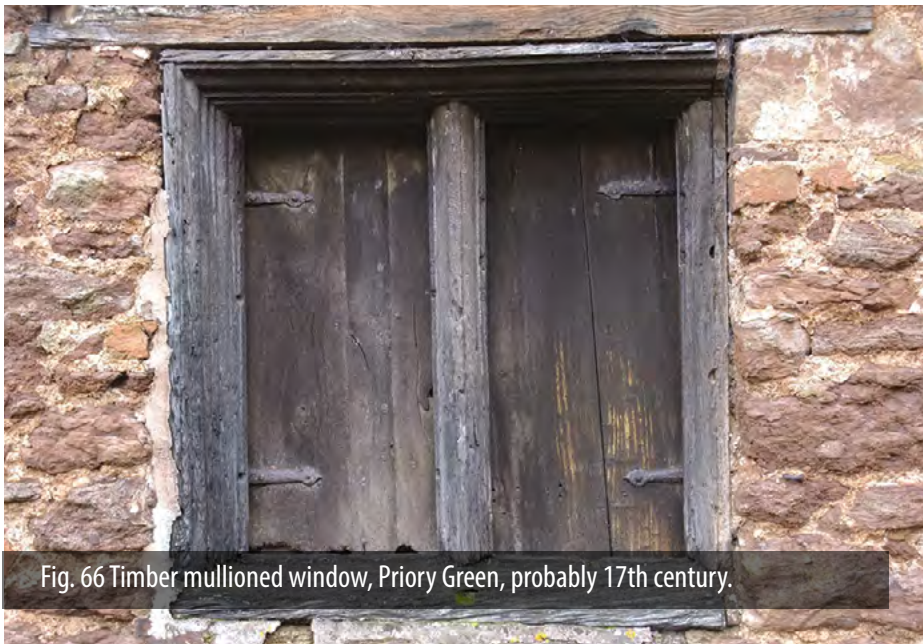
Fig. 66 Timber mullioned window, Priory Green, probably 17th century.

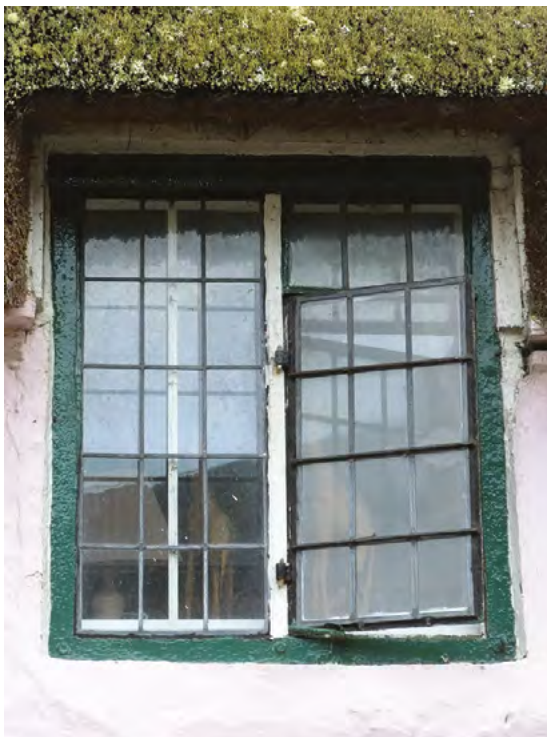
Fig. 67 Iron casement, Park Street, probably 19th Century

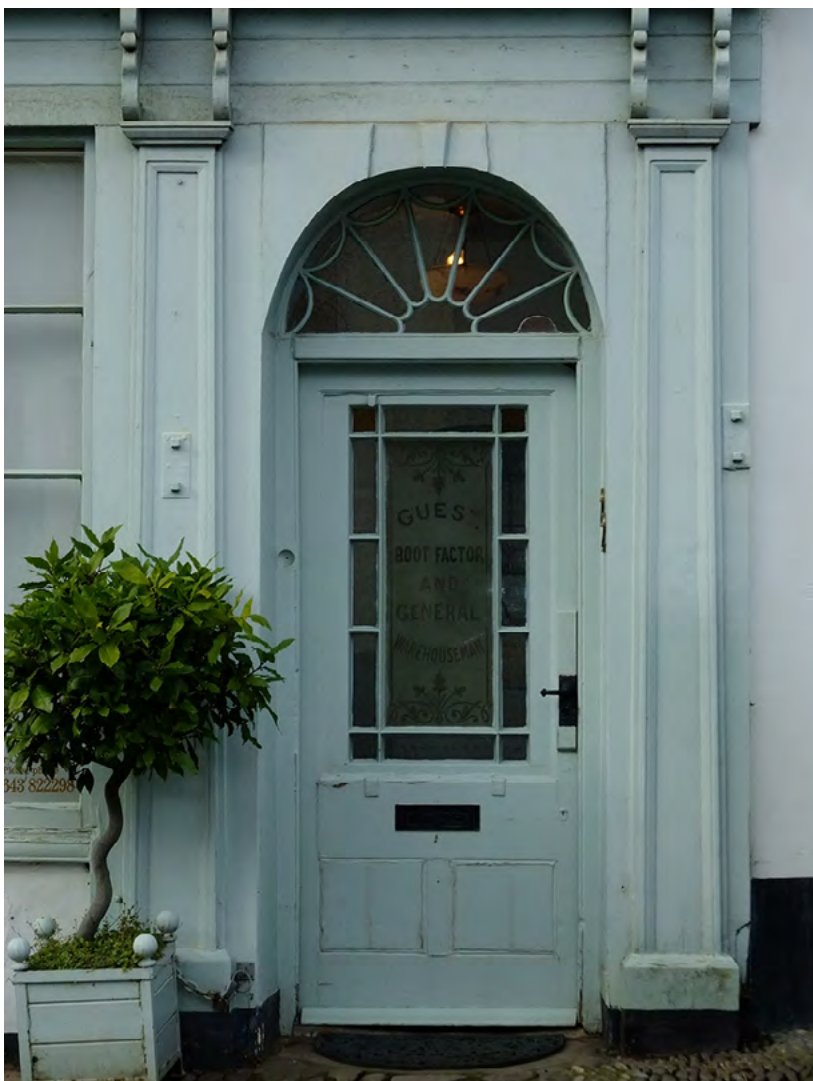
Many Dunster shop-fronts are traditional in style, with such features as sign-written fascia boards with cornice, flanking pilasters, console brackets, and recessed doorways. There are numerous good examples along the main streets, with the early 19th shop front at 22 Church Street, which includes late 19th /early 20th century etched glass to the door and an ornate fanlight, being of particular note (Figs 31 & 70).

Fig.70 Doorcase at
22 Church Street

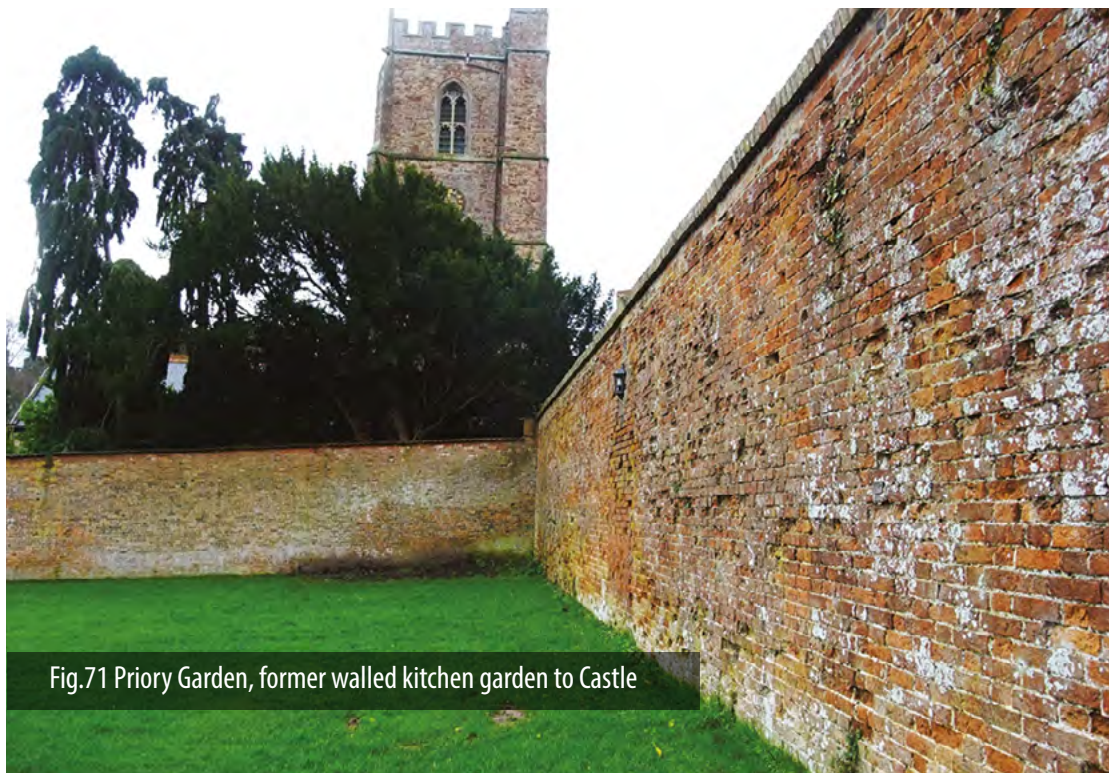
There are considerable stretches of boundary walling, mostly mortared random rubble of local sandstone but also in brick. There are particularly fine examples of both materials in the area around the church, such as the former walled garden to the east and north where the brick walls stand at over 2m in height (Fig 71).

Fig.71 Priory Garden, former walled kitchen garden to Castle

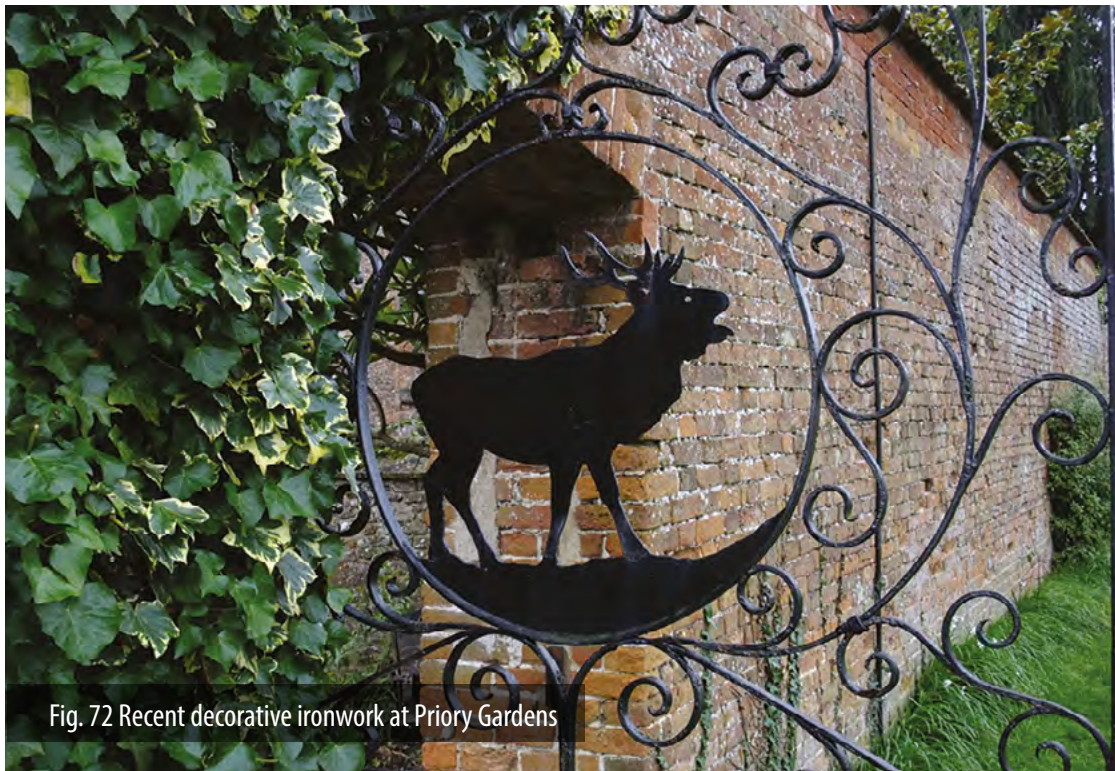
Church Street has two lengths of listed wall. The first is in two sections between nos. 16 and 18. It is early-mid 19th century of sandstone rubble, backed by brickwork and with brick and dressed stone coping. The wrought iron gate and railings under a segmental arch give access to the Priory Gardens. The second listed section is of similar date and fronts the churchyard with an arched recess at the left hand end which might have housed a water conduit. The gateway (Fig 29) giving access to no.18 has Hamstone coping and dressings with a four centred moulded arch. Also listed are the two stone archways spanning the road in Priory Green . (Fig 72).

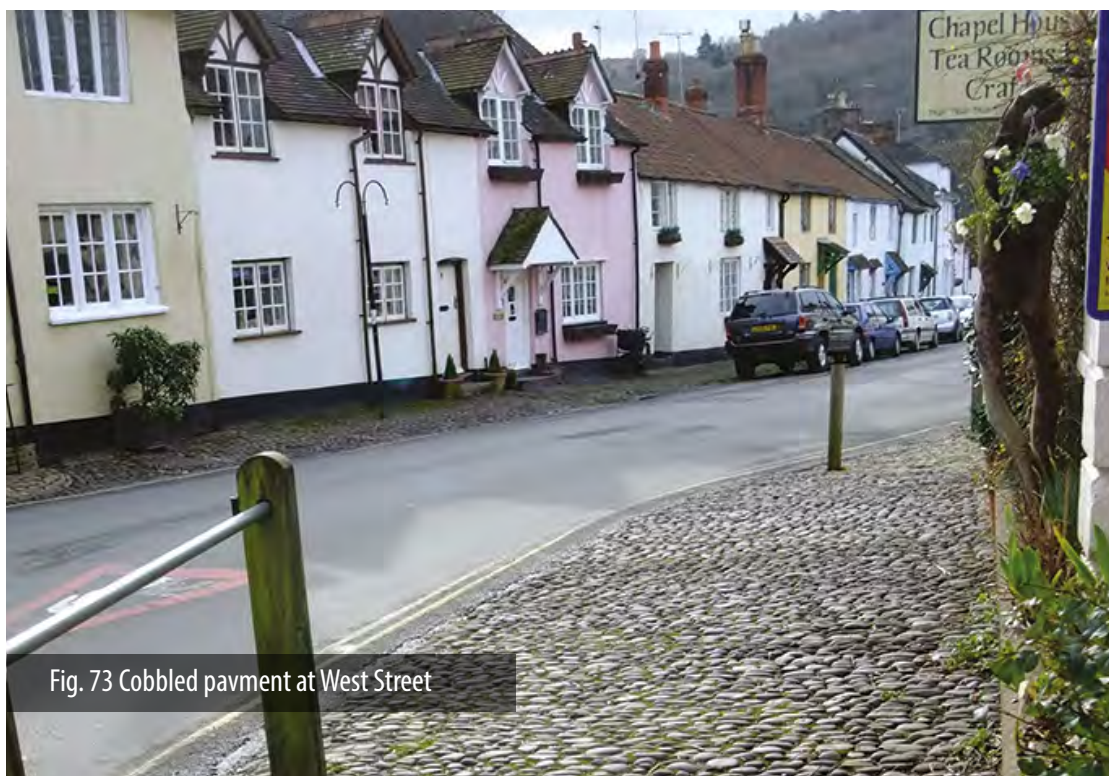
Fig. 73 Cobbled pavement at West Street

Dunster has an exceptional extent of cobbled pavements along both sides of High Street, much of West Street and part of Church Street. They are mainly of local red sandstone and water-worn. Since the 2002 appraisal, large areas of the cobbled surfaces in High Street and, most recently, West Street have been lost and replaced with paving slabs to provide a more even walking surface. Some cobbled surfaces survive in the private realm where it forms the surface of yards. In many places stone kerbing survives. Where they survive, these historic ground surfaces make an invaluable contribution to the Conservation Area's character and appearance.

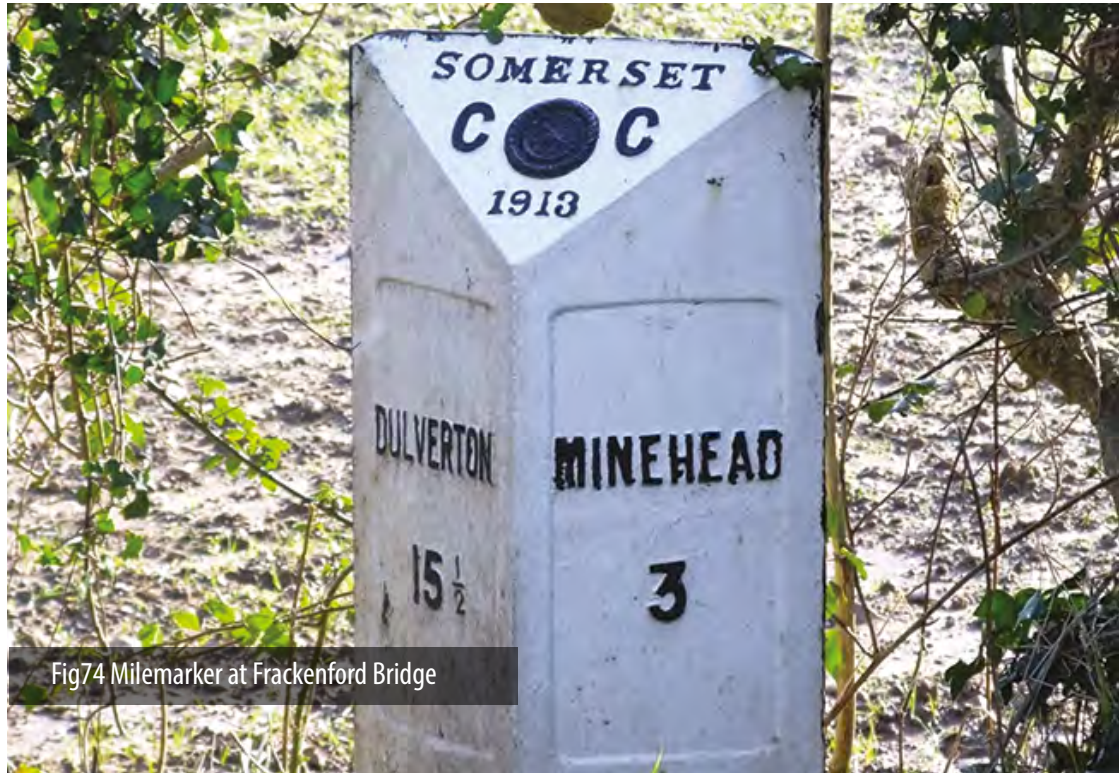
At the western edge of the Conservation Area, at Frackenford bridge, there is a Somerset County Council triangular metal milemarker dated 1913 and marked 'DULVERTON 15 ½ MINEHAED 3' (Fig 74).

Fig74 Milemarker at Frackenford Bridge

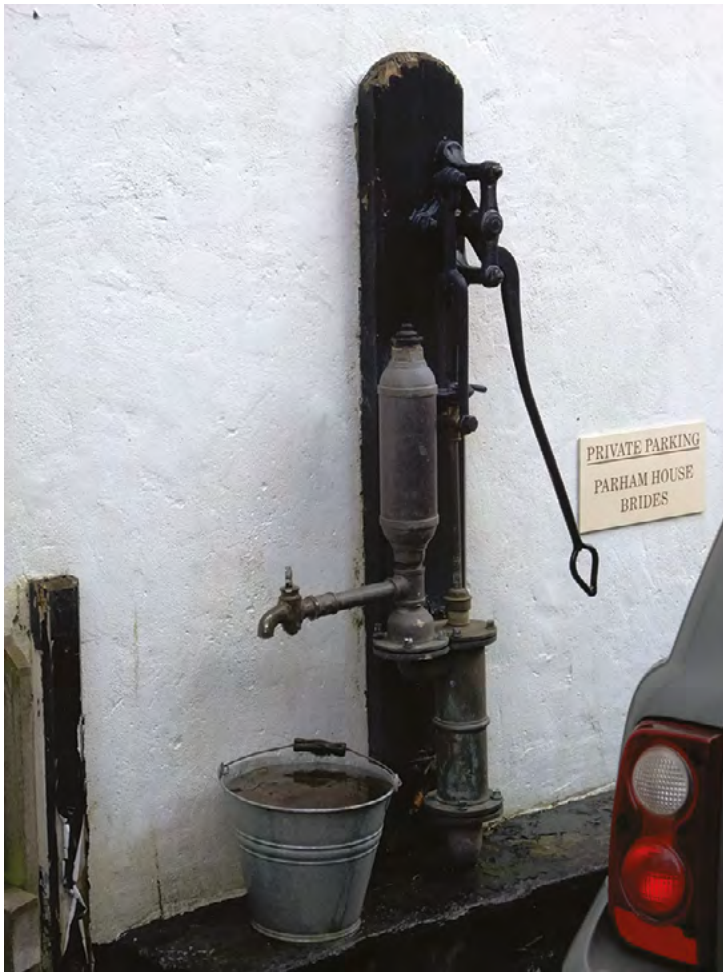
Fig.75 Water pump at
22 Church Street

There is some variety in the street name signs, including cast metal, although none of these are of particular note. Outside of the public domain, No 22 Church Street has a water pump on the side elevation (Fig 75) a relic of the underground water chamber in the yard.

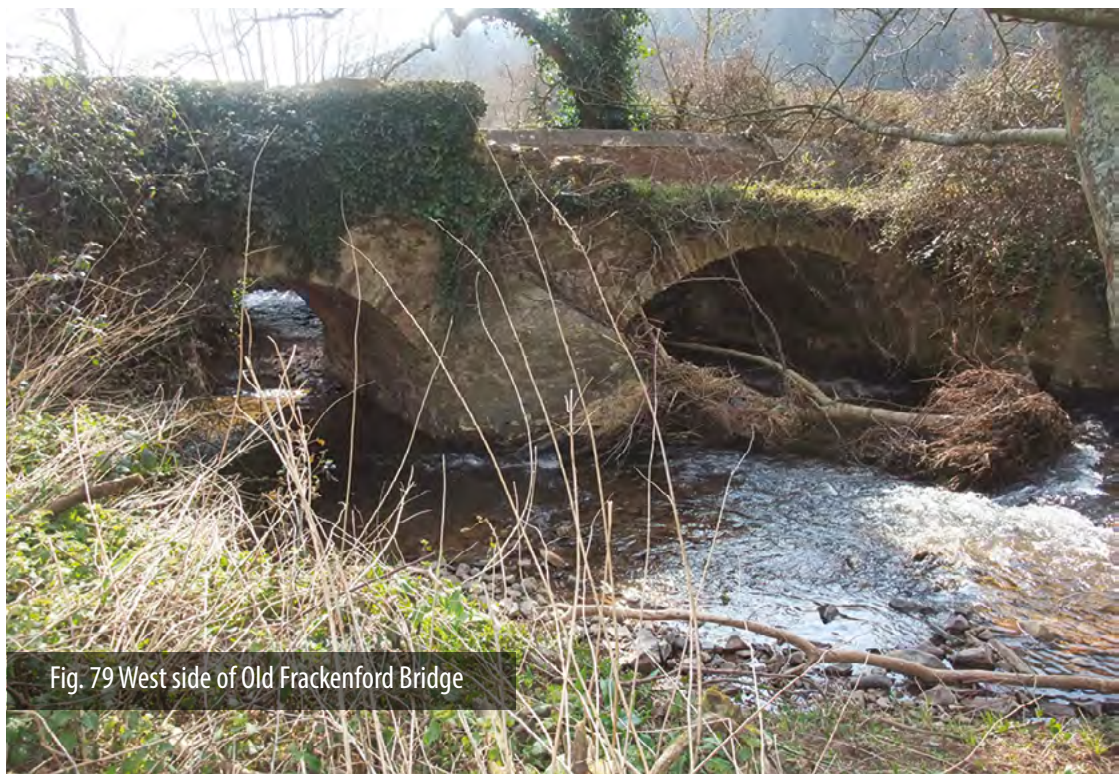
At the extreme western limit of the conservation area, Old Frackford Bridge (Fig 79) is dated 1768 and was built by William and George Rawle, recorded on a slate plaque let into the east face. It consists of twin semi-circular arches and added triangular section coping to the parapets. It was superseded by the present road bridge in 1913 and is now mainly used by cattle.

Fig. 79 West side of Old Frackford Bridge

Only one listed building has been identified as 'at risk'. Old Frackford Bridge is in a poor condition with part of the west parapet missing and the remainder leaning over (Fig 83). This is in need of urgent remedial action. Also in need of attention, although less urgent, is the sham ruin known as 'the arches' within Conygar wood, which is partially overgrown with ivy (Fig 84).

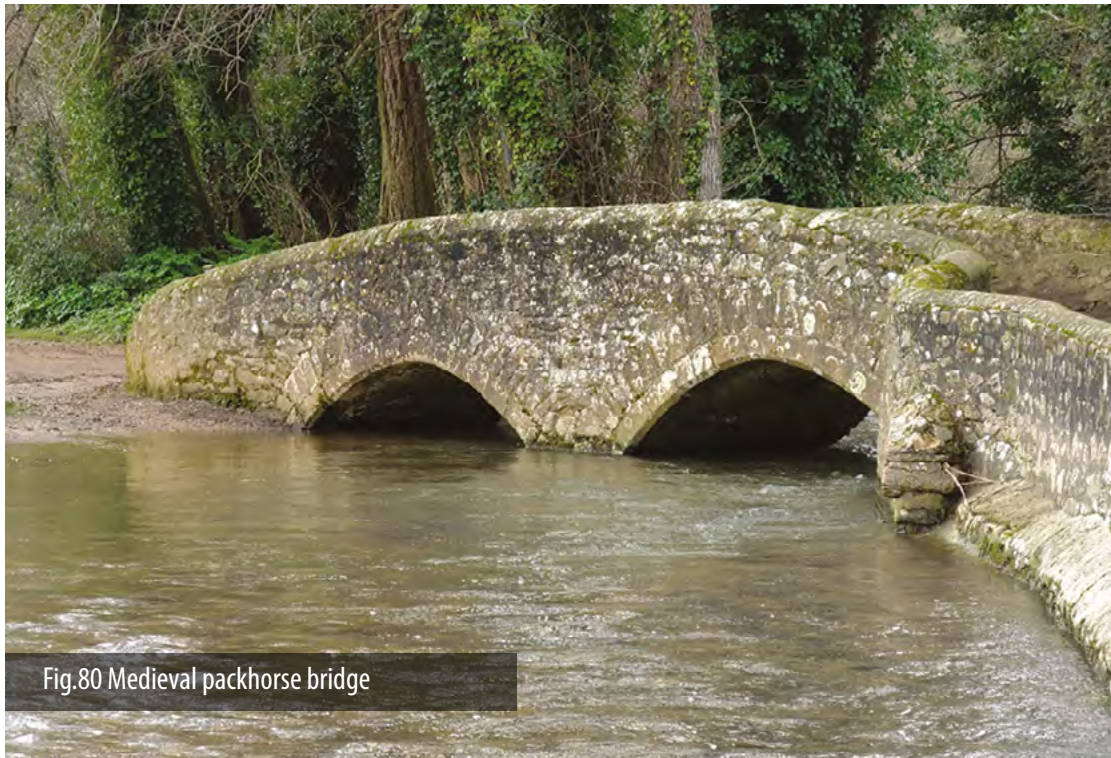
Gallox Packhorse Bridge (Fig 80) is the oldest of the group and is believed to date from the 15th century. It carries a narrow path with an adjoining ford for vehicles. There are low parapet walls above two arches with a central cutwater on the upstream side; the walls also border the northern approach.

Fig.80 Medieval packhorse bridge

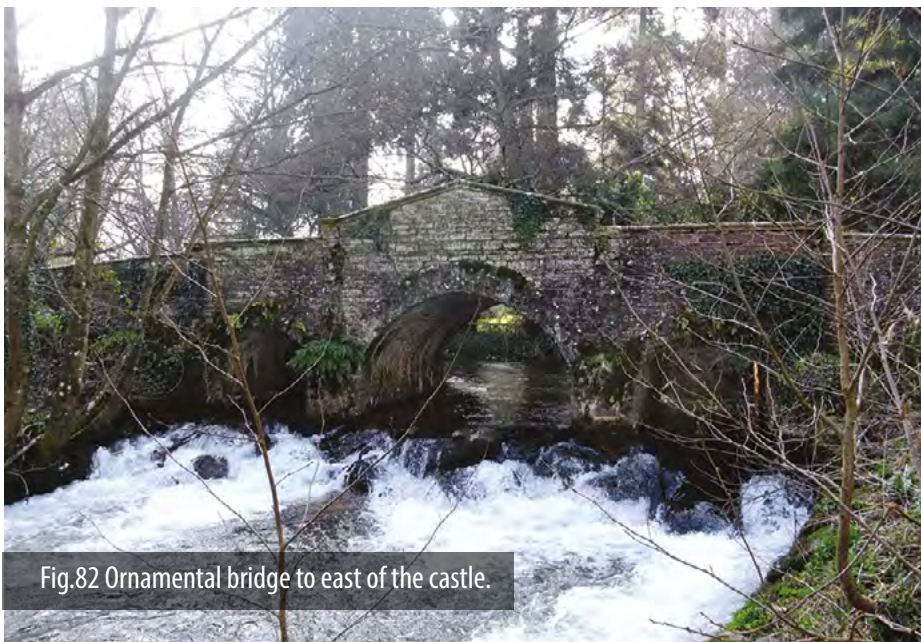
Fig.82 Ornamental bridge to east of the castle.

At the eastern end of the park is a further ornamental bridge (Fig 82) of a similar date and rusticated appearance. It is stone built with three semi-circular arches, wider central arch with depressed triangular parapet. It has moulded stone copings to the parapets and abutment walls, rock-faced rusticated pilasters and voussoirs.

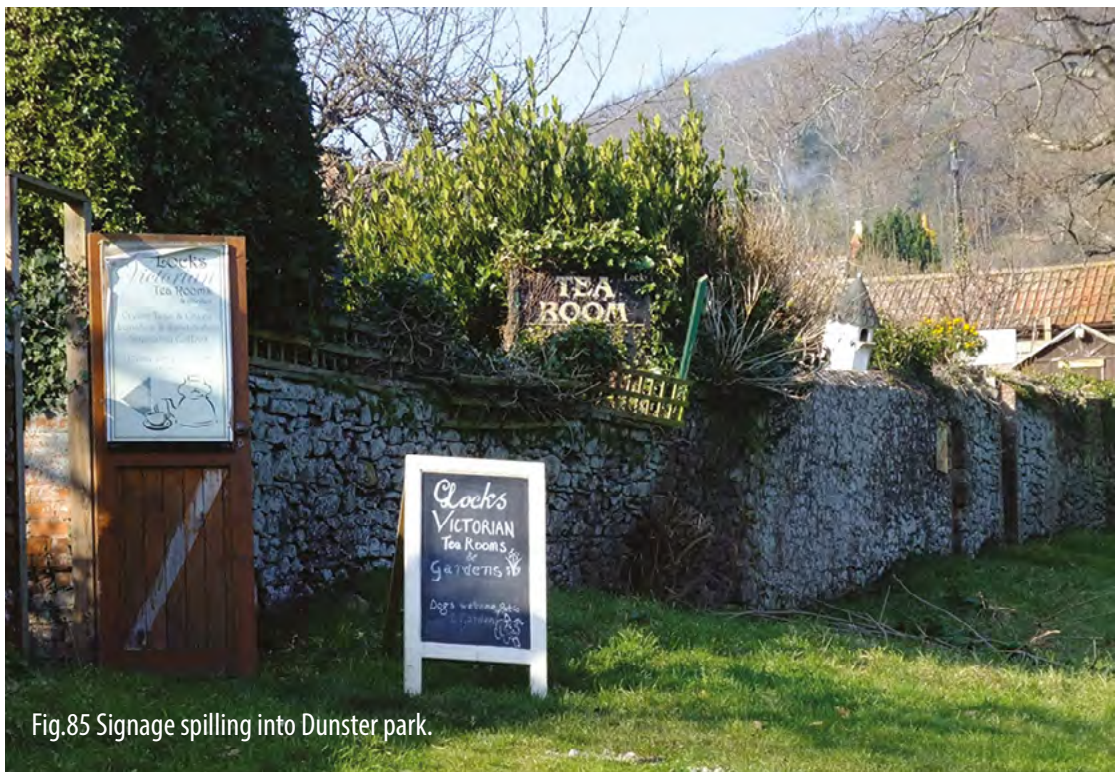
As a tourist centre, there is an inevitable proliferation of signage, particularly at the Castle end of High Street. While there some scope for improvement, in terms of design it is relatively restrained in comparison with some other major visitor destinations. Advertising has, however, appeared to the rear of the east side of the High Street properties, facing the Park, which detracts from the Conservation Area (Fig 85). 'A' boards are also widely used along the main High Street frontages and can be a hazard to pedestrians.

Fig.85 Signage spilling into Dunster park.
