Exmoor National Park
Historic Environment Report Series No 15

LUCCOMBE CONSERVATION AREA: APPRAISAL DOCUMENT

Adopted 2018

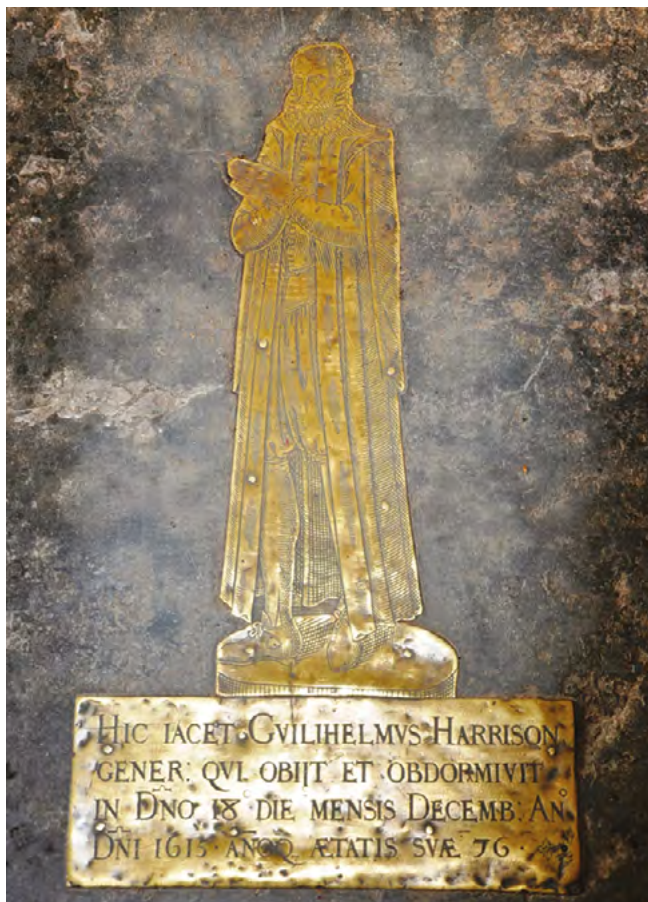
Fig.1 Brass to William Harrison died 1615

The former manor house, if one existed, is likely to have been the sited in the position of the Old Rectory, or closer to the church, which has 13th century origins. The age of the houses immediately around the church and along Stoney Street strongly suggest that the current linear settlement form was established during the medieval period. Wychanger, to the south of the village centre, was a discrete manor and is first mentioned in the 13th century. The Harrisons are recorded as owning Wychanger from 1547 (Fig1), followed by the Wroths until the mid 19th century.

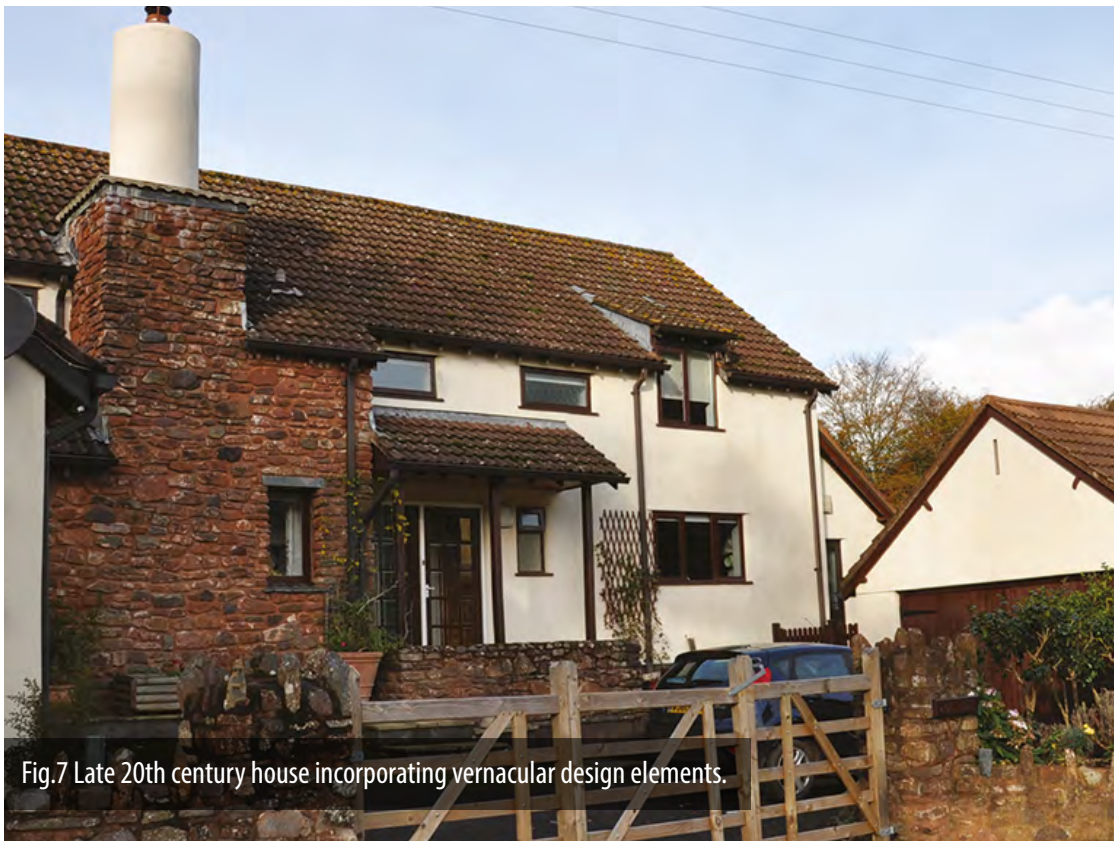
Fig.7 Late 20th century house incorporating vernacular design elements.

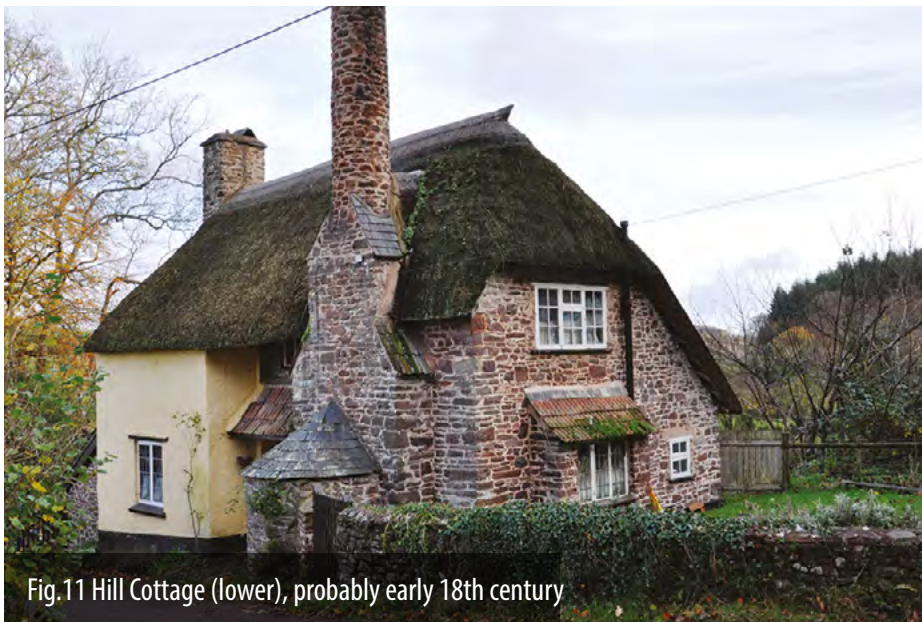
Fig.11 Hill Cottage (lower), probably early 18th century

Luccombe has had an unbroken succession of belonging to an estate held by landed gentry until passing to the National Trust in 1944. Although no individual feature is especially lavish in style or detail, the overall pattern is of thatch, clay tile or natural slate combined with local red sandstone and cream or honey coloured lime-wash over render or cob. The Trust's survey of buildings in the village has revealed some very early detail, notably smoke-blackened roof timbers providing evidence of several former open hall houses, dating from the 15th century or earlier.

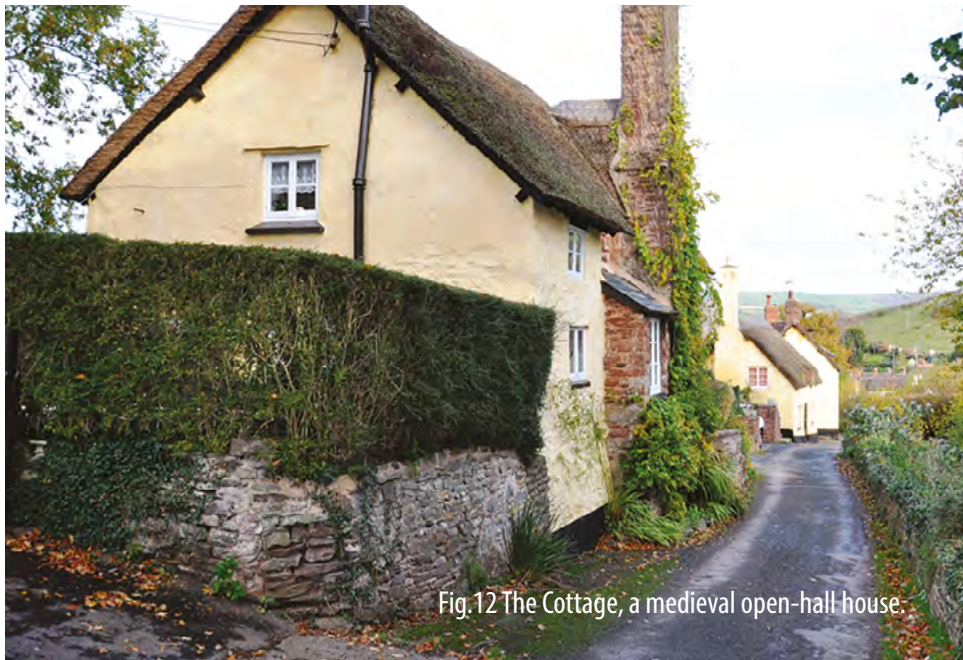
Fig.12 The Cottage, a medieval open-hall house.

Further down Stoney Street is **The Cottage** (Fig.12), built of red sandstone rubble and part colour-washed with a thatched roof. The National Trust survey has demonstrated that it originated as a former longhouse. Inside it has a smoke-blackened roof, internal jetty in the hall and remnants of 15th-16th century paint on the upper hall partition. The next of the Stony Street group is **Rose Cottage** (Fig.13) which dates to the 17th century with early 19th century alterations, including leaded iron casement windows rising from below the eaves. The thatched roof, combination of roughcast and colour washed random rubble, with large external shouldered stack is of typical local vernacular style. The interior of this cottage is shown in *Exmoor Village*.

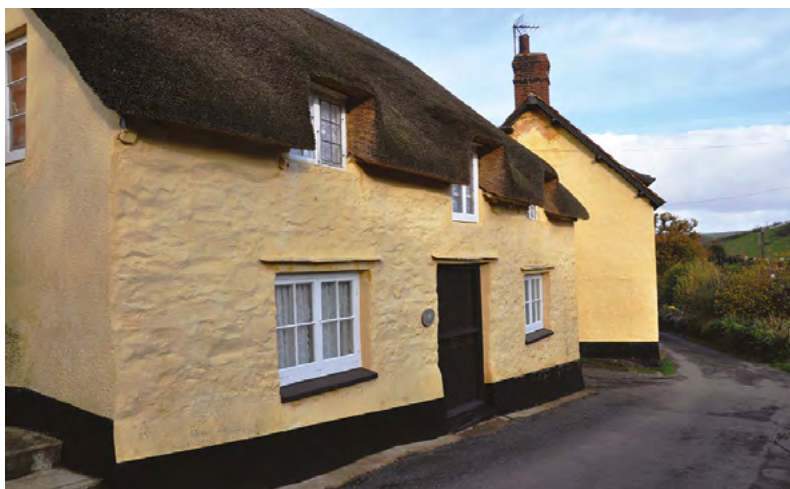
Fig.13 Rose Cottage,
17th century with later
alterations.

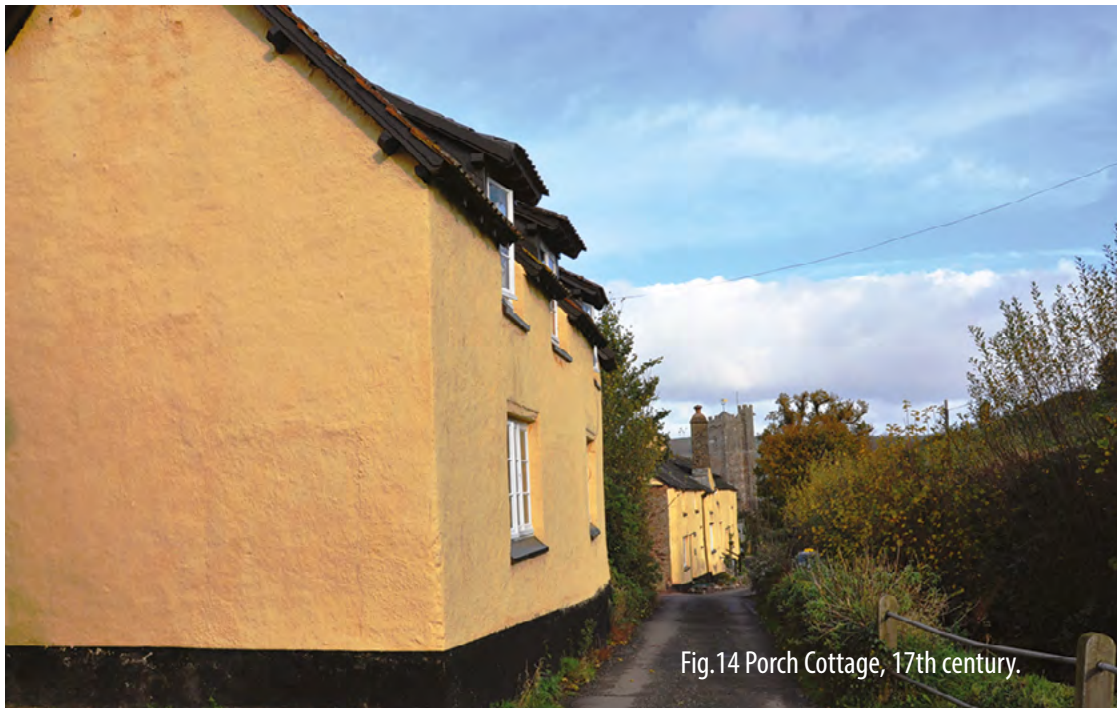
Immediately south is **Porch Cottage** (Fig.14) again 17th century and built of rendered cob and stone with Bridgwater pantiles. The pent-roofed lowered 'Somerset' dormers suggest that the roof was formerly thatched. The three-light casement windows and plank doors are probably early 19th century. The National Trust's vernacular building survey has shown **Goulds and Myrtle** (Fig.15), to have originated as a single 14th-15th century longhouse. In the early 17th century it was converted to a cross-passage configuration and the front stack and oven added. **Combe and Post Cottages** (Fig.16) are 17th century, with a surviving stair-turret window in the north east gable. The latter retains visible indications of a post office letterbox on its front. Apart from an older mullioned window, most windows are plain casements, probably dating from the 19th century.

Fig.14 Porch Cottage, 17th century.

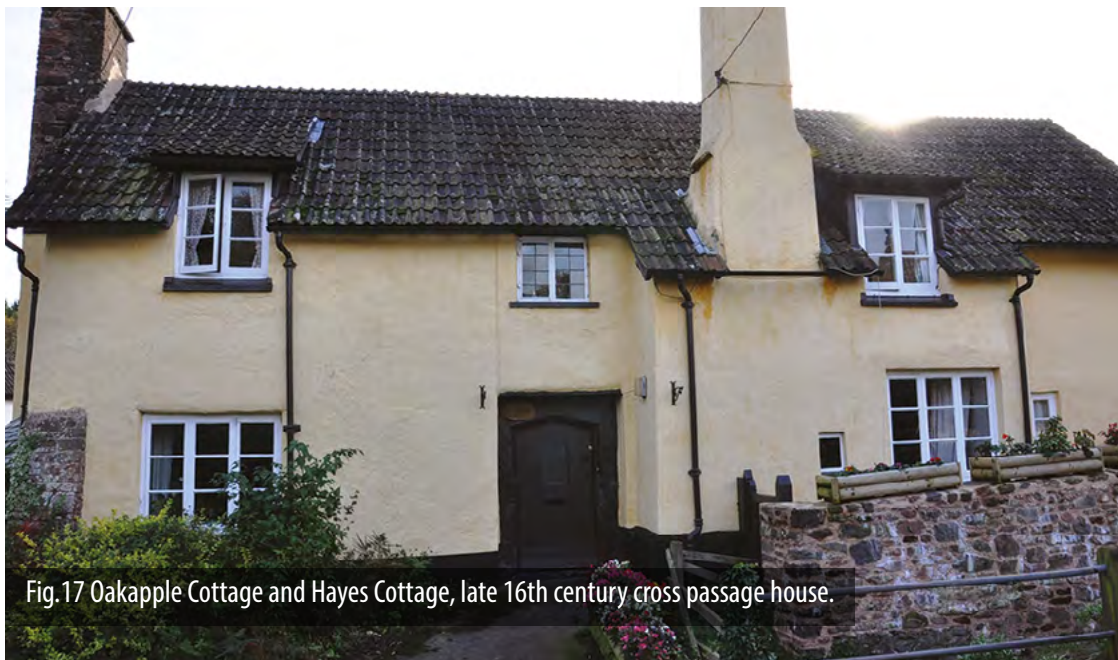
Towards the lower end of Stoney Street are **Oakapple Cottage** and **Hayes Cottage** (Fig.17), which were formerly one late 16th - early 17th century three-bay and cross passage house with full-height projection to the right of the lateral stack and a rear wing. The construction is roughcast render over stone rubble with double Roman tiled roofs. There are 19th century casement windows, both timber and metal. The plank door in a chamfered peak-headed doorframe indicates a possible 16th century date (Fig.43).

Fig.17 Oakapple Cottage and Hayes Cottage, late 16th century cross passage house.

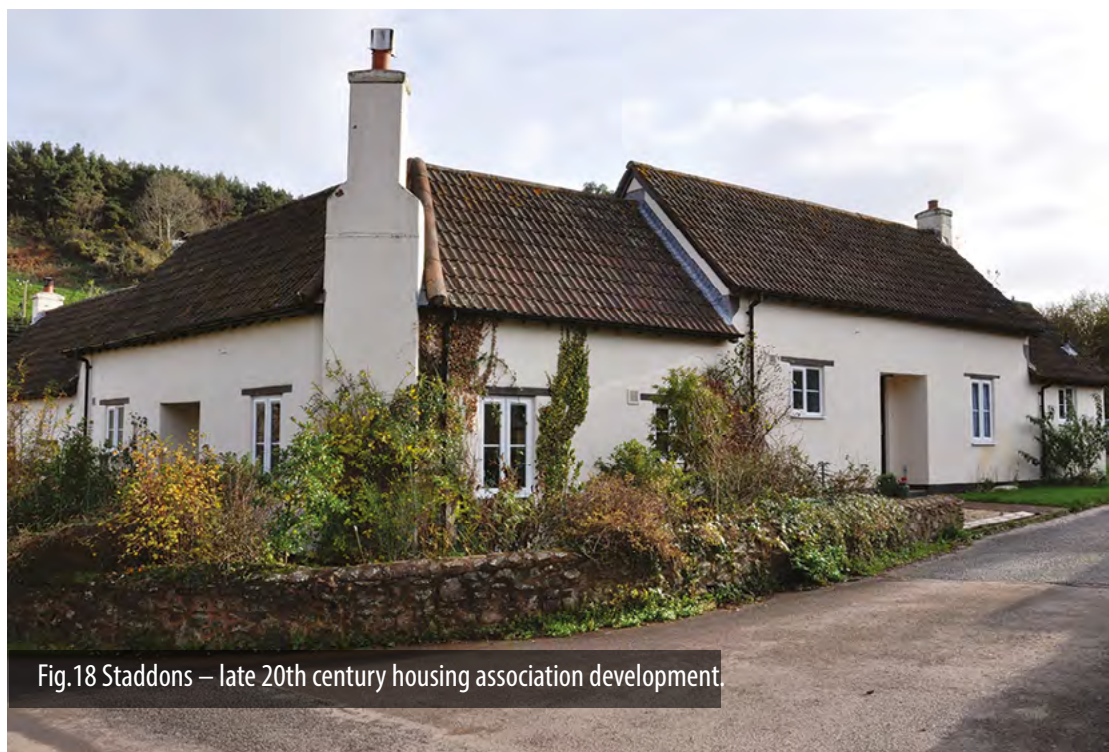
Also worthy of mention is **Staddons** (Fig.18) a joint venture between the National Trust and a local Housing Association built in 1991 and incorporating some local vernacular features, such as recessed doors, a shouldered external stack. The building, and the wider Conservation Area, is, however, let down by the replacement PVCu windows.

Fig.18 Staddons – late 20th century housing association development

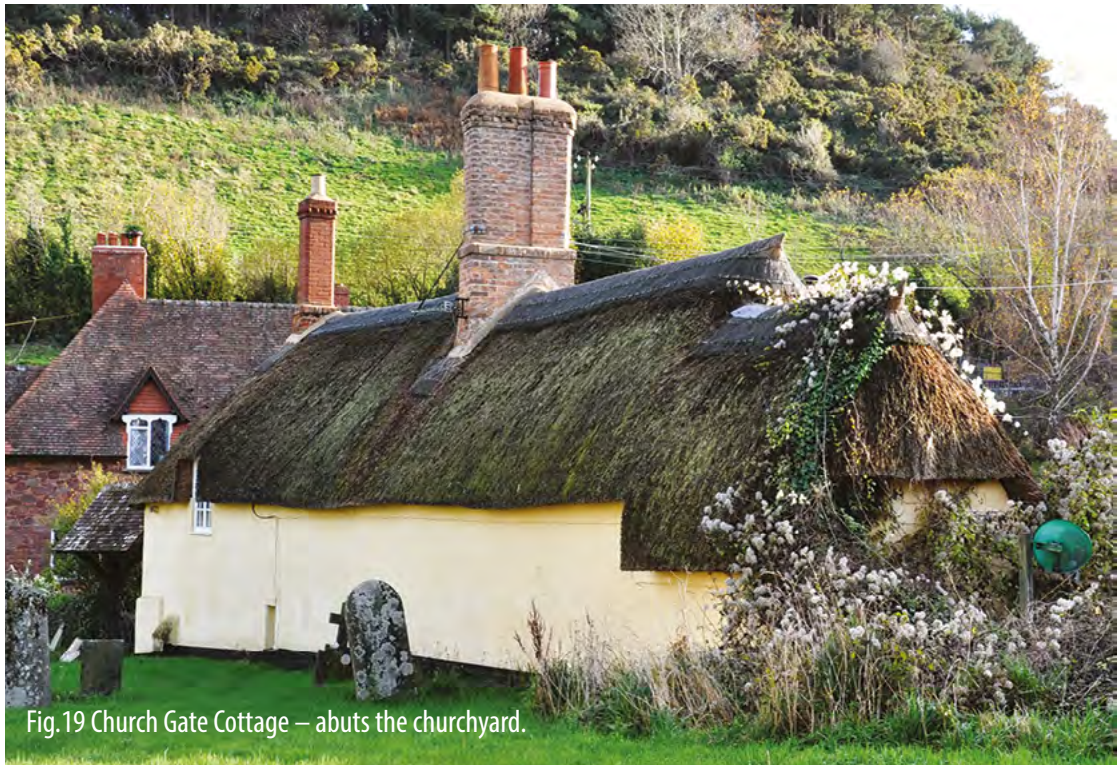
Opposite Staddons is **Church Gate Cottage** (Fig.19). This dates to the 17th century with the school extension (now church rooms) added in the late 18th–early 19th century. The position of this building, on the edge of the churchyard, suggests a formal connection with the church. Both parts of the building have good examples of leaded iron casement windows, with the former schoolroom incorporating tall windows and wrought iron window box supports.

Fig.19 Church Gate Cottage – abuts the churchyard.

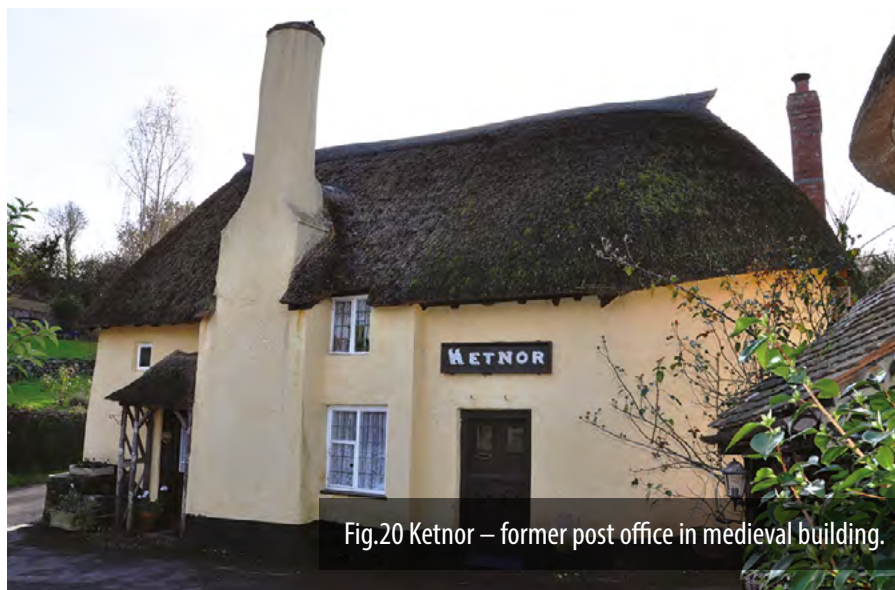
At the junction of Stoney Street and the main road, **Ketnor** (Fig.20) formerly served as the village Post Office and also features in *Exmoor Village*. It is a partly medieval building containing evidence of smoke-blackened thatch and blackened roof timbers from an open hearth fire. The chimney and first floor were added in the late 16th century. Externally it retains its fascia board and Victorian letterbox and also boasts a mounting block.

Fig.20 Ketnor – former post office in medieval building.

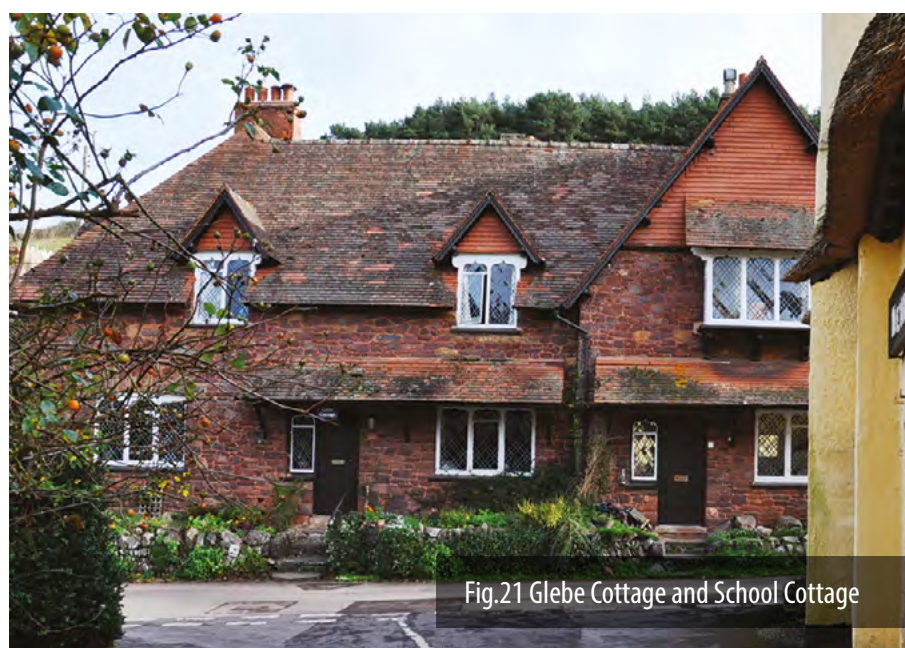
Fig.21 Glebe Cottage and School Cottage

Opposite the junction on the main street are **Glebe Cottage** and **School Cottage** (Fig.21). These are late 19th century estate cottages which despite being built of local red sandstone rubble, are of a scale and design outside of the vernacular tradition for this area. The tile-hung gable and plain clay tile roof are similarly not found on earlier buildings, they do, however, retain their original ogee-headed windows that are a feature of the Acland estate buildings. The projecting bread oven at the neighbouring Church View is believed to be the vestige of a cottage that was demolished when these cottages were built, although it could equally been a removed bay from the existing building. **Church View** (Fig.22) is built of rendered stone rubble with double Roman tiled roof. The date plaque of 1680 above the vertical plank entrance door, may well relate to when the chimney and first floor were added to this probably 16th century building.

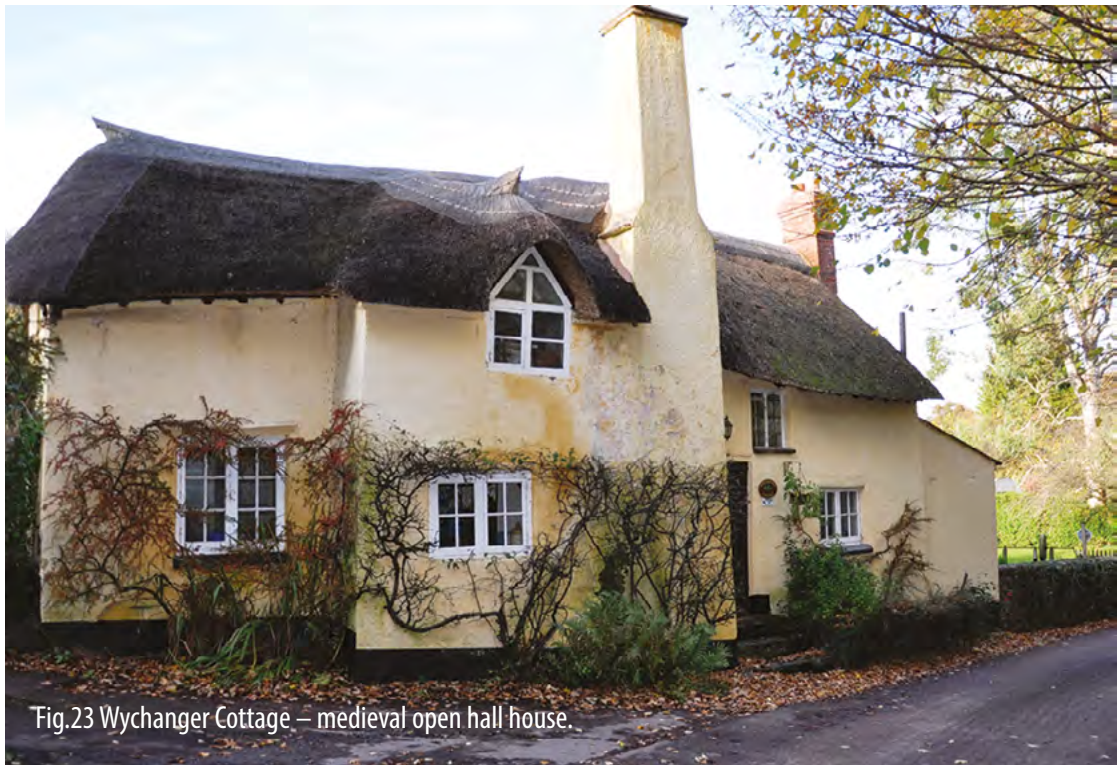
Wychanger Cottage (Fig.23), further south along the road towards Wootton Courtenay, shares a similar developmental history. Here the 15th century former open-hall house is evidenced by a smoke-blackened truss: the stack and ceiling were added in the 17th century. There is an early 19th century enlargement of full-height bay adjoining the stack and a single bay addition to the left.

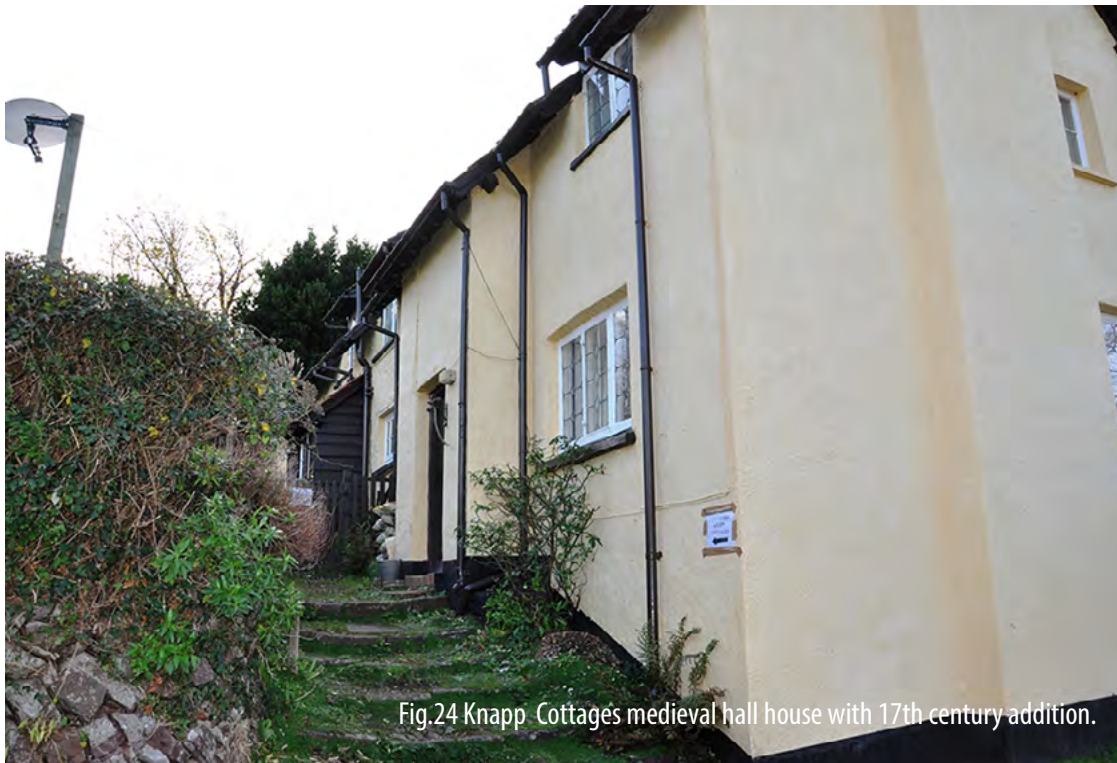
Fig.24 Knapp Cottages medieval hall house with 17th century addition.

At the northern edge of the village, **1 Knapp Cottages** (Fig.24) has also been shown to be part of a late medieval former open-hall house with a surviving smoke-blackened roof truss. Thought to be a former farmhouse, the present cottages are set laterally into the slope. **2 Knapp Cottages** is a 17th century addition with surviving door-frame and fireplace. The plank doors and casement windows are probably early-mid 19th century, several with decorative leaded glazing. The double-Roman tiled roof, replacing thatch, and a combination of exposed red sandstone, and limewashed render echoes many of the other Holnicote estate cottages.

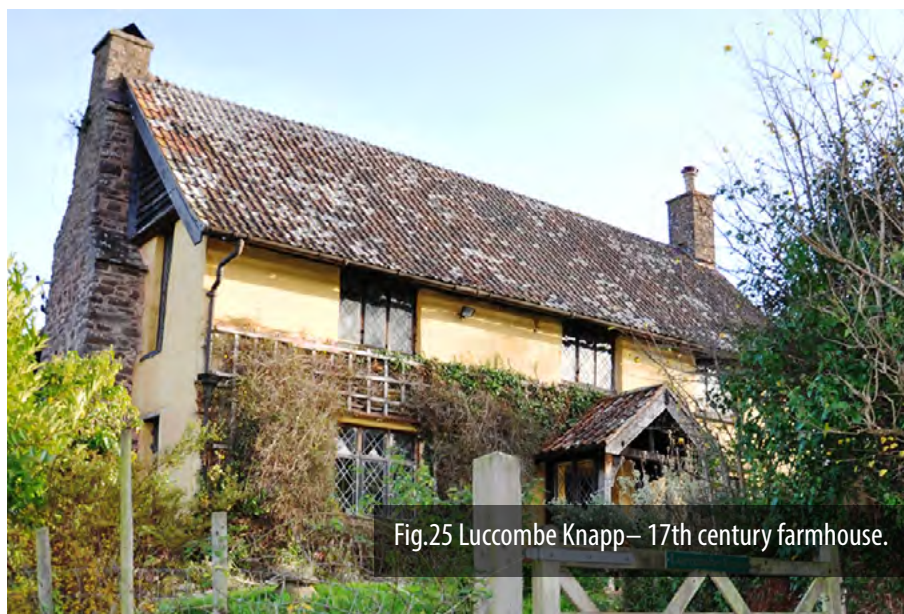
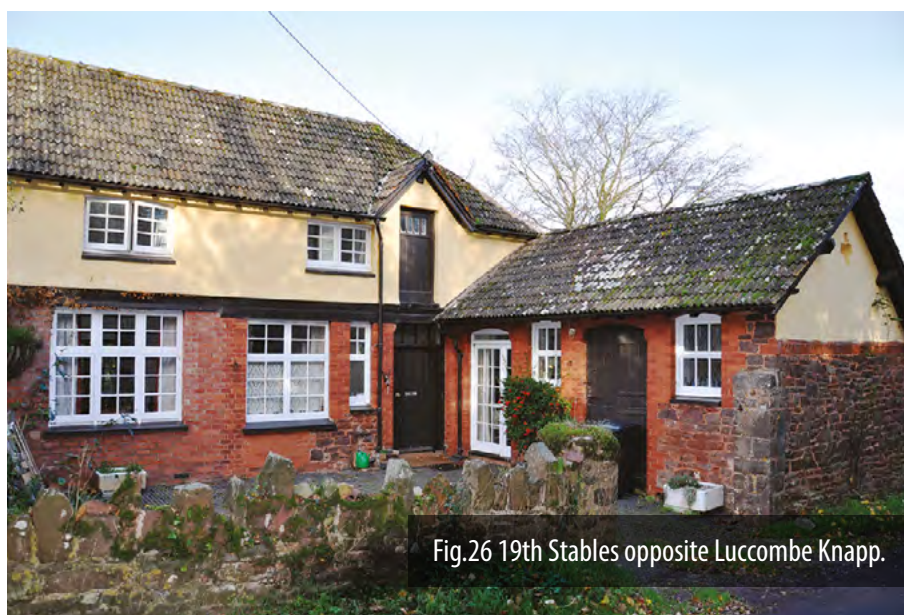
On the same side of the lane, **Luccombe Knapp** (Fig.25) is a 17th century former farmhouse. Its walled garden and stables are opposite (Fig. 26) and just to the north. Owned by the Wroth family of Wychanger until the 1880s, it contains examples of the ornate leaded glazing patterns that typify several cottages altered in the 19th century.

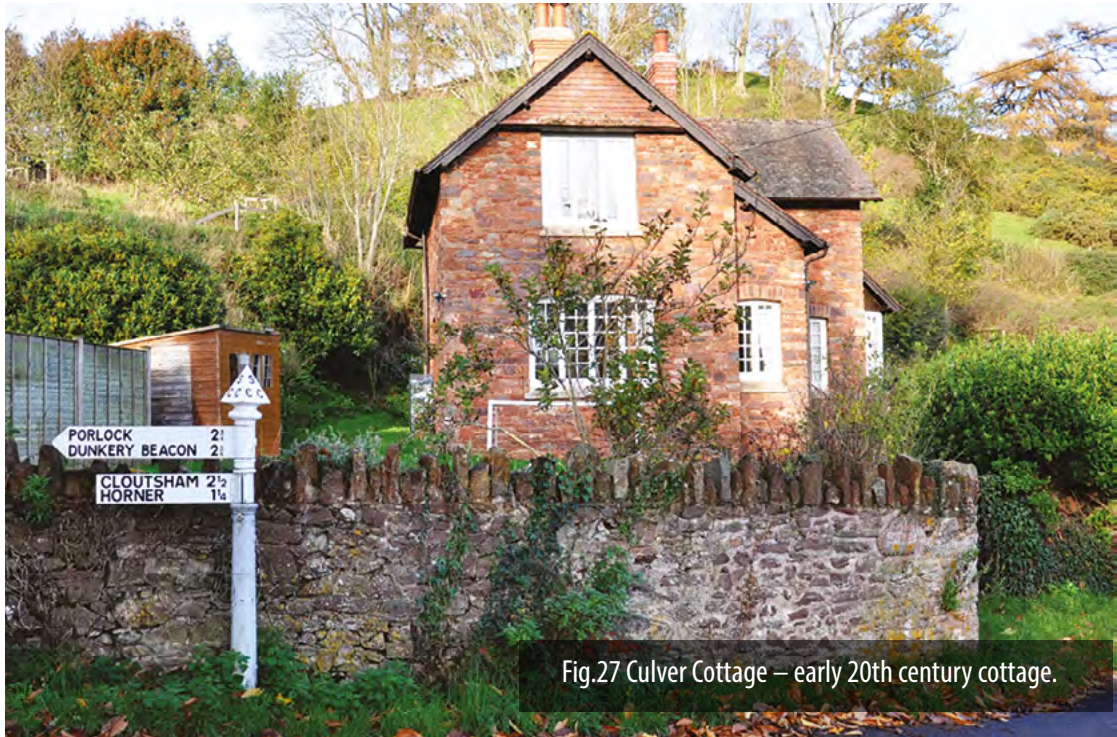
At the north-west end of the Conservation Area is **Culver Cottage** (Fig.27), early 20th century and stone-built with 10-light casement windows, set within segmental arched openings. It has a plain tiled roof with brick stacks, and is an important visual stop at this end of the village.

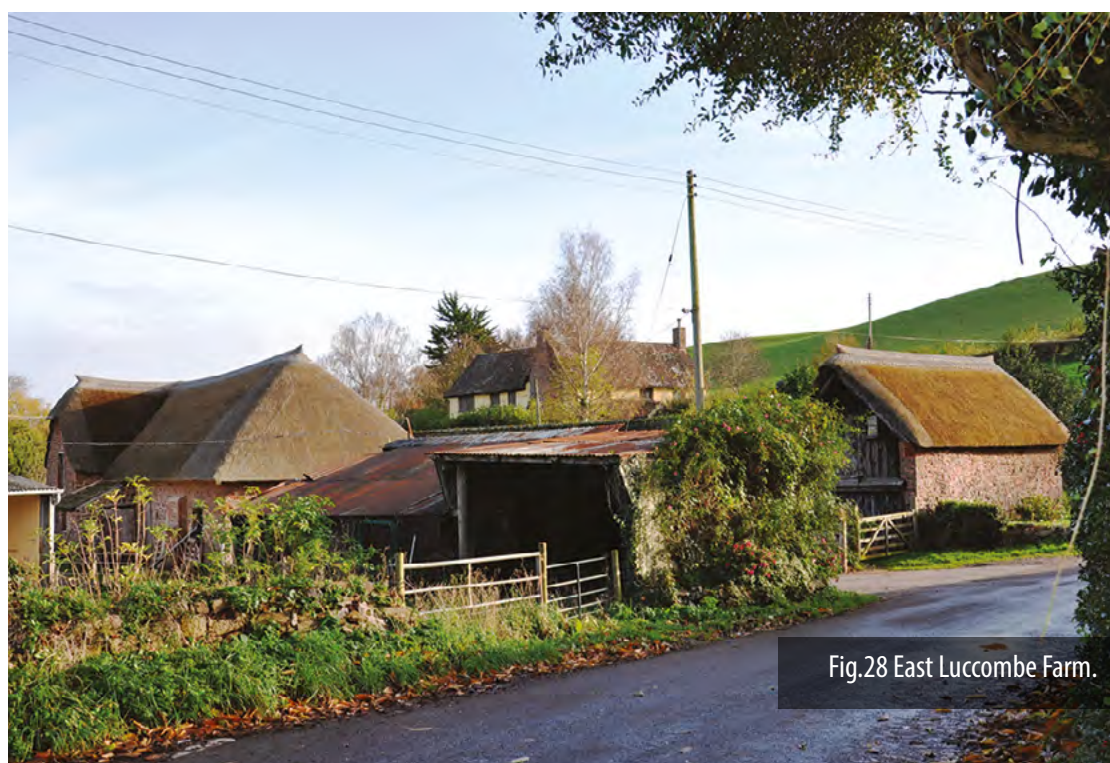
East Luccombe Farm (Fig.28) comprises a significant group of outbuildings, built of sandstone rubble with thatched and double Roman tiled roofs, around three sides of a cobbled yard. They are thought to date from the 18th century, were altered in the mid 19th century, and consist of a threshing barn, loft over a stable with shelter sheds opposite. To the south is a detached linhay (Fig.29), probably of late 17th century date and separately listed. It is built of sandstone rubble and cob, with circular stone piers and weatherboarded infill. The farmhouse is of historic interest but is just outside the Conservation Area.

Fig.28 East Luccombe Farm.

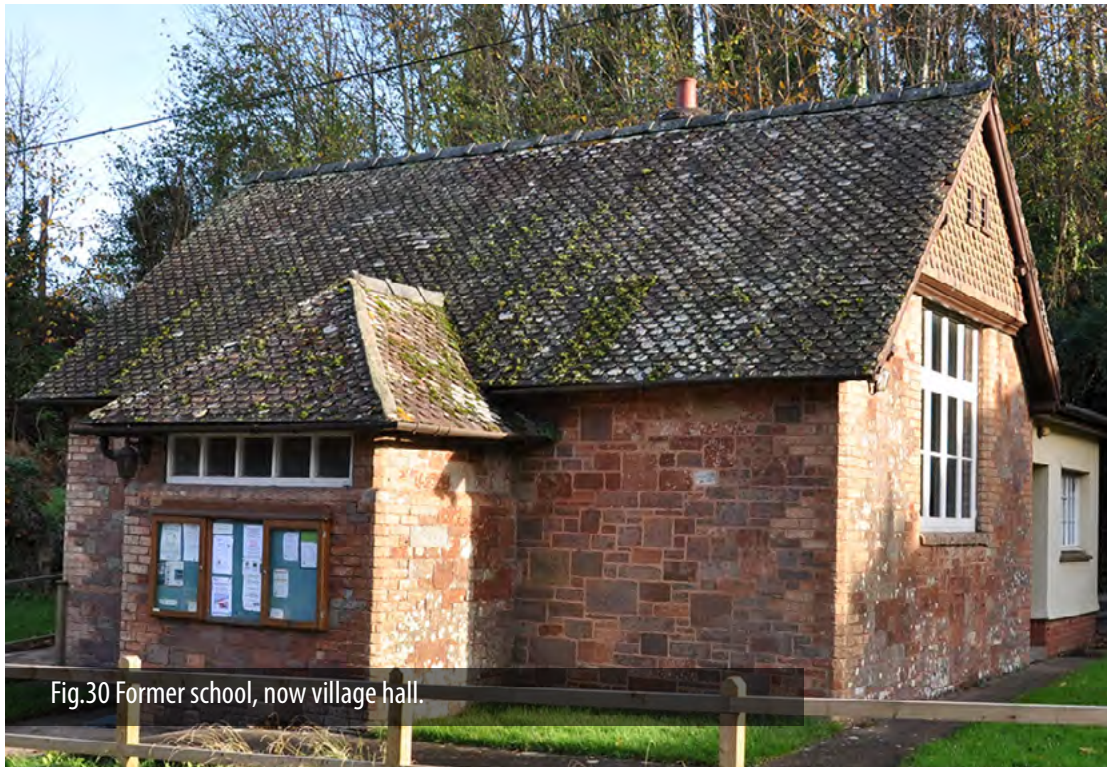
Somewhat set apart on the east side of the main street is the former School, now the **Village Hall** (Fig.30) built by the 11th Baronet Acland in the late 19th century. It is single-storey, built of squared-off local sandstone with brick dressings and 'fishscale' plain tiled roof. It has some school child graffiti incised in the bricks, which add to its interest. The flat roofed extension is, however, a negative feature.

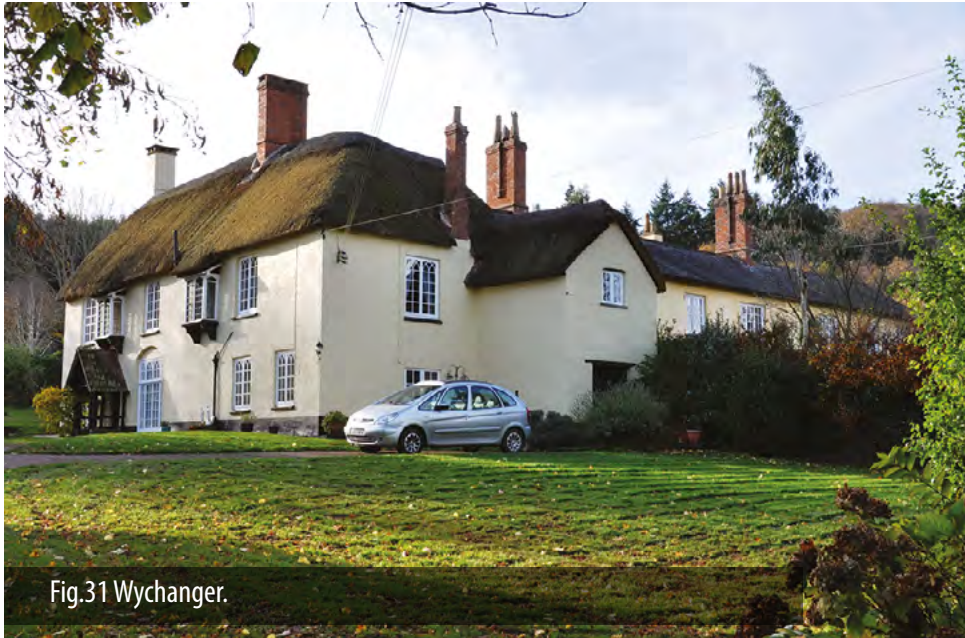
As would be expected, the high status buildings are set apart, both spatially and in terms of scale and design. **Wychanger** and **Wychanger Barton** (Fig.31) are now semi-detached portions of the former manor house with some parts, such as jointed cruck trusses and curved struts, dating from the late 16th–early 17th century. In the former, which is part thatched, there is a 16th century studded entrance door and other 17th century doors, but in the early-mid 19th century it was altered to a Gothick style with casement windows, including French windows with divided tracery. An interesting sundial is incised in stone on the south chimney. Wychanger Barton was largely rebuilt in the late 19th century after a major fire. East of Wychanger is the **former stable and coach house** (Fig. 32) dating from the late 17th– early 18th century and built of stone rubble with segmental arched ground floor openings.

When converted to residential, probably in the latter half of the 19th century, casement windows, some with ornate leaded glazing patterns were added, typical of examples seen elsewhere in the village. It is now holiday lets.

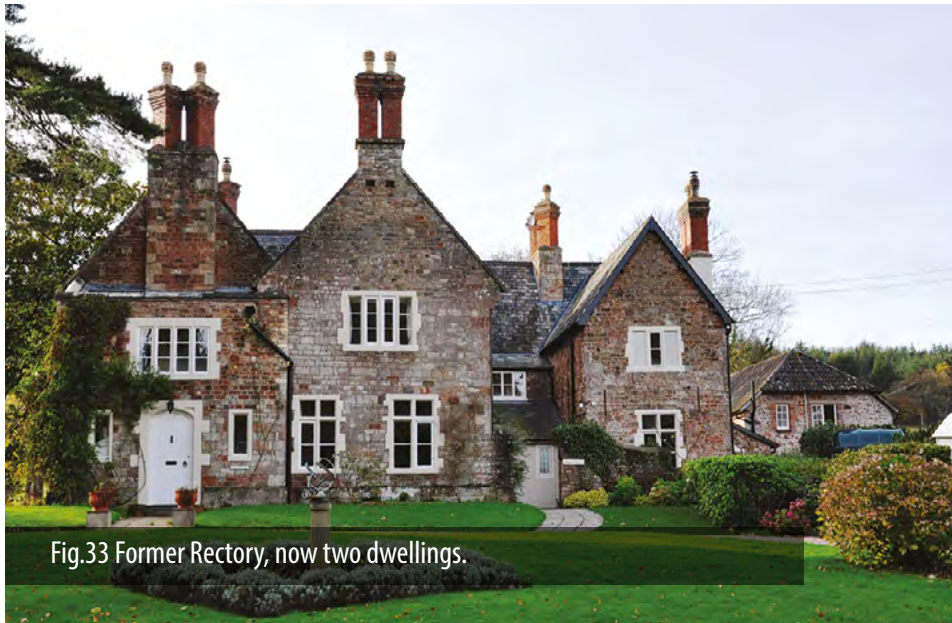
Fig.33 Former Rectory, now two dwellings.

The former rectory, now split into **The Old Rectory** and **The Manor House** (Fig.33), was built between 1839 and 1856 for the then rector Thomas Fisher, and is reputed to have replaced a much earlier building on this site. It is in a sprawling neo-Elizabethan style, stone built with slate roof, mullioned windows, raised gables corbelled out, and diagonally opposed brick stacks on stone shafts. Adjoining, and also stone-built, are the **former stables** (Fig.34) with a half-hipped Bridgwater tiled roof, and six-light timber casement windows with brick architraves.

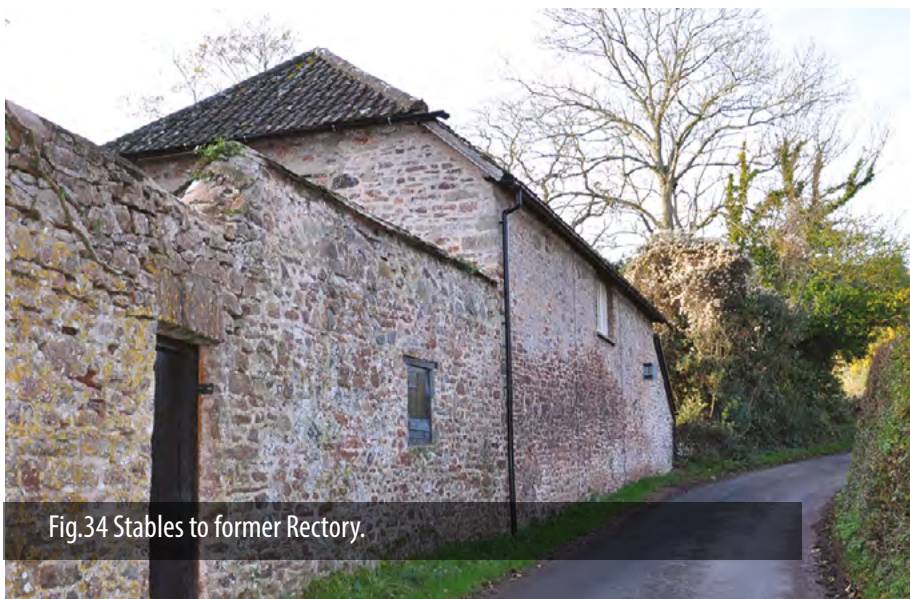
Fig.34 Stables to former Rectory.

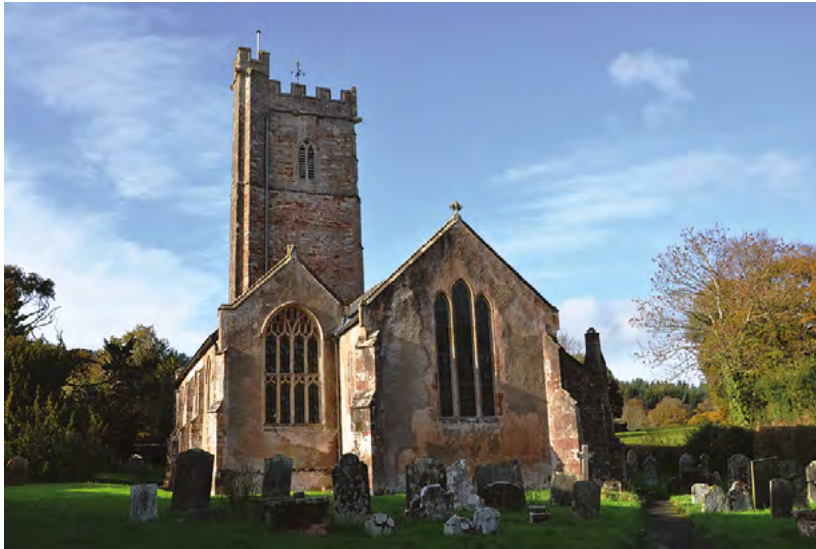
Fig.35 Parish Church of St. Mary.

The **Parish Church of St. Mary** (Fig.35) is mainly executed in Perpendicular style and has a chancel dating from c.1300, a nave and tower of c.1450, and an aisle added c.1350. There were restorations in 1840, when a gallery of 1752 was removed, and in 1895 by Edmund Buckle, when the present seating was added. The three-stage crenellated tower and stair turret built of squared red sandstone and with trefoil-headed windows is fairly typical of others in West Somerset. Some fragments of early 16th century English and Flemish glass survive and were reset in the east window of the aisle in 1935. Important furnishings and monuments include a Jacobean pulpit, an early 16th century table tomb, a fine brass to William Harrison (Fig.1), and several 17th and 18th century tablets, mainly in Classical styles. In the churchyard is a red sandstone **churchyard cross** (Fig.36) dating from the 15th century. The lower part of the octagonal shaft survives set on a three-stage plinth.

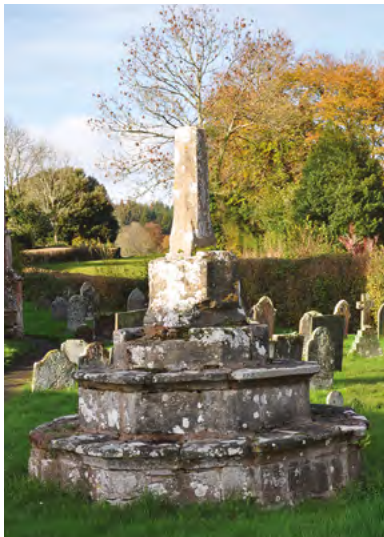
Fig.36 Medieval churchyard cross.

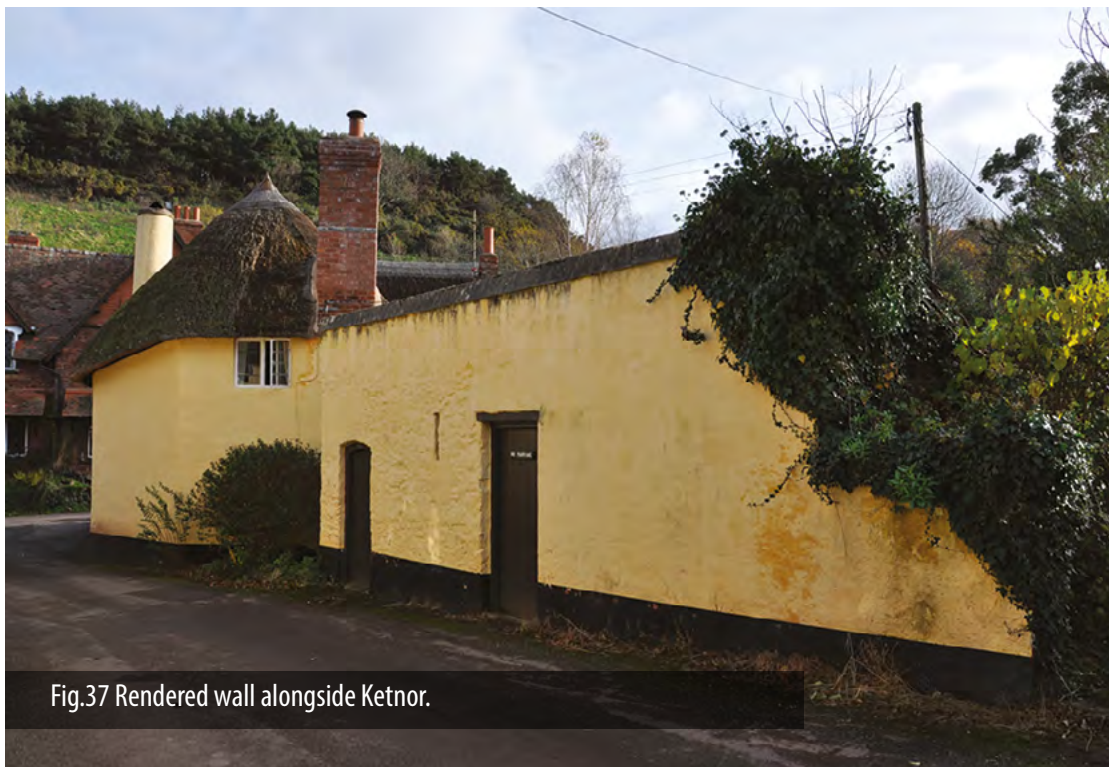
Fig.37 Rendered wall alongside Ketnor.

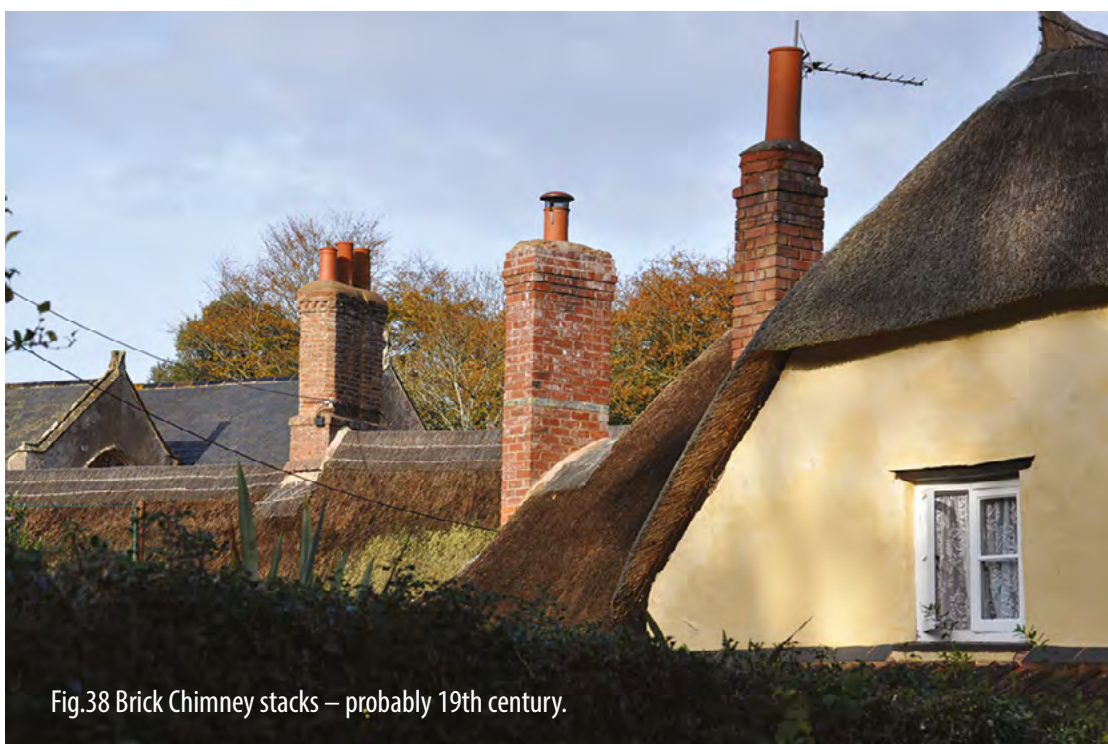
Fig.38 Brick Chimney stacks – probably 19th century.

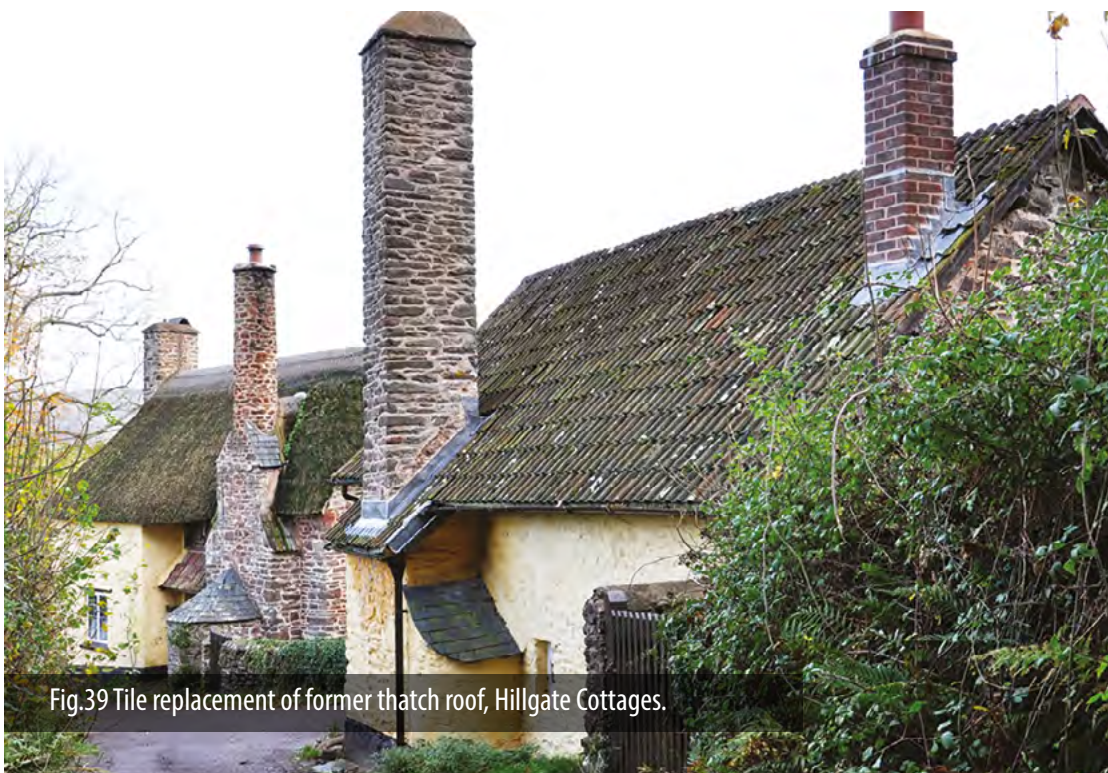
Up until the later 19th-century thatch would have been the only available roofing material for all but the highest status buildings. Traditionally, thatch was combed wheat reed. In recent years, this tradition has been under threat from the non-indigenous water reed, much of which is now imported from Eastern Europe. In recent years The National Trust has been carrying out trials on the Holnicote Estate, and now produces enough straw from this source to carry out patching and re-thatching on its own cottages.

Fig.39 Tile replacement of former thatch roof, Hillgate Cottages.

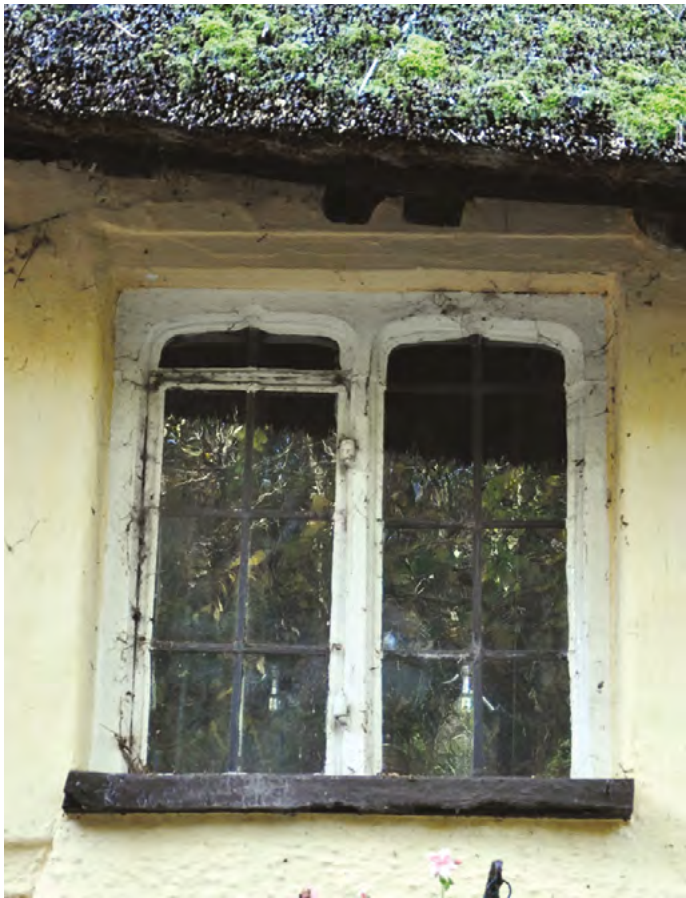
Historic windows in the Conservation Area are mainly a mixture of timber and metal casement with few sash windows evident. Some cottage windows have forged iron casements, and there is a range of leaded light glazing patterns. Frames are typically plain rectangular but more decorative examples may be seen, for example at Knapp Cottages and Glebe and School Cottages.

Fig.40 Casement windows with ogee head.

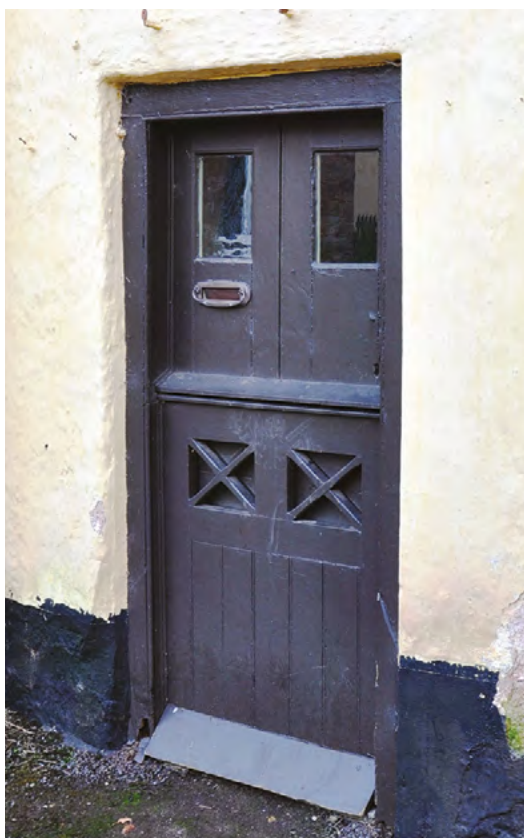
Most doors are constructed in a traditional plank and ledged form (some with non-traditional fixed lights), and a few have examples of what may be termed rustic Arts & Crafts detail, for example use of diagonal boarding, and others with ribs or studs (Fig.42). The earliest openings have massive oak frames, and are jointed with pegs or chamfered with stops, and are possibly of late medieval origin (Fig.43).

Fig.42 Stable door with rustic detailing.
