Exmoor National Park
Historic Environment Report Series No 15

LUCCOMBE CONSERVATION AREA: APPRAISAL DOCUMENT

Adopted 2018

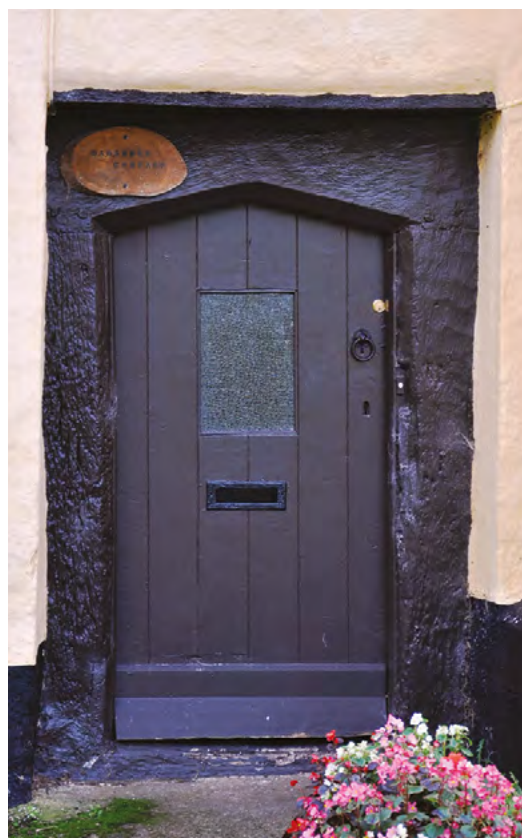
Most doors are constructed in a traditional plank and ledged form (some with non-traditional fixed lights), and a few have examples of what may be termed rustic Arts & Crafts detail, for example use of diagonal boarding, and others with ribs or studs (Fig.42). The earliest openings have massive oak frames, and are jointed with pegs or chamfered with stops, and are possibly of late medieval origin (Fig.43).

Fig.43 Modern door in C17 or earlier frame.

Towards the lower end of Stoney Street are **Oakapple Cottage** and **Hayes Cottage** (Fig.17), which were formerly one late 16th - early 17th century three-bay and cross passage house with full-height projection to the right of the lateral stack and a rear wing. The construction is roughcast render over stone rubble with double Roman tiled roofs. There are 19th century casement windows, both timber and metal. The plank door in a chamfered peak-headed doorframe indicates a possible 16th century date (Fig.43).

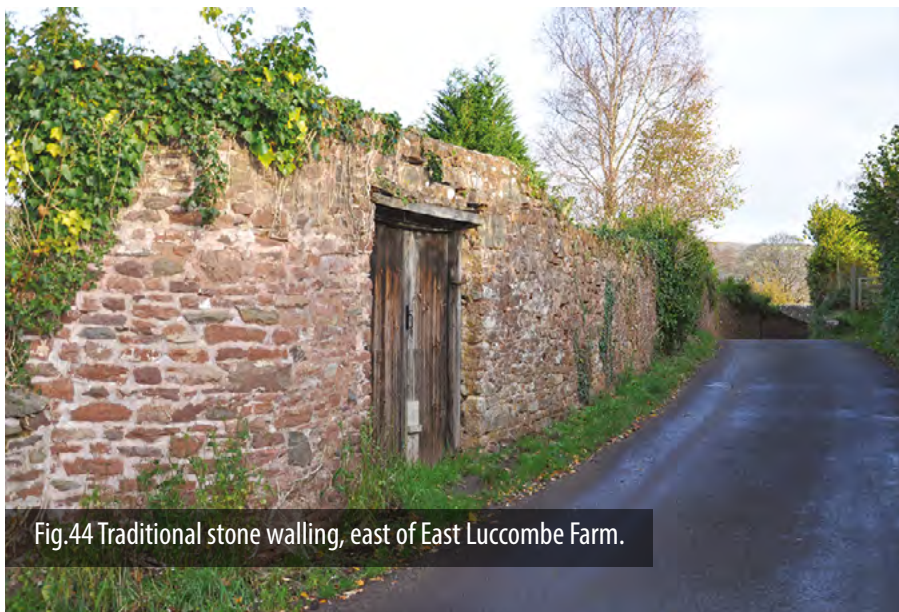
There are considerable stretches of high boundary walling built of local sandstone rubble, notably along the lane east of East Luccombe Farm (Fig.44) and from the Old Rectory/Manor House to the church. These contribute considerably to the character of the Conservation Area. There is limited walling of the locally distinctive dry-stone pattern known as 'dyking'. This adds a pleasing contrast to the more widespread use of roughly coursed stone rubble. Some stretches of walling, form a retaining feature to hedge row banks and can be prone to deterioration when not regularly maintained. Nevertheless, all the local types of stone walling make a valuable contribution to the character of the Conservation Area, as well as providing a strong sense of enclosure or privacy.

Fig.44 Traditional stone walling, east of East Luccombe Farm.

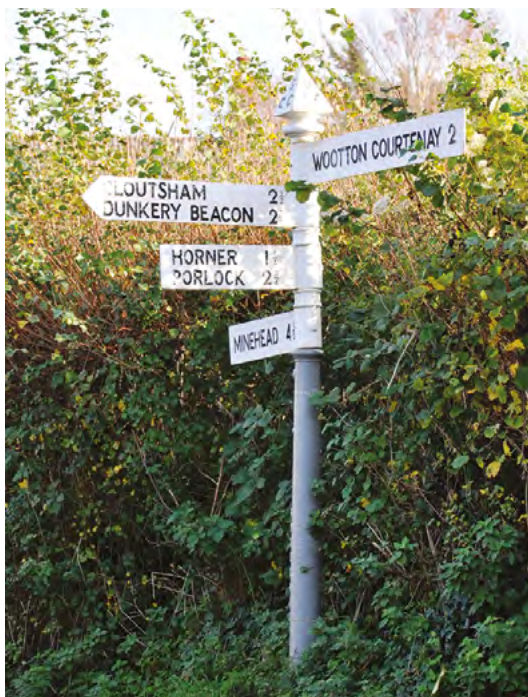
Fig.45 Cast iron finger post.

The earliest piece of street furniture identified is the Victorian letterbox set in the wall of Ketnor. There are two mid 20th century cast iron Somerset County Council guideposts, at the north end of the Conservation Area (Fig.45) and a K6 telephone kiosk just north of the village hall. Other items of interest include a hand painted timber National Trust 'no parking' sign (Fig.46) and the Luccombe Millennium lamp, fixed to the village hall.

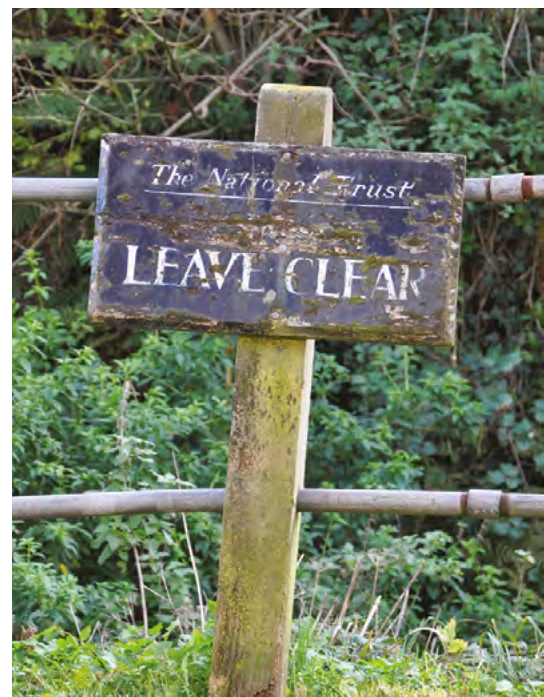
Fig.46 Early National Trust sign

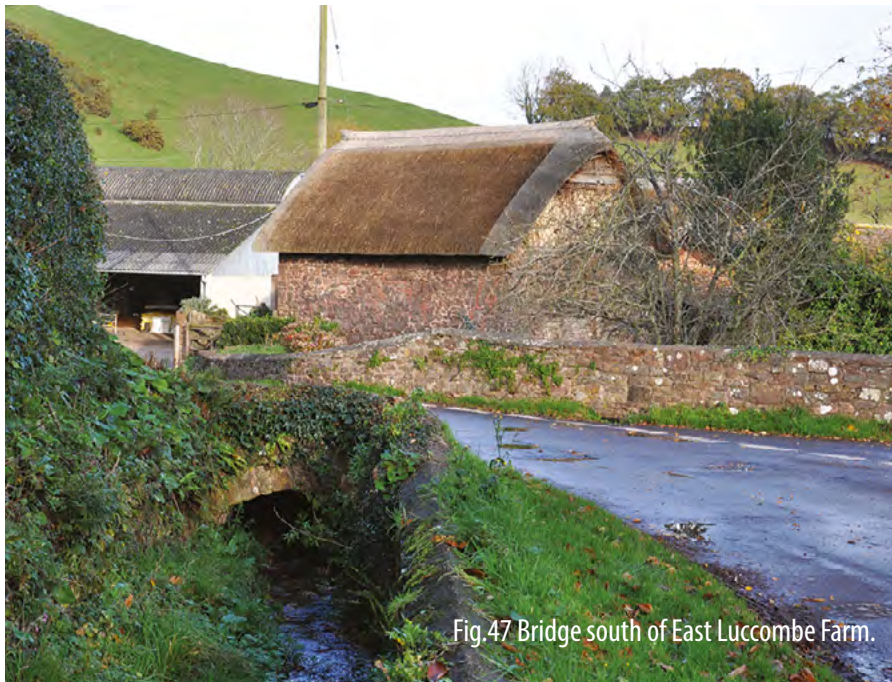
The streams flowing through the village contribute greatly to its character and appearance. The stream alongside Stony Street has cut a deep gully but once it reaches the more level ground near the Square it is narrow and easily crossed. The bridges and conduits appear to be relatively recent responses to modern traffic demands and are either flat or are shallow single-arched stone bridges.

Fig.47 Bridge south of East Luccombe Farm.

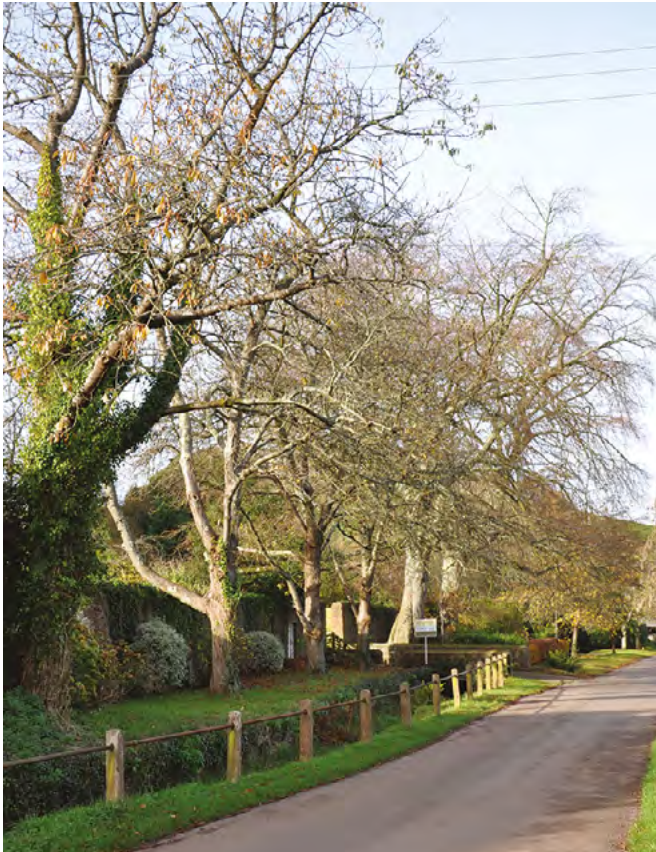
Fig.48 Trees lining main road through village.

Trees and hedgerows make strong contribution to the character and appearance of the village and its wider landscape setting. Generally, this is informal but there is a notable avenue of mature deciduous trees between the wall of the former rectory and the stream running along the main street (Fig.48). Despite modern dwellings occupying space on the opposite side of the wall, including one house within the former walled garden, part of the former rectory's formal garden planting survives. Here, and at Wychanger, are some of the finest specimen trees within the Conservation Area, for example, oak, beech, copper beech, lime, sweet chestnut, pine, yew, ilex and holly.

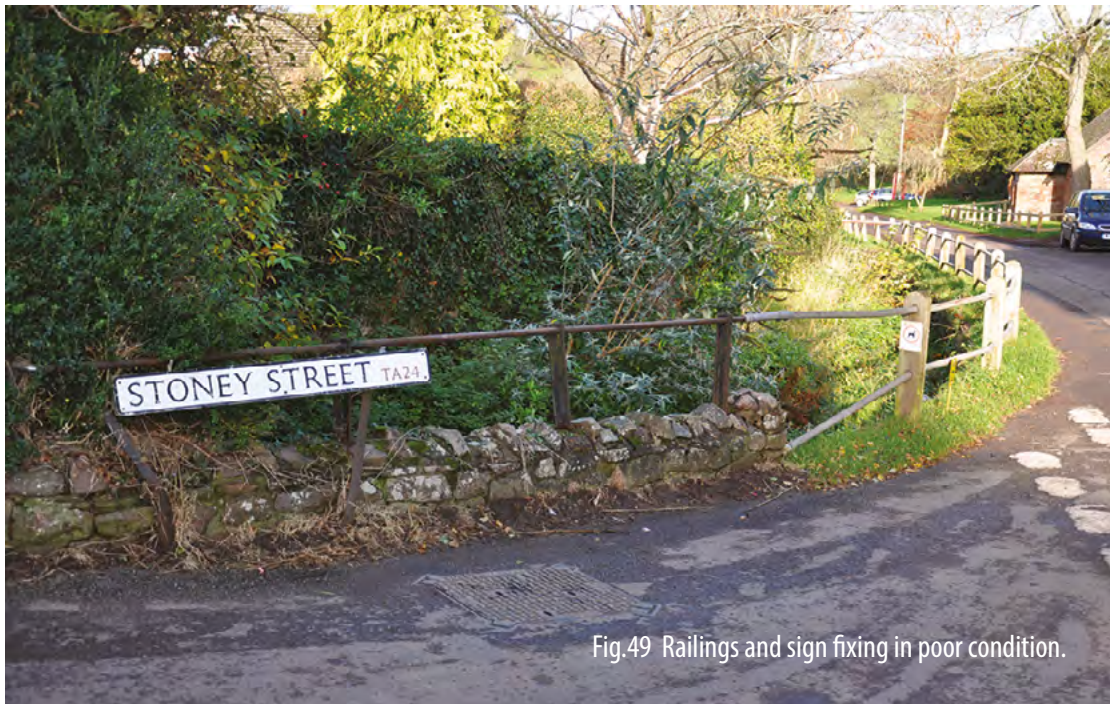
Most historic buildings, both listed and unlisted, are well maintained, and appear sound in terms of their maintenance and structural condition. There is a large proportion of timber or metal windows, mainly casements, and of entrance doors, most of which are ledged and braced. These either survive in their original form, or where replacements have been made, are generally close to a traditional form. For the most part, PVCu replacement windows have made no significant inroads into the Conservation Area although it is noted that the 2004 appraisal records Staddons as having timber framed casements. PVCu windows and doors should be strongly discouraged as they invariably destroy both the historic and visual integrity of even the most modest of traditional buildings. Some localised deterioration of stonework is noted, especially the condition and structural integrity of some boundary walls. The concrete post and metal tube fencing is in poor condition in places.

Fig.49 Railings and sign fixing in poor condition.

- The conservation, and where necessary, the repair of walls and/or historic railings, and timber fencing is considered important. Where appropriate consider using additional timber or ironwork that reflects the local craft traditions.
