Exmoor National Park
Historic Environment Report Series No 17

LYNTON CONSERVATION AREA: APPRAISAL DOCUMENT

Adopted 2019

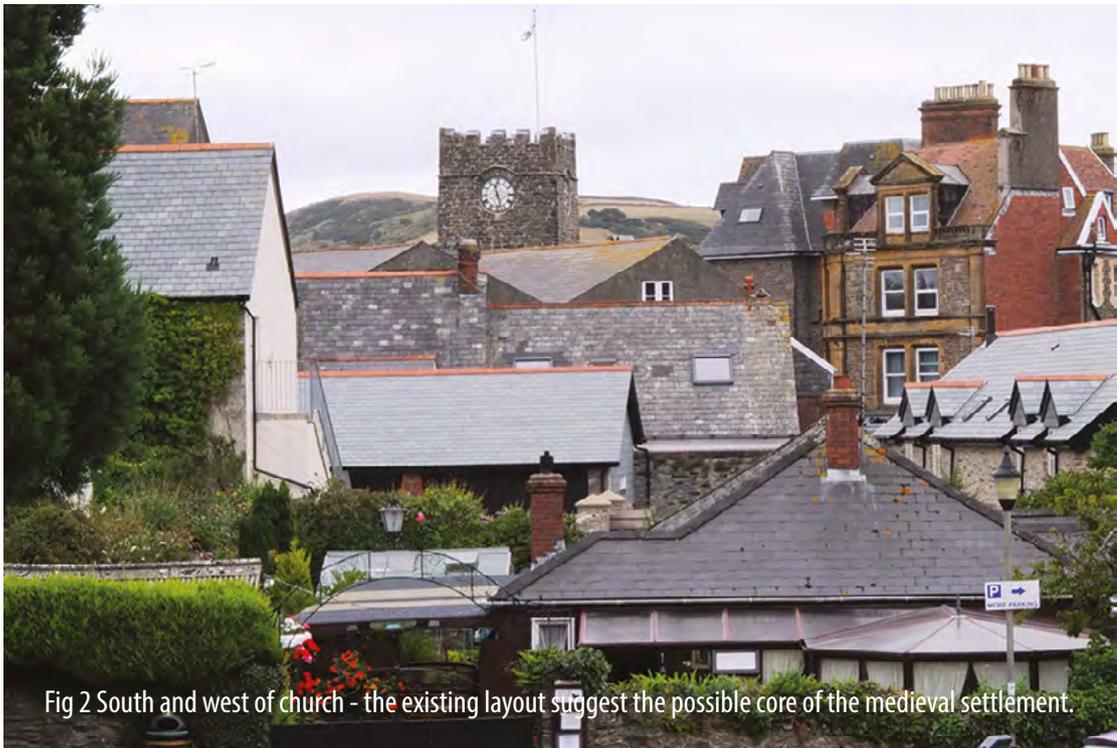
Fig 2 South and west of church - the existing layout suggest the possible core of the medieval settlement.

Physical evidence of the early development of Lynton is elusive. Based on the existing irregular network of narrow streets and dense concentration of buildings on small plots, the area around Queen Street immediately below the church is probably the most likely candidate for the medieval settlement core. St Mary's Church was certainly in existence in the 13th century and the rebuilding of the nave in 1741 suggests an increase in population at this date. The earliest surviving domestic buildings so far identified also date from the mid-eighteenth century.

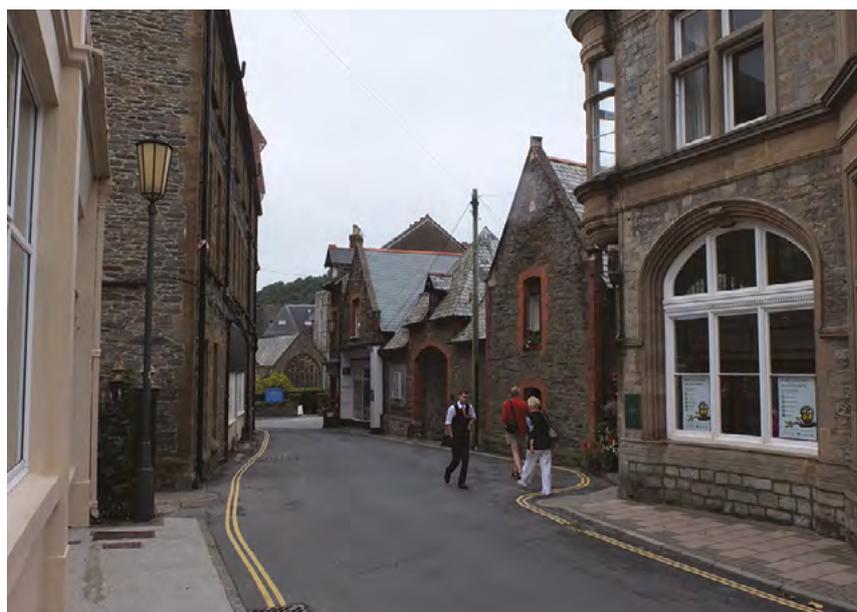
Fig 5 Variety of heights at east end of Lee Road

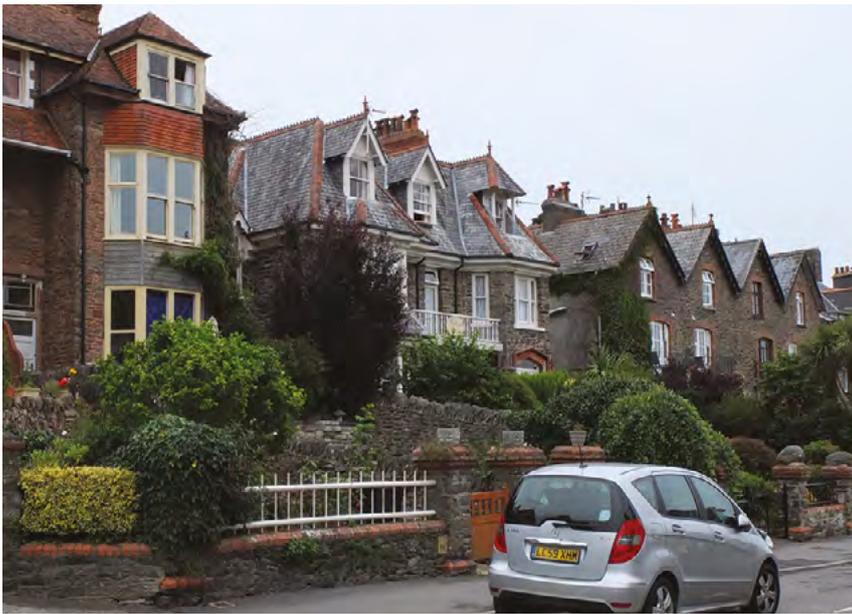
The villas along the north side of Lee Road are semi-detached or in short terraces, mainly three storey or two storey with attics. In contrast, the buildings to the south, are generally lower. The shops opposite the town hall are again two-three storey but are built close up to the pavement giving an impression of greater bulk. Overall, there is little uniformity in the buildings, with quite sudden changes in massing and height within relatively short distances.

Fig 11 Villas along west end of Lee Road – Victoria Lodge is centre.

To the west is a long line of 19th century villas on the north side of Lee Road, most of which are guest houses. The earliest is **Victoria Lodge** (nos 30 and 31), which stood briefly in isolation before its neighbours appeared from c.1900. Of these, **Southcliffe** (no. 34) and **Gable Lodge** (no. 35) (Fig 27) are listed, and form a nearly identical semi-detached pair dating from c.1900 in a late Victorian Picturesque style, with half-hipped and pyramidal gables with deep eaves. They are built of stone rubble with brick dressings and slate roofs. There is considerable frontage ornament, including timber balustrading, sash windows, some tripartite, and entrance doors with geometrical glazing bars.

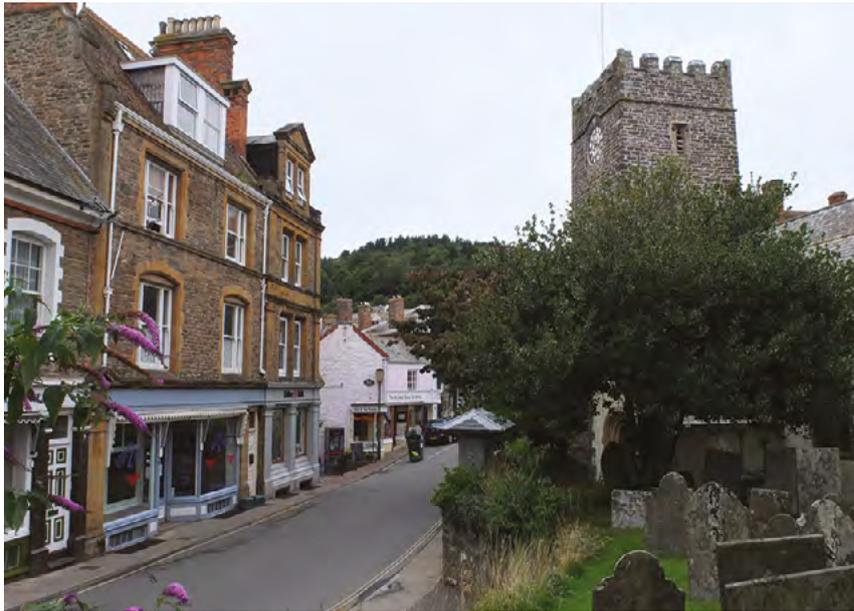
In comparison with the Town Hall and the larger hotels, the parish church does not dominate its surroundings and its squat tower is rivalled in height by the four storey buildings opposite and immediately south-east. Further down towards Castle Hill, the fall of the land means that the two-storey Royal Castle Hotel is not dominated by its taller neighbours at Castle Heights.

Fig 13 Church tower – not a visually dominating presence.

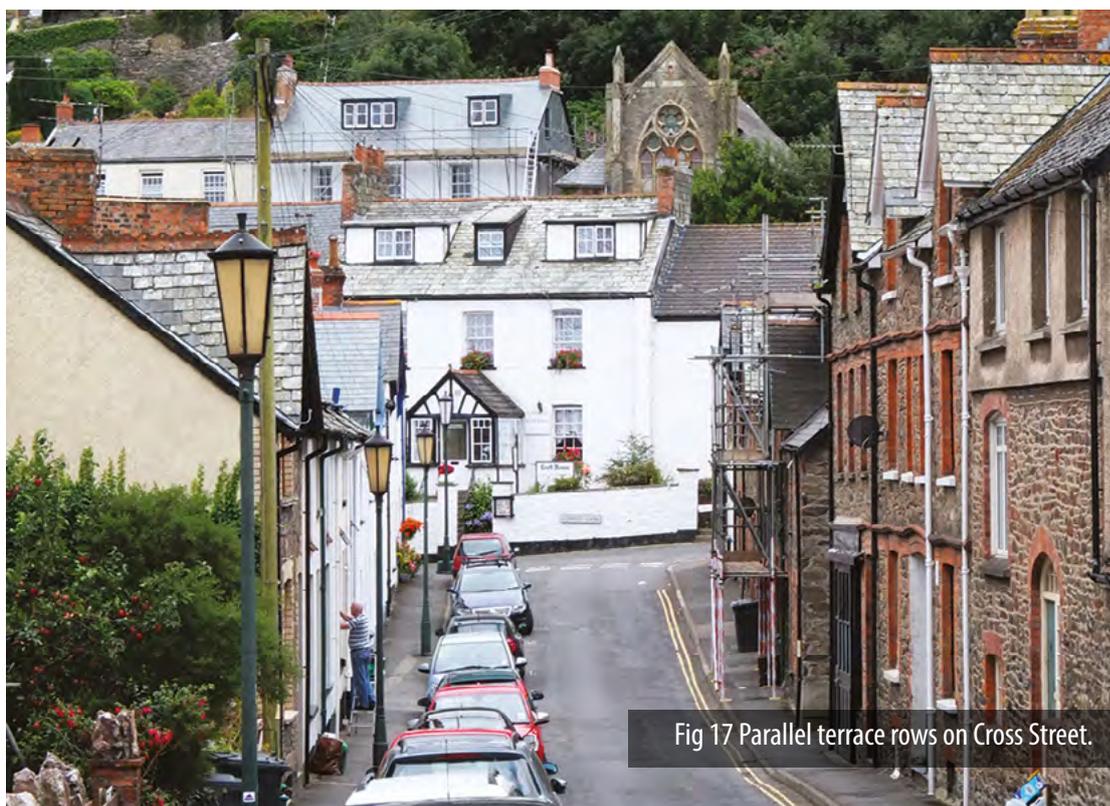
The terraces on Cross Street are the most uniform in the Conservation Area. They are two storey at the south end, becoming three storey as they approach the Town Hall.

Fig 17 Parallel terrace rows on Cross Street.

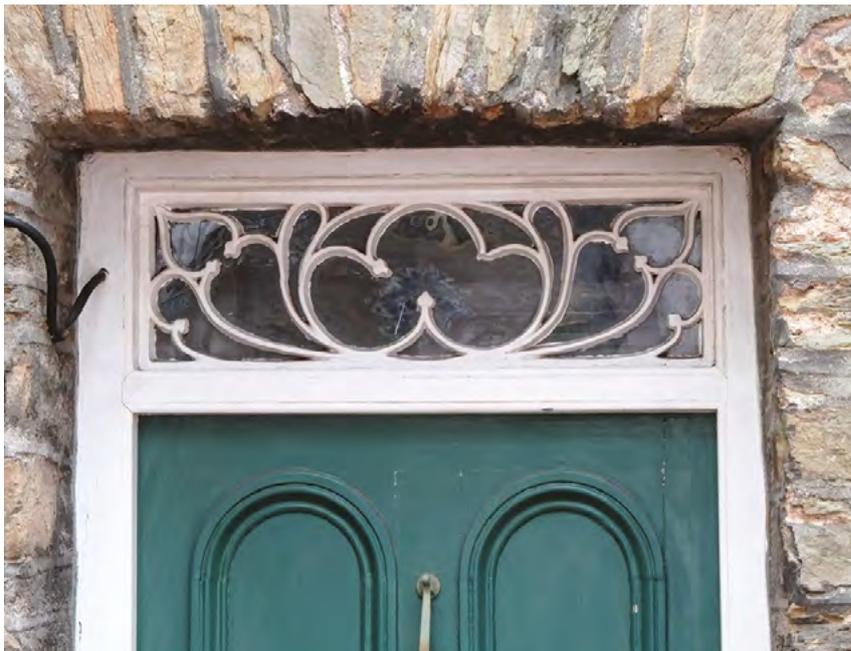
Fig 20 Fanlight, Queen Street.

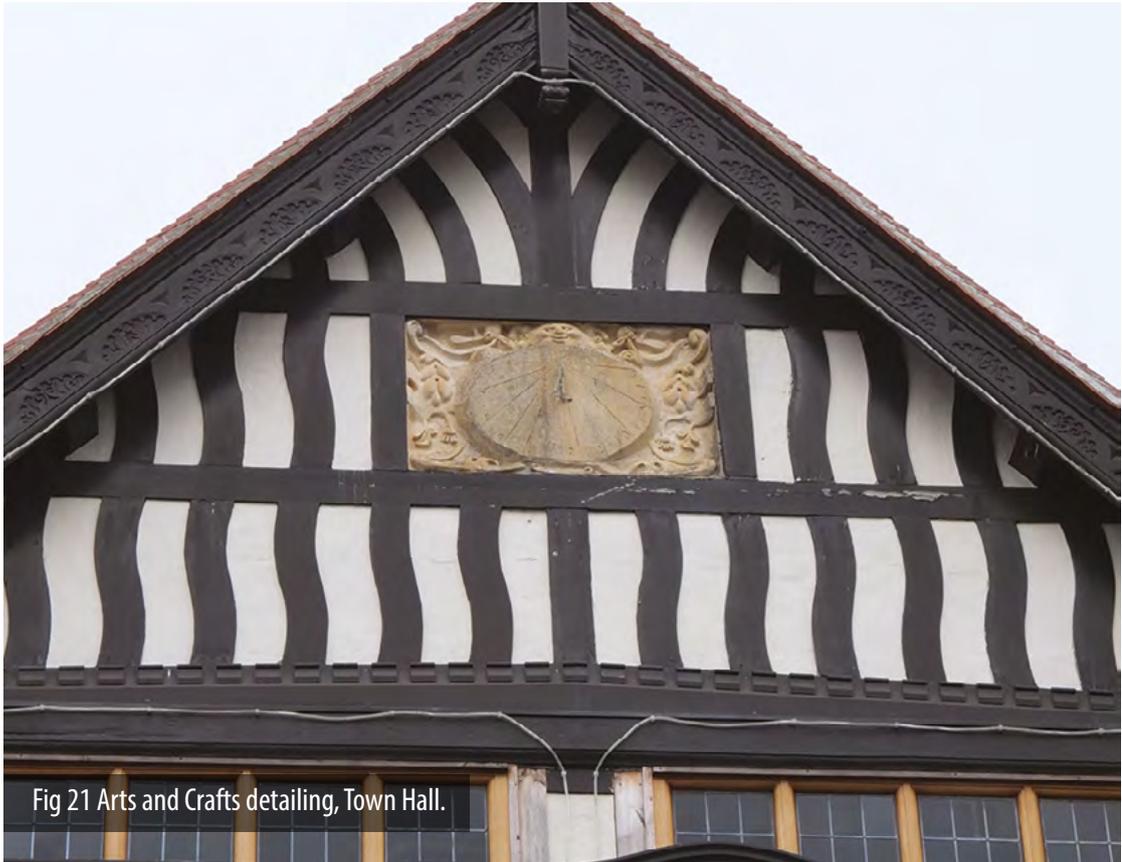
Fig 21 Arts and Crafts detailing, Town Hall.

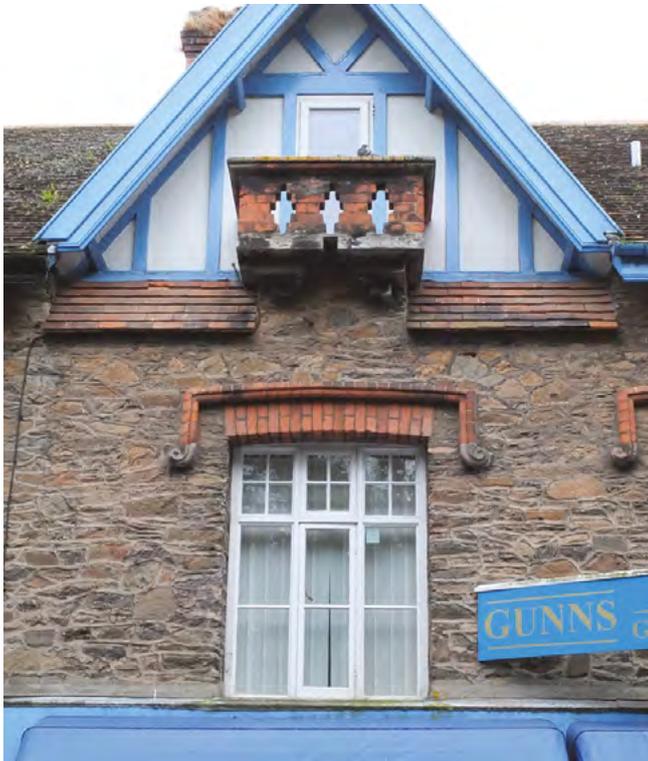
Fig 22 Eclectic detailing,
Lee Road.

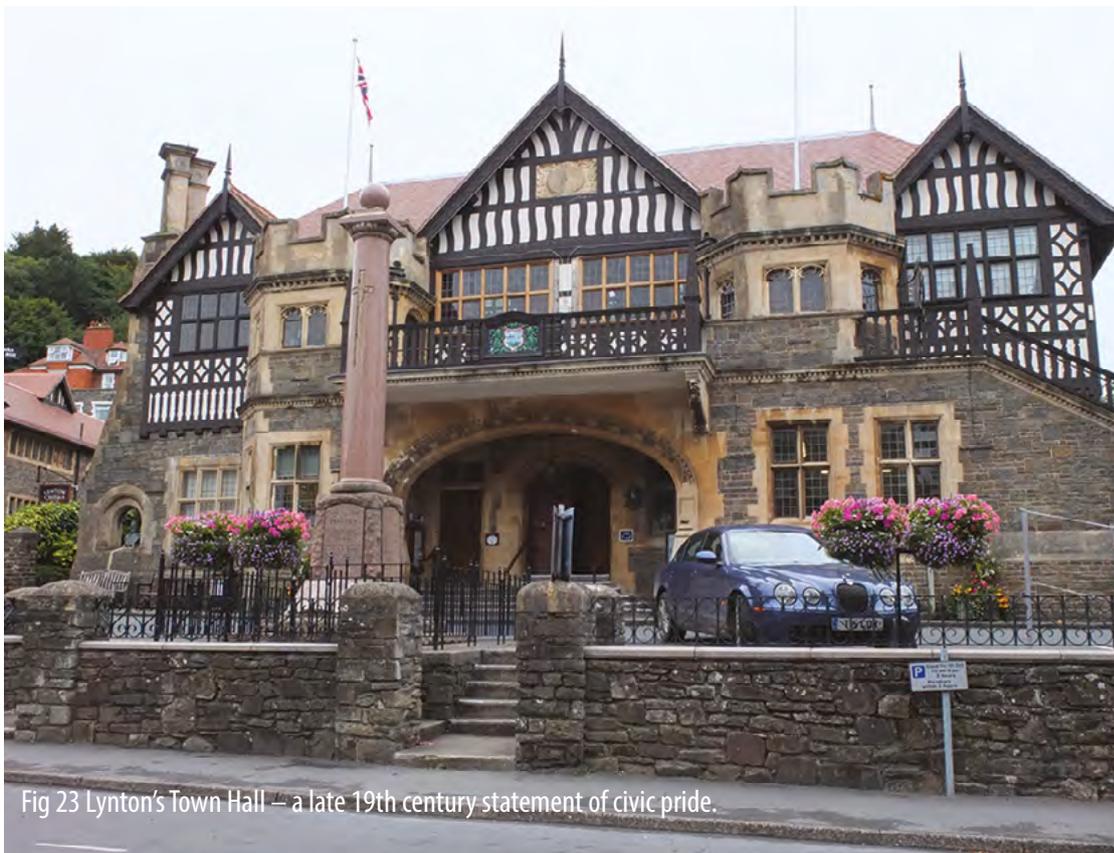
The **Town Hall** (Fig 23) is regarded as one of the finest Domestic Revival examples in England, which is reflected in its listing at Grade II*. It was built between 1898 and 1900 with no expense spared by Sir George Newnes, using London architects Read & Macdonald and local contractors, Pevsner describes it as 'an attempt at municipal architecture in a holiday spirit' and despite its dominating presence it does not take itself too seriously, mixing neo-Tudor design with Art Nouveau details which owe nothing to the local vernacular tradition. Inside it is equally rich in high quality detail, with fine panelling, doors and fireplaces.

Fig 23 Lynton's Town Hall – a late 19th century statement of civic pride.

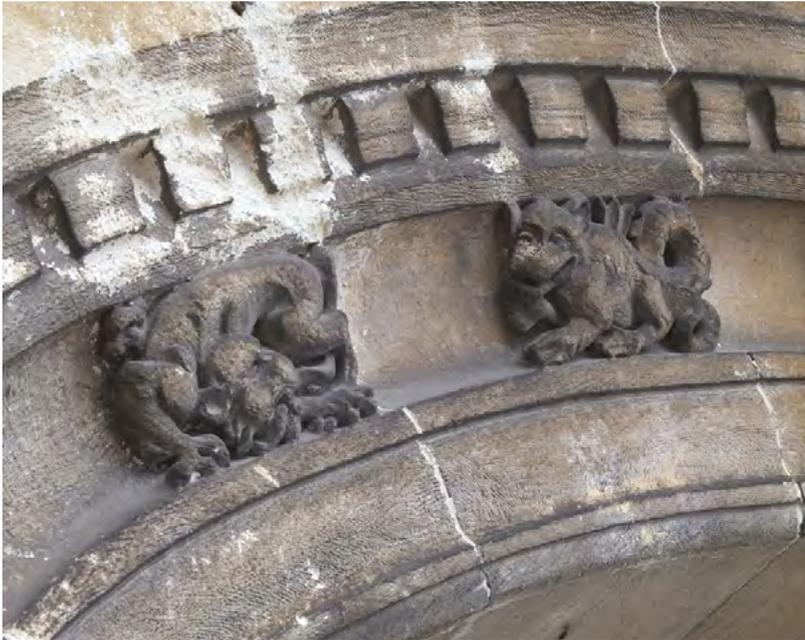
Fig 24 Playful stone carving around main entrance.

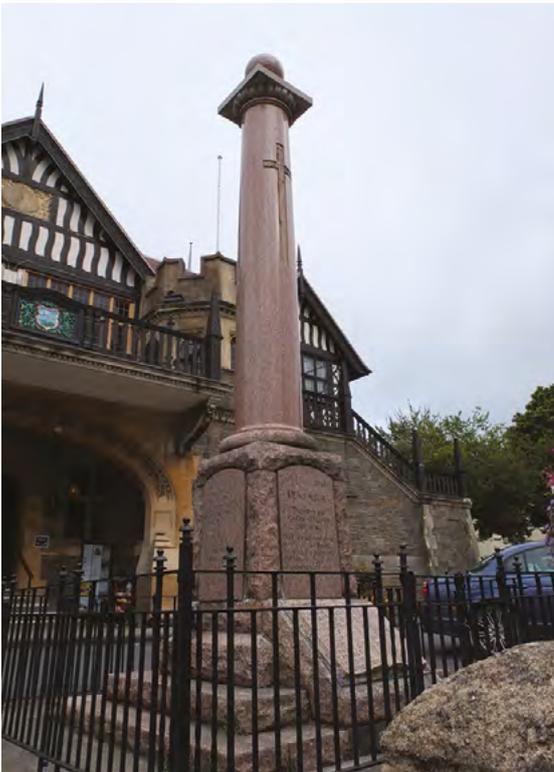
At the front of the Town Hall, the **War Memorial** (Fig 25) of 1920 comprises a granite column with ball finial on a rock-faced granite plinth with polished panels, mounted on a stylobate, and enclosed by a low iron railing.

Fig 25 War memorial at front of Town Hall.

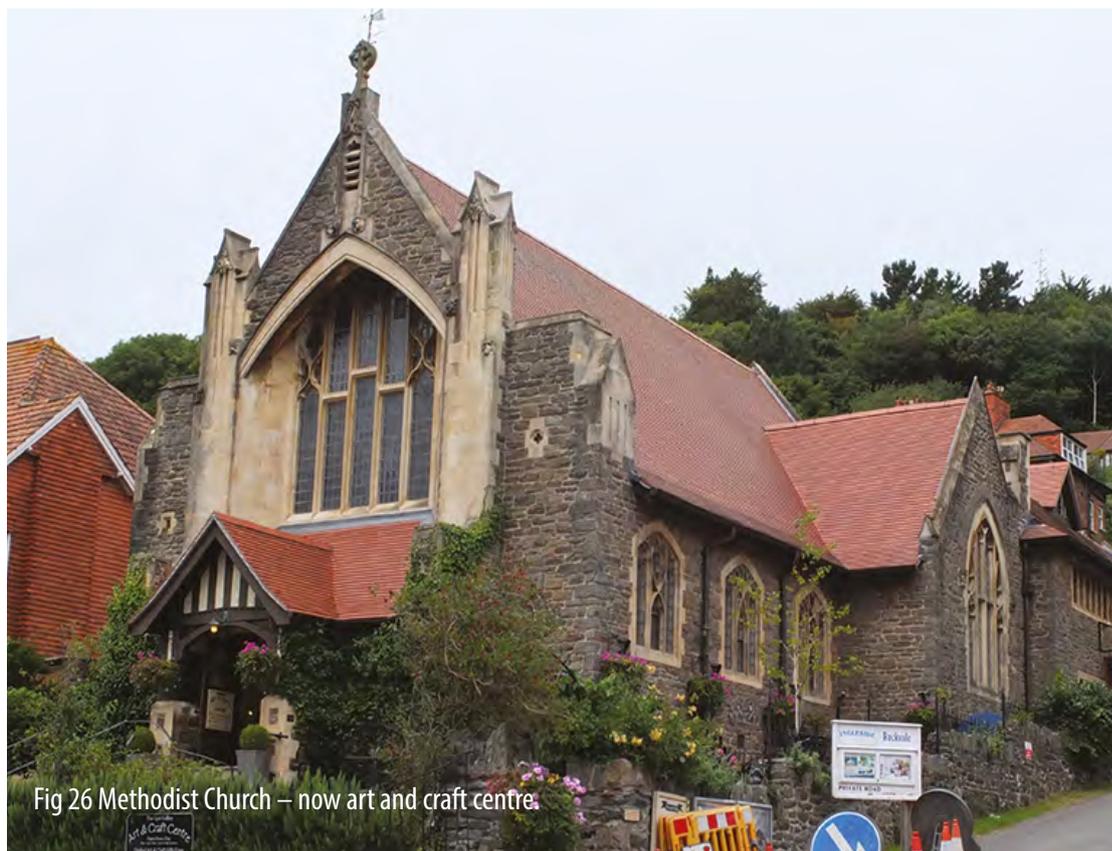
Adjoining, and complementing the Town Hall in a similarly elevated position, is the **Methodist Church** (Fig 26). It is an exceptionally fine Methodist church of the period which is reflected in its Grade II* listing. Completed in 1910 'with (a) fanciful art nouveau stone front' (Pevsner) it was designed by fashionable Bristol architects La Trobe and Weston. The building cost over £3000 so in all probability Newnes helped fund it.

Fig 26 Methodist Church – now art and craft centre.

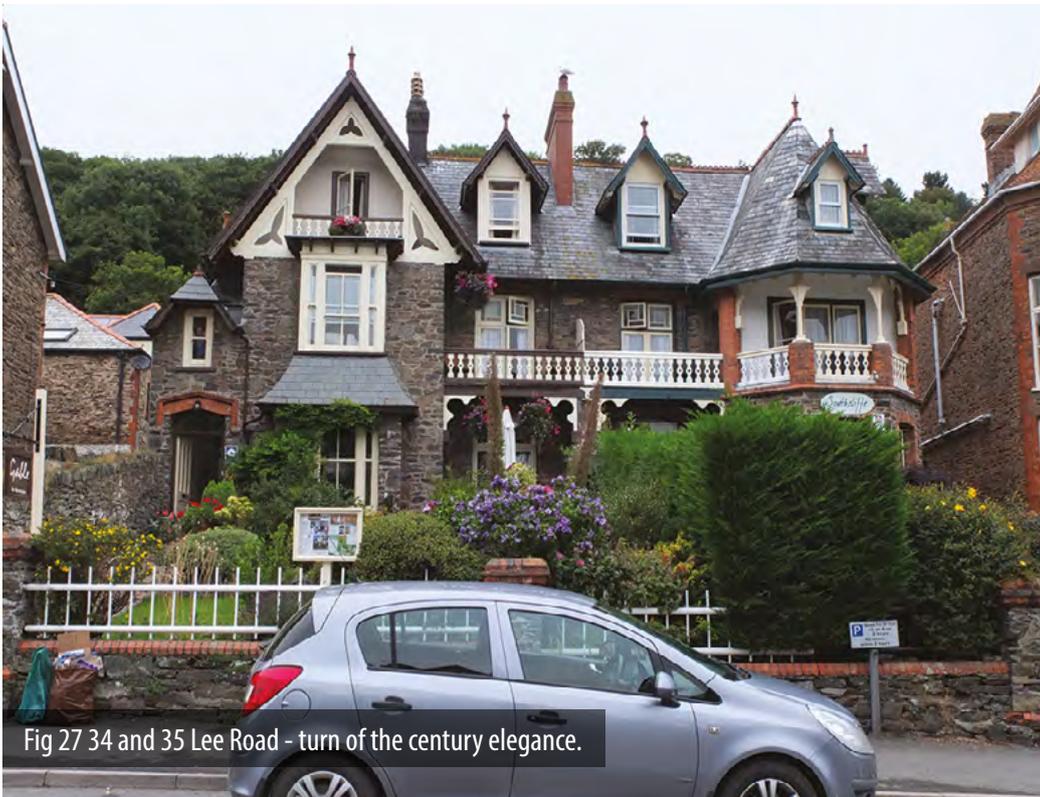
Fig 27 34 and 35 Lee Road - turn of the century elegance.

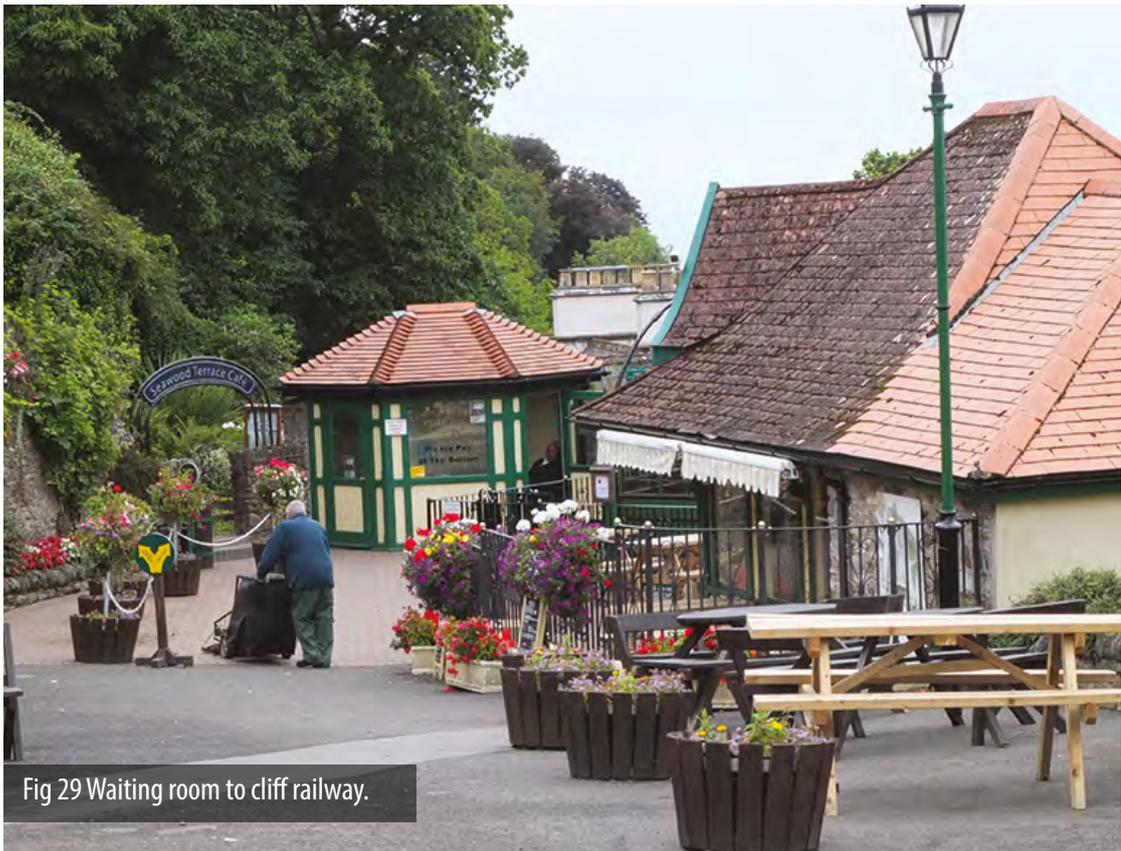
To the east of Garson House, a metal arch marks the start of the path to the cliff railway. The **waiting room** (Fig 29) at the head of cliff railway was built by Bob Jones in 1890 and is a small pavilion style single-storey building, timber-framed with some rubble walling and a cement slate hipped roof.

Fig 29 Waiting room to cliff railway.

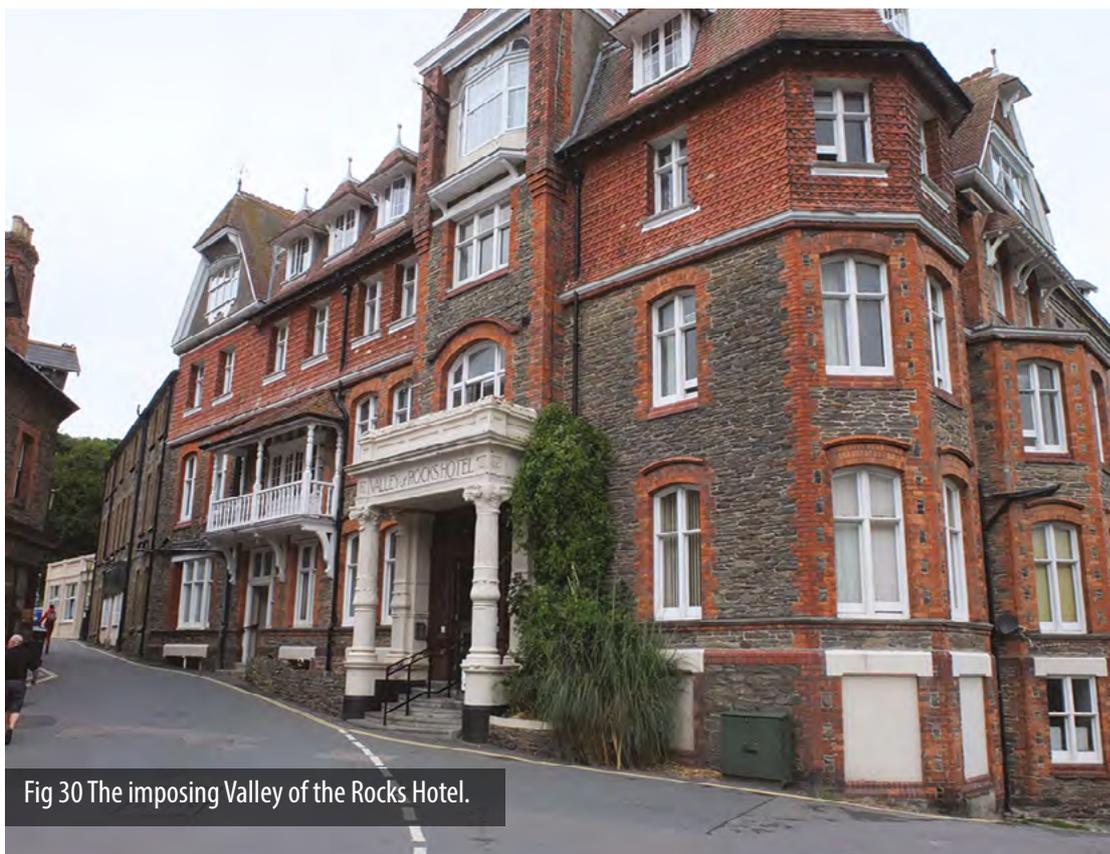
In a complete contrast of scale, the east end of Lee Road is dominated by the **Valley of the Rocks Hotel** (Fig 30), a vast mainly late 19th century edifice in an eclectic mix of styles and materials, including plain tile, slate, brick, stone render and tile-hanging. It is up to six-storeys in height and there are tall, mainly casement windows, conical roofed corners and ornate Corinthian capitals to the projecting porch.

Fig 30 The imposing Valley of the Rocks Hotel.

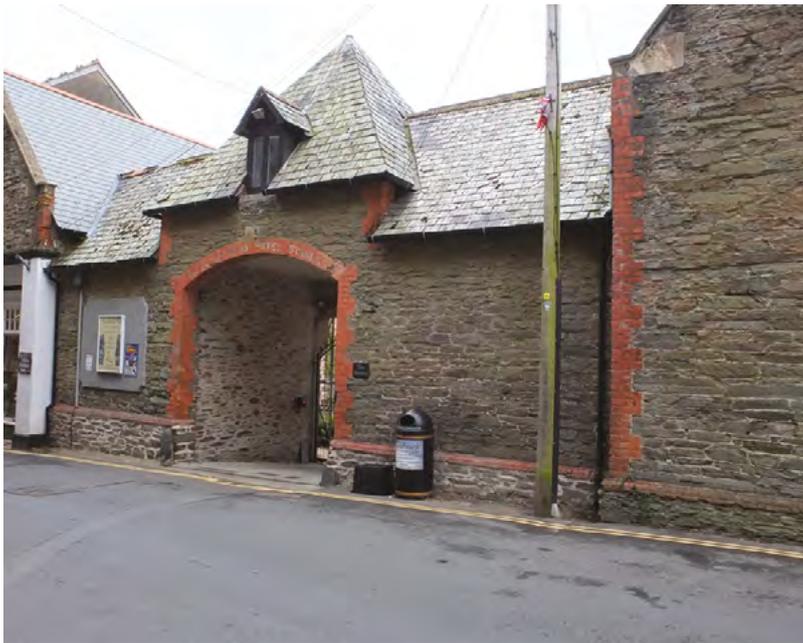
Opposite are the **former stables** (Fig 31) to the hotel, probably c.1870. Stone-built with tuck-pointed brick dressings and a segmental brick arch carriage entrance retaining 19th century painted lettering. The east side is now in use as a shop. There is a further block behind recently converted to domestic accommodation within what is now a development known as Stable Mews.

Fig 31 Former stables to Valley of the Rocks Hotel.

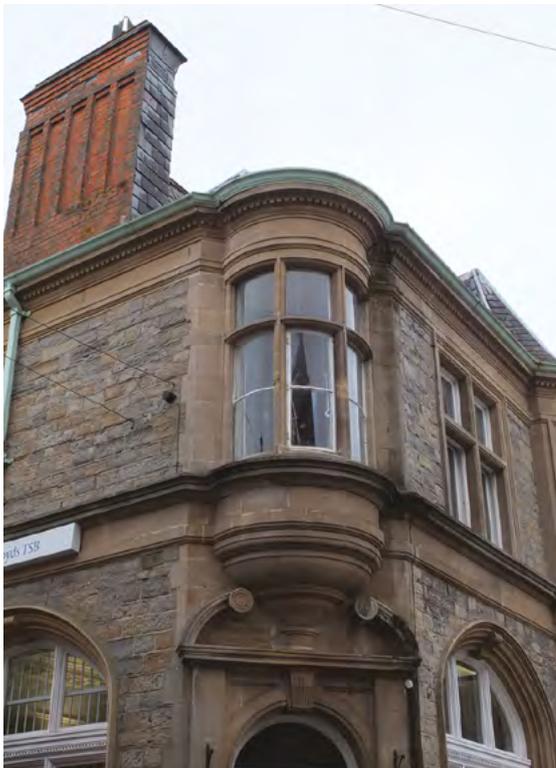
Projecting forward beyond a narrow gap to create a further impressive corner site, is **Lloyds Bank** (Fig 32), in a late 19th century urban neo-Baroque style with casement windows, typical moulded stone dressings, but as a concession to the local vernacular, a slate-hung gable.

Fig 32 Lloyds Bank - Baroque detailing.

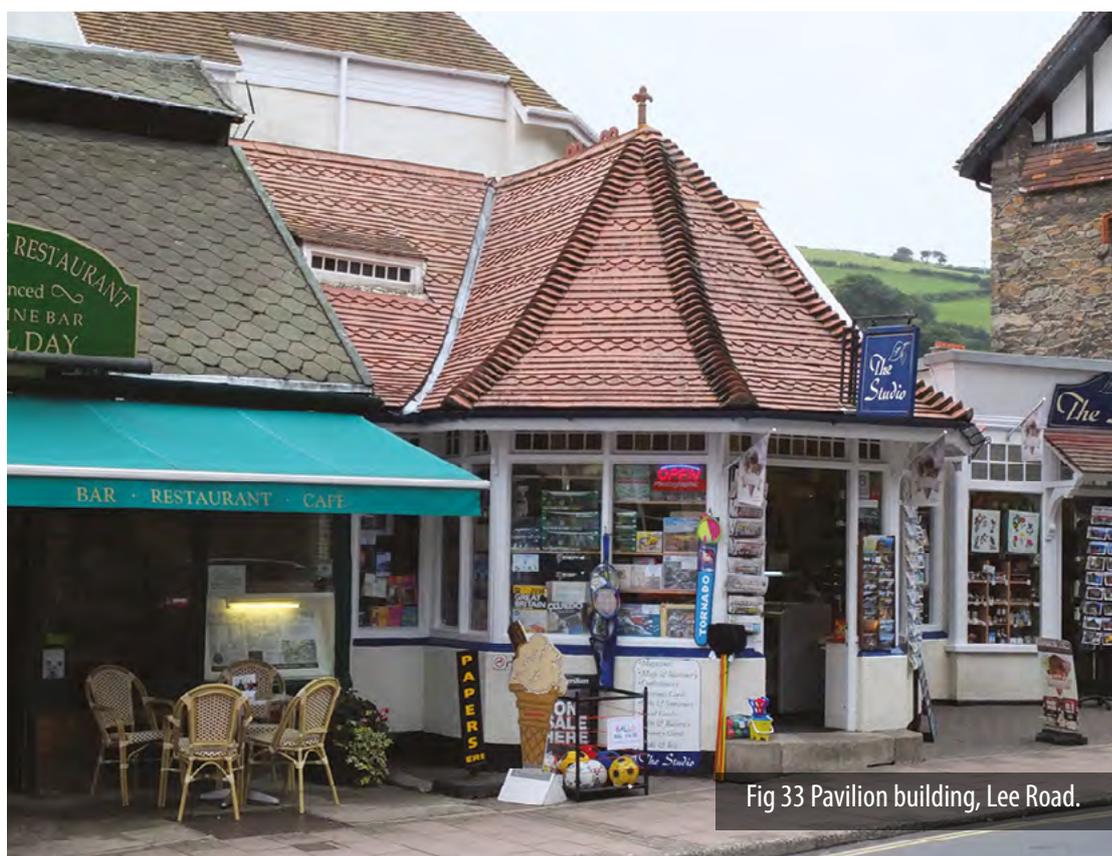
Adjoining, and looking as if it belongs on a pier or promenade, is a single-storey pavilion style frontage (Fig 33), again likely to be originally late 19th century, but subsequently modified with a part glazed roof with tiled lantern complementing a half-octagonal plain tiled roof with 'fish-scale' banding. The shopfronts appear largely unaltered with small-paned upper lights of coloured glass.

Fig 33 Pavilion building, Lee Road.

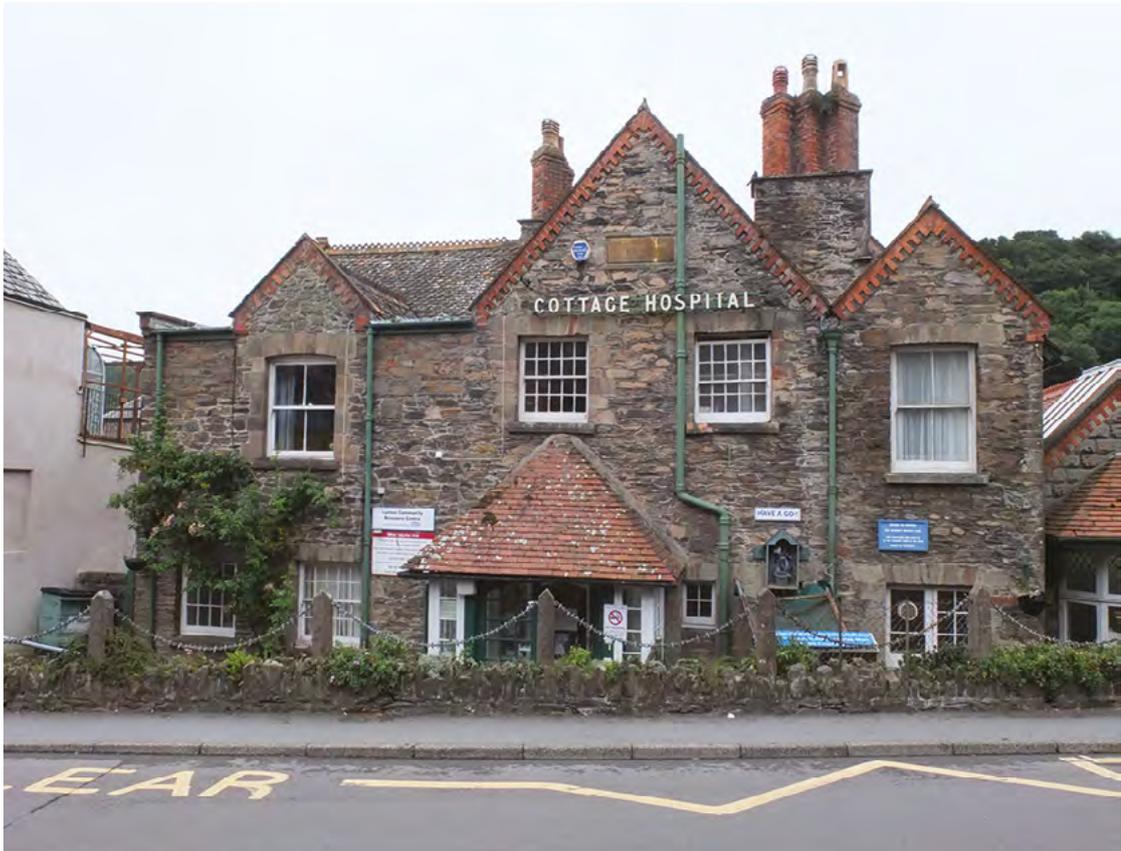
Closer to the Town Hall, earlier in date, and set slightly below the road surface, **Lynton Cottage Hospital** (Fig 34) was established in 1873. It is rubblestone with brick dressings, a tall central central gable flanked each side by two lower ones, large stack behind and clay tile roofs. New wards and an operating theatre were added in a broadly similar style in 1922 and a less satisfactory maternity department built in 1965 in NHS 'bungalow style'.

Fig 34 Main 19th century block to Cottage Hospital.

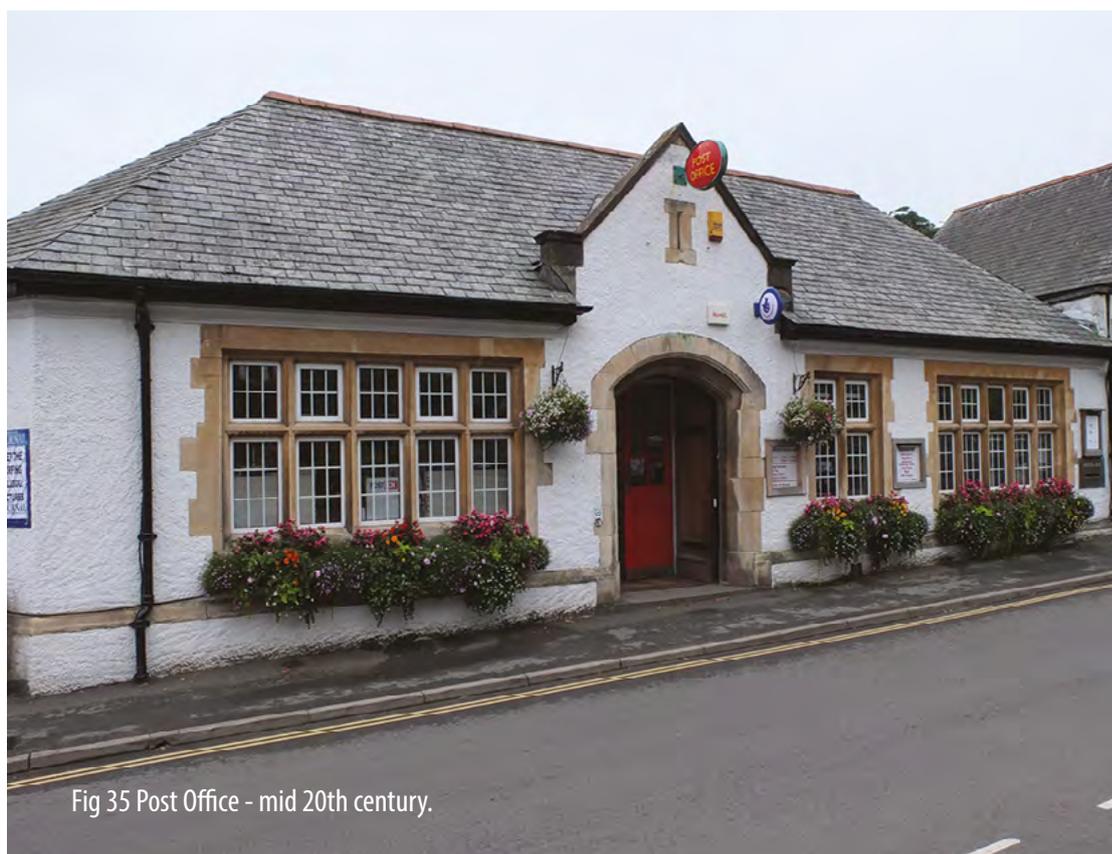
The **Post Office** (Fig 35) is a single storey rendered building with bath stone dressings to the stone mullioned windows and large central arched opening and forming a string course above the plinth and slate roofs. Its style is reminiscent of a barn and probably dates to the 1930s and is a good example of municipal architecture of the period. There is a two-storey telephone exchange using the same materials to the rear.

Fig 35 Post Office - mid 20th century.

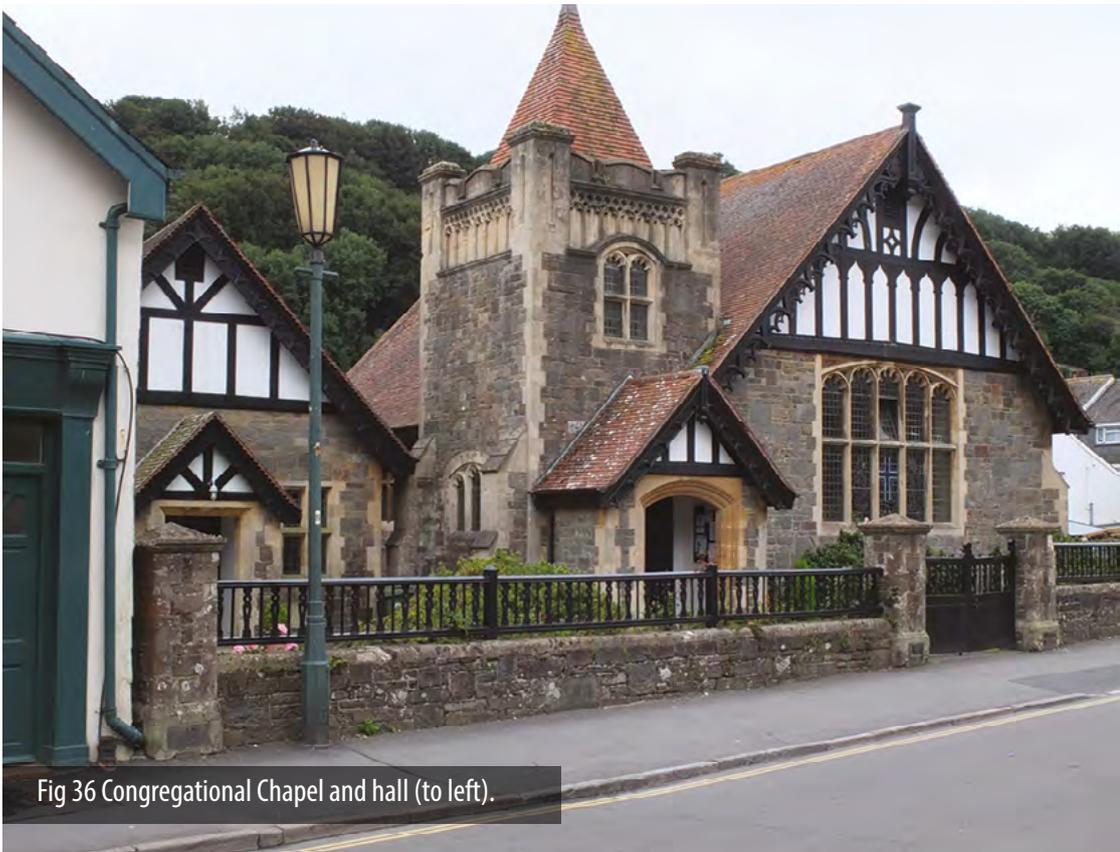
Further west is the former Congregational Chapel (Fig 36) built 1904, again by Bob Jones for Sir George Newnes. It is in a similar style to the Town Hall but is more plain in decoration. It comprises a single-storey 4-bay nave, with vestry to south-west, and squat tower above porch to the north-east. It is set gable-end to Lee Road and constructed of squared rubble red sandstone, Bath stone ashlar dressings and a tile roof. The hall to the east is in a similar style but later in date. The site is enclosed by a boundary wall with piers, railings, and gates.

Fig 36 Congregational Chapel and hall (to left).

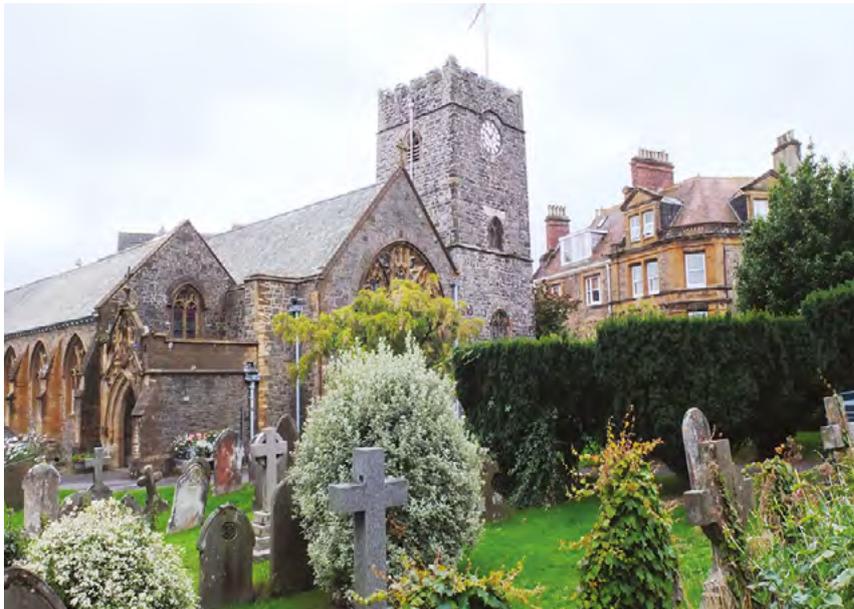
The **Church of St Mary** (Fig 37), at the top of Church Hill, occupies a site which has been in use since at least the 13th century. With the exception of the tower, the present structure was largely rebuilt in 1741, with a new chancel in Early English style added in 1869. A three-gabled east end was completed in 1905 with some unusual detail which combines a traditional Norman style with Art Nouveau. The churchyard has a good collection of late 17th-19th century headstones, four of which are listed.

Fig 37 Church of St Mary.

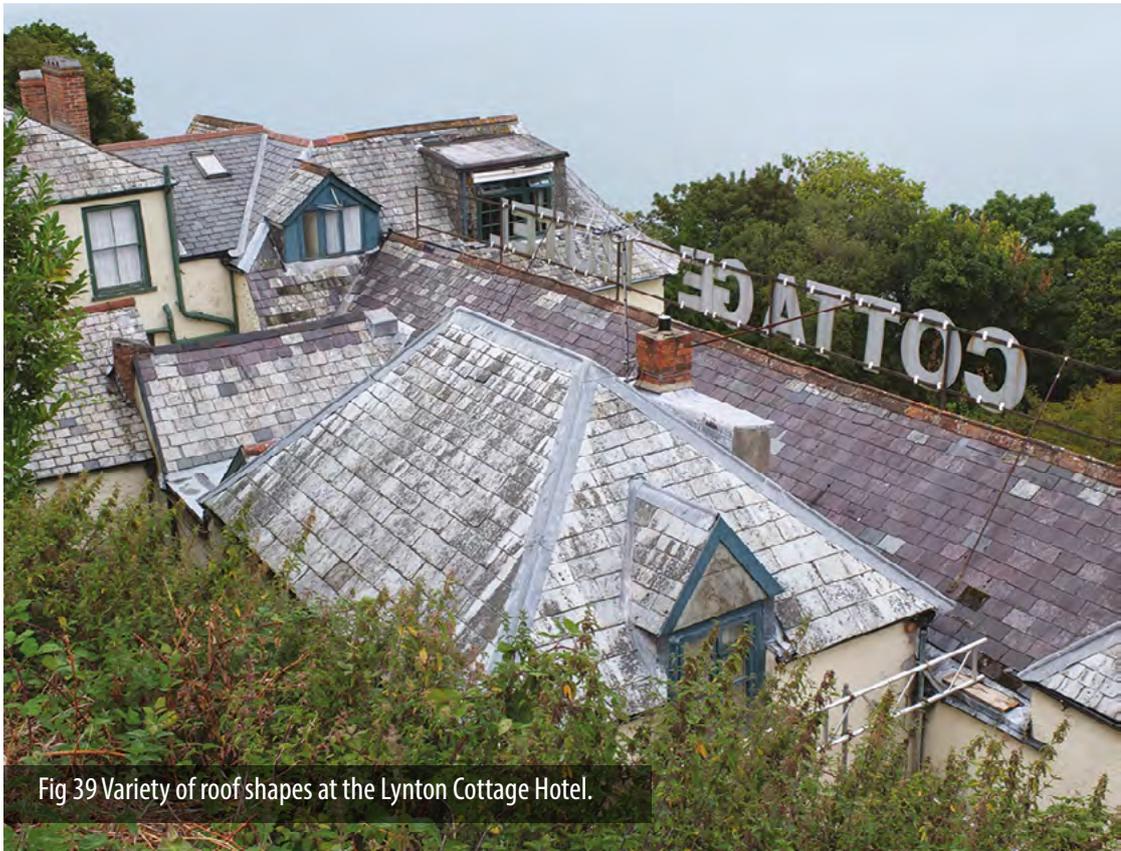
Below the churchyard and accessed off North Walk and from lower down Castle Hill, is **Lynton Cottage Hotel** (Fig 39). It is rendered with a slate roof and dates from the early 19th century with later 19th and 20th century additions. The original mainly two-storey range is in a cottage-ornee/neo-Tudor style and has five bays of small-paned casement windows with first floor drip moulds. There are French doors and casement bow windows to the ground floor. The later extension is three storey with many gables, brick stacks with Tudor detail, and mainly four-pane sash windows.

Fig 39 Variety of roof shapes at the Lynton Cottage Hotel.

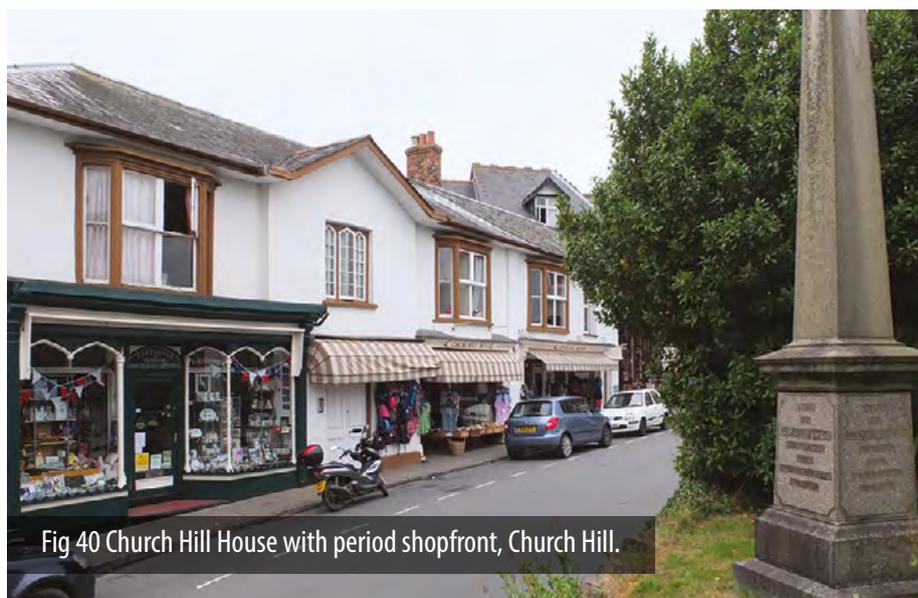
Back on Church Hill, opposite St. Mary's Church, is **Church Hill House** (Fig 40), part of an early-mid 19th century island group of houses with shops. The main range is five-bay with three canted oriel windows, and the ground floor has three late-19th century pilastered shop-fronts with moulded cornices. The best preserved is to the left with original plate glass display windows with cast-iron mullions and a tiled stall-riser, but all three retain some authentic detail.

Fig 40 Church Hill House with period shopfront, Church Hill.

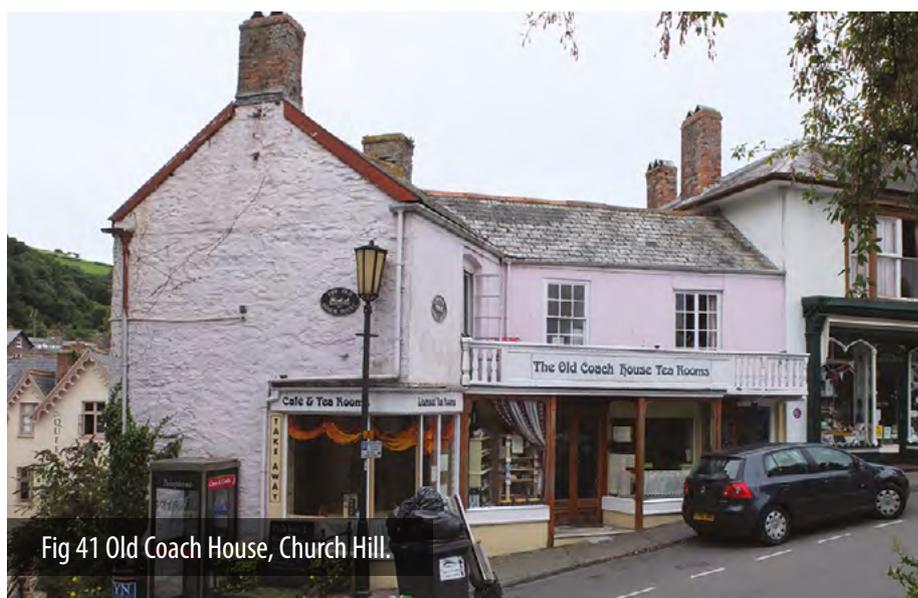
Fig 41 Old Coach House, Church Hill.

Also occupying the triangular island block is **The Old Coach House** (Fig 41). Probably late 18th or early 19th century, it has a late 19th century plate glass shop-front with recessed central door under a sash window bay, and with a four-panel door to the right. A continuous balcony with square end pilasters spans the frontage but is largely covered by a later plain fascia.

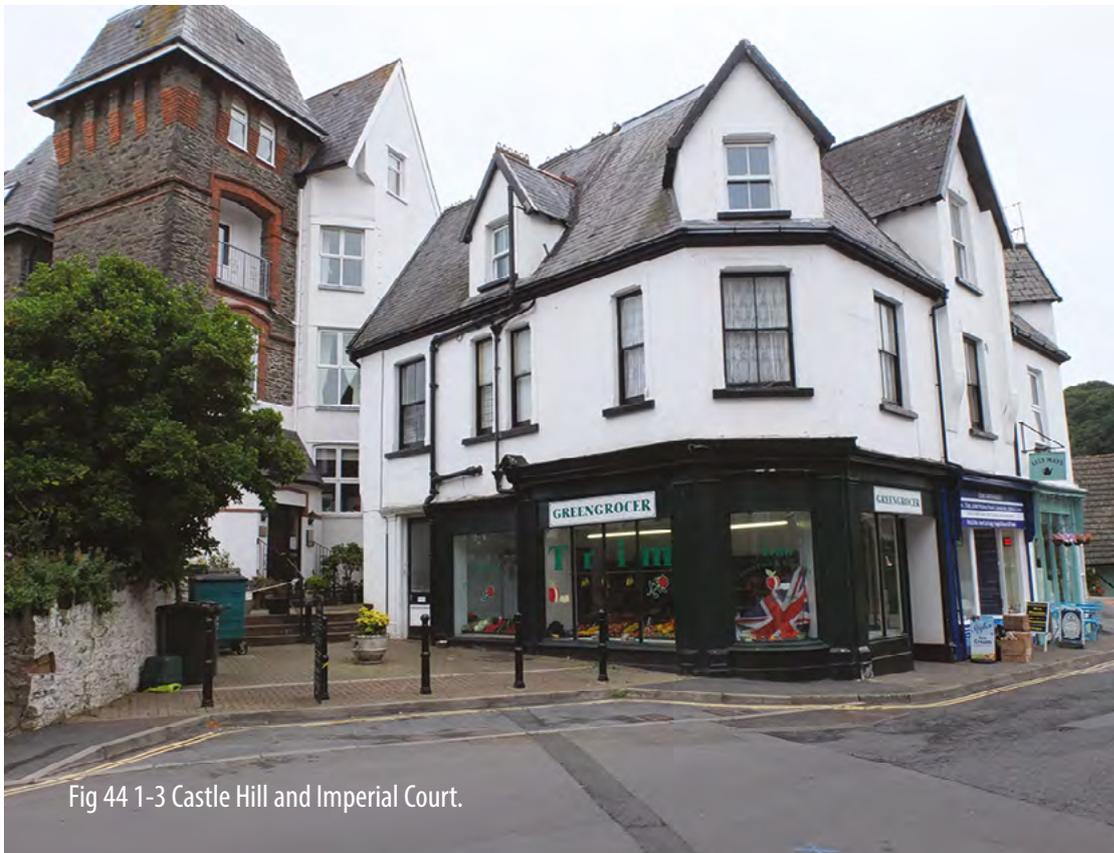
1-3 Castle Hill also retain good period detail although the four storey **Imperial Court** (formerly a hotel), which looms behind, has lost its timber windows.

Fig 44 1-3 Castle Hill and Imperial Court.
