Exmoor National Park
Historic Environment Report Series No 17

LYNTON CONSERVATION AREA: APPRAISAL DOCUMENT

Adopted 2019

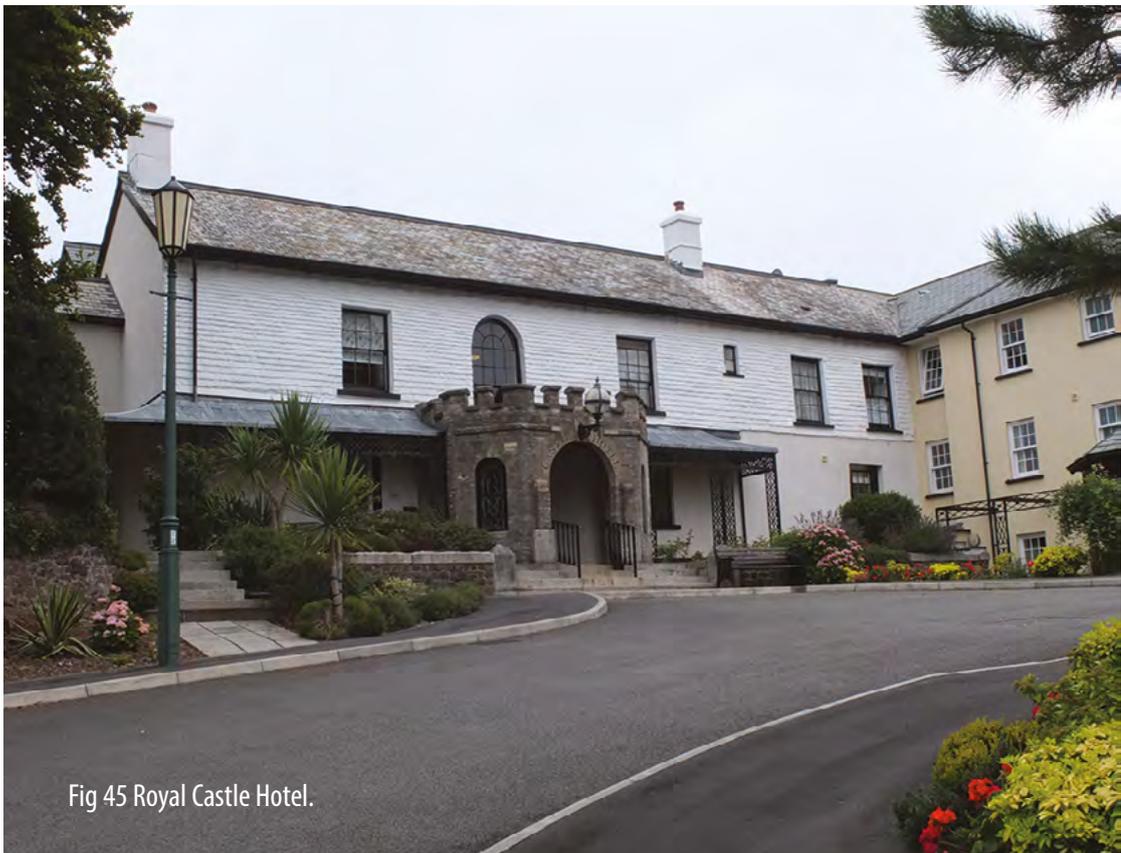
On Castle Hill, the **Royal Castle Hotel** (Fig 45) dates from 1810. The present building is all that remains of a much larger and later 19th century four-storey building with crenellations, demolished in the late 20th century. The remaining range with slate-hung frontage retains early 19th century sash windows, some with margin glazing bars, and tent canopy with decorative cast-iron frieze and standards. The later 19th century modifications, include the semi-octagonal granite-built porch, a double-gabled extension set back to the right of the sea frontage, and a former billiard room with large 20-pane sash windows having Y- tracery.

Fig 45 Royal Castle Hotel.

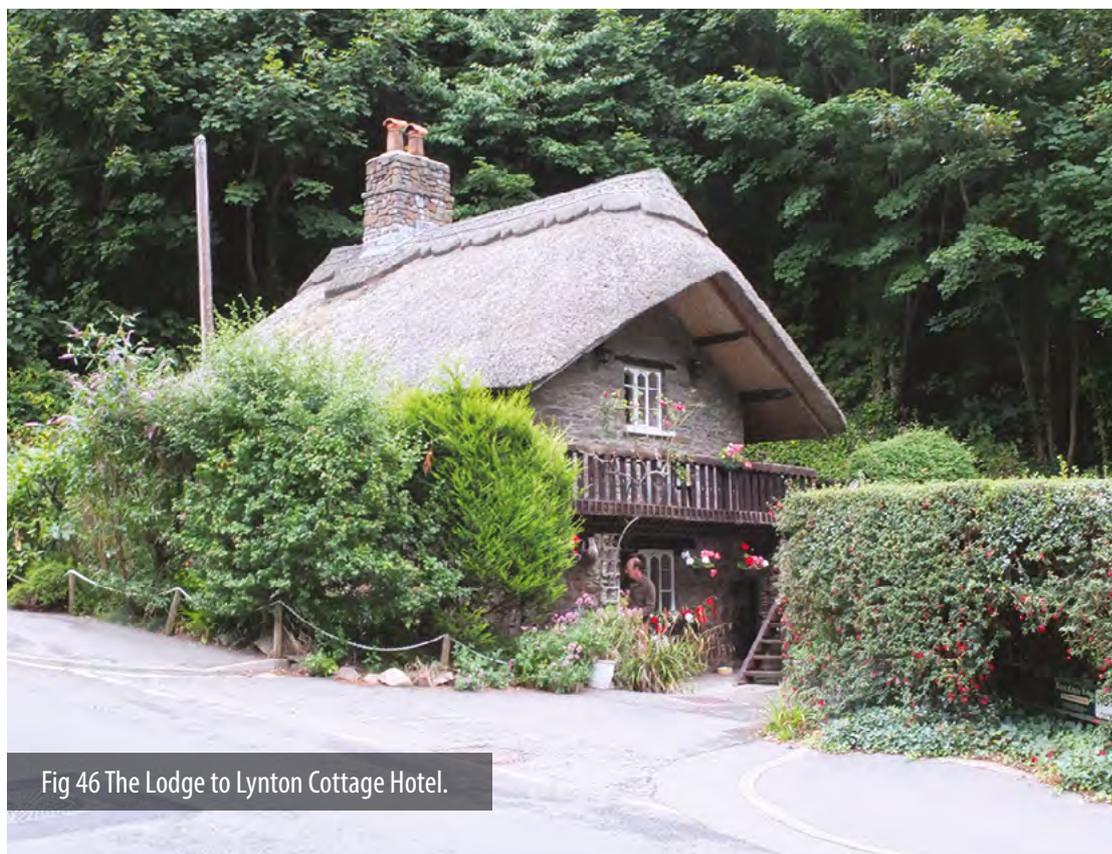
Lower down Castle Hill, **The Lodge** to the Lynton Cottage Hotel (Fig 46), is also early 19th century, and built of stone rubble with a thatched roof in an ornate cottage-ornee style, with timber balustraded balcony under deep-set eaves.

Fig 46 The Lodge to Lynton Cottage Hotel.

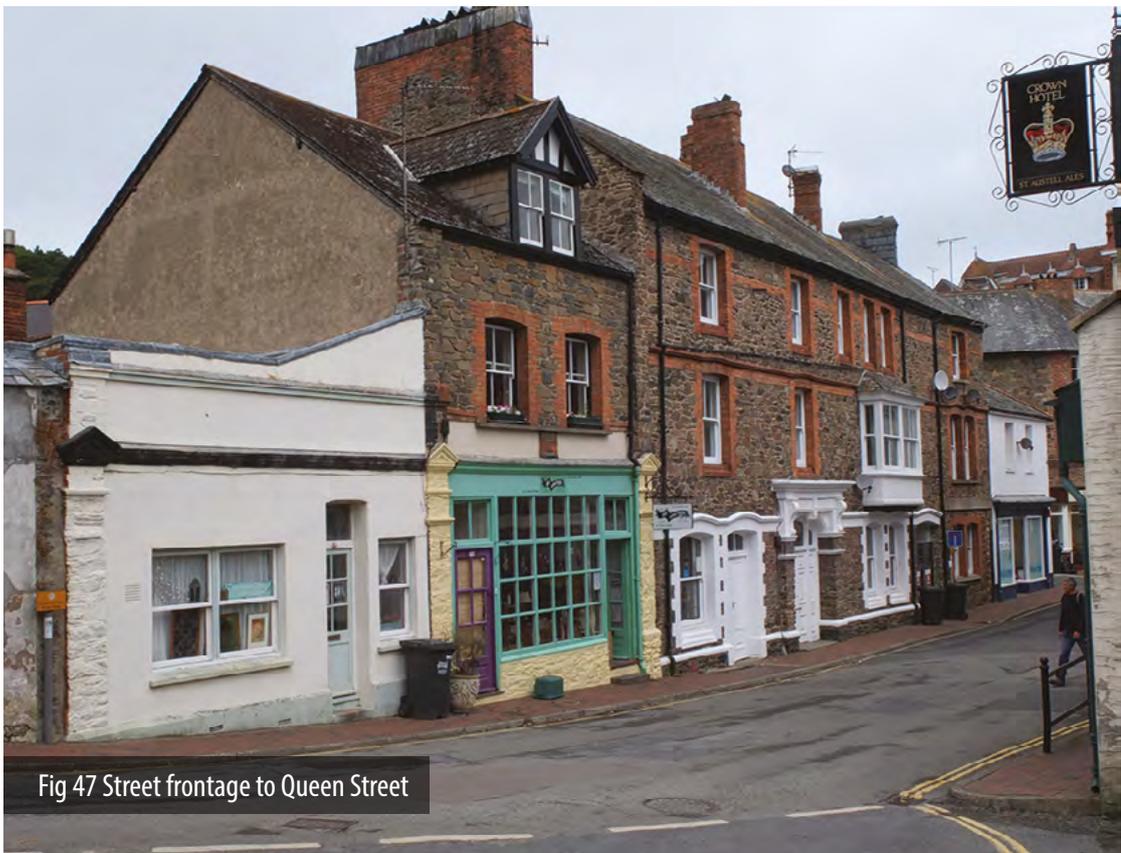
Queen Street has several noteworthy buildings. There is a good group of mixed stone and render facing Church Steps, with an irregular frontage extending to the corner of Cavendish Place. Within the mainly three-storey frontage detail, are gables with barge-board and finial, original timber casement windows and panelled doors including an ornate Art Nouveau style over-light (Fig 20). The effect is spoiled at the splayed corner with Cavendish Place by a wide later 20th century former shop-front.

Fig 47 Street frontage to Queen Street

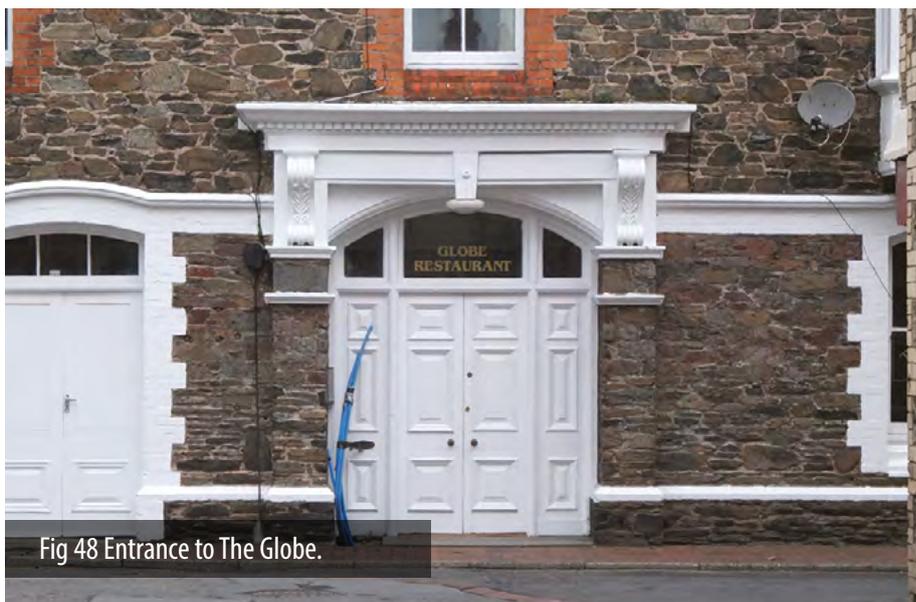
Fig 48 Entrance to The Globe.

The Globe public house (Fig. 48) has an elongated late 19th century frontage that has been very little altered. It is stone built with segmental brick arches and moulded brick drip-stones. There are square-bay oriels, and ornate entrance detail with adjoining panelled double doors, one with side and over-lights, leaded light glazing, and some period stained glass with lettering.

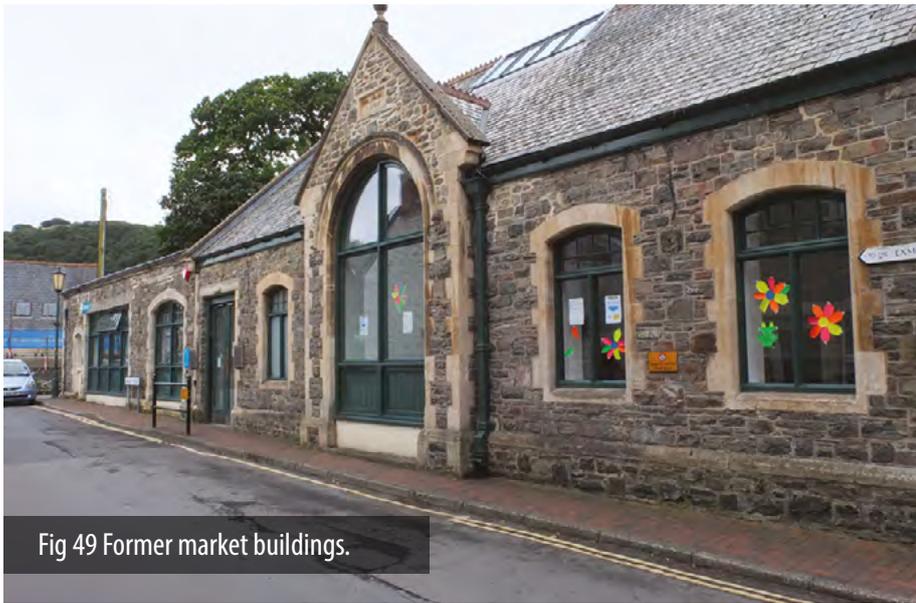
Another significant group in this part of Lynton are **Market Buildings** (Fig 49), dated 1901, single-storey and stone-built with raised gables capped by ball finials and a Cornish slate roof. The timber casement windows have fixed upper lights with small panes. A circular date-stone records the restoration of 2000.

Fig 49 Former market buildings.

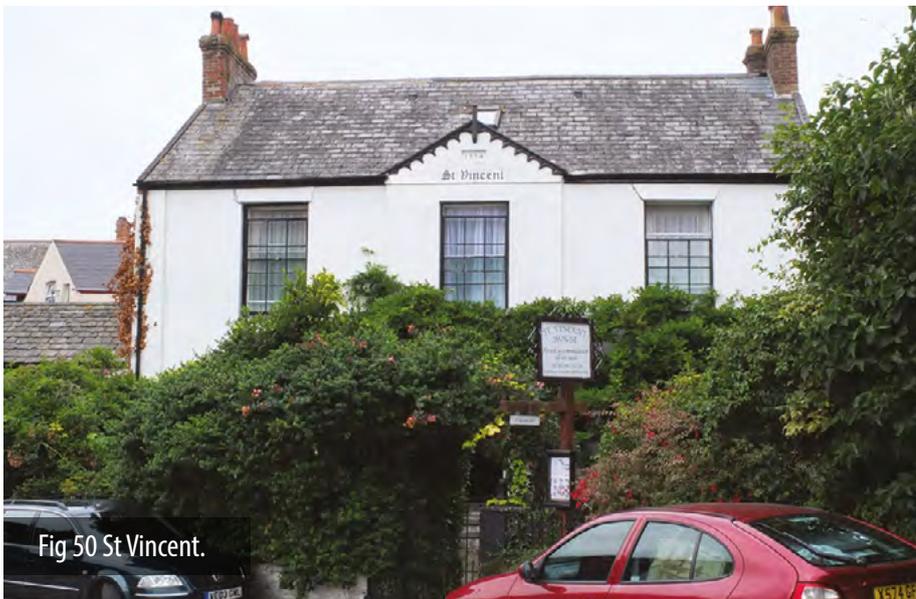
Fig 50 St Vincent.

In Market Street, **St Vincent** (Fig 50) is a detached villa dated 1834, having a typical symmetrical two-storey frontage with central six-panel door and radial fanlight. The central gable has a scalloped barge-board and inset date-stone. At the time of listing there was a fine interior geometric staircase with stick balusters and swept hand-rail, and original panelled doors with moulded panel surrounds in moulded architraves.

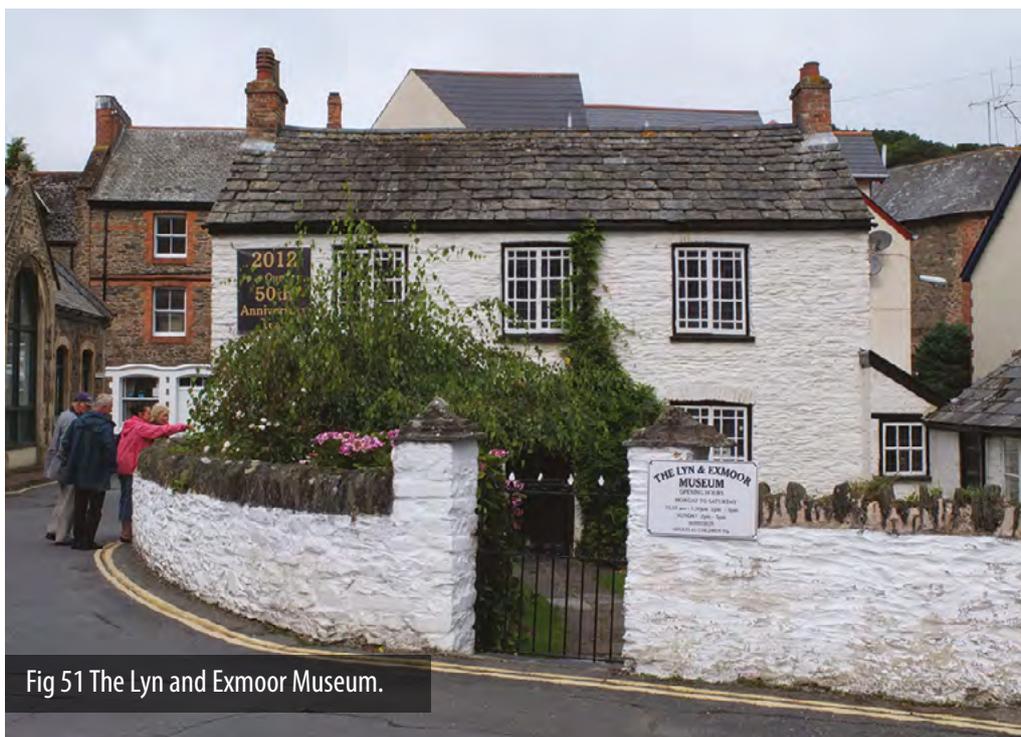
Fig 51 The Lynton and Exmoor Museum.

Adjoining, is the **Lynton Museum** (Fig 51), one of the more obviously earlier buildings, probably dating to the late 18th century with mid 19th century two-light casement windows with margin glazing bars. It was at one stage the service wing to St Vincent. It is built of lime-washed rubble and roofed with stone slate on the front pitch. The three-bay front has a central six-panel door.

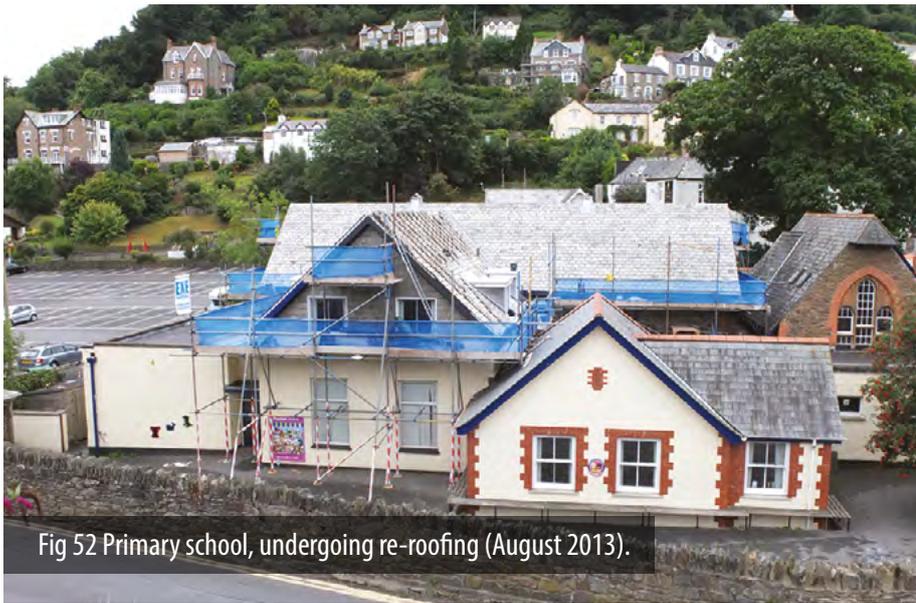
The **Primary School** (Fig 52) was built as a National School in 1844. The present building has later 19th and 20th century extensions. The 19th century part is built of stone rubble with brick dressings, pointed arch windows in larger brick arched recesses. The windows incorporate some iron glazing bars, there is a school bell under a small hipped gablet, and there is an unusual shouldered brick stack with randomly inlaid dressed limestone.

Fig 52 Primary school, undergoing re-roofing (August 2013).

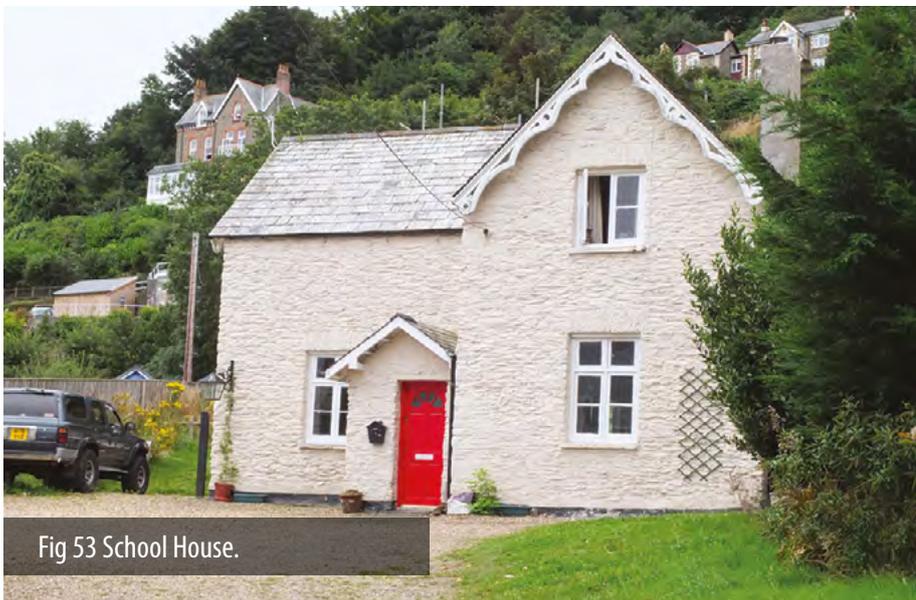
Fig 53 School House.

Also in Market Street, but set well back, is **School House** (Fig 53), a mid 19th century detached cottage of painted stone rubble with a roof in graded Delabole slate and decorative pierced barge-boards.

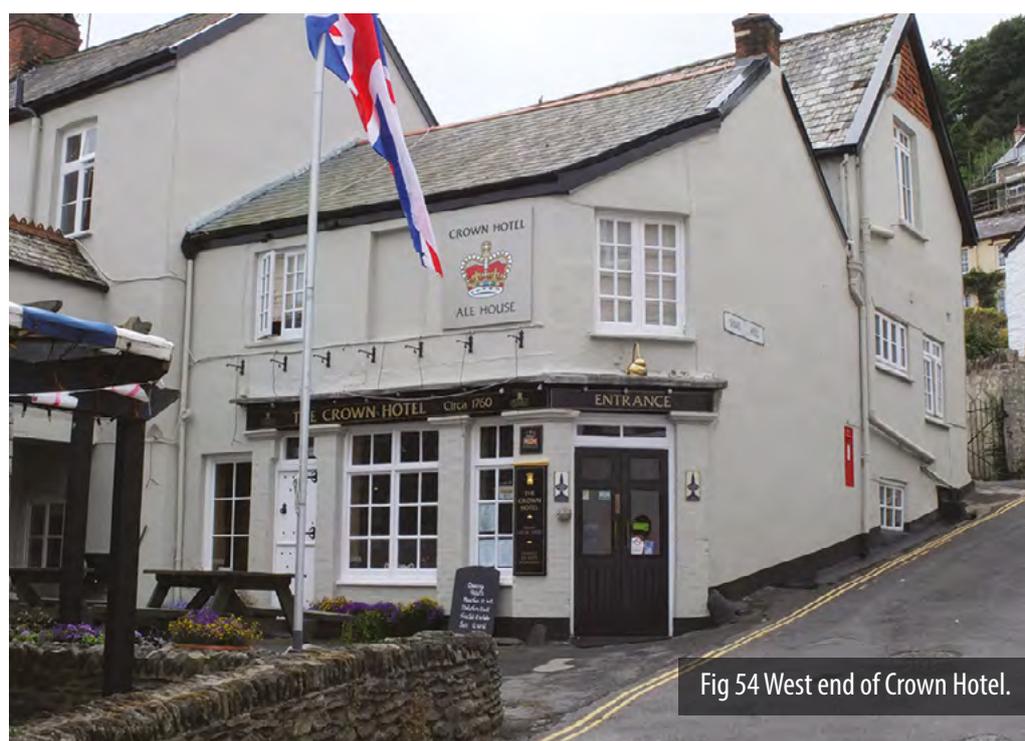
Fig 54 West end of Crown Hotel.

Adjacent is the **Crown Hotel** (Fig 54), one of the earliest surviving buildings in Lynton. It comprises an extensive irregular T-shaped range which lies well back from Market Street, and with the slate-hung lower block abutting Sinai Hill. It reputedly dates from c.1760 but evidently with some early 19th century remodelling. A six-panel door has a radial fanlight over. There are mainly timber casement windows with three pairs of French doors having horizontal glazing bars.

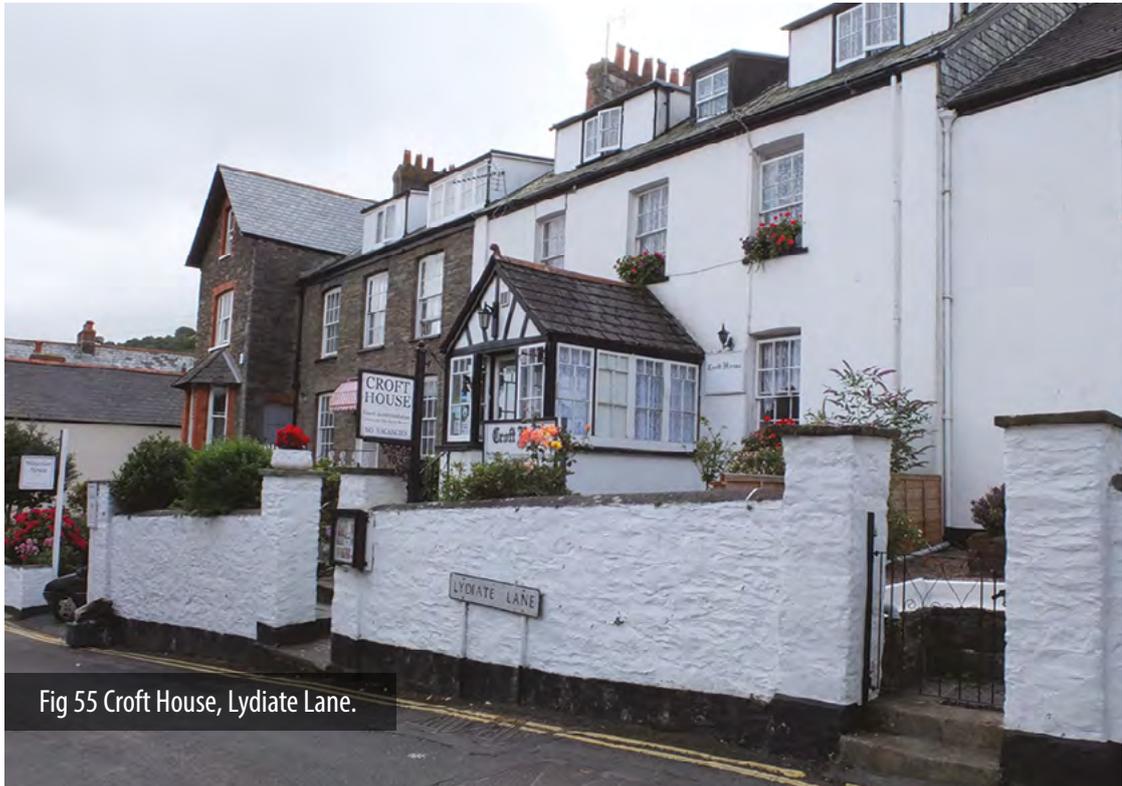
Fig 55 Croft House, Lydiat Lane.

On the south side, **Croft House** (Fig 55) is a mid 19th century two-storey house, rendered with a slate roof. The central door is under an arch with a plain tympanum and there is a large gabled porch. The first floor frontage has three twelve pane sash windows.

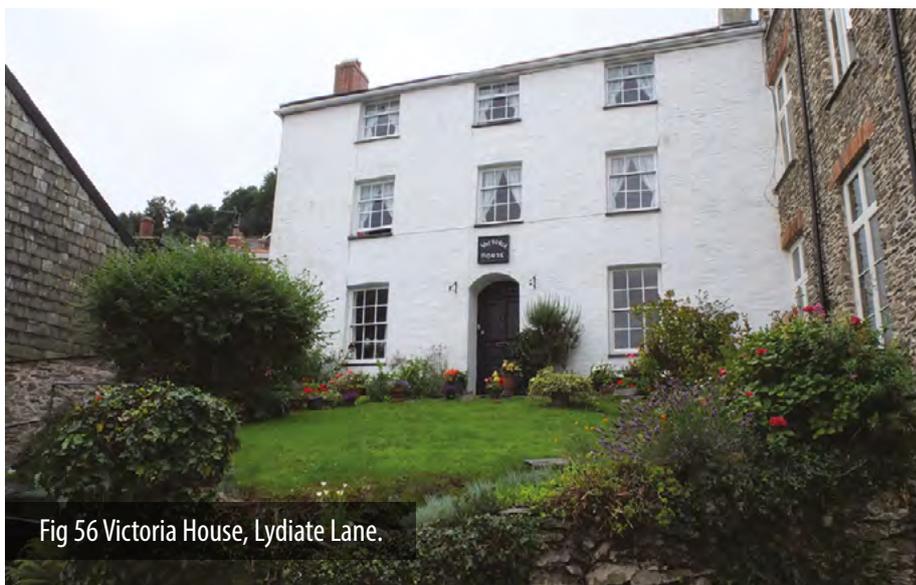
Fig 56 Victoria House, Lydiate Lane.

Victoria House (Fig 56), built into the slope, is an early 19th century house with symmetrical three-storey three-bay rendered frontage with central six-panel fielded door under a flat elliptical fanlight, and probably original sash windows with narrow glazing bars.

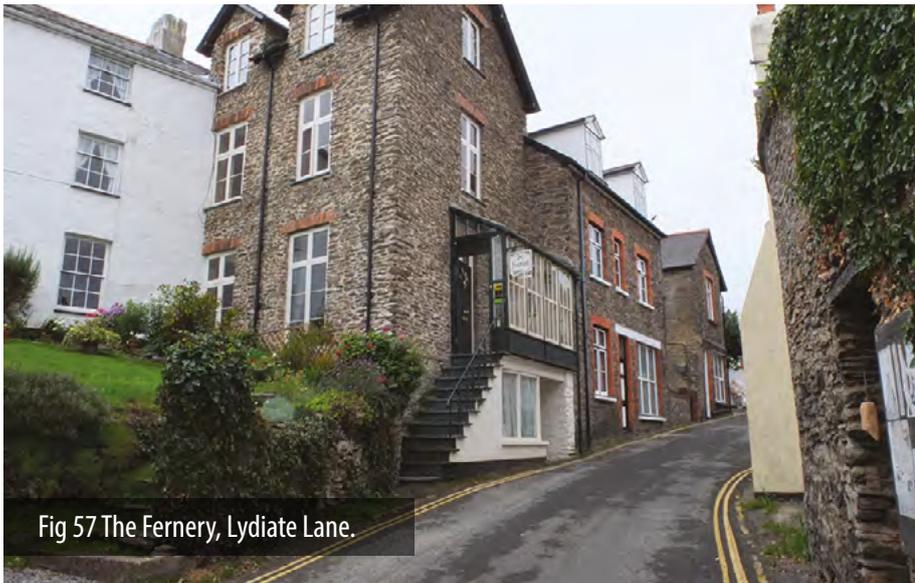
The **Fernery** (Fig 57) and **Victoria Place**, form a composite group of four mid-late 19th century houses, predominantly stone-built, with original frontage detail. The former is three-storey with a lower floor and former shop-front at street level. Steps with cast-iron railings, parallel with the street, ascend to a conservatory porch above road level. The openings have brick lintels, and the second floor gables break through the eaves line. The latter are also stone-built with brick architraves and there is a former shop-front with six-panel door, whilst the centre property is set back from the carriageway within a small courtyard.

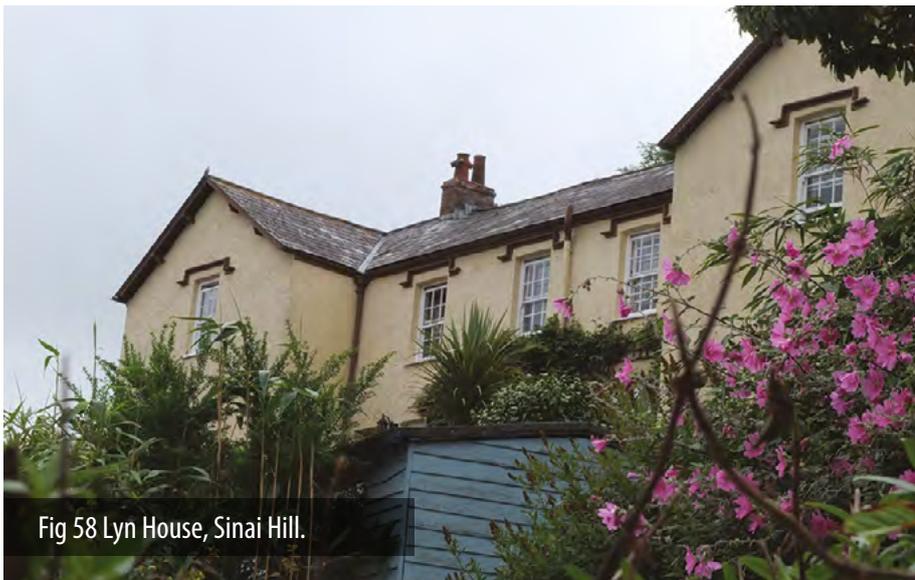
On Sinai Hill, **Lyn House** (Fig 58) is a large, detached, two-storey house of the early-mid 19th century with a probable former service wing, angled to accommodate the road gradient. The five-bay formal frontage of the main house with projecting single-bay wings at each end has sash windows with narrow glazing bars. Most openings have hood moulds with dropped ends, and there are French doors with margin panes to the ground floor. Because of the steeply sloping site, the main entrance is at the upper level to the rear with a gabled and panelled doorway.

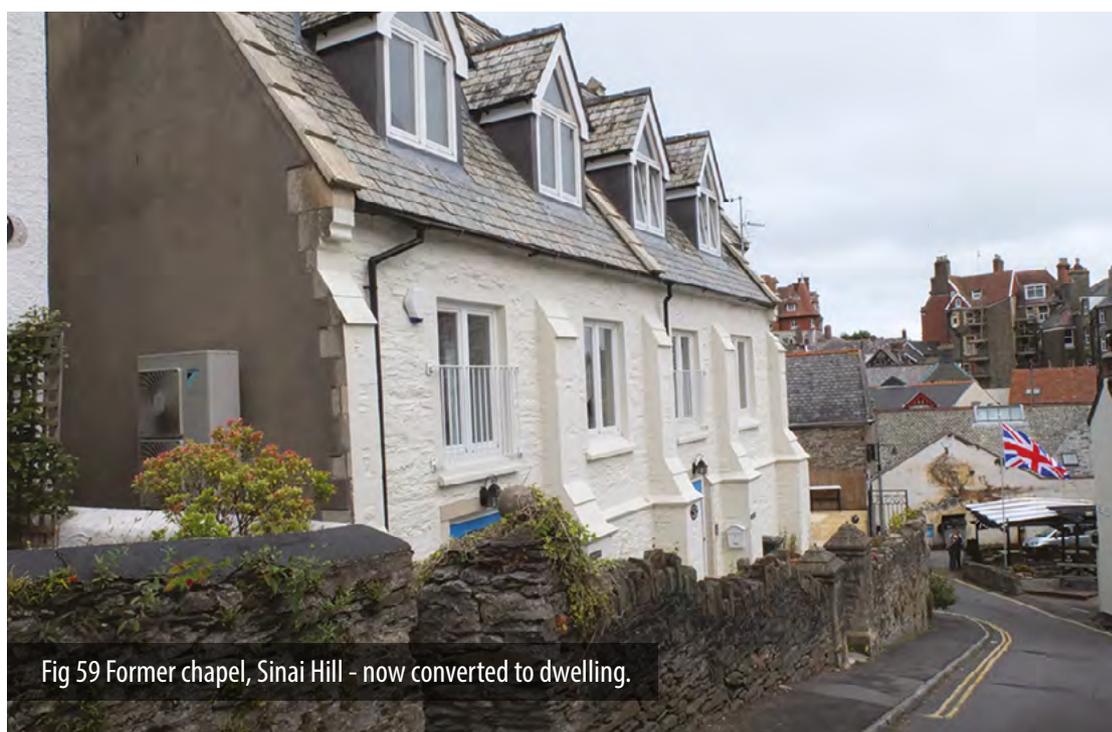
Sinai Hill has several cottages possibly dating from the late 18th century of stone with brick dressings, some painted over. Typical details include sash and casement timber windows, in shallow segmental arched openings, shutters and barge-boarded gables, the latter with dropped finials.

Fig 59 Former chapel, Sinai Hill - now converted to dwelling.

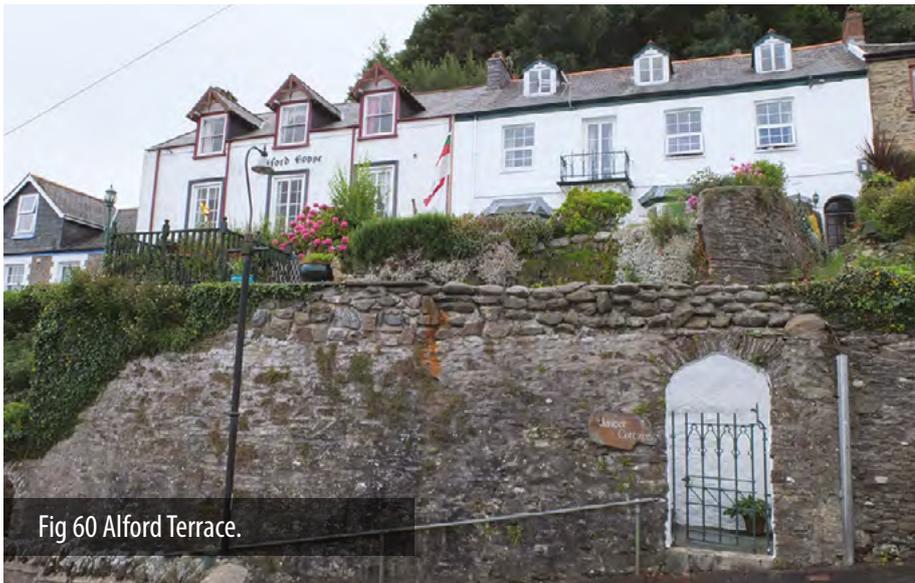
Fig 60 Alford Terrace.

Off Sinai Hill and forming a prominent group on the hillside overlooking the town centre, is **Alford Terrace** (Fig 60). Stepped gradually up the slope and a mix of stone, painted stone and render, the terrace dating from the early-mid 19th century, has symmetrical frontages and central doors, typical of the period. The right hand pair has a blind central window. The group includes **Alford House Hotel**, reputedly built as a boarding house in 1845. It has a two-storey, three-bay frontage with barge-boarded half dormers having drop finials and arch braces. There is a combination of French doors, casement and sash windows, some forming canted bays, others with margin glazing bars. An arched landing sash window has tinted and etched glass. The central five-panel door is set in a deep, square portico on Doric columns. The wall (up to 3.5 m in height) retains the terrace garden to the hotel, and there is a rough arched opening with wrought iron gate and flight of slate steps.

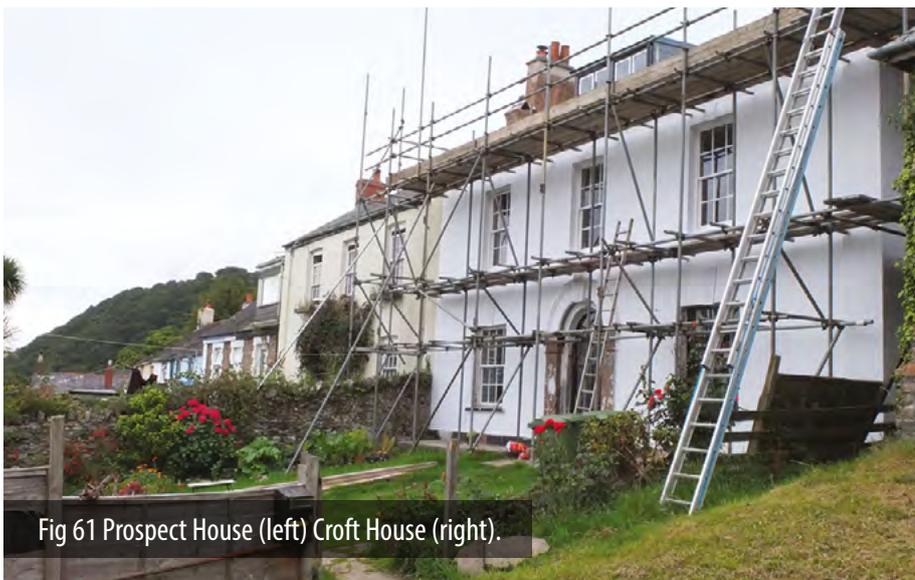
Below, on Blackmore's Path is another terrace. This includes **Prospect House** a mid 19th century house with a symmetrical frontage with eight-pane sash windows in recesses, the end two have shallow segmental arches. There is a front path through a rustic four centred stone arch. **Croft House** is at the end of a row with a key-stone dated 1897 above the door. The house is probably earlier, with a typical three-bay front, the central door having flanking pilasters and a moulded arch over a plain fanlight, although the door is a 20th century replacement. Each side of the door are sixteen pane sash windows and above are three twelve-pane sashes, all with vermiculated key-stones, the two attic dormers have casement windows.

Fig 61 Prospect House (left) Croft House (right).

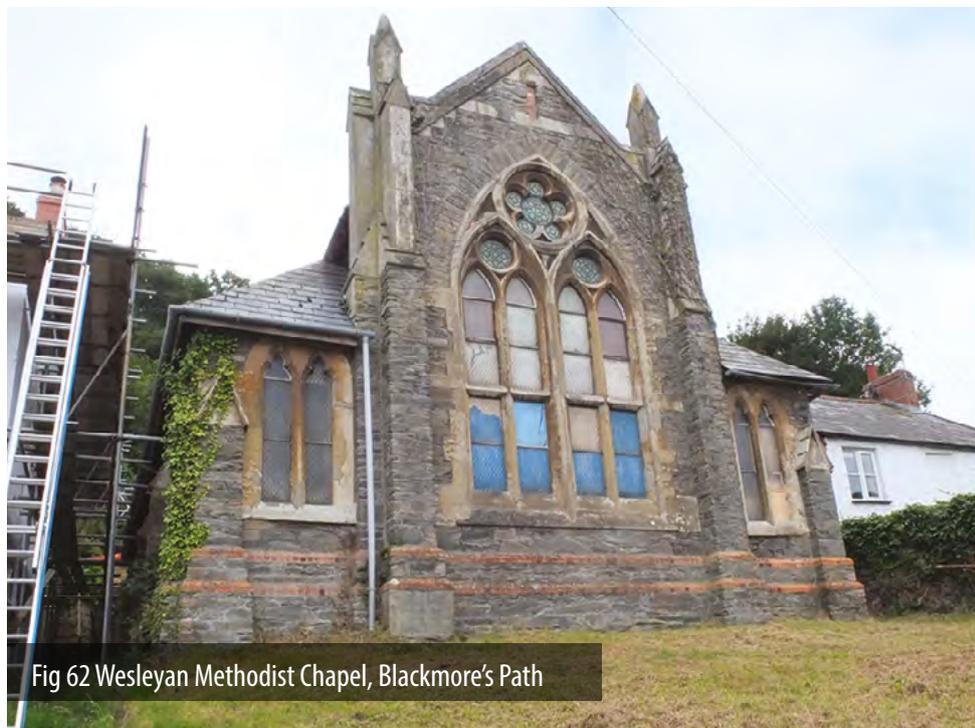
Adjacent is a former **Wesleyan Methodist Chapel** (Fig 62) dating from c.1880 stone-built and gable fronted with large Gothic window and flanking pinnacles.

Fig 62 Wesleyan Methodist Chapel, Blackmore's Path

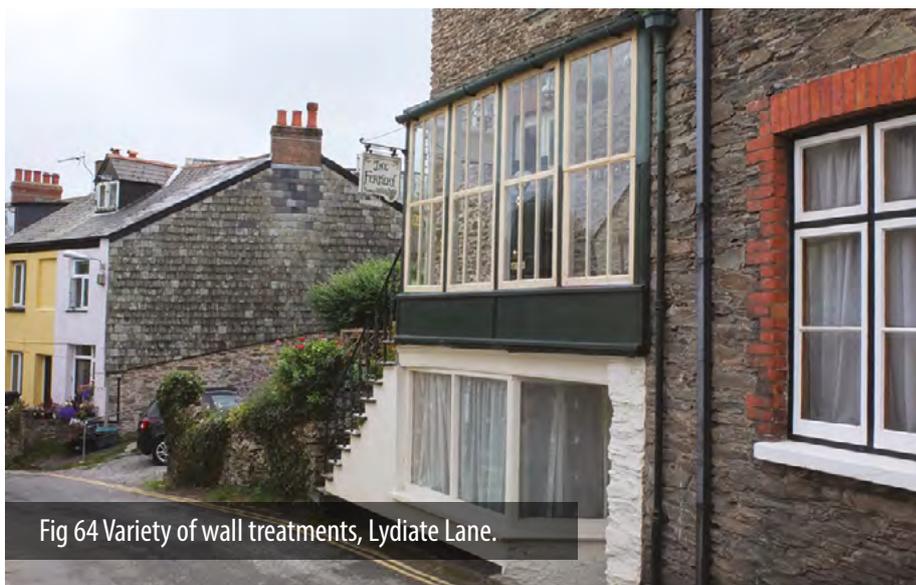
The majority of early buildings are stone built. The stone is mainly from the Old Red Sandstone series, with much in shale form. It is not readily worked, and normally laid as roughly coursed stone rubble. Some walls have subsequently been colour-washed or rendered. Originally lime wash or lime render would have been applied, and the stone used is probably from small local quarries.

Fig 64 Variety of wall treatments, Lydiate Lane.

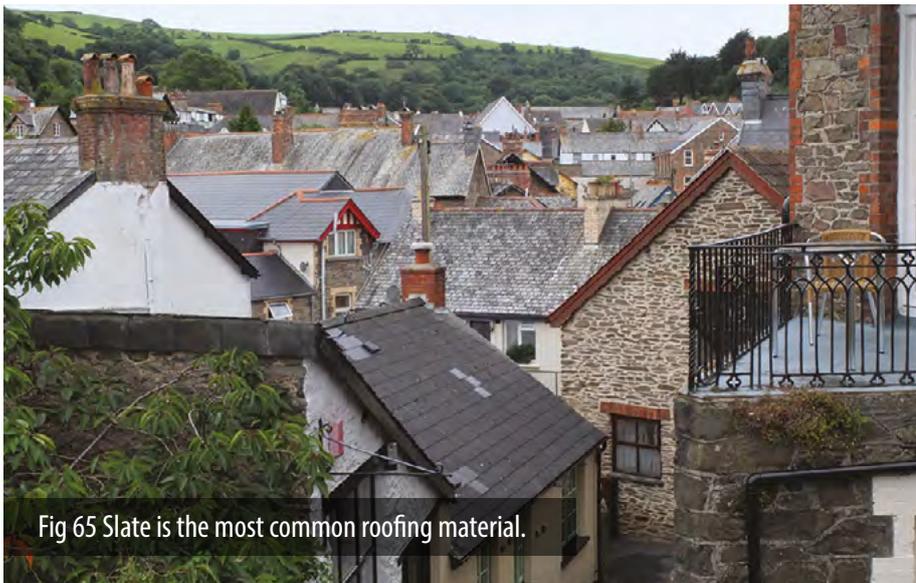
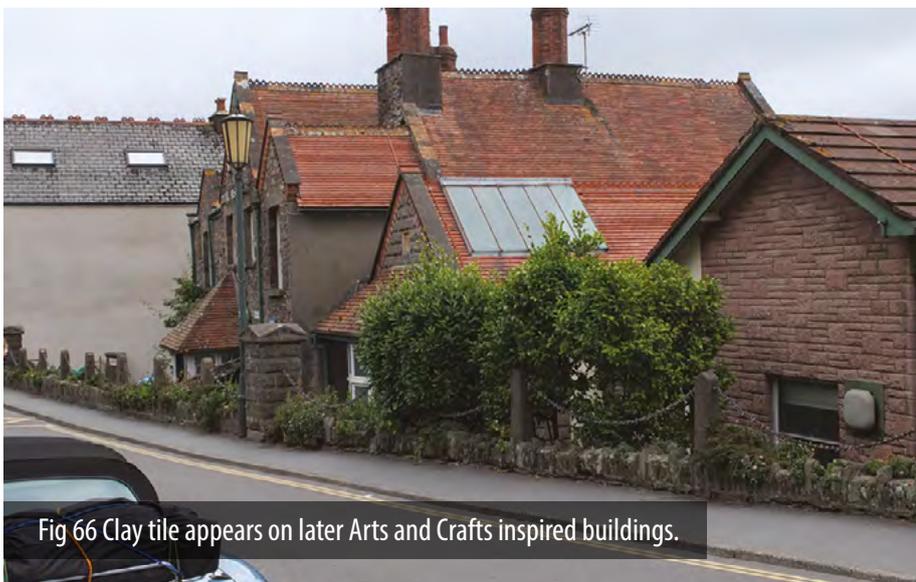
Much of the grey-green slate widely used as roofing slate and the distinctive local method of slate hanging is Cornish, probably from Delabole. Welsh slate is also widely encountered. Some slate may also be locally derived and from the Devonian Morte series, mainly centred near Treborough in the Brendon Hills and at Chibbet Ford near Exford. Much of this slate is of a somewhat inferior 'rag' material compared to slate from Cornwall or Wales.

From the later 19th century clay tiles were also available and these occur on some Arts and Crafts influenced buildings, especially evident along Lee Road, in plain or patterned form.

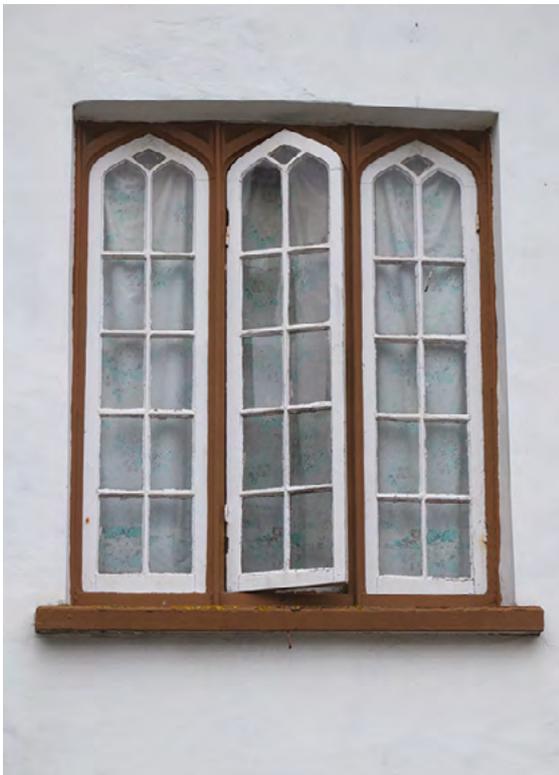
Despite an increase in occurrence of PVCu windows since the 2002 appraisal, there are still examples of good quality timber casement and side hung slash windows surviving. In comparison with other Conservation Areas in the National Park, the number of traditional or original windows and doors is, however, low - probably a result of a combination of high attrition rate in this coastal location, commercial pressures and the relatively small number of listed buildings. Most surviving traditional windows in the Conservation Area are casement type, although some sash windows also occur.

Fig 67 Gothic-style casement window, probably early 19th century.

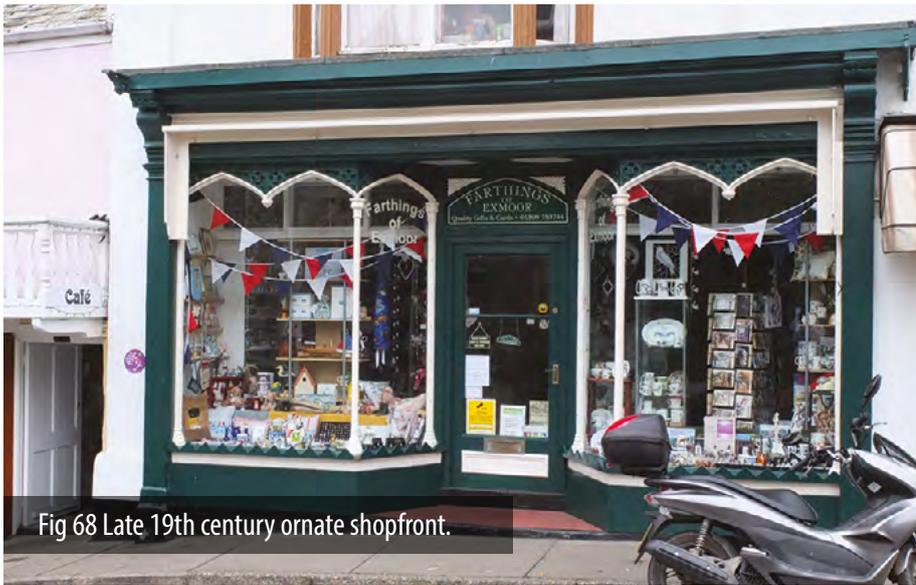
Fig 68 Late 19th century ornate shopfront.

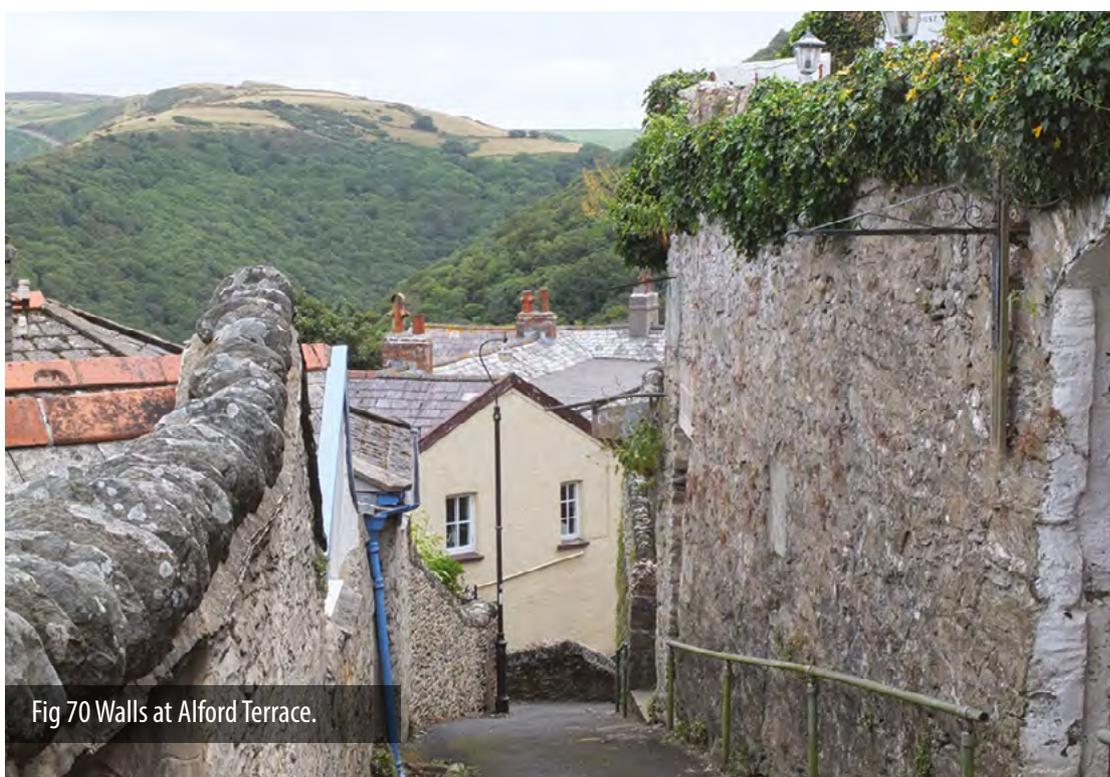
There are extensive stretches of boundary walling in Lynton. Many of these, for example in the Alford Terrace/Sinai Hill area, are stone retaining walls as a result of differences of level where building or cutting into the slope has occurred, and are combined with steps. This often adds great character to the setting of buildings, as well as providing privacy.

Fig 70 Walls at Alford Terrace.

The majority of walls follow the pattern of roughly coursed rubble stone or shales with coping stones aligned vertically. Less common, although more locally distinctive, is where all the stone is set vertically, yet horizontally coursed. Entrance features to buildings are relatively plain for the most part, but some principal buildings, including several hotels, have dressed stone gate-piers, for example the entrances to the churchyard and former Royal Castle Hotel, or ironwork, as to the side entrance of the Valley of the Rocks Hotel.

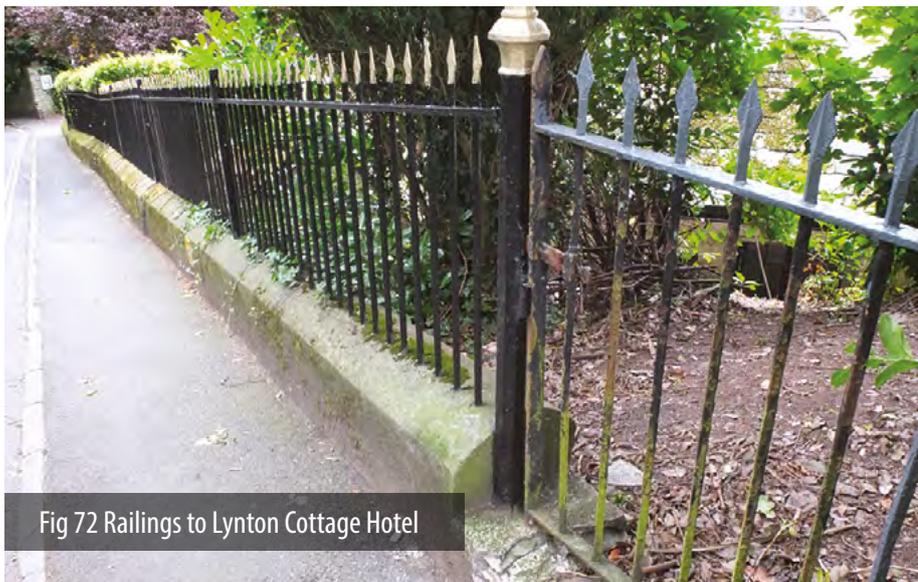
A significant number of the walls, railings and gate complexes are listed, either as part of the main listing or in their own right.

Fig 72 Railings to Lynton Cottage Hotel

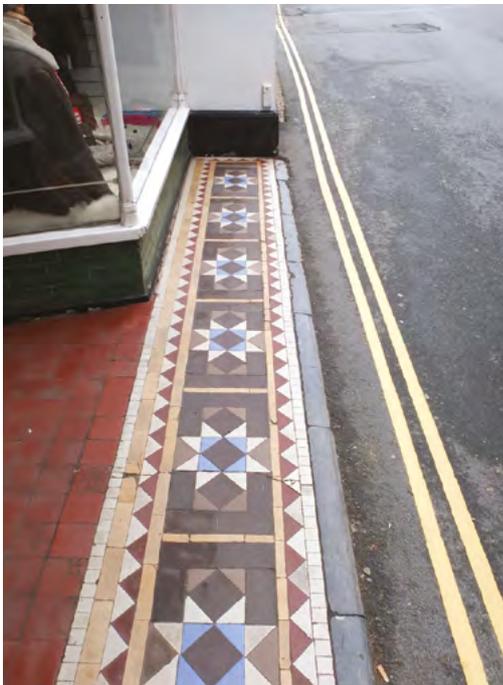
Lynton possesses relatively little of character in terms of historic ground surfaces. What survives is mainly confined to natural stone kerbs and gulleys, probably dating from the time some streets were originally laid out in the late 19th century. Slate is used in some steps, for example up to hotels in Lee Road. There are also examples of original 19th century tiles at the entrance to some shops. Some 19th century or earlier paving and cobbled areas may yet be discovered below later asphalt coverings. Where this might be the case, based perhaps on evidence from early photographs, some form of reclamation might prove possible.

Fig 73 19th century tiles - a rare survival.

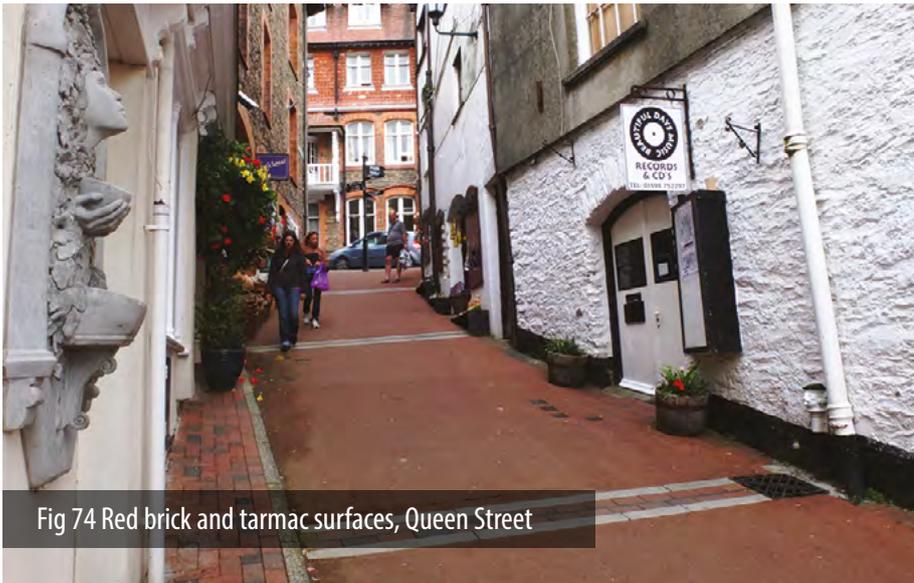
The paving layout at Church Steps and in Queen Street would have been more effective if some natural stone paving or cobbles had been used. Surfaces that would blend better with the local natural stone are preferable to the use of red brick and tarmac. This is especially the case in some of the more intimate and enclosed or footpath only and forecourt settings.

Fig 74 Red brick and tarmac surfaces, Queen Street

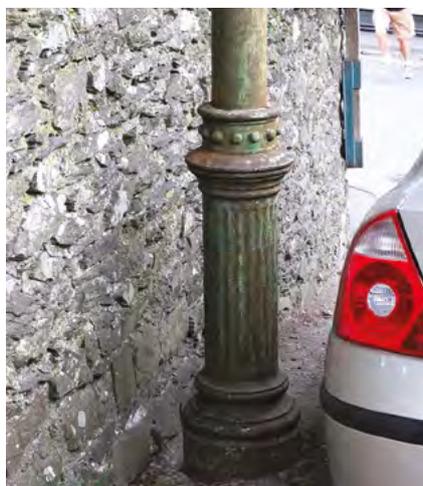
Fig 75 Sewer stench pipe.

Worthy of note is the cast iron sewer stench pipe to the east of the drive to Hollerday Hill which is likely to date to the late 19th century (Fig 75) and the overarch to the Cliff Railway (Fig 76), which while not of any age adds to the character of the Conservation Area.

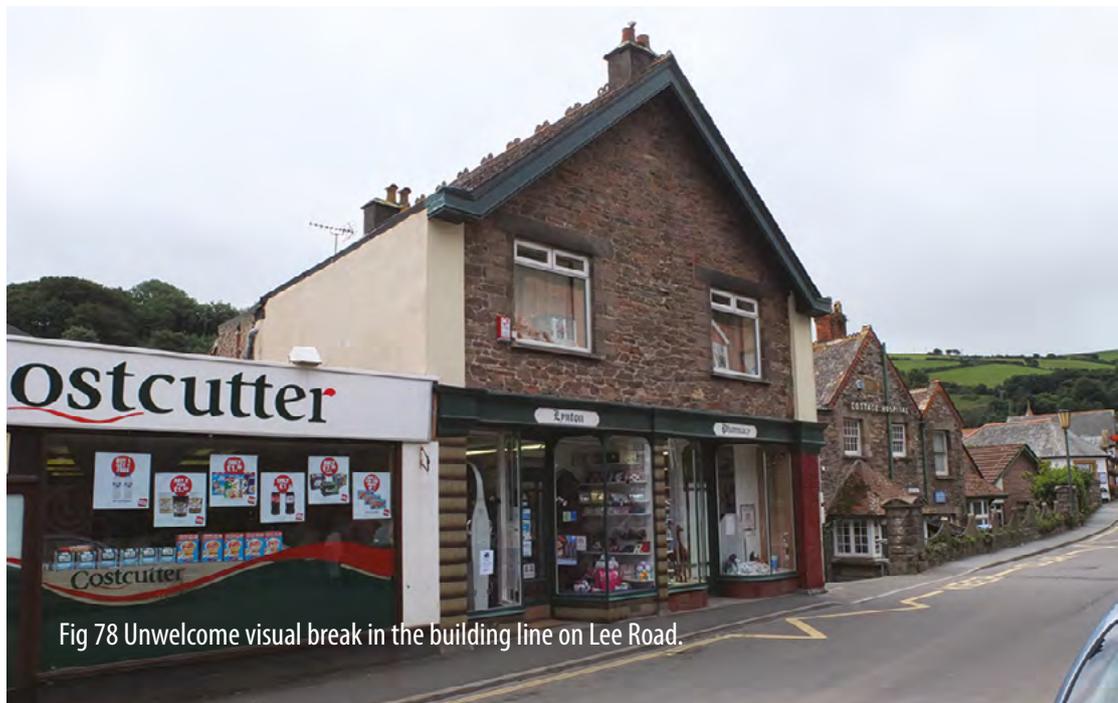
The poor quality later 20th century single-storey shop at the corner of Lee Road and Cross Street (Fig 78) in a visual context, would benefit from redevelopment, preferably with an added storey that reflects the character of adjoining historic buildings.

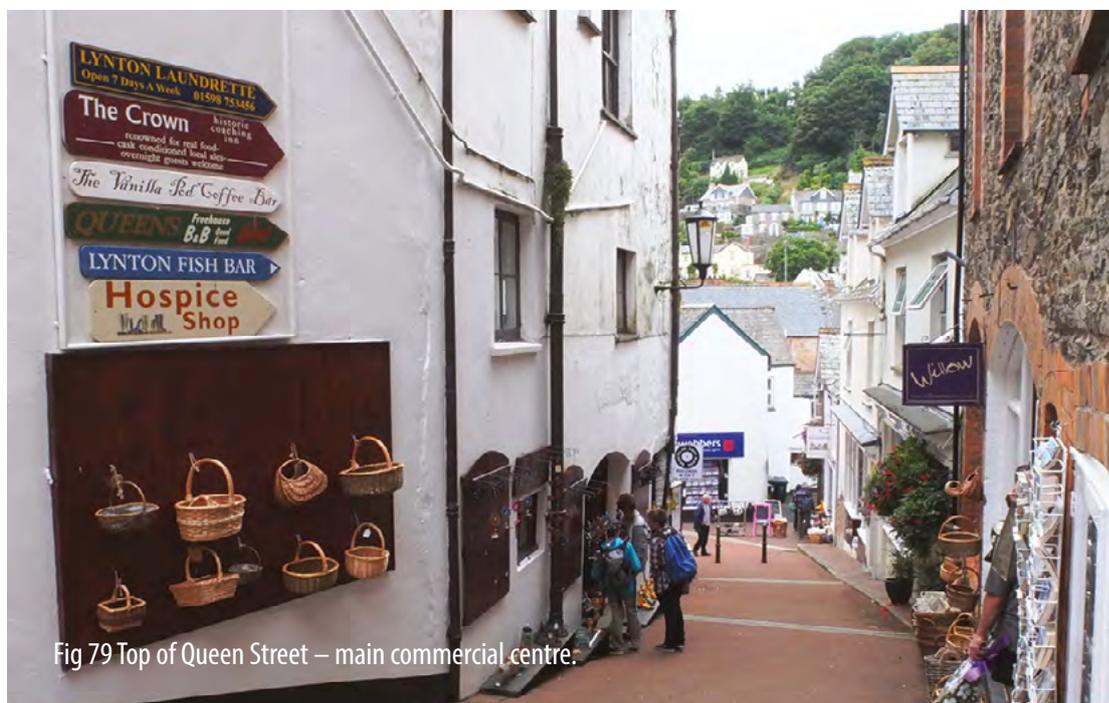
Lynton owes its development and continuing prosperity to the tourism so it is not surprising that there are some instances of less than satisfactory signage as business vie with each other to attract trade. On the whole, however, signage is relatively restrained and can be regarded as a minor detraction from the Conservation Area.
