## **PORLOCK WEIR**

### CONSERVATION AREA CHARACTER APPRAISAL

Prepared for Exmoor National Park by John Fisher BA MA MRTPI IHBC

Published by Exmoor National Park Authority  
© Copyright Exmoor National Park 2004

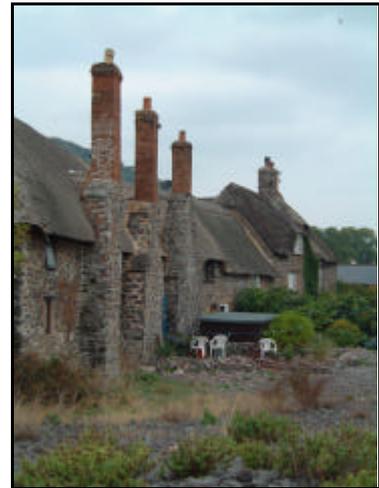
*Gibraltar Cottages date from the 17th century, and display the characteristic tall lateral stacks.*

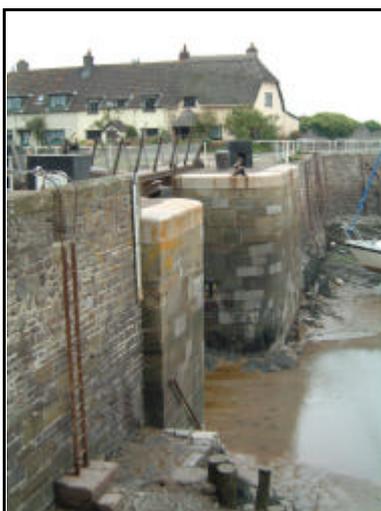
*The present quayside is mainly 19th century, and not a weir so much as a tidal inlet which can be controlled by lock gates*

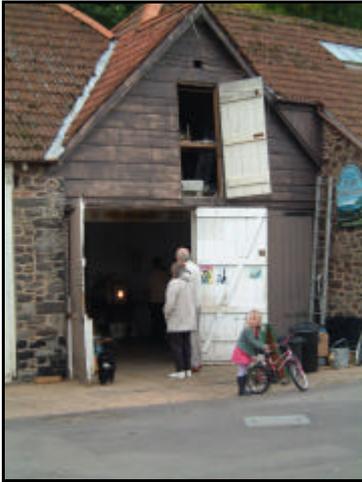
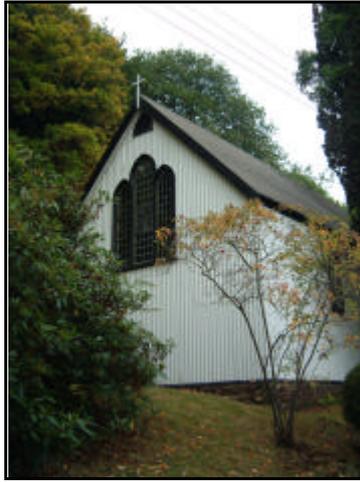
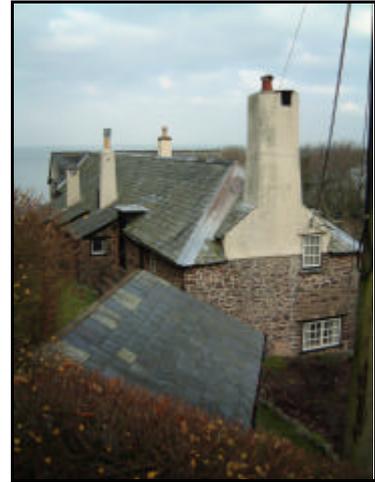
*There are diverse architectural styles within the conservation area. None of the buildings shown are currently listed. Above left: an example of a 19th century outbuilding, largely unaltered, and currently used as a workshop. Above centre: St. Nicholas' Church is a typical example of a "tin tabernacle" which has been little altered and is still in use. There is increasing interest in the historic importance of corrugated iron buildings. Above right: An example of estate cottages of the Worthy Estate. This example is in the style of Voysey, though more likely the work of Lady Lovelace and dates from the early 20th century.*

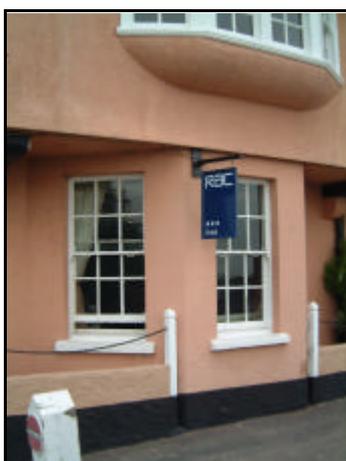
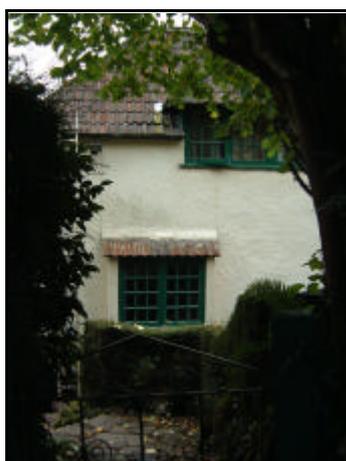
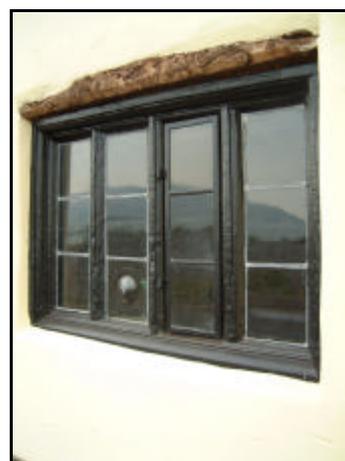
*Left: Window detail at the Anchor Hotel showing late 19th century sash windows with narrow glazing bars. Centre: an example of a house dating from around the 1920s with original small-paned casement windows and clay double-Roman tiles. Although lacking ornament, there are continuing elements of Arts & Crafts design. Right: A timber mullioned frame with metal casement windows, probably dating from the late 17th-18th century.*

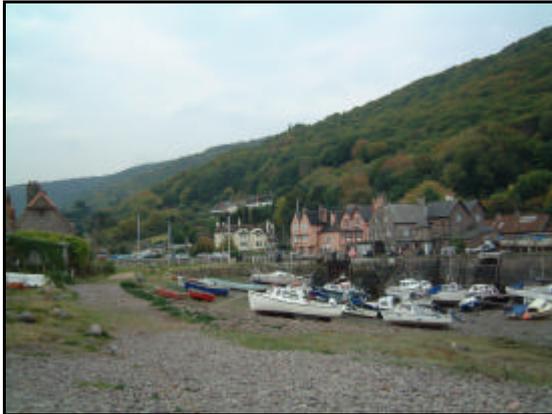
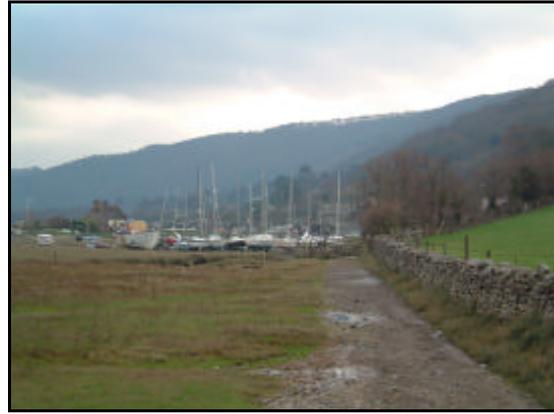
A series of photographs that emphasise the coastal setting and sense of remoteness of Porlock Weir. Top left and right views of the tidal inlet showing the backdrop of Worthy Woods and with the beach to the left. Right: to the east, the beach appears to be extending and is gradually being colonised by vegetation. In such low-lying settings, buildings become important skyline features. Lower left: the entry to the conservation area from the east is along a hedged and banked road, providing glimpses of the sea. Lower centre and right: as in the views above, boats as much as buildings add to the visual character. Bottom left and right: coastal locations often provide a setting for historic defensive features; in this case former World War II “pill box” fortifications. In the example on the right, sea erosion of the foundations has led to acute subsidence.

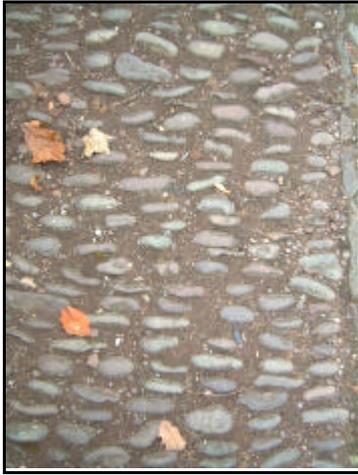
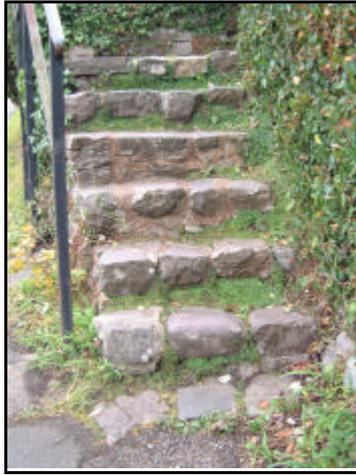
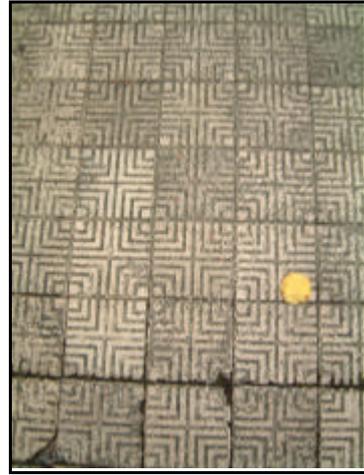
There are some locations where ground surfaces and steps are constructed using natural materials, or where original paving blocks survive. The example shown on the right probably dates from the late 19th century.

4.11 A number of locations in Porlock Weir have stone paved or cobbled surfaces as part of the street scene. The most prominent are around the quayside and as forecourt features to several outbuildings and workshops. The elevated cottage row beyond St. Nicholas’ Church has access by steps of squared stone blocks. There are also several examples of patterned “stable-block” paving, some probably dating from the late 19<sup>th</sup> century.

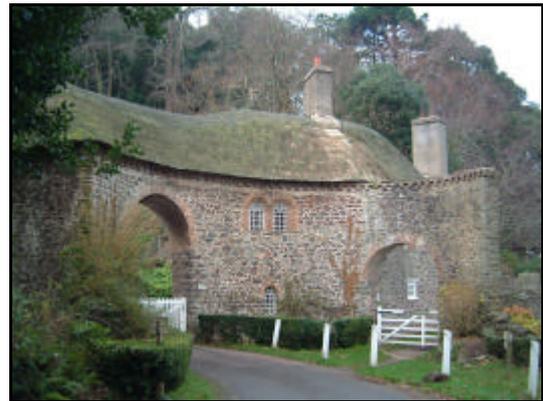
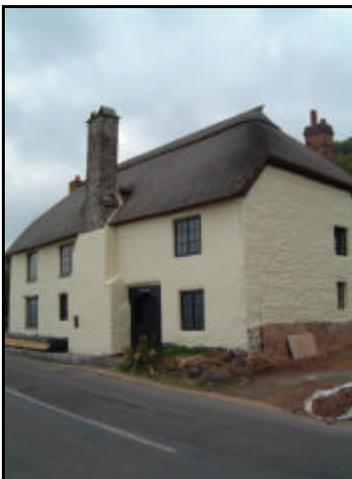
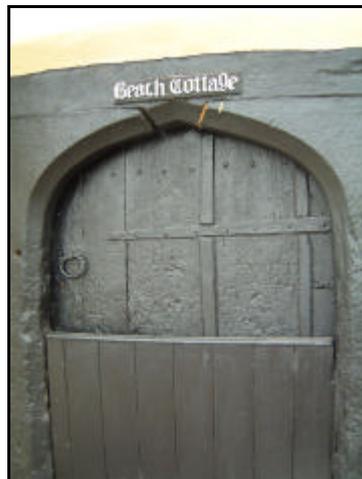
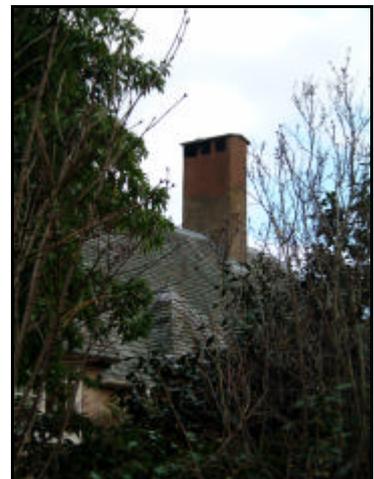
Some examples of listed buildings within the conservation area; *Top right: Toll cottage, Worthy Estate, one of several buildings dating from the early 20th century designed or influenced by Voysey. Above left: Beach Cottage; a good example of a 17th century three-cell cottage in the local vernacular style. Above centre: The door and jointed door-frame at Beach Cottage are probably original. Above right: a glimpse of Voysey's work at the outbuildings of Worthy Manor showing a massive stack with triple smoke vents exemplifying his style.*

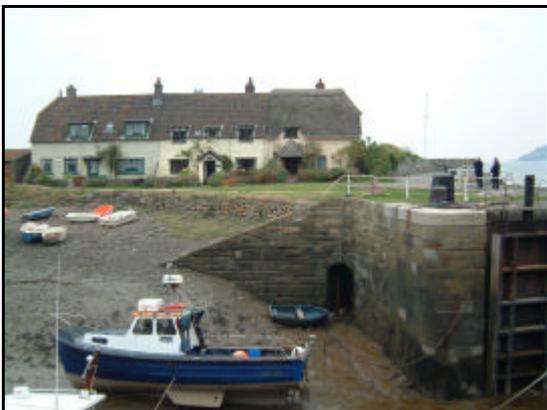
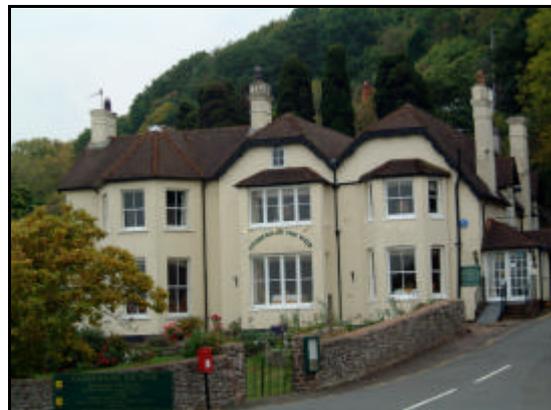
Some buildings, although not listed are prominent within the conservation area. *Above left:* A cottage row adjoining the harbour, and probably of 17<sup>th</sup> century origin is visible from many vantage points. *Above right:* A late 19<sup>th</sup> century building facing the harbour was probably built to accommodate holiday visitors. It retains most original frontage detail.

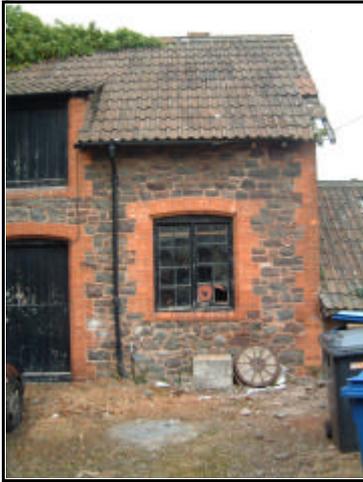
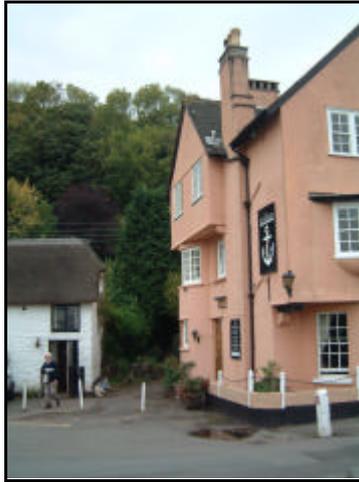
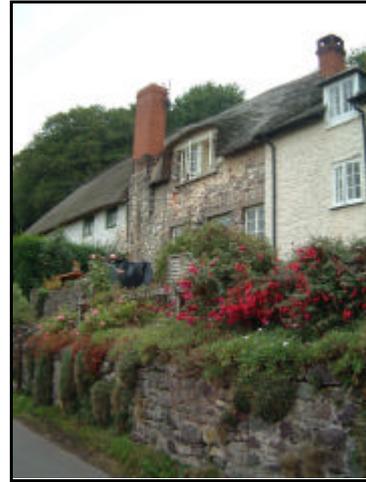
Further examples of unlisted but historic buildings that make a valuable contribution to the character of the conservation area. *Above left:* late 19th century former stables/workshops adjoining the Ship Hotel. *Above centre:* buildings facing the coast in the latter half of the 19th century were built on a much grander scale than the vernacular buildings that preceded them. This sometimes leads to dramatic contrasts between them as here with the 17th century Ship Hotel on the left and late 19th century Anchor Hotel to the right. *Above right:* part of an attractive row of six cottages. The front lateral stacks suggest late 17th – early 18th date with later frontage alterations.

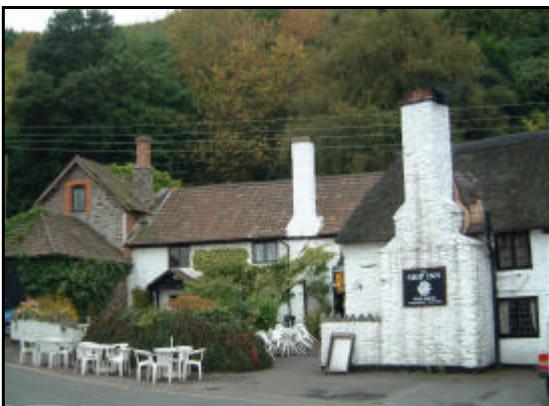
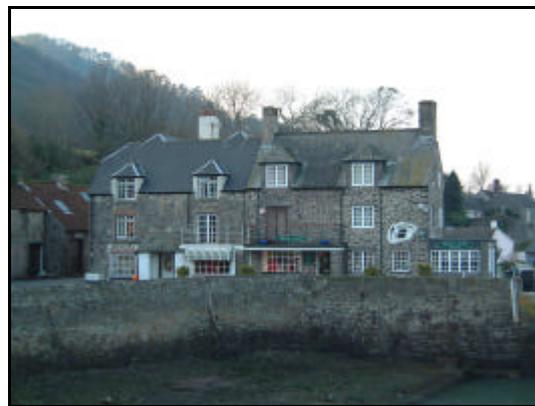
*Above right:* former lime kilns, probably dating from the late 19th century with later house (early 20th century) built over. *Below left:* The Ship Inn includes two houses built in local vernacular style; that in the foreground predating that to the rear, to which 19th century stables (on the left) were added. *Below right:* This three-storey group, by the quayside appear on the 1840 Tithe Map, and are likely to date from the early 19th century. It is probable that the ground floor has always been reserved for commercial use with living accommodation above.

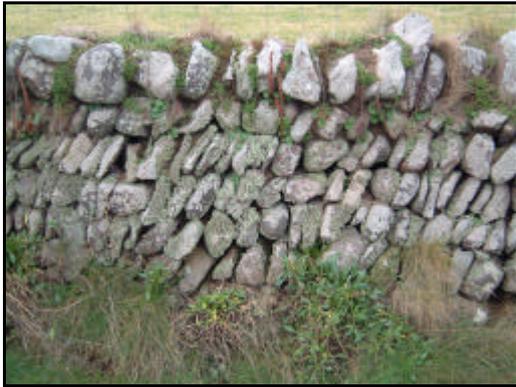
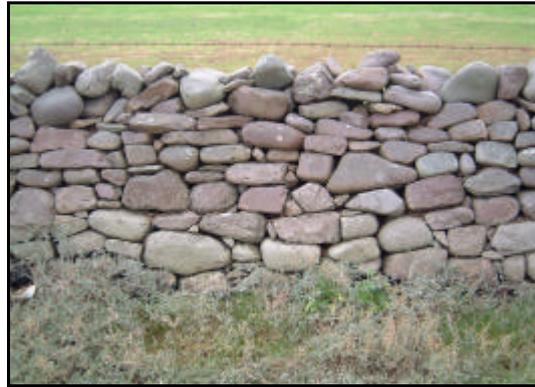
Left: a section of field wall showing the traditional method of “dyking” where the stone is laid towards a vertical plane. Right: a recently laid section of wall using beach boulders.

4.10 There are substantial stretches of boundary or retaining walls built of local sandstone rubble, usually roughly coursed. In some instances beach boulders have been used and no mortar is added. Some free-standing walls are in a dilapidated condition, whereas others have been or are being painstakingly rebuilt, as shown in the examples illustrated (see p.16). Sometimes, especially as a support to earth banks the locally distinctive dry-stone pattern known as “dyking” is evident. This method places the bedding plane of the stone in a vertical or slanted “herring-bone” pattern and adds a pleasing contrast. When a retaining feature to hedgerow banks, it can become prone to deterioration as a result of root spread when not regularly maintained. These local types of walling make a valuable contribution to the character of the conservation area, as well as providing a strong sense of enclosure or privacy in several cases.

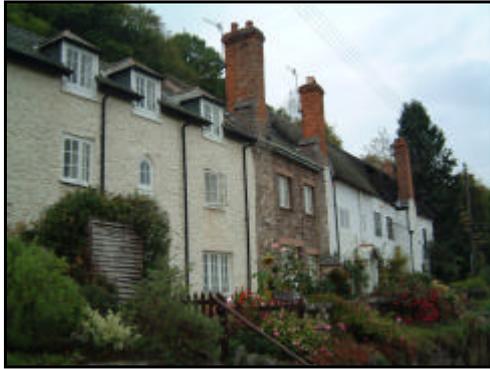
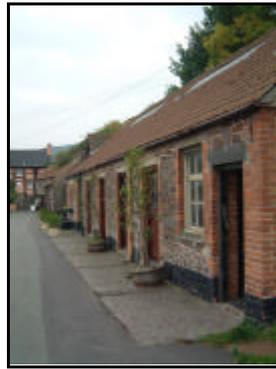
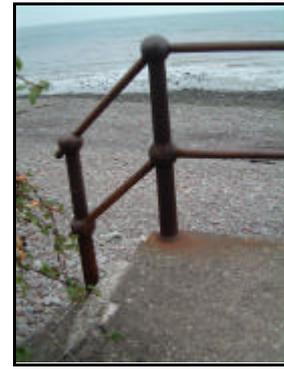
*Above left and centre: unlisted buildings of historic character can be vulnerable to inappropriate frontage alterations, especially to doors and windows Above right: an access to the beach which would benefit from improvement in keep-*

- Seek to retain or reinstate all existing period windows, doors, and cast iron rainwater goods. This includes the typical 19<sup>th</sup> century decorative estate features, and any examples of an Arts and Crafts tradition, for example, decorative window glazing and forged metal window and door catches.
- It should be noted that the National Park Authority can consider introduction of an Article 4(2) Direction where boundary features, for example, stone or brick walls, and openings are under threat. This also has the potential to effect control over the potential installation of UPVC windows and doors, inappropriate roof materials, external cladding, and use of exposed block-work.

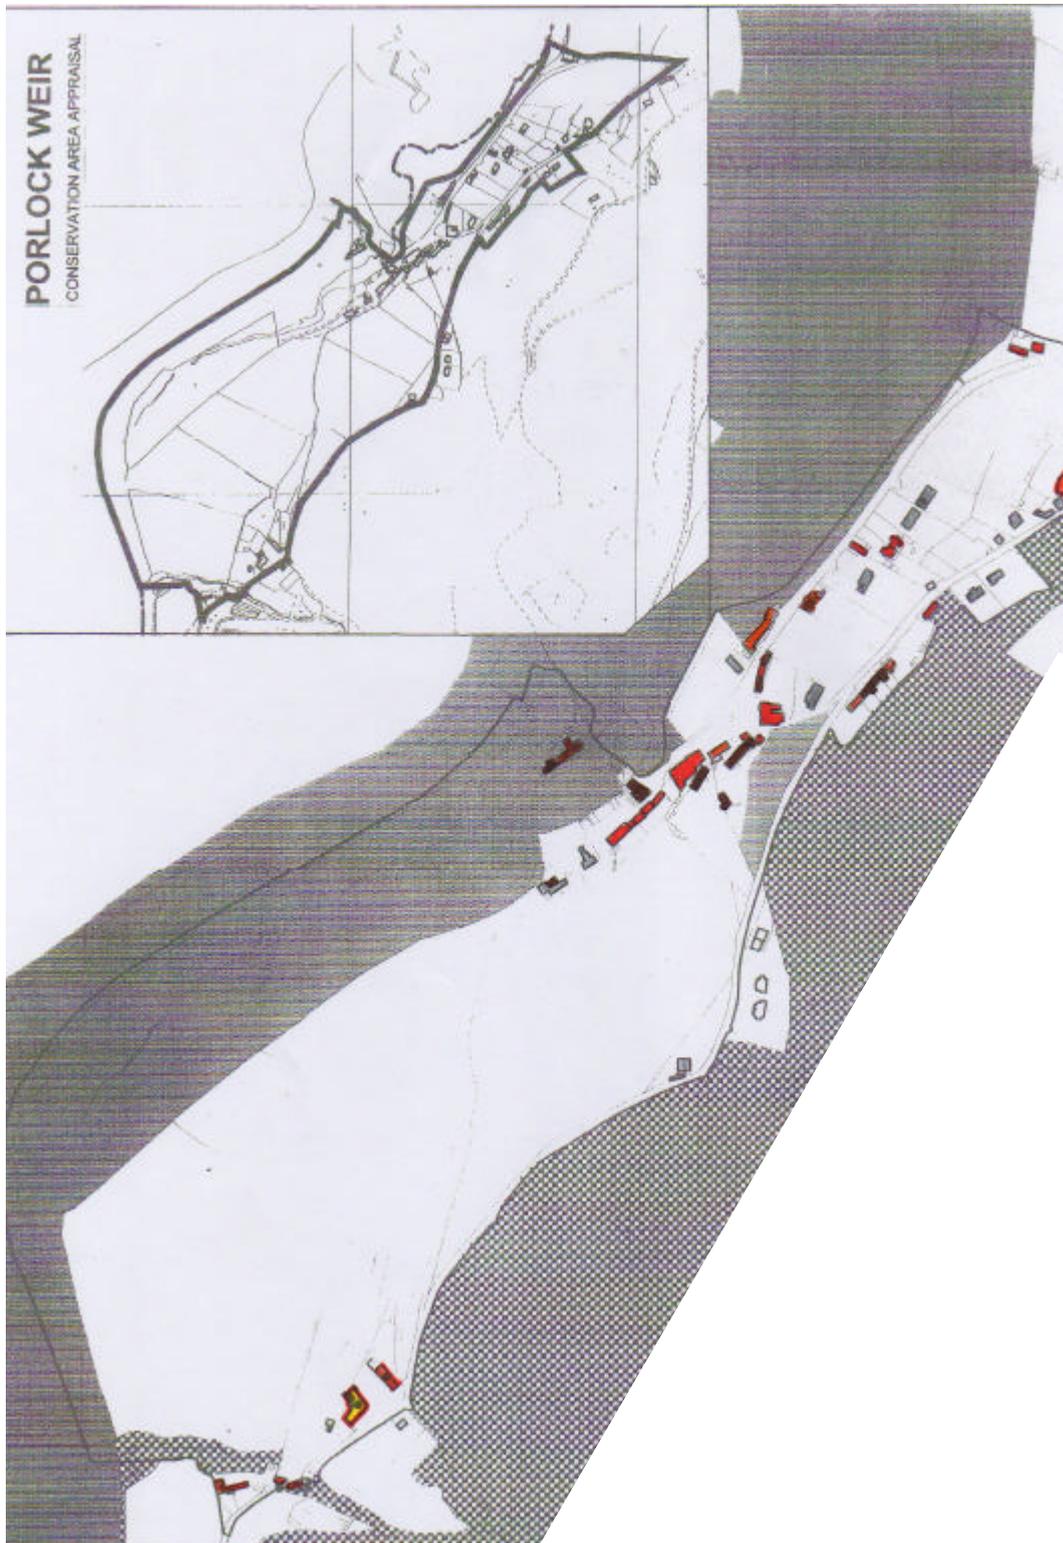
## AGE OF BUILDINGS

**NOTE:** The dates shown are approximate. Parts of the building may be earlier than shown. A more accurate date can often only be determined by a detailed internal inspection. Buildings shown in two colours indicate the original and one other main phase of development, although there may have been others.

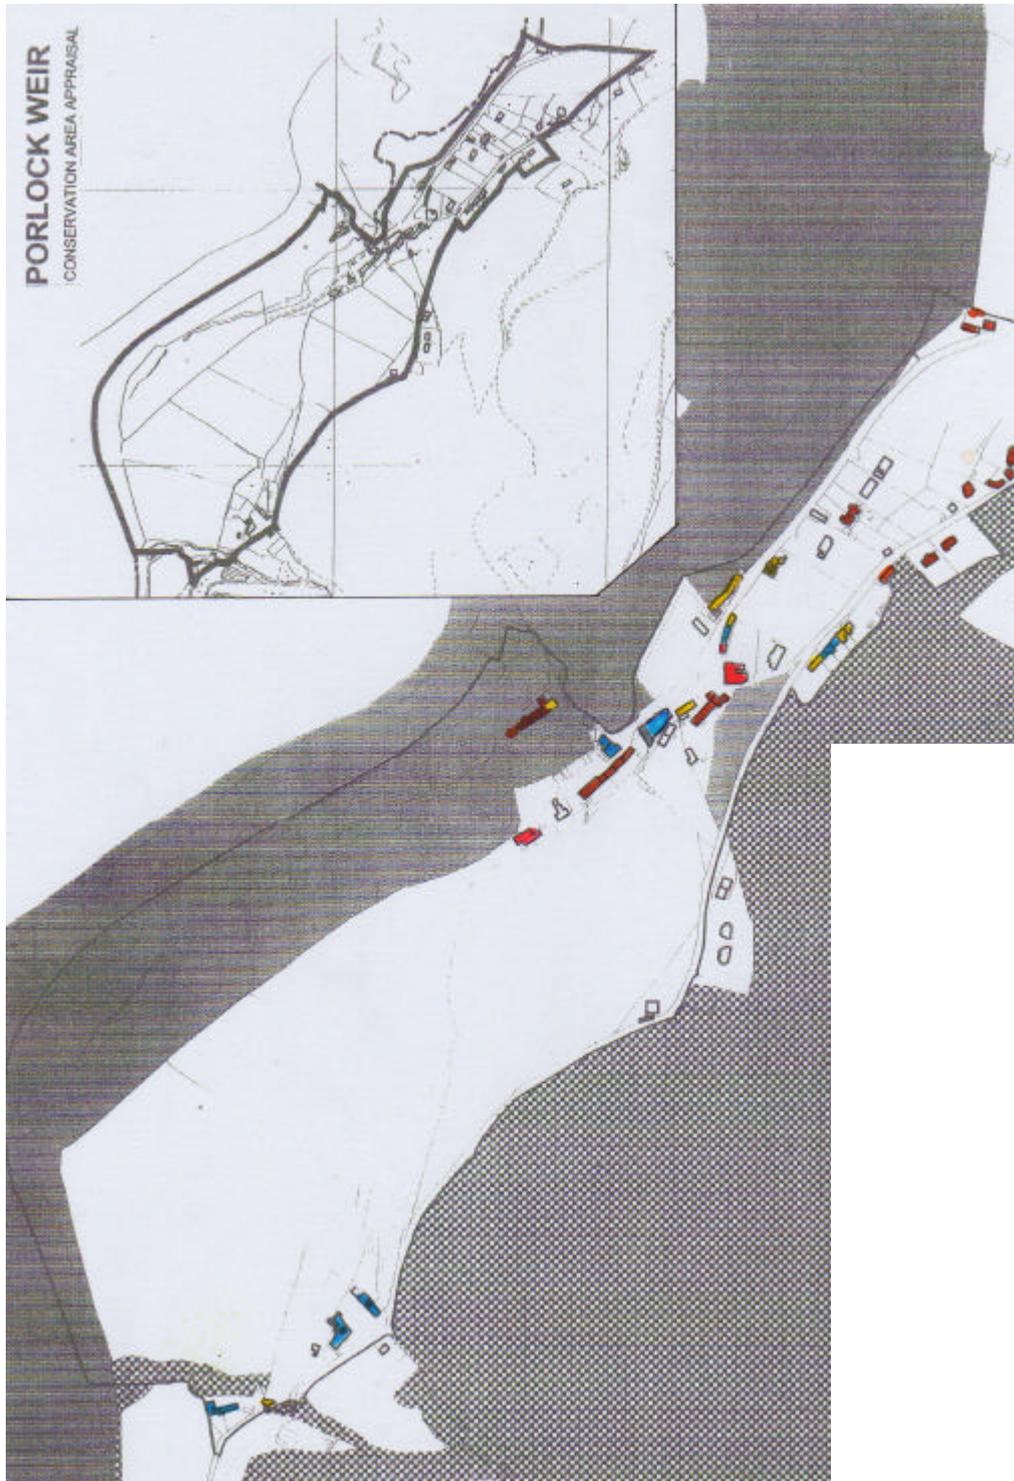
## BUILDING MATERIALS – ROOFS

**NOTE:** This visual survey is for guidance purposes only, and indicates the predominant, rather than the precise roofing material in every instance. Accuracy cannot always be guaranteed in differentiating between natural slate and slate substitutes. Sites left blank either indicate that inspection was not possible, or that buildings are of too recent origin to be classified as historic.

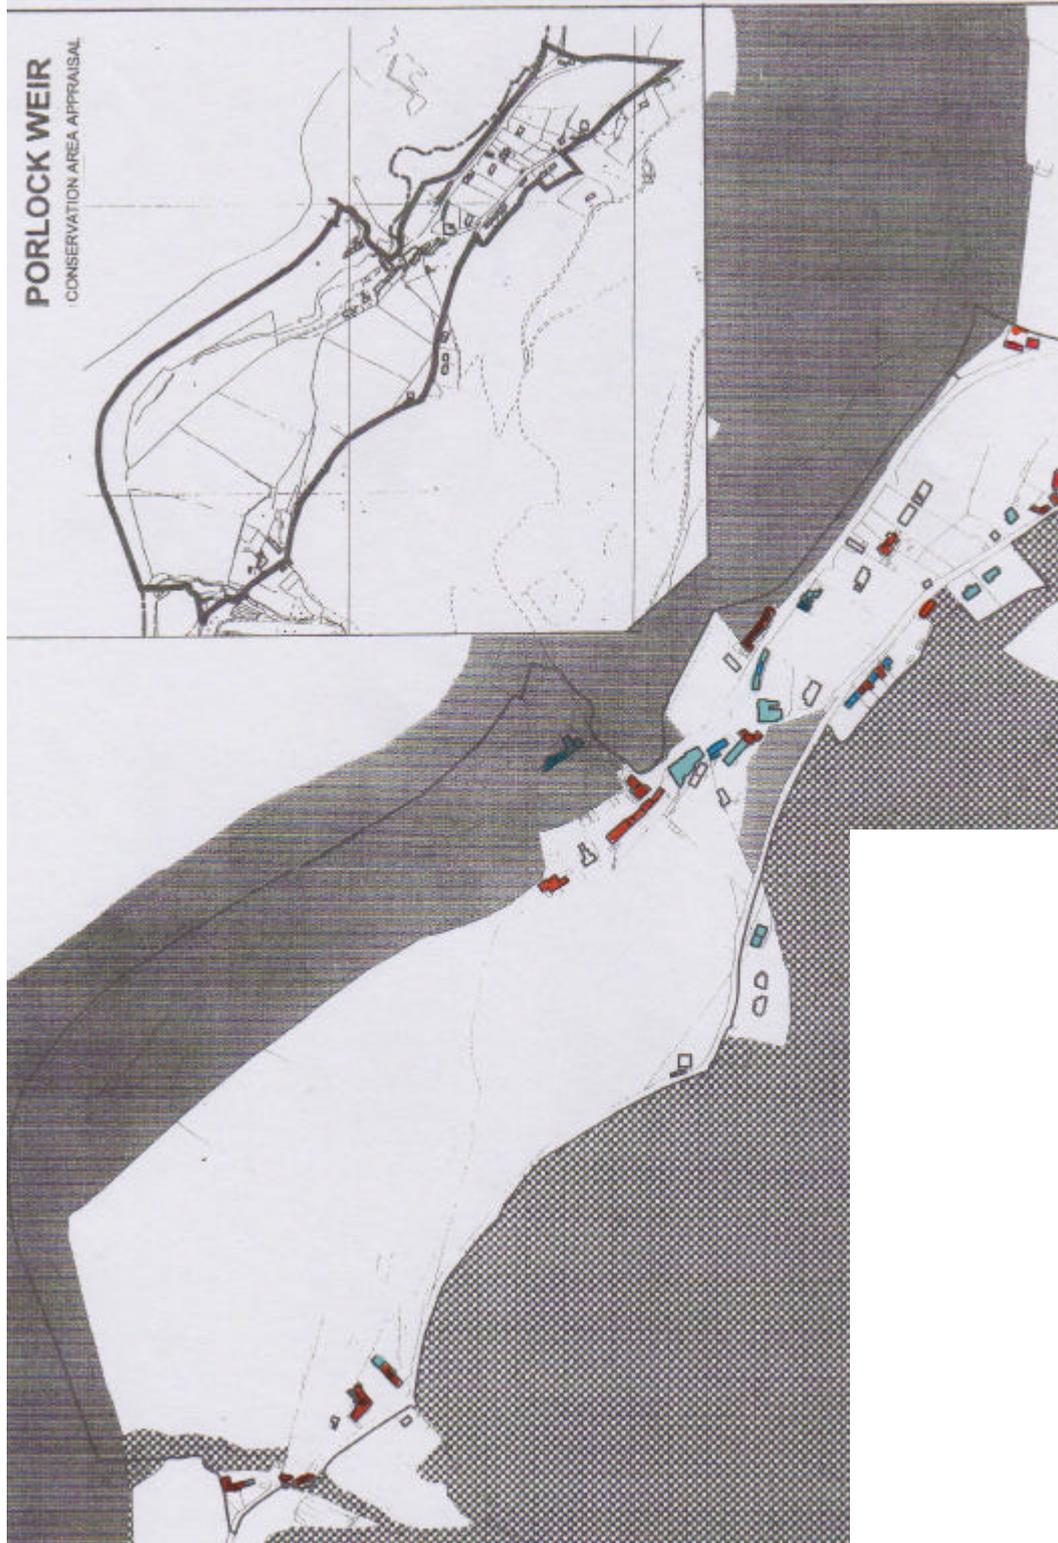
## BUILDING MATERIALS – WALLS

**NOTE:** This visual survey indicates the predominant rather than the precise walling material in every instance. Buildings outlined in one colour and filled in with another, denote the two main building materials (e.g. painted stone and render). Accuracy cannot always be guaranteed, since buildings may have a different frontage material to the rest of the building, which may not be visible. Sites left blank, indicate inspection was not possible, or that buildings are considered too recent to be classified as historic.
