Exmoor National Park
Historic Environment Report Series No 23

ASHCOMBE 'GROTTO', SIMONSBATH

A DETAILED ASSESSMENT OF THE FABRIC AND DISCUSSION OF COMPARATOR SITES

ASHCOMBE GROTTO, SIMONSBATH, EXMOOR: DESCRIPTION AND ASSESSMENT OF THE FABRIC BY DR STUART BLAYLOCK

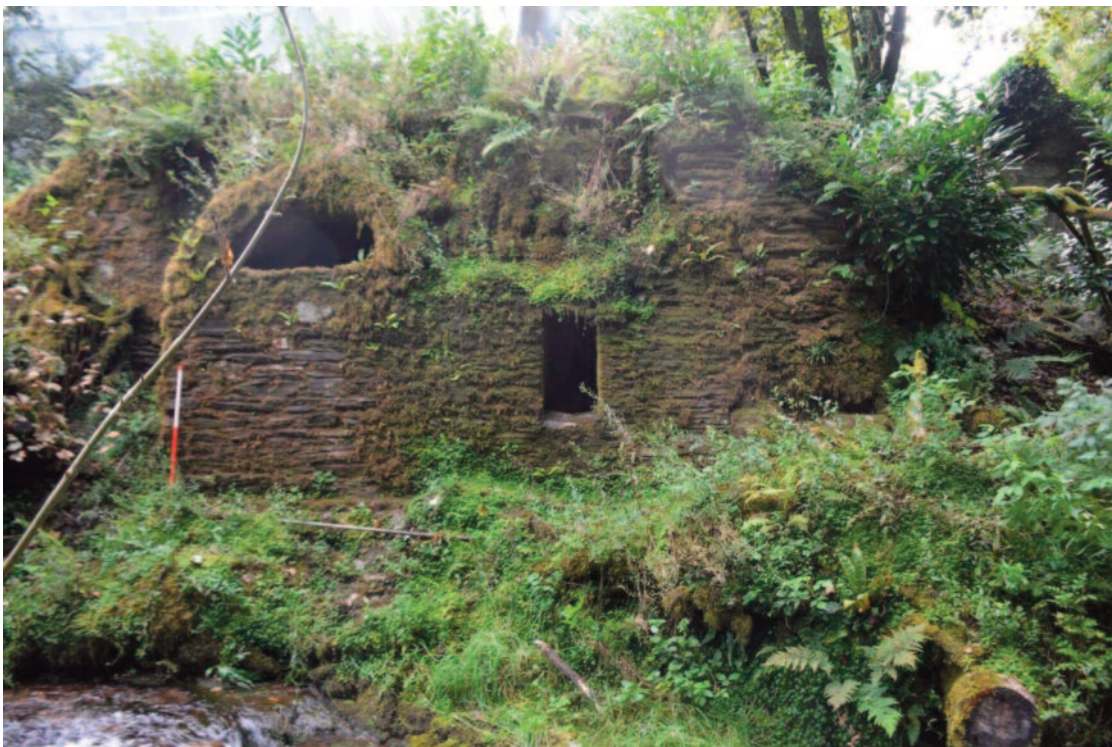
Fig. 1 The west elevation before stripping of vegetation, 7.ix.16 (photo ref: SRB 9539).

Site visits were made on 7.ix.16 to view the building before it was cleared of vegetation (Fig. 1); on this day I was able to form a view of the fabric in general and of the nature and phasing of the interior. Vegetation was removed in the week of 12–16.ix.16; I made a second visit to view the stripped external elevations from scaffolding on 28.ix.16 (Figs 3–4), and a further visit once the scaffolding had been removed on 9.x.16 to take photographs of the main elevation for annotation (Fig. 2). This text is based on field notes and subsequent study of the photographic records, plus the phased plan made previously by South-West Archaeology (see also commentary, below).

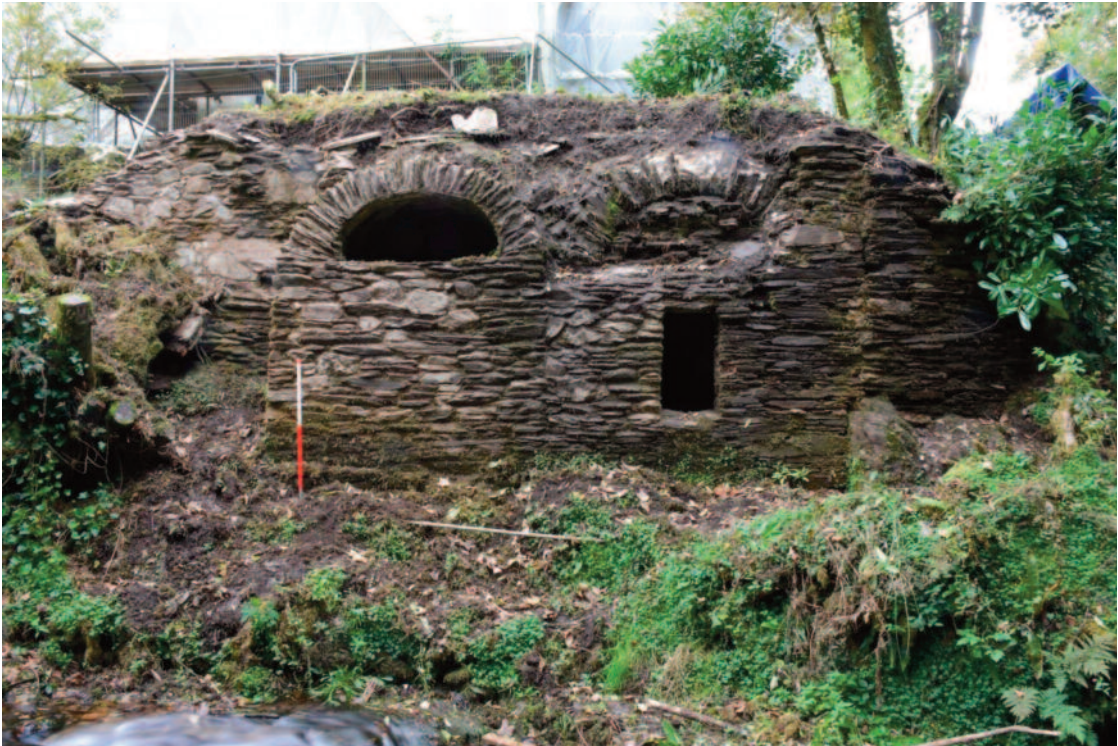
Fig. 2 The west elevation after stripping, 9.x.16 (photo ref: SRB 0037).

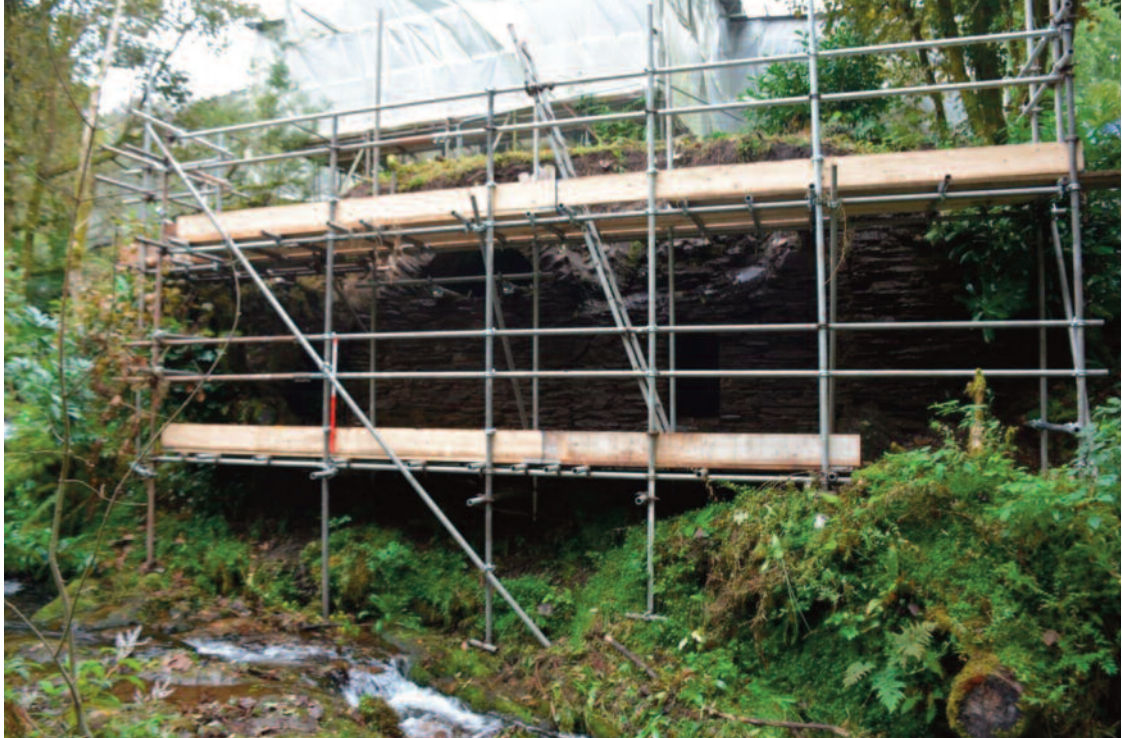
Fig. 3 The west elevation with scaffolding in place, 28.ix.16 (photo ref: SRB 9691).

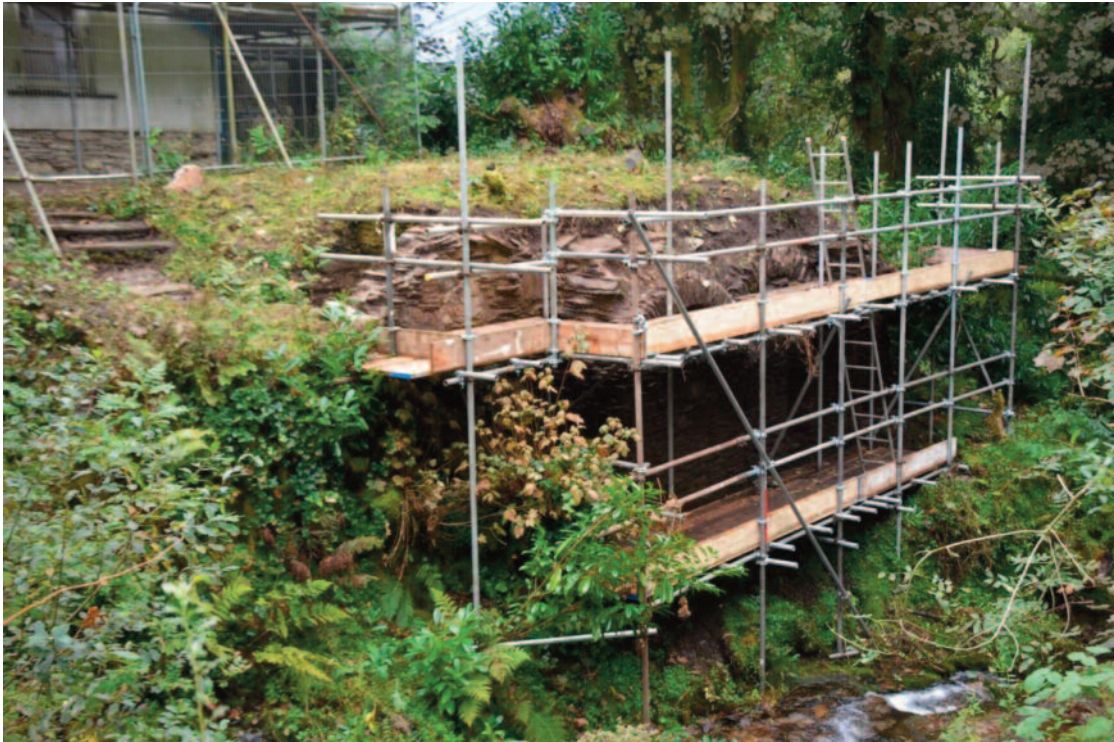
Fig. 4 The building from the north-west, with scaffolding in place, 28.ix.16 (photo ref: SRB 9696).

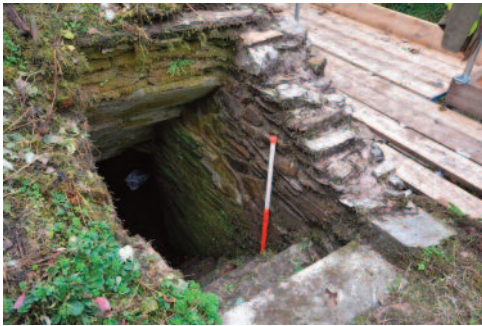
Fig. 6 West wall of stair, looking south-west, showing original masonry below, repair above (photo ref: SRB 9742).

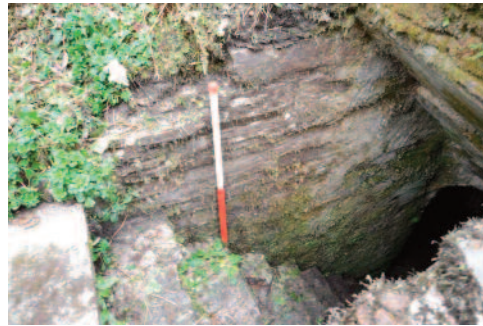
Fig. 7 East wall of stair, looking east, showing original rubble masonry throughout (photo ref: SRB 9745).

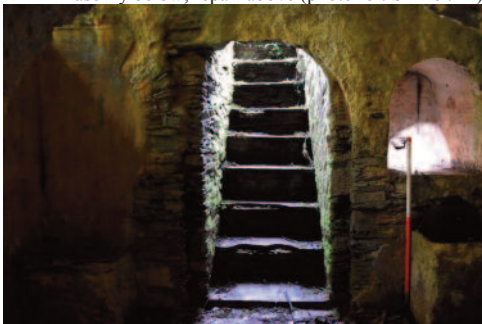
The steps were originally of rubble masonry, but are now capped with cement slabs/made-up treads some 40mm thick, 310–20mm deep (Fig. 8).

The northern cell has three features in its north wall (Fig. 8): the central doorway at the foot of the steps, a niche to the east and traces of a blocked niche to the west. The doorway (0.92m wide originally had an arched head, and the right-hand (east) side of the arch survives (Fig. 8); to the west the head has been disrupted by repair, and now consists of a crude lintel construction. The east and west reveals of the doorway are rebated, as if to receive a door, although no traces of hanging of or furniture from a door were noted. The niche to the east has a semicircular head, and measures 610mm wide at the wall face; 730mm high; and is 600mm deep. The wall face is obscured by plaster, but is assumed to possess a relieving arch on comparison with the western arch (below). Traces of the eastern jamb and eastern side of the relieving arch of a second such niche appear to the west of the doorway (Fig. 8), but this has been blocked and much of the area is rendered over in pinkish cement continuous with the rendering of the west wall, meaning that the masonry fabric is not visible at this point.

Fig. 8 Interior north wall, showing stair and doorway, extant niche (right) and remains of blocked niche (left); (photo ref: SRB 9745).

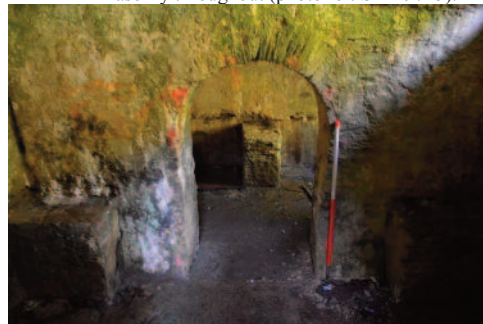
Fig. 9 Interior looking south, showing door in party wall and remains of benches in foreground and rear centre (photo ref: SRB 9563).

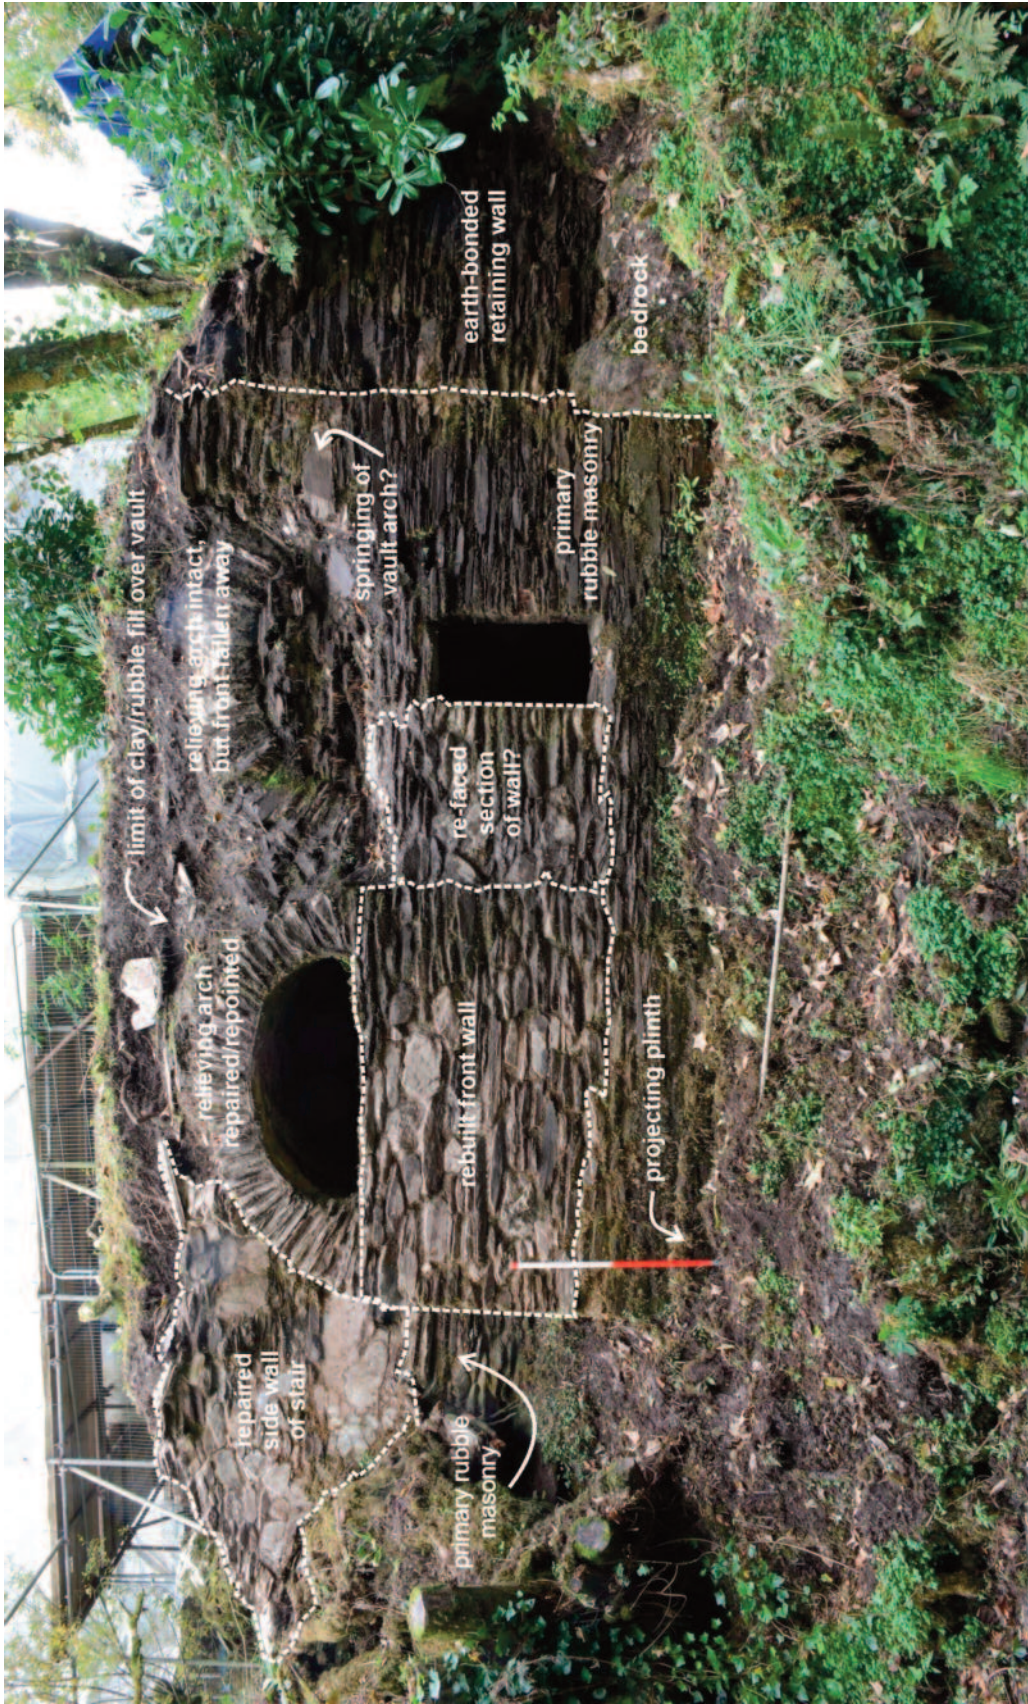
The basic building material of the visible exterior elevations is of newly-won/quarried slate stone with a variable admixture of quartz boulders and other water-worn stones; these form as much as 25% of the fabric in places, elsewhere (such as the south end of the west elevation; Fig. 5) they are entirely absent. It emerges that these boulders are most characteristic of the repairs (could it be that they were collected from the river along with collapsed material from the front wall?), and while not being wholly failsafe, form one strong indicator of rebuilt fabric. In common with the surrounding landscape setting, occasional use is made of large white quartz boulders, notably two either side of the 'entry' to the shallow approach steps at right angles to, and to the north-east of, the main flight of steps. This is presumed to be an intentional part of the design. Bedrock is visible between the two flights of steps, and at the south end of the west elevation (Fig. 5).

probably been repaired (the extrados is pointed in pink cement at its outer/west end, although white lime mortar can be seen deeper into the joints). The front of the southern arch has fallen away, so that its voussoirs survive some 300–350mm short of the wall face. There is a little repair/rebuilding at the top, but this is largely intact with original lime mortar bonding visible in situ; it is presumed also to have extruded onto the wall face originally. A large slate block in the main wall face probably represents the springing of the south side of the arch (Fig. 5).

Over the crown of each vault there appears to be c.3–400mm of clay and rubble, some of it displaced, and then 3–400mm more of soil capping over the structure (Fig. 5). Removal of this would be desirable eventually, and might contribute to the better understanding of the fabric.

Fig. 5 West elevation annotated with the lines of masonry breaks and other details (photo ref: SRB 0037, cropped).

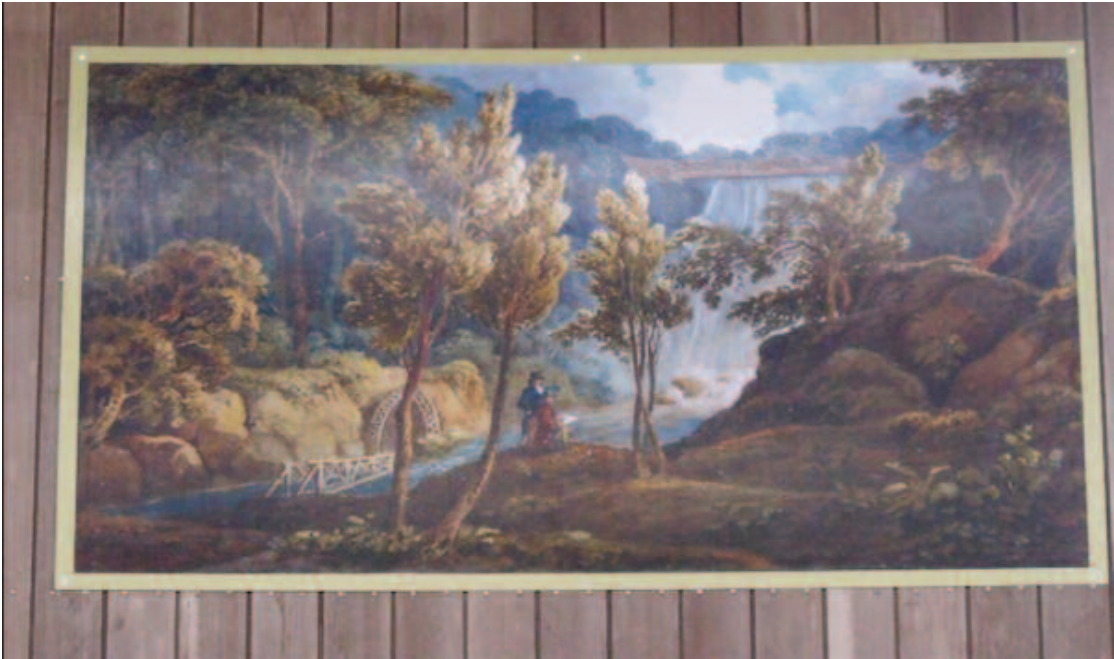
Horners Station 10, 1815, Middleton Hall. The footbridge and arcade are now wholly lost, partly due to a landslip on the steep bank, and later flood damage. Only a small patch of puddling clay remains in the bed of the stream as evidence of managing the water flow.

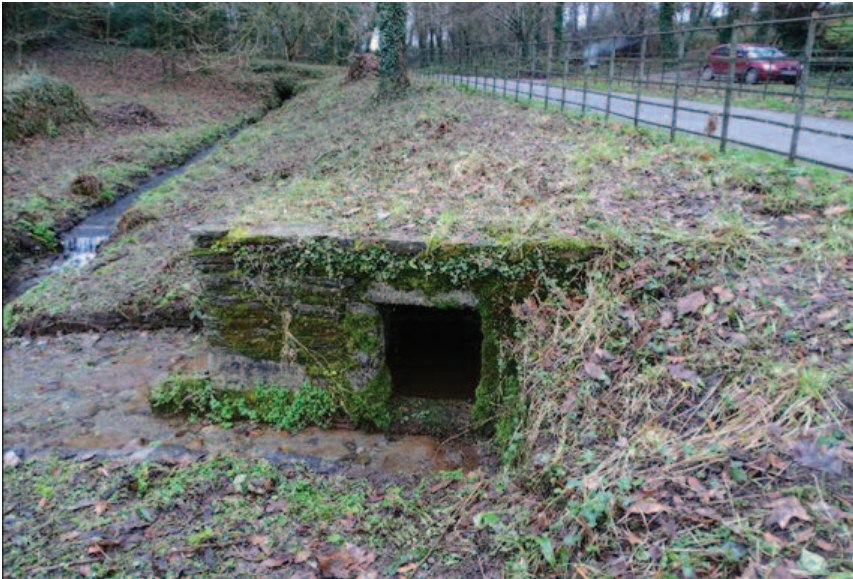
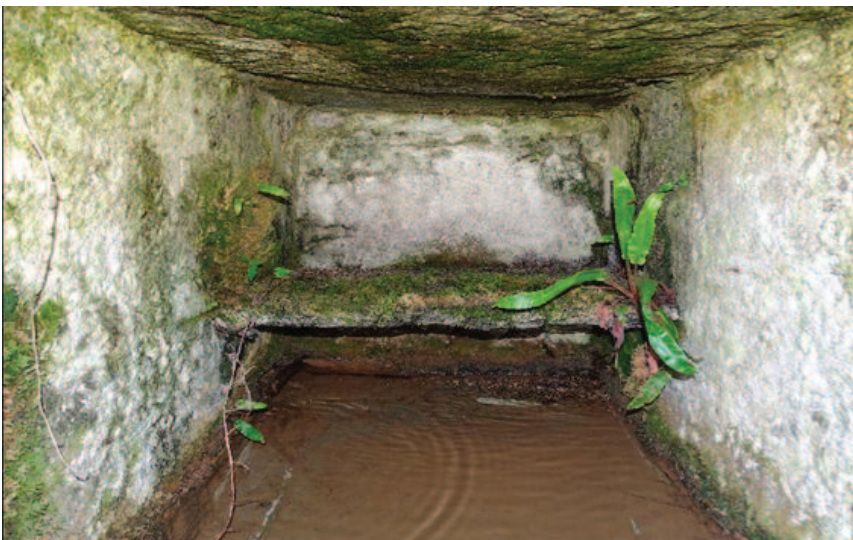
Spring House Cool Store at Buckland Abbey

- 2.13 At Buckland Abbey, a spring house is fitted with a slate shelf, presumably to conserve or cool clotted cream, possibly planned by William Marshall, the agricultural improver while at Buckland in 1794. Notably and regrettably, Marshall regarded registering the *minutiae of the Dairy Management as a tedious and irksome task*, so we have no record of how it was used.

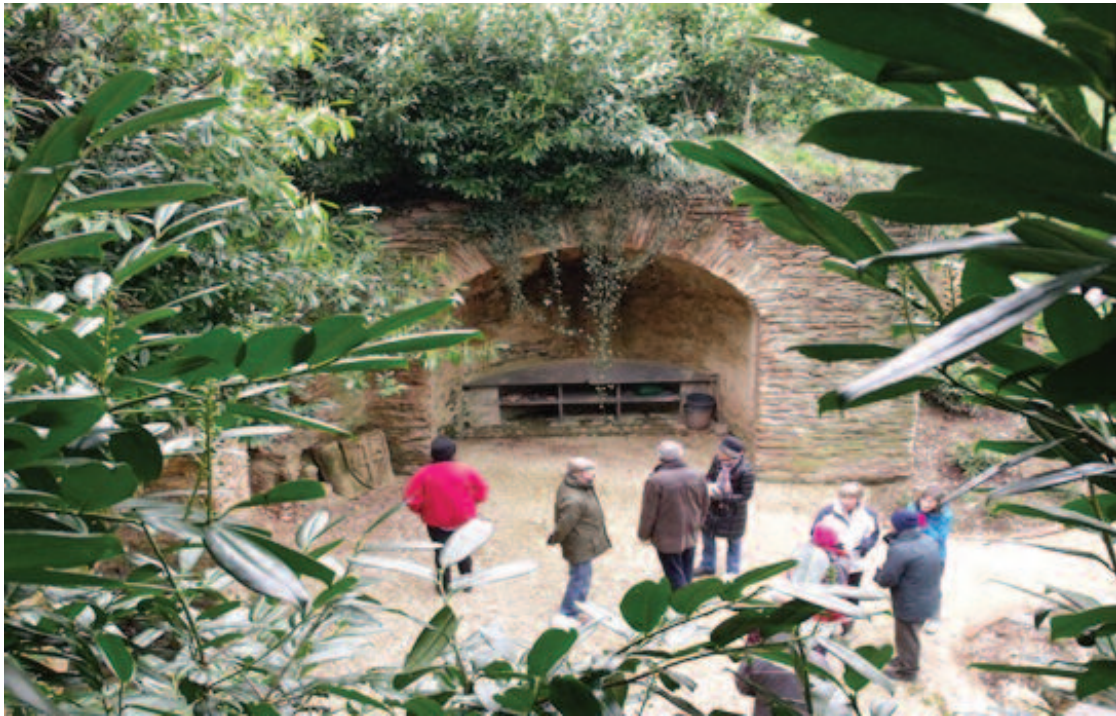
Mill Wood, Halswell

2.14 This is clearly a far cry from the ornamental Lady's dairy of the eighteenth century stately home, but does bear some comparison with the alfresco larder around the spring head grotto at Mill Wood, Halswell; somewhere safe and cool to store provisions and a picnic, managed and operated by staff, but close to the owner's polite landscape.
