EXMOOR STANDING STONE CONDITION SURVEY 2017-2018

Exmoor National Park
Historic Environment Report Series
Author: Jack Fuller - ENPA Historic Environment Intern
December 2018

This report presents the current condition results of standing stones and stone settings within Exmoor National Park, for their consideration for conservation and land management. The survey was undertaken by the ENPA Historic Environment Intern (the author) and supported by ENPA and Historic England by means of funding from the Capacity Building Grant. Fieldwork took place between October 2017 and May 2018.

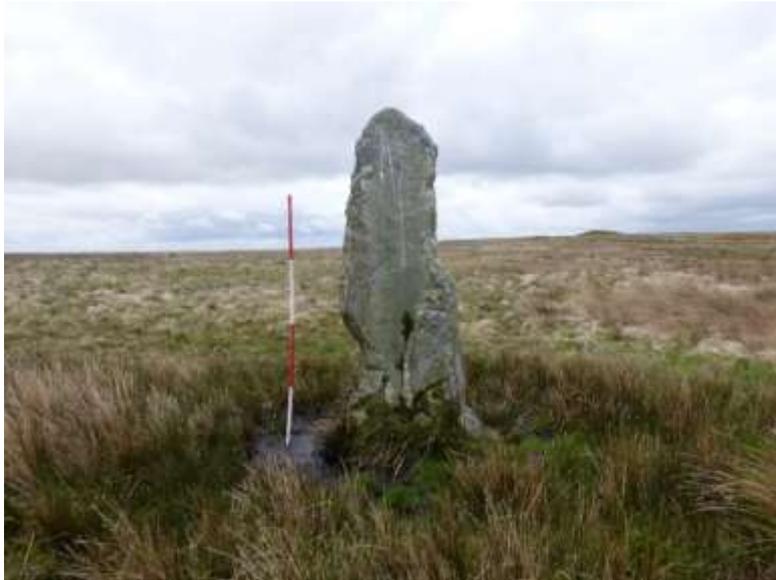
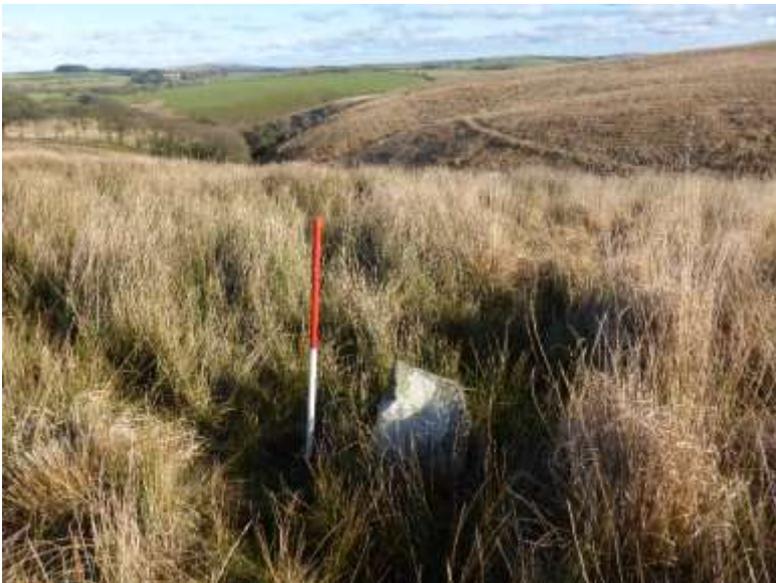
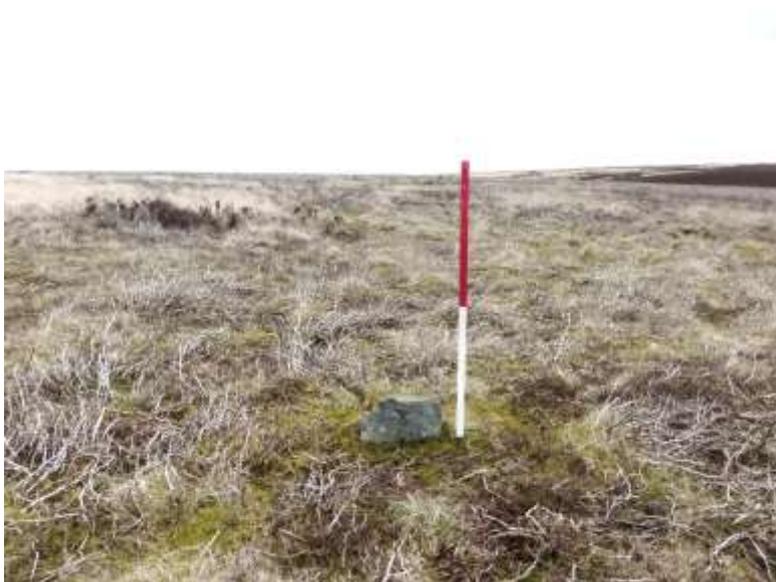
Fig. 1: Different examples of standing stones. **Top:** The Challacombe, or “Chapman”, Longstone (MDE1280). **Middle:** The Halscombe Stone Setting (MSO6889). **Bottom:** One of two standing stones near Black Barrow (MSO6886).

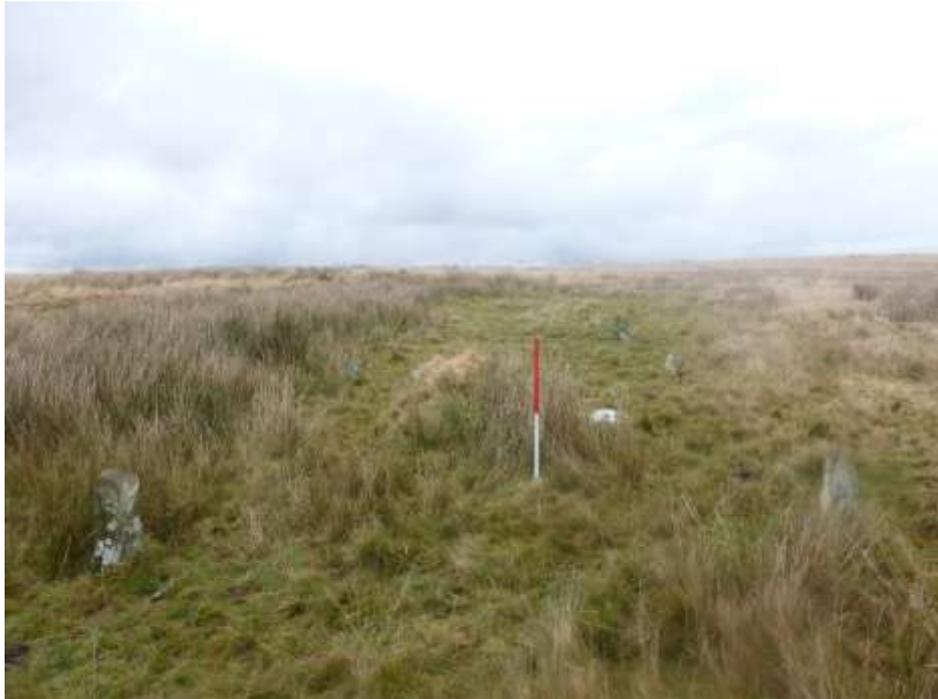
Fig. 2: Pinford Stone Setting (MSO6820) (**Top**), a setting consisting of two parallel rows of three stones. The quincunx on Brendon Two Gates (MDE1257) (**Bottom**) – plan from Quinnell, Dunn, 1989.

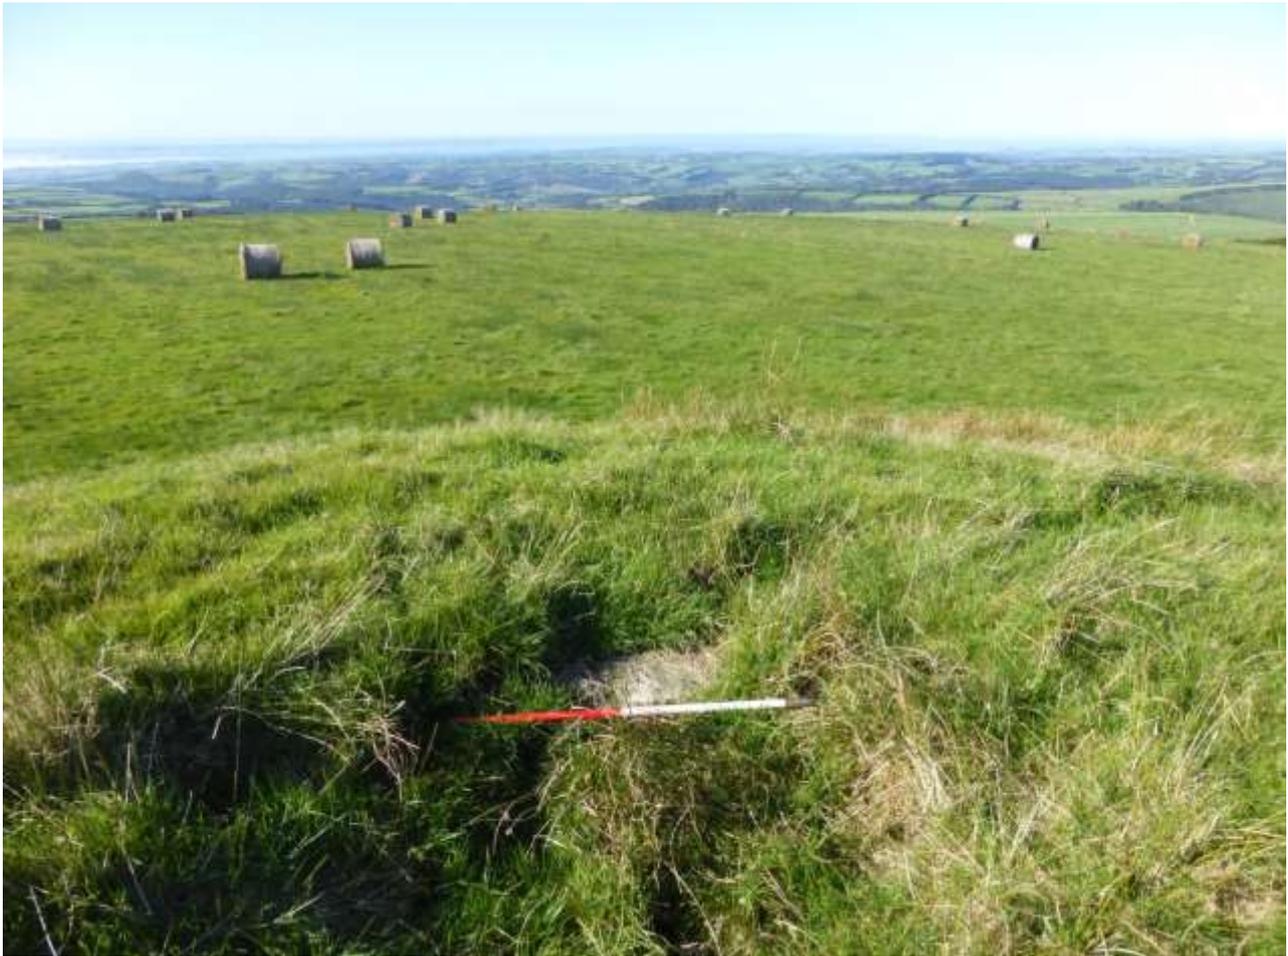
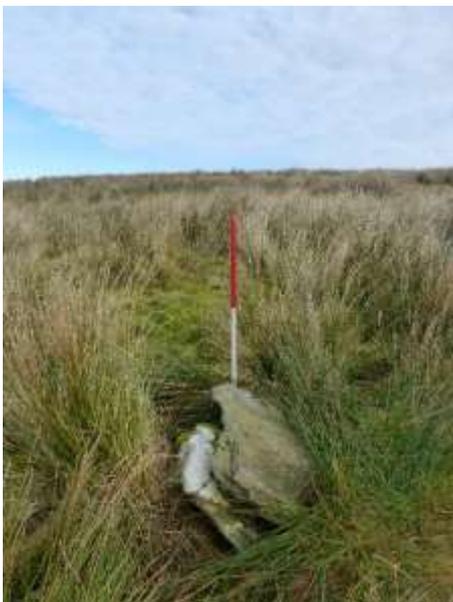
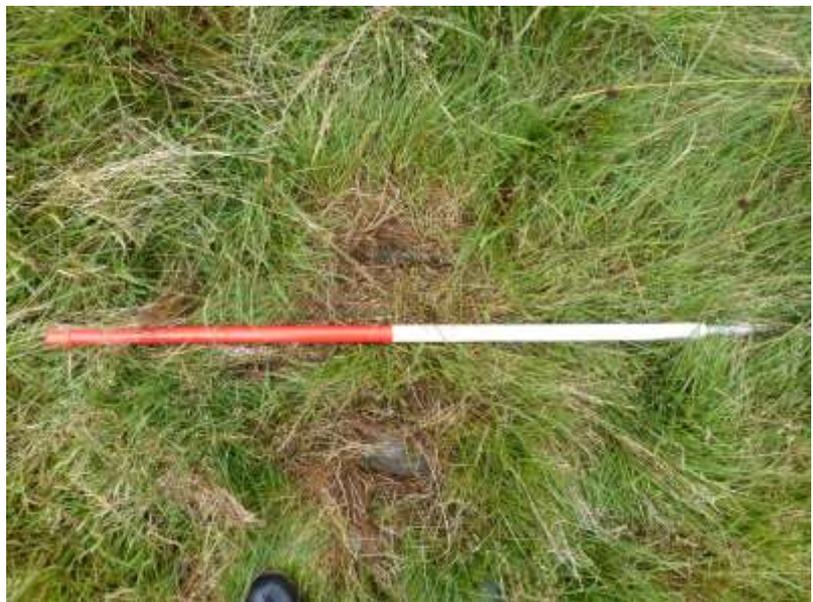
Fig. 6: Three sites in a “very bad” condition that could be considered to be “destroyed”. **Top:** One of the stones from MDEI190 placed atop one of the barrows. **Bottom Left:** MEM7 two uprooted stones stacked within a pit (although the sites identification is uncertain). **Bottom Right:** Stone B at MSO12161 which has been broken at the base, likely by an off-road vehicle or mowing equipment.

Four sites are in a “Very Bad” condition. Three of these sites: MDE1190, MEM7, and MSO12161, could be considered to be “destroyed”, where they have been damaged to such an extent that any remedial conservation work is ill-advised or not currently possible (fig. 6). In the case of MEM7, the site may have been miss-identified by this survey, however, no other stones aside from outcropping were visible during the survey. MSO9189 is also considered to be very bad, as the rate of deterioration and loss at this site has almost halved the number of upright stones (3 have been lost from 7), however conservation is strongly recommended for this site (see. Section 4).

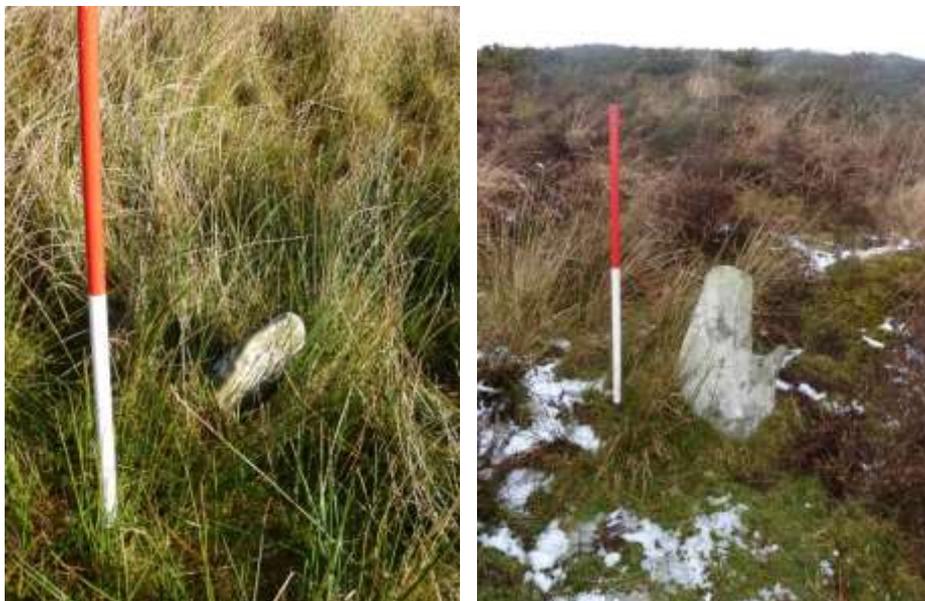
Fig. 16: Two sites which have improved since they were last surveyed. **Left:** A standing stone on Hoar Tor (MSO6817). **Right:** the Hoccombe Hill Stone Setting (MDE9886).

Seven sites could be considered to be improving. Five of these sites are Scheduled Ancient Monuments (MSO6886, MSO8534, MDE1283, MSO6815, and MSO6966), and have improved following vegetation controls or closer inspections of the monuments, relocating “lost” stones. The other two undesignated monuments (MDE9886 and MSO6817), have improved through the reduction of rubbing on the upright stones, which has allowed the erosion hollows to recover (*fig. 16*). In the case of MSO6817, this may also be due to the stones concealment in rushes.

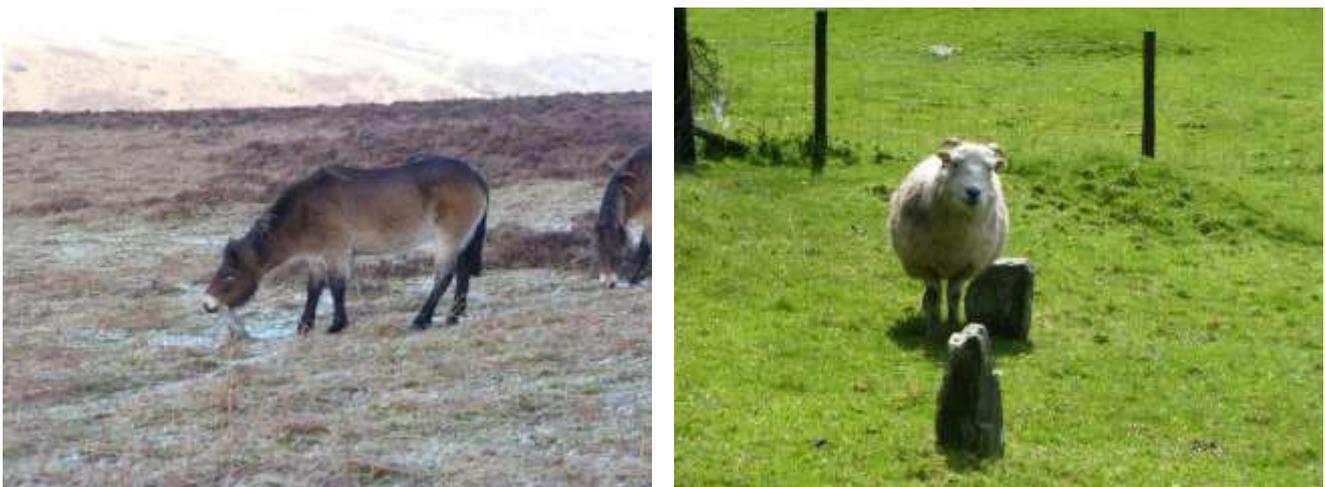
Fig 28: Livestock rubbing against upright stones at Pig Hill – MDE9885 (**Left**) and the West Middleton Stone Rows (**Right**).

The majority of livestock risk recorded during the 2017-2018 survey was considered to be “light”, with 55 recorded cases. There were 23 cases of moderate risk, where hollows were reasonably deep and some stones were beginning to show signs of instability (i.e. MDE1280, MSO6809, MSO9189). However, there was a single case of severe risk at the Horsen Stone Setting (MSO6805).

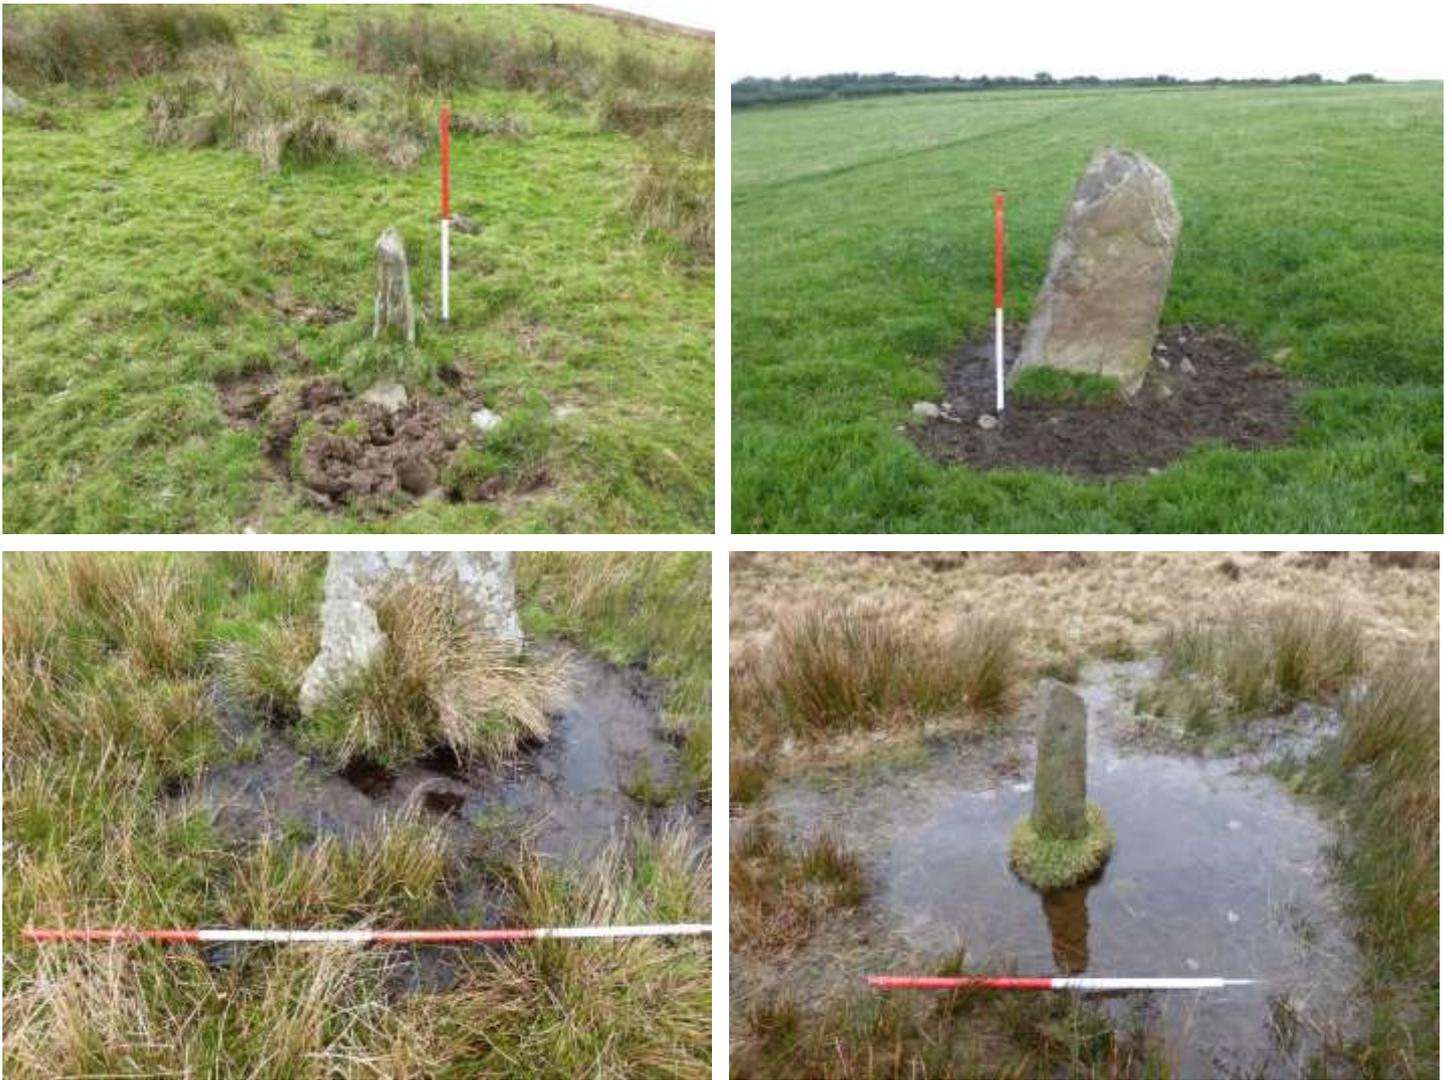
Fig 29: Erosion hollows at the Horsen Stone Setting (MSO6805) (**Top Left**), the standing stone on Kentisbury Down (MDE20394) (**Top Right**), the Chapman Longstone (MDE1280) (**Bottom Left**), and the quincunx on Brendon Common (MDE1257) (**Bottom Right**).

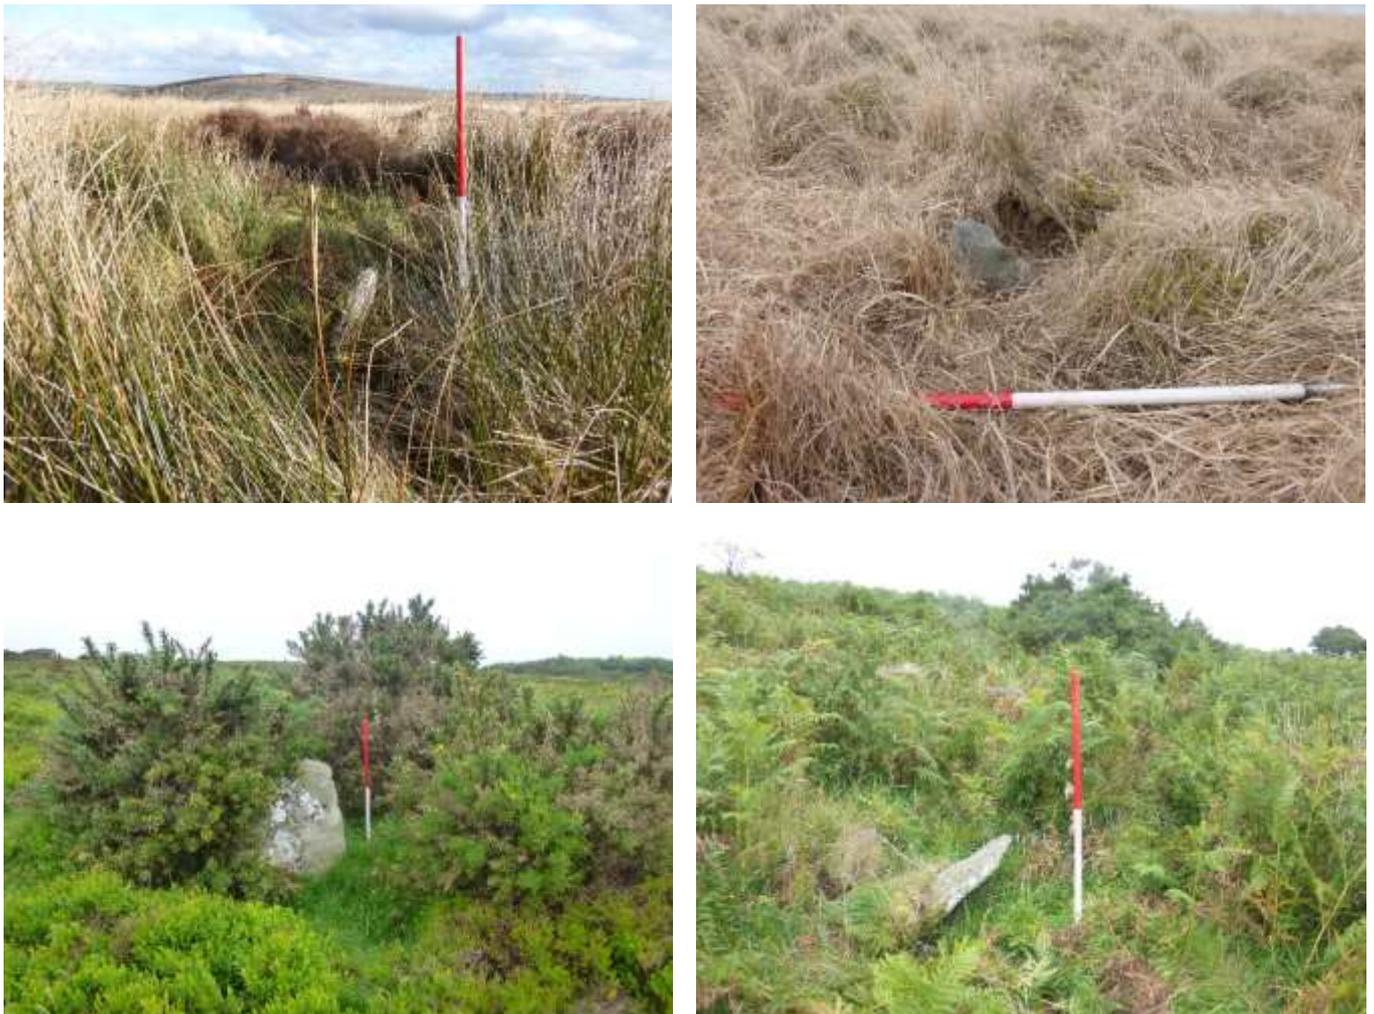
Fig 30: Various forms of vegetation cover. **Top Left:** Rushes covering a standing stone close to Portford Bridge (MSO8749). **Top Right:** Molinia tussocks covering the setting at Trout Hill III (MSO6966). **Bottom Left:** Gorse covering Stones B and C at the Porlock Hill Stone Setting (MSO7882). **Bottom Right:** Bracken covering the area around a standing stone above White Water Valley (MSO7055).

Vegetation is most commonly a “potential” threat, with 52 recorded cases. A light risk was recorded at 14 sites, and a moderate risk was recorded at a further 18. In these cases (especially those recorded as moderate) it is largely due to the sites concealment in vegetation or the presence of bracken or gorse over stones. There was only a single severe case, recorded at the Pig Hill Stone Setting (MDE9885), where the site has been completely obscured by bracken, which has possibly encouraged vehicle damage to some of the stones (fig. 31).

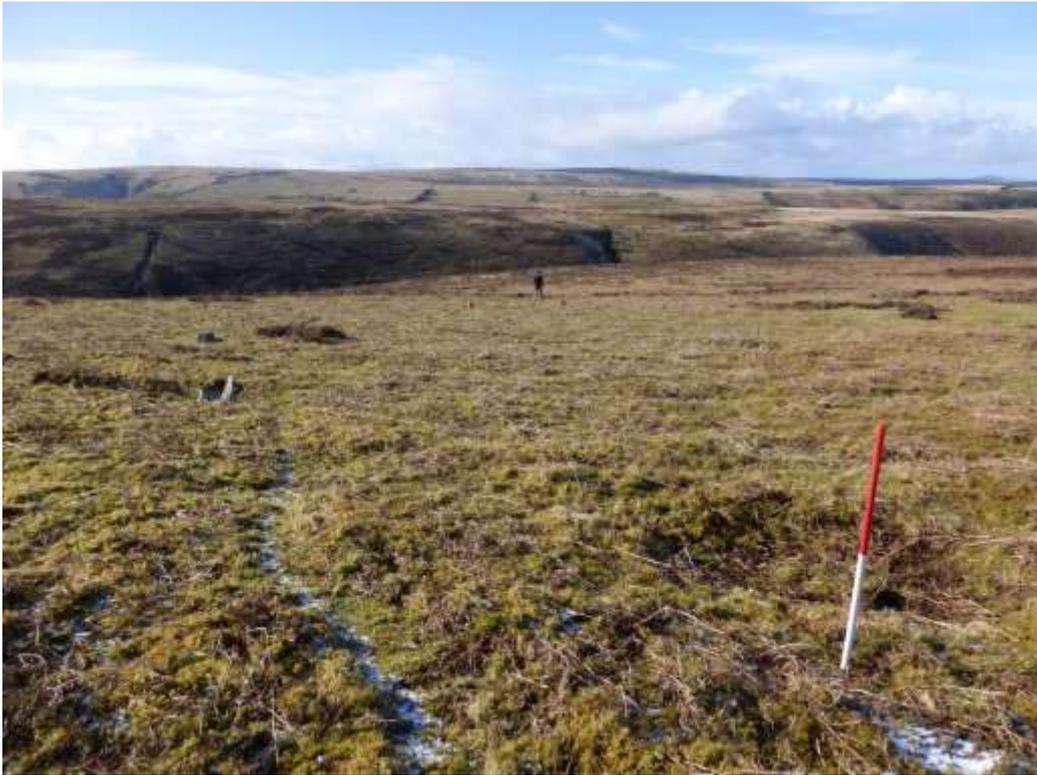
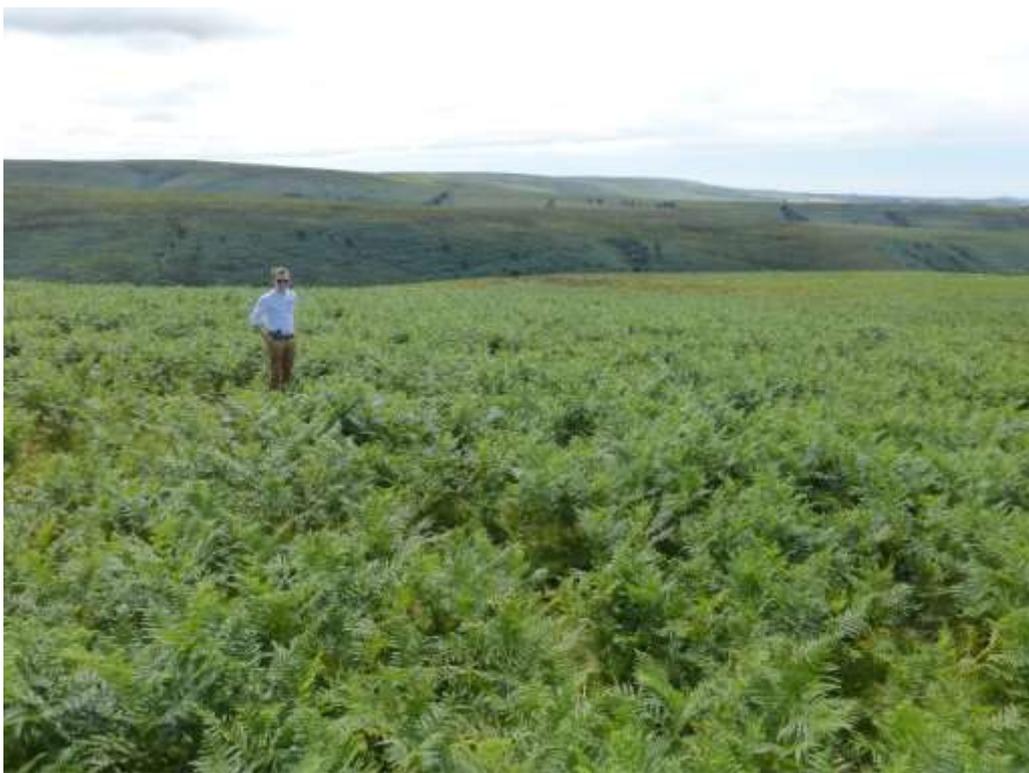
Fig 31: The change in vegetation levels at the Pig Hill Stone Setting (MDE9885), a site previously damaged by vehicles. The two photographs were taken at approximately the same point and orientation. **Top:** The site in February with the stones clearly visible. **Bottom:** The site in July, completely concealed by thick bracken.

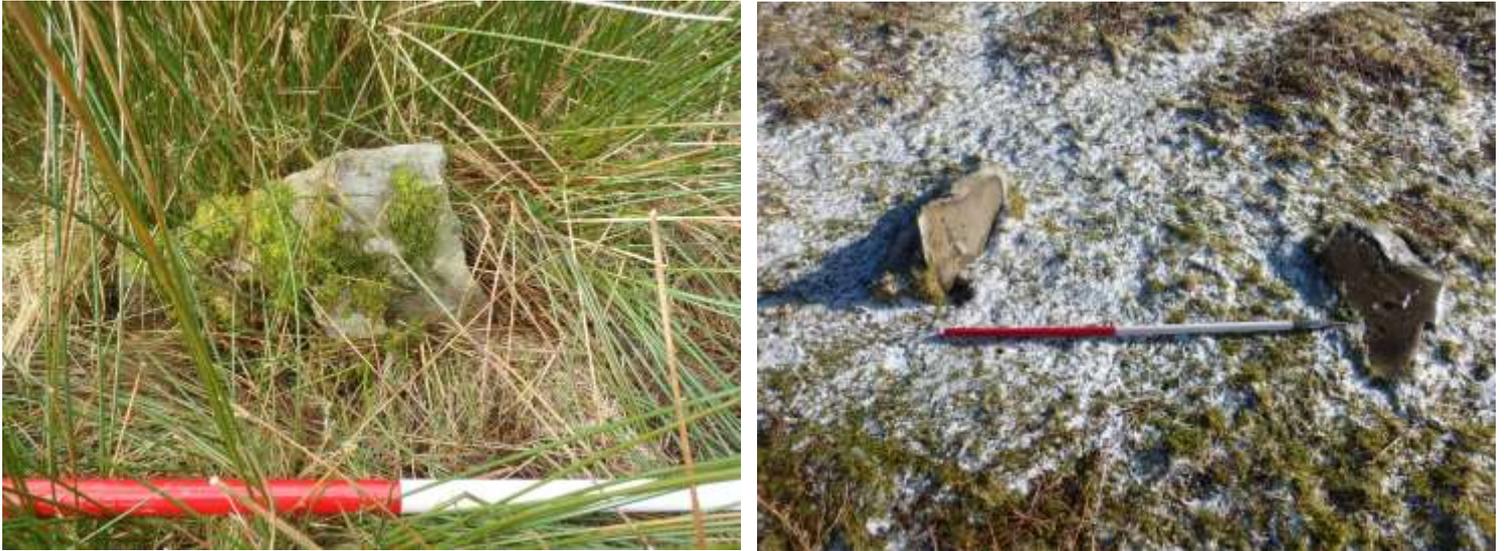
Fig 28: Examples of frost damage. **Left:** Minor damage to the top of Stone J on the Chains Valley Setting (MSO6834). **Right:** A severely split Stone J from the Pig Hill Stone Setting (MDE9885), however, it should be noted that this could have been caused by vehicle damage.

During the survey it was noticed that frost damage had affected 2 sites “severely”, the Almsworthy Stone Setting (MSO6727) and the Pig Hill Stone Setting (MDE9885). Lesser damage was also noticed at Furzehill 5 (MDE1305), the Setting Southwest of Longstone Barrow (MDE1317), and the Orchard Bottom Stone Setting (MDE11261).

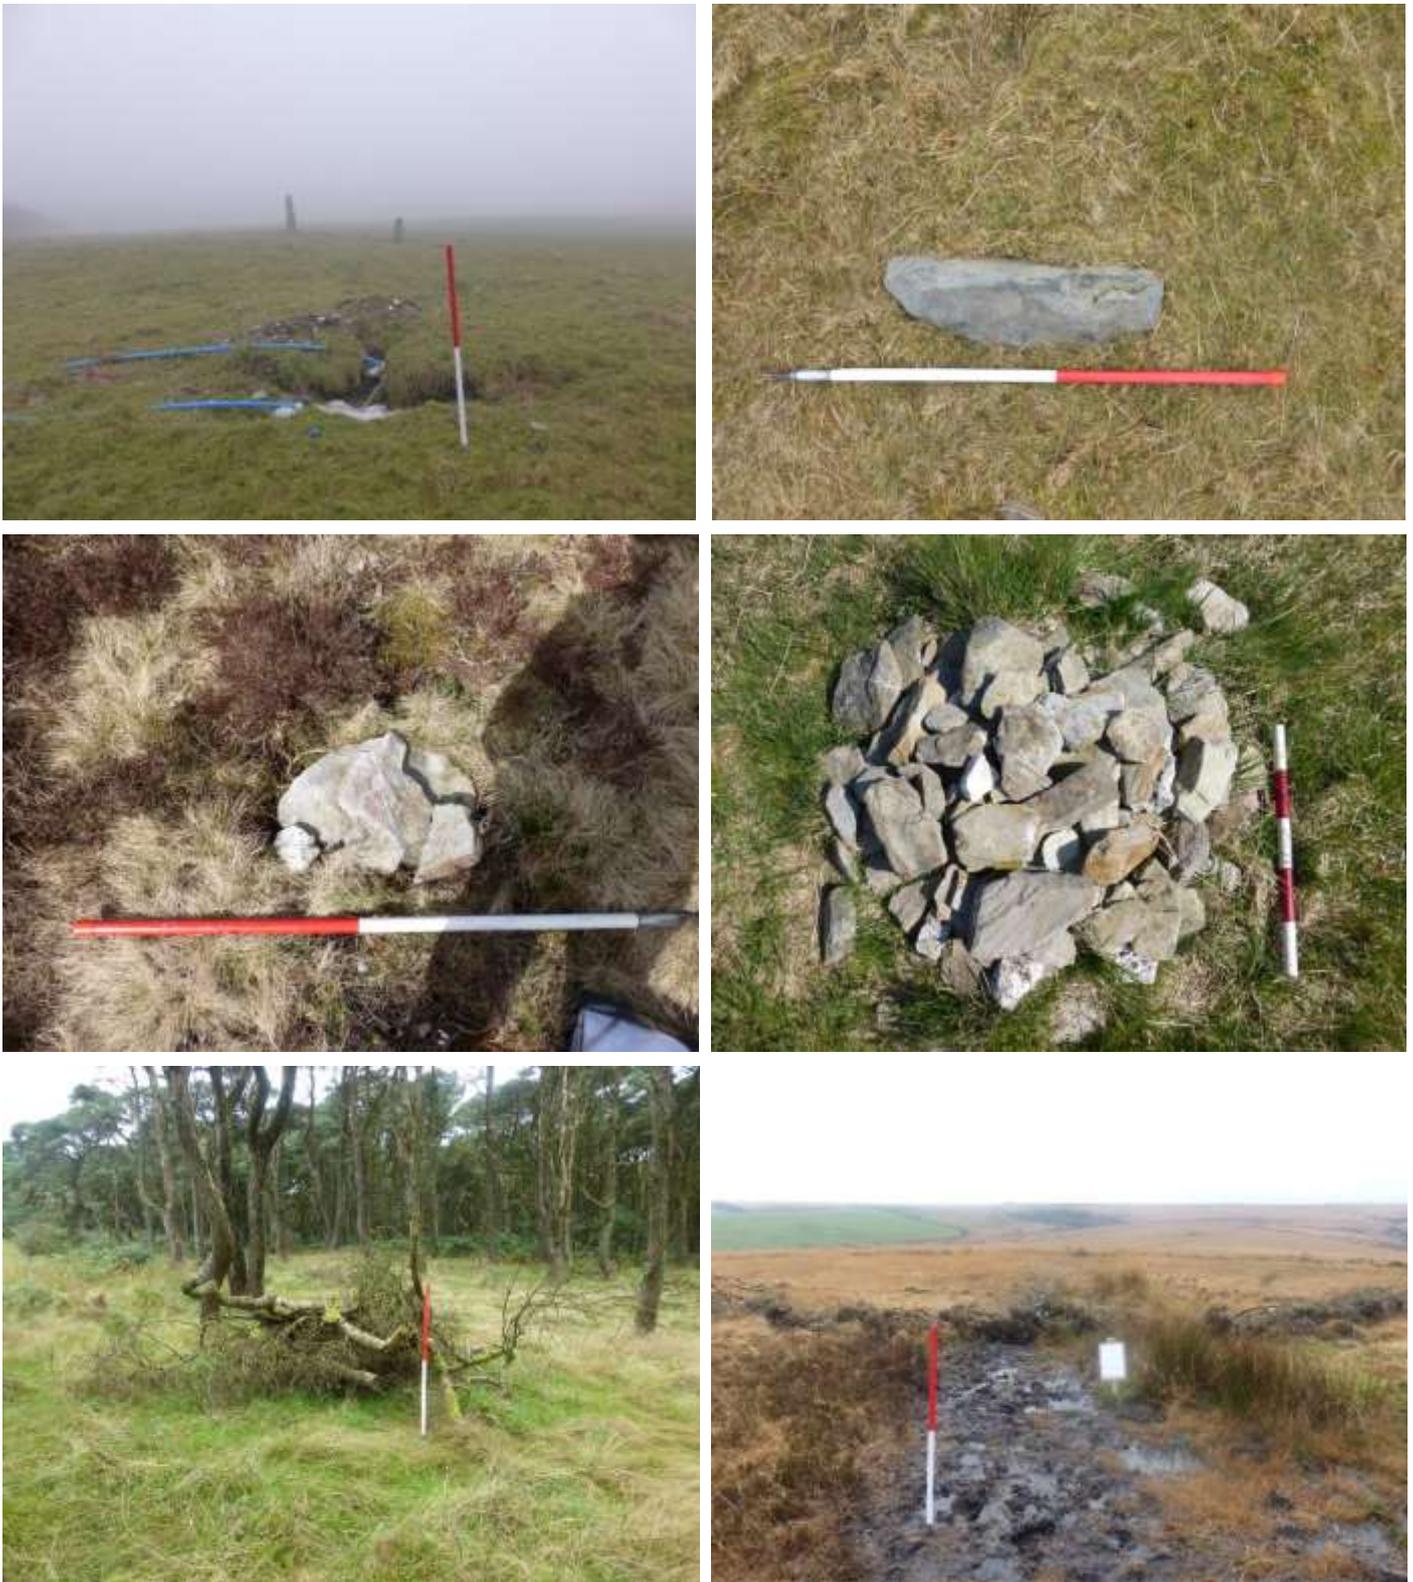
Fig. 34: Various examples of human impact at sites. **Top Left:** A water pipe excavation close to the Lyn Long Stones (MDEI250). **Top Right:** Stone I from the setting near Hoarook Cottage (MDEI304), which has been moved from its last recorded location. **Middle:** Cairns of a recent origin in the centre of the Porlock Stone Circle (MSO7898) (**Left**), and the Withypool Stone Circle (MSO8682) (**Right**). **Bottom Left:** Branches piled above the recorded location of Stone 16 on the Culbone Stone Row (MSO7893). **Bottom Right:** The desire line through the Withypool Stone Circle (MSO8682).

Of the 11 sites affected, 3 of them have suffered “severe” interference. This includes the Withypool Stone Circle (MSO8682), the possible prehistoric standing stone near Farley Water (MEM7), as well as the water pipe excavations close to the Lyn Long Stones (MDE1250). There are also 4 cases of “moderate” risk visible in the human actions at the Prehistoric Stone Setting Below Cheriton Ridge (MDE1259), the Porlock Hill Stone Setting (MSO7882), Porlock Stone Circle (MSO7898), and the Caratacus Stone (MSO8534), where recreational use of the sites has encouraged some negative effects.

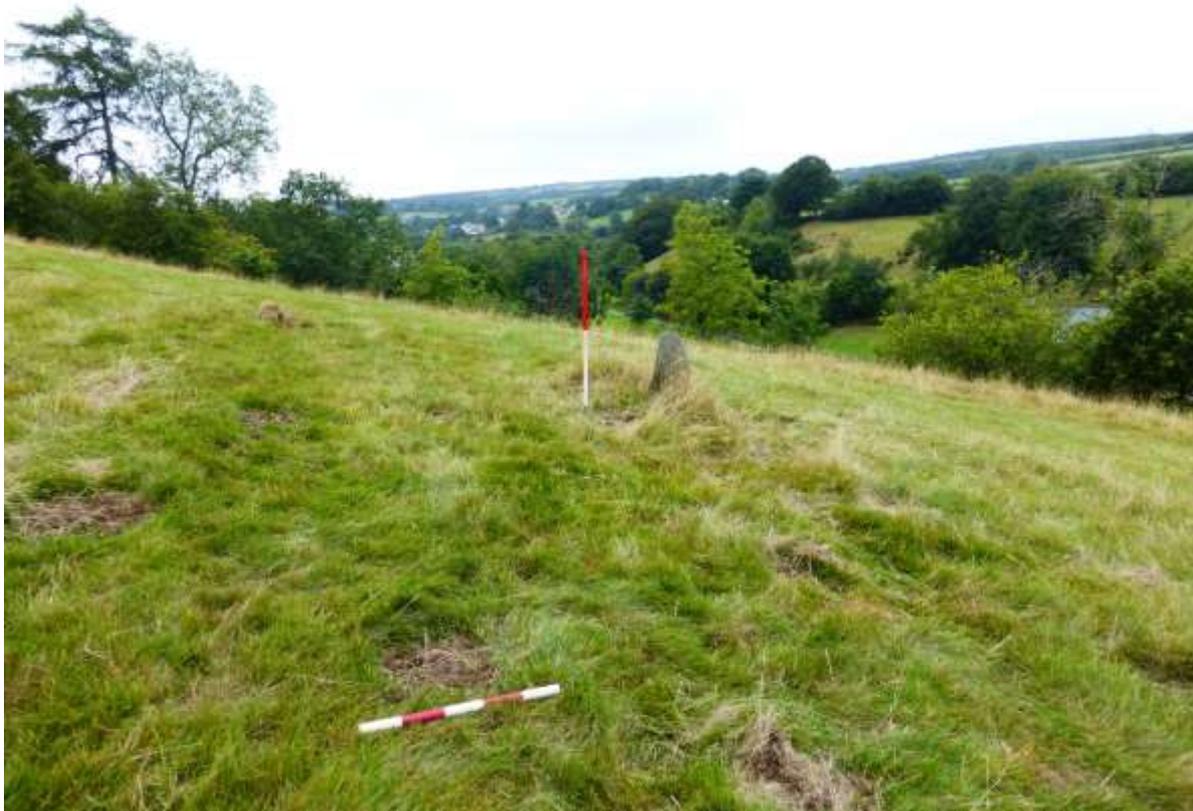
Fig 35: Mole hills around the standing stone at Hantons Farm (MEM21896).

Whilst difficult to prevent, burrowing animals have the potential to be destructive to sub-surface archaeology and earthworks. As little is understood about Exmoor's standing stones this could be particularly disruptive. Amongst Exmoor's standing stones there are only 6 cases of burrowing animals. Three of these cases are considered to be a potential threat, where there has been very limited or inactive burrowing activity, this includes the Long Stone Combe Long Stone (MDE8557), the Horsen Stone Setting (MSO6805), and Squallacombe III (MSO12226). Two cases are considered to be light as burrowing appears active they are present in areas of limited stratigraphic value. This includes the Whiteladder Stone Row (MSO6810) where mole hills are away from the rows alignment, and the Lyn Long Stones (MDE1250) where the stones were reset away from their original location in 1905 (Chanter, Worth, 1906: 536). Finally, a single stone is at moderate risk, the standing stone close to Hantons Farm (MEM21896) (*fig. 35*). This stone has an uncertain prehistoric provenance, however, mole hills are present immediately around the area of the stone.

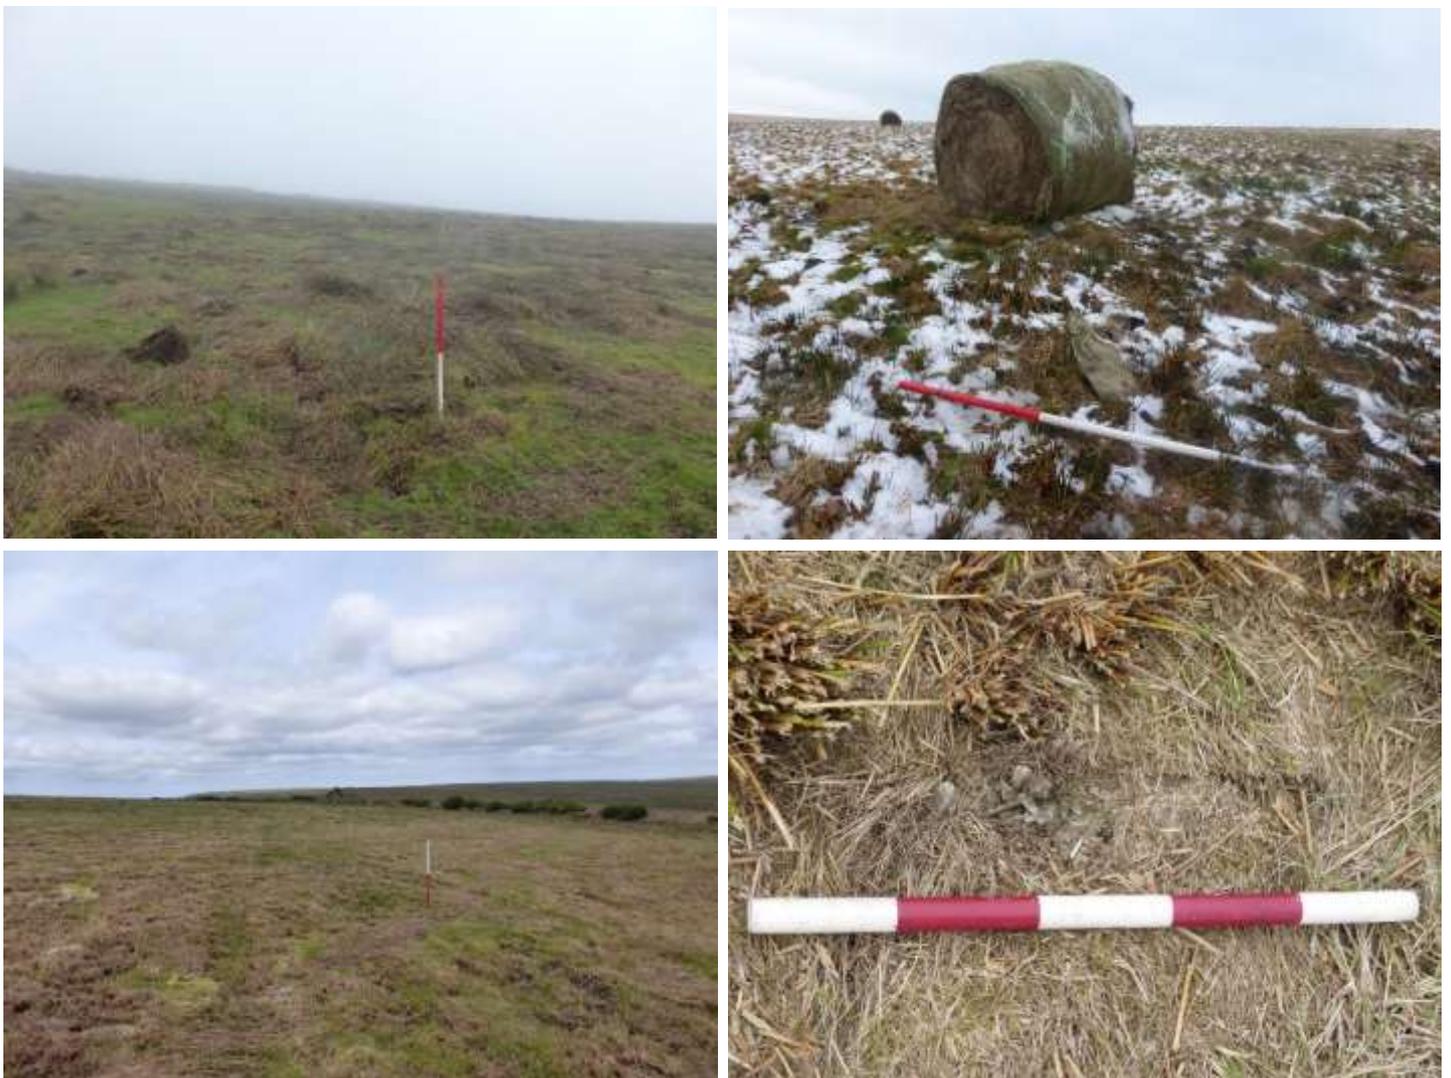
Fig 36: Sites affected by cutting/mowing. **Top Left:** The rushes mown over the Shoulsbury Stone Setting (MEM15179). **Top Right:** Stone A, close to bailing on Lanacombe II (MSO6947). **Bottom:** Cutting over the Whiteladder Stone Row (MSO6810), and one of the damaged stones.

Whilst the standing stones do not occupy land regularly used for cultivation, cutting for animal fodder and bedding does occur on areas of moorland. This can lead to damage from vehicles towing the machinery, and from the machinery itself. Three sites in this survey were put at risk from cutting (fig. 36). The most severe of these was the Whiteladder Stone Row (MSO6810), where mowing was noted across the length of the row and a stone appeared to show signs of a recent collision. Two sites were also noted to be at a moderate risk. The Shoulsbury Stone Setting (MEM15179), similarly was mowed over, and while this had ripped up some turf, the upright stone was avoided and the recumbent stones were not damaged. Similarly, bailing occurred very close to Lanacombe II (MSO6947), and whilst there is a risk of damage to Stone A, no further damage to it was noted since 2015.

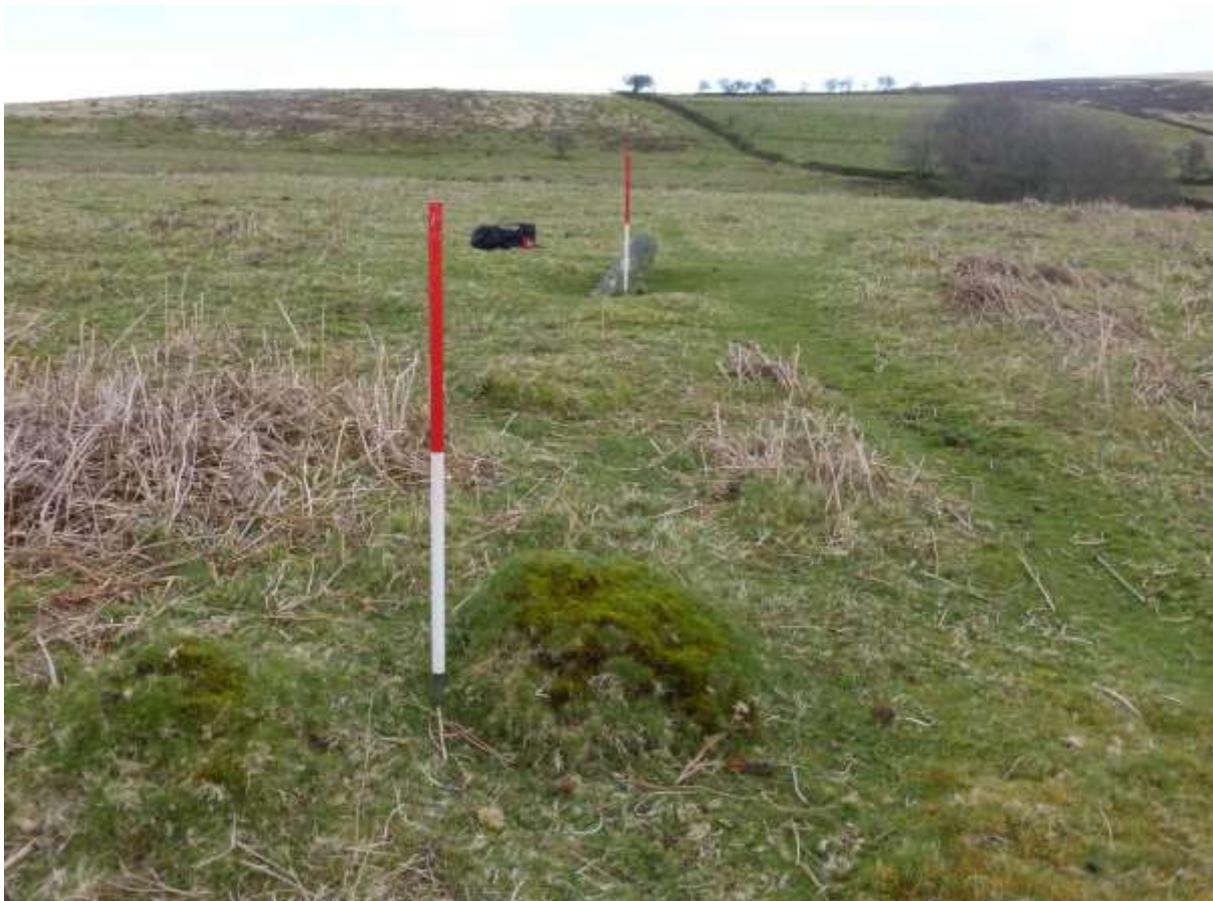
Fig. 37: An ant hill completely concealing Stone J at the Hoccombe Combe stone setting (MDEI256). The stone is present and upright within the mound.

Ant hills are not considered to be damaging to the fabric of the stones themselves, however, they encourage their concealment through the complete or partial burial of the stone (*fig. 37*). If this is not noted by surveys it could lead to sites being misinterpreted or lost. Ant hills have only been recorded on 5 sites. A light risk has been noted at the Hoccombe Combe Stone Setting (MDEI256), Badgworthy Lees Stone Setting MDEI267, and Furzehill Common I Stone Setting (MDEI327). Less intrusive ant hills, which pose a potential risk were noted at the setting below Cheriton Ridge (MDEI310), and the Hoccombe Stone Setting (MDE9886).

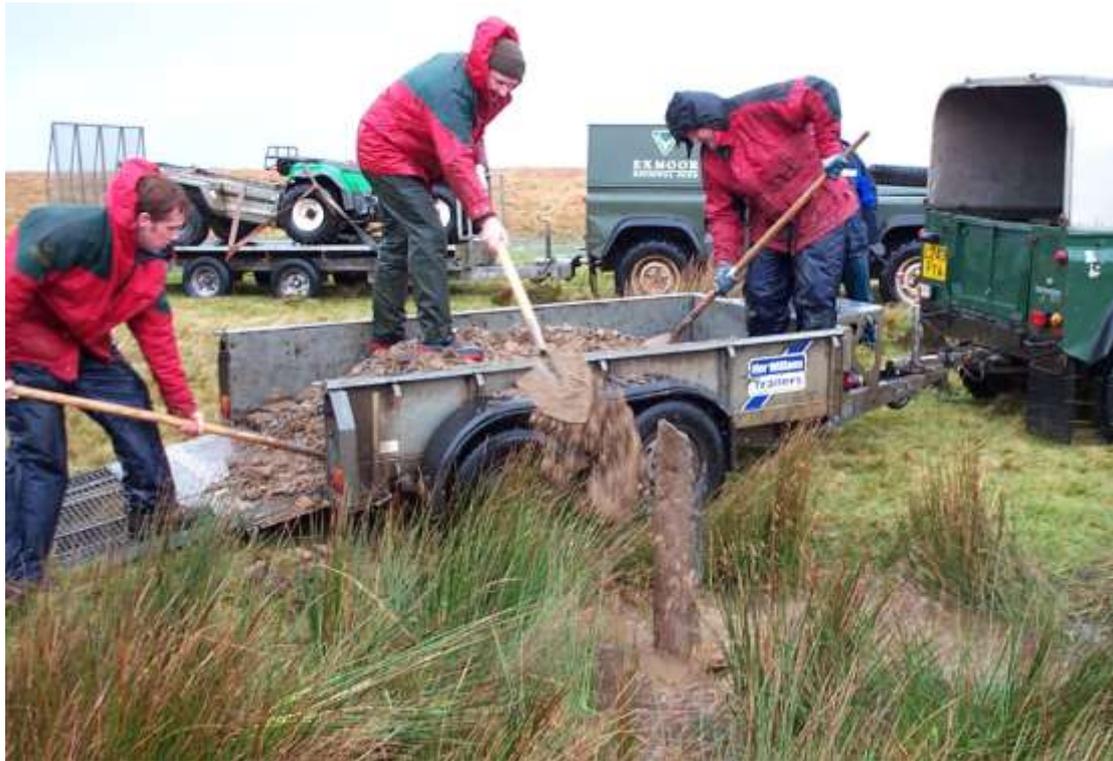
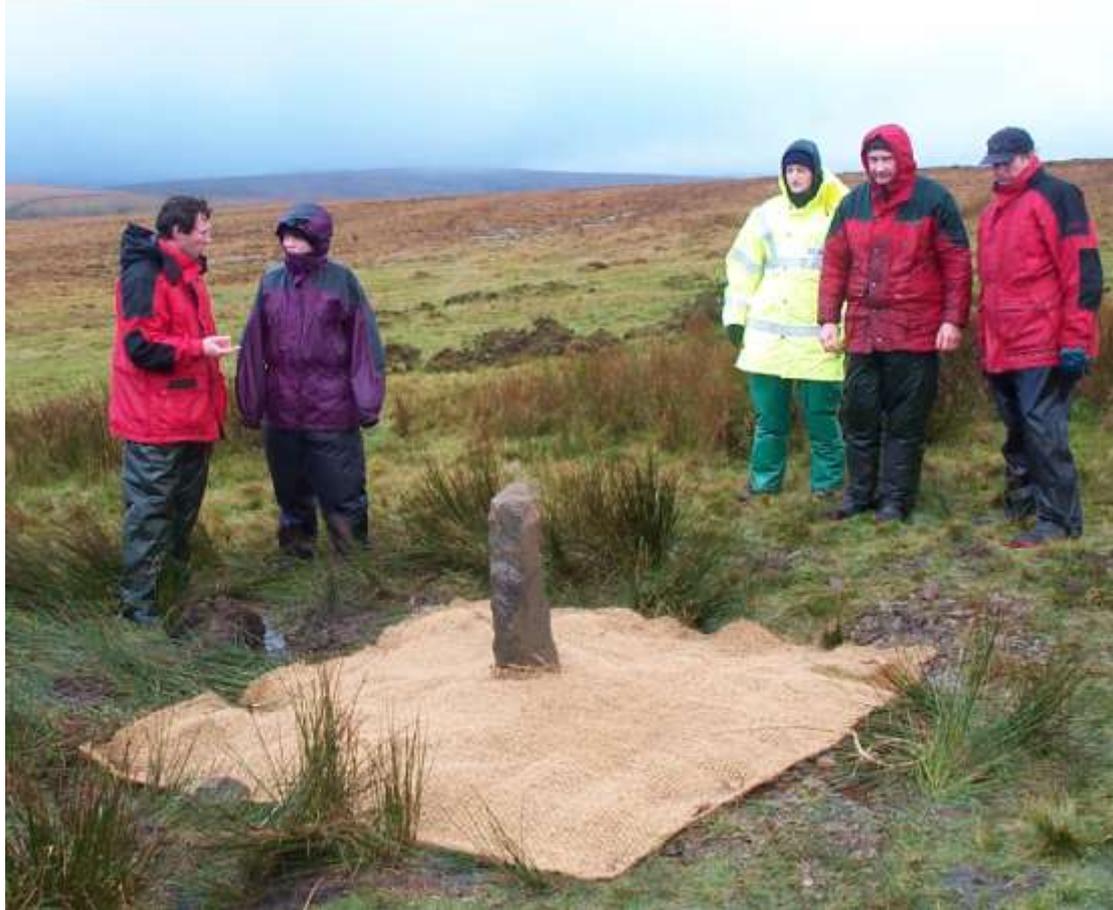
Fig. 38: Resetting and backfilling the erosion hollow around Stone B on the quincunx at Brendon Two Gates (MDE1257). Photographs after Dray, 2003: 18.

Many sites which are not at an immediate risk could still benefit from changes in management or intervention. Presented below are general responses to various threats with lists of sites recommended for specific management. As many areas of Exmoor are covered by a SSSI designation, permission for the work may be required from Natural England before it is undertaken.

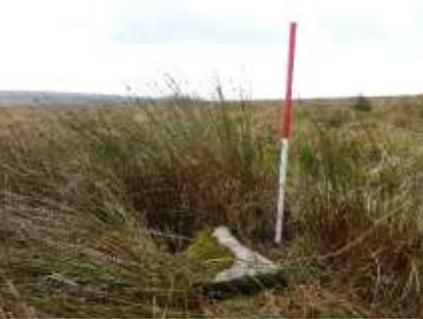
ENPHER No.	NGR.	Name	Land Owner	Area	Photograph
MEM23907	Prehistoric Standing Stone on Long Holcombe	SS 7733 3599	Exmoor National Park Authority	Long Holcombe

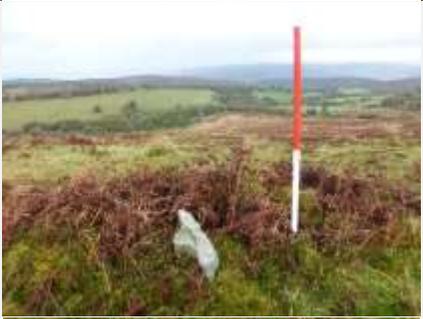
MEM23912	Possible Prehistoric Standing Stone on Goosemoor Common	SS 88100 41930	National Trust	Dunkery and Luccombe

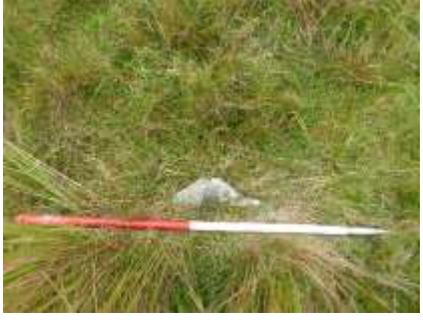
MEM24523	Possible Prehistoric Standing Stone on Lanacombe	SS 77082 42858	Exmoor National Park Authority	Lanacombe

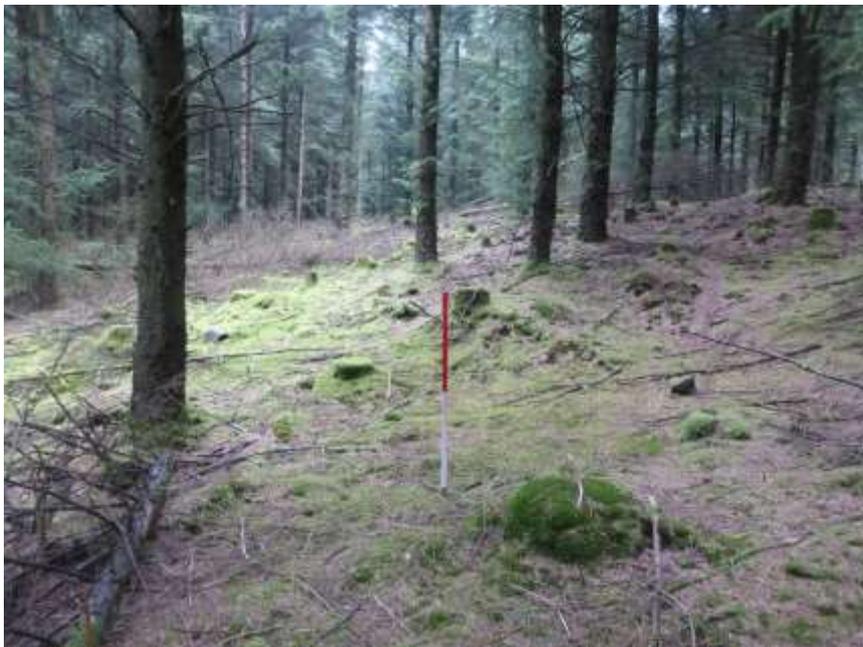
No stones could be located in this area of forestry plantation with mature trees. Ground cover is thick, and it is likely that anything in the subsurface has been disturbed. It is possible that this record is confused with the prehistoric cairns on Withycombe Common (MMO195) or Rodhuish Common (MSO7442).

MSO12023 – Supposed location of the site looking northwest.
