EXMOOR STANDING STONE CONDITION SURVEY 2017-2018

Exmoor National Park
Historic Environment Report Series
Author: Jack Fuller - ENPA Historic Environment Intern
December 2018

This report presents the current condition results of standing stones and stone settings within Exmoor National Park, for their consideration for conservation and land management. The survey was undertaken by the ENPA Historic Environment Intern (the author) and supported by ENPA and Historic England by means of funding from the Capacity Building Grant. Fieldwork took place between October 2017 and May 2018.

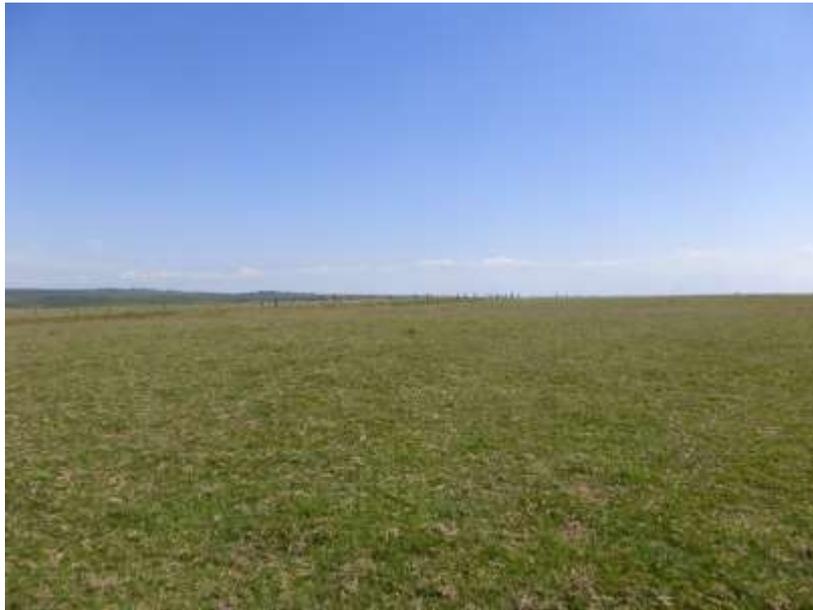
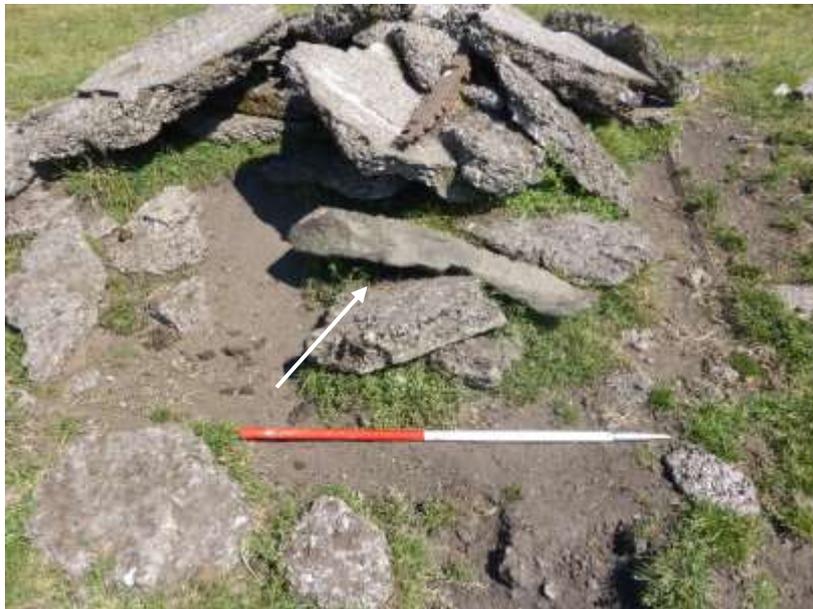
No extant stones were visible in this area of heavily grazed pasture. The site also likely represented an area of boundary stones, and not a prehistoric Standing Stone or Stone Setting. A smoothed stone, which may have once represented an upright stone, was visible in a modern clearance cairn in the centre of the allotment.

MSO7772 – The low grass of Stowey Allotment, and the smoothed stone in the clearance cairn.

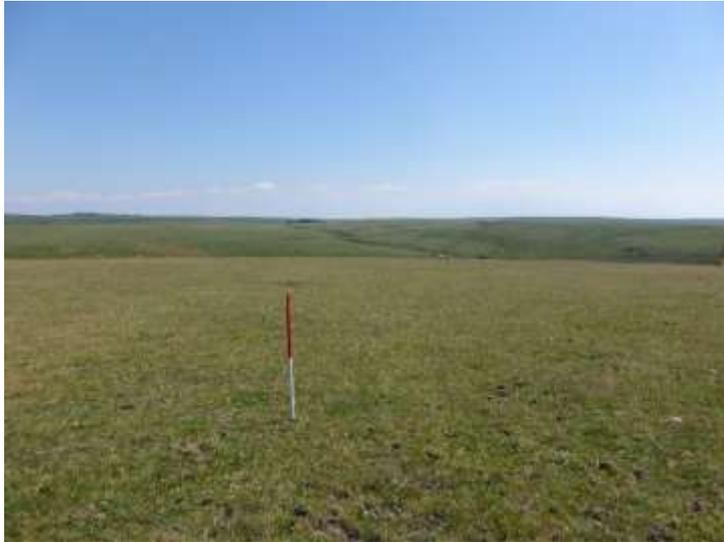
No extant stones were visible in this area of heavily grazed pasture. The site was also likely a boundary stone related to the nearby stones (MSO7772), and not a prehistoric Standing Stone.

MSO7774 – The low grass of Stowey Allotment.

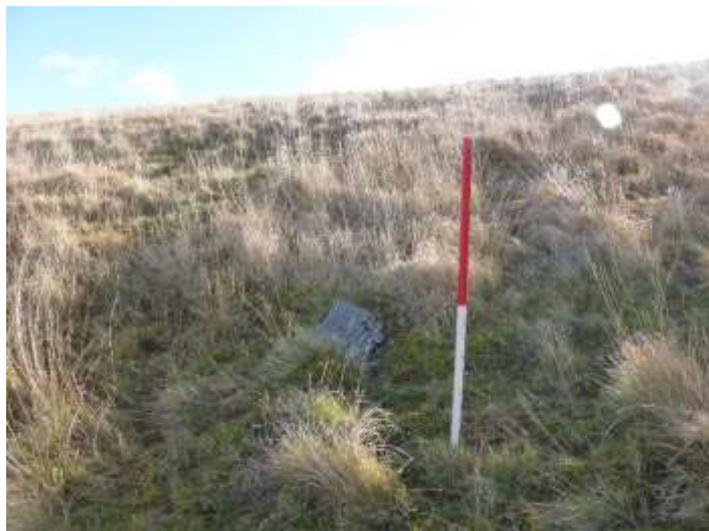
Several recumbent stones were present on a steep slope. It could be a natural spread of stones or damaged cist/cairn. It seems unlikely to be a standing stone. The site is not under any significant threat.

MEM22561 – One of many natural stones on the slopes of Deer Park.

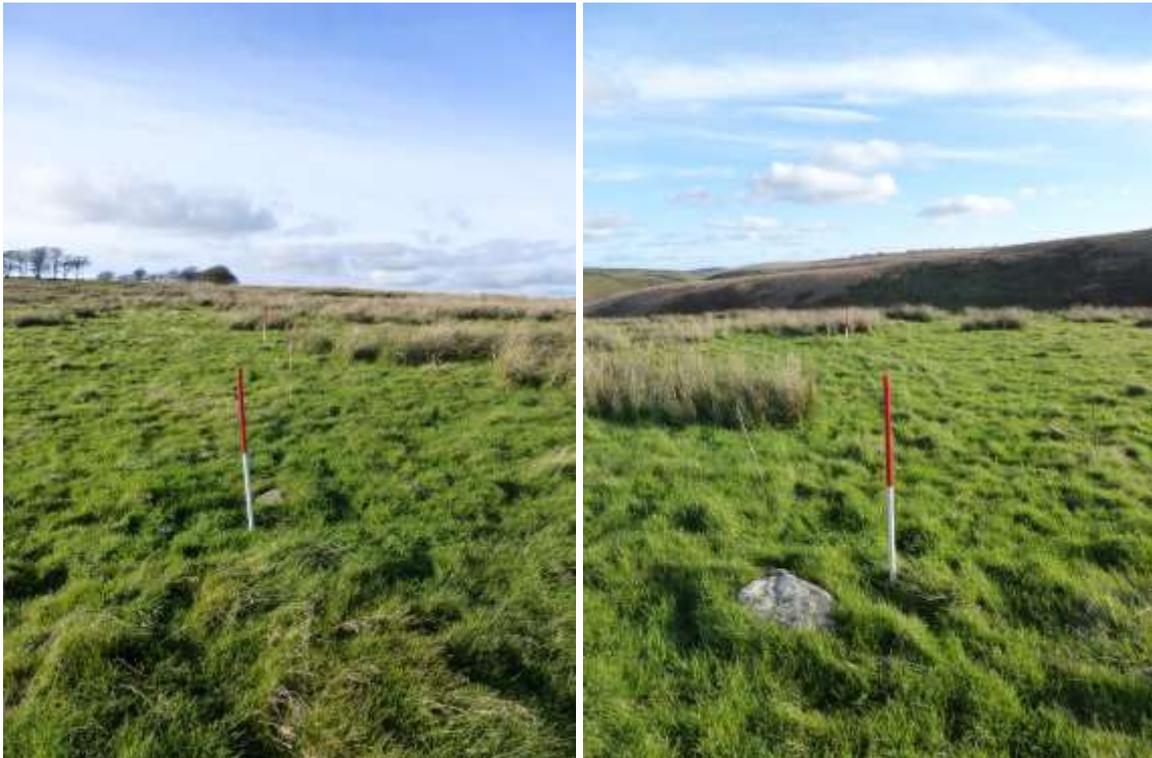
Several surface stones of an unknown provenance were noted in Deer Park, close to a turf bank. A better plan of the stones and area is required, and some indication that these stones were once upright. Several other surface stones are also spread around the area. The site is not clearly under any significant threat.

MEM22562 – Some of the recumbent stones and their linear relationship.

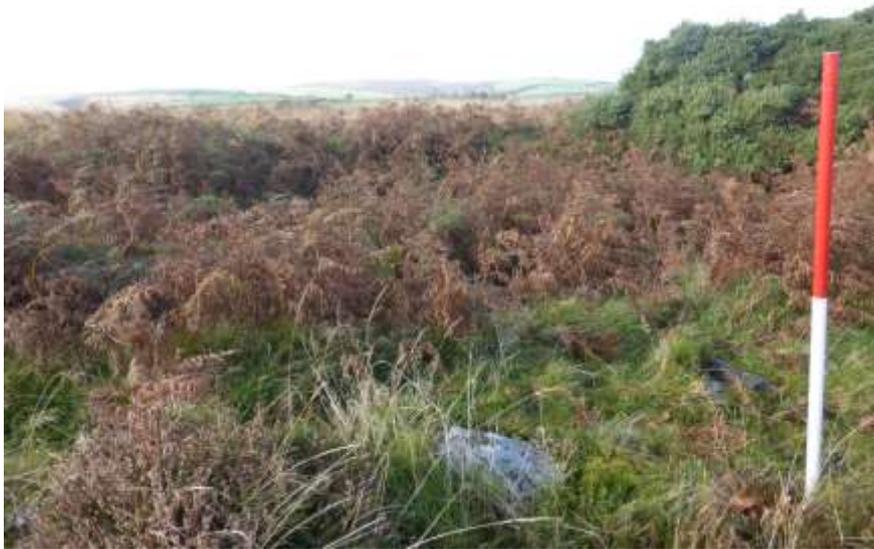
No clear standing stones were witnessed in the area during the survey. Numerous loose stones were noted in the area of the grid reference close to a 19th century enclosure and large depression in the ground.

MSO10475 – Some of the surface stones close to the large depression.

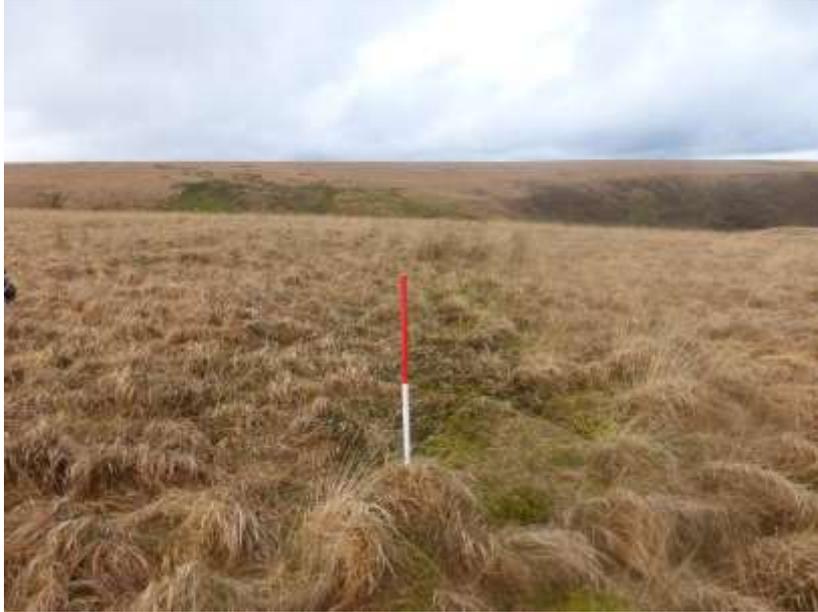
An incorrectly identified stone row. The site instead appears to be more similar to a prehistoric field boundary.

MSO12238 – The prehistoric field boundary running southeast to northwest.

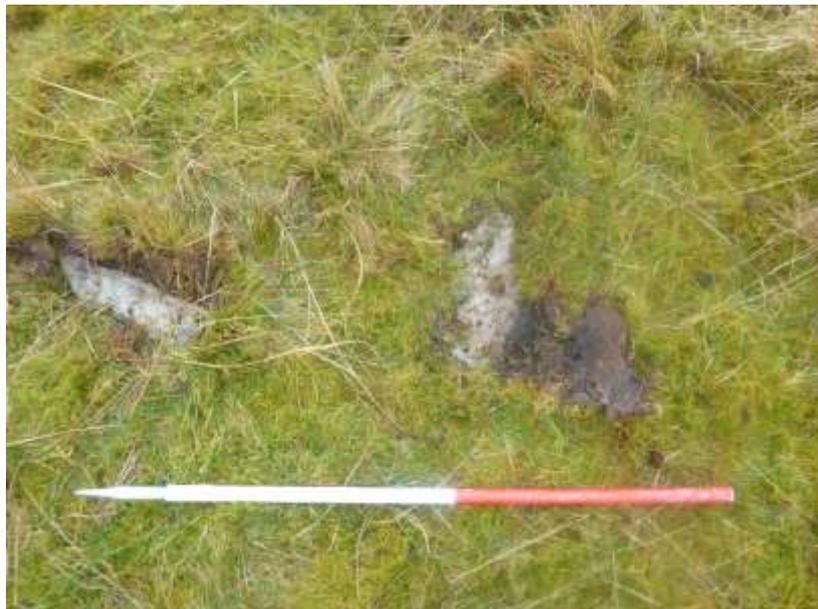
Close to the small standing stone discovered by the Mires project (MEM23768), the recumbency of these stones and their closeness to the drainage ditch, may suggest that they came out with the spoil from the ditch.

MEM23806 – The recumbent stones close to MEM23768.

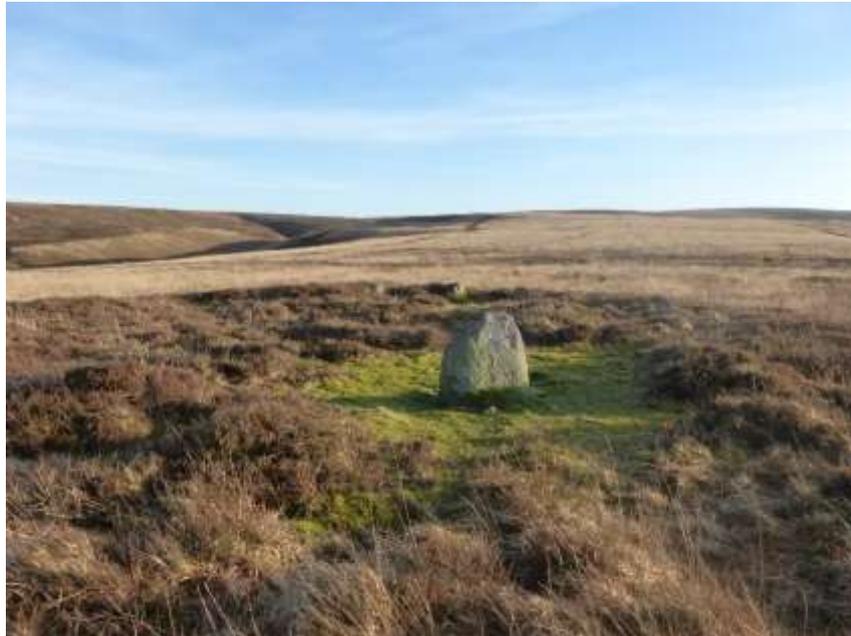
The record appears to be confused with the ring cairn on Cheriton Ridge (MDE12859), as this survey nor the RCHME could locate a stone circle in the reported grid reference.

MDE9883 – The ring cairn on Cheriton Ridge MDE12859

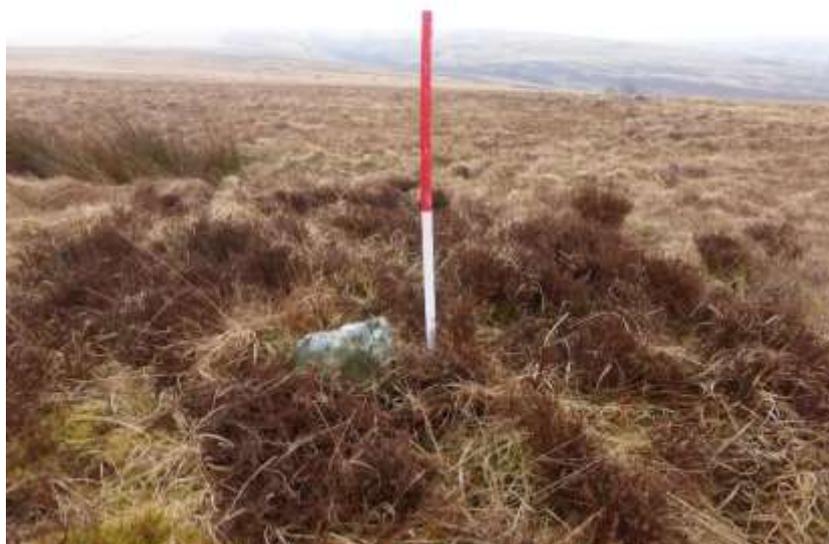
These appear to be post-medieval boundary stones crossing the common. They may have once been standing stones removed from the nearby settings, but there is no definitive proof of this. One of the stones also appeared upright on a turf and stone mound and could represent a cairn later used as a boundary marker.

MDEI306 – One of the stones atop a low mound, possibly a cairn.

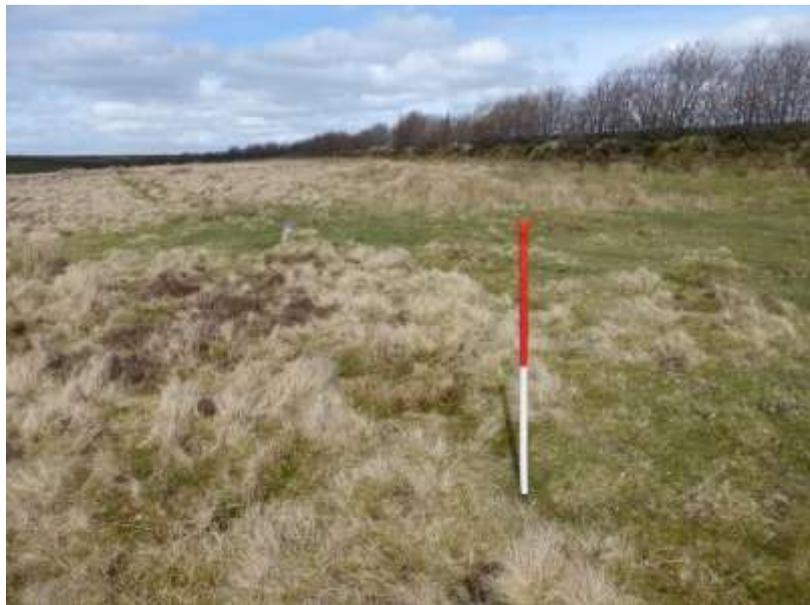
The stones in this area are more-likely to be part of the cairn close to the Porlock Stone Circle, rather than standing stones themselves. One slightly larger stone is present, but it was unclear what monument it was related to, and believed the cairn was more likely. It is worth noting however, that proximity of humans and livestock to this area could put the stones here at some risk.

MSO11544 – The area of the grid reference, the slightly larger stone stands just left of the centre of the image.

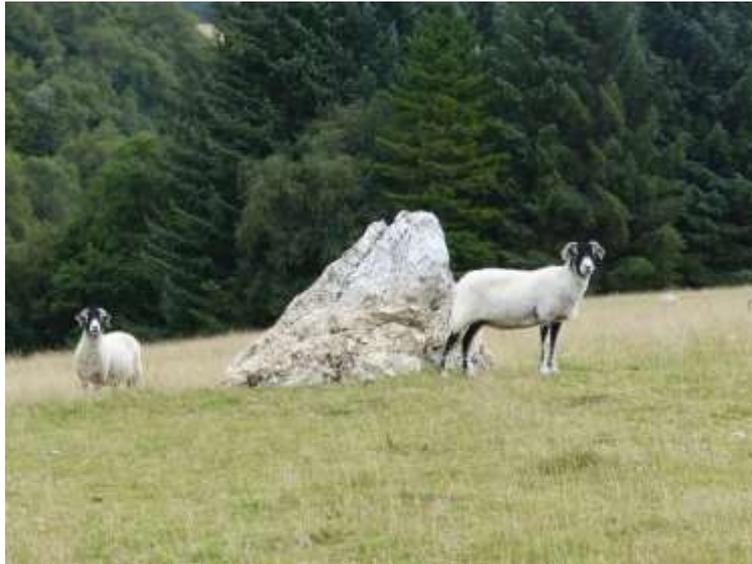
Unlikely to be a prehistoric standing stone. The fabric of the stone is rough, similar to Naked Boy Stone (MSO8857), and has a squat tapering shape. It likely came from the nearby quarry towards the footpath to Luckwell Bridge. The folklore of this stone, where the Devil was said to have thrown it from Dunkery Beacon to this field, does ascribe this monument with historical significance and so the age of the stone remains uncertain.

MSO9261 – The Devil’s Stone.

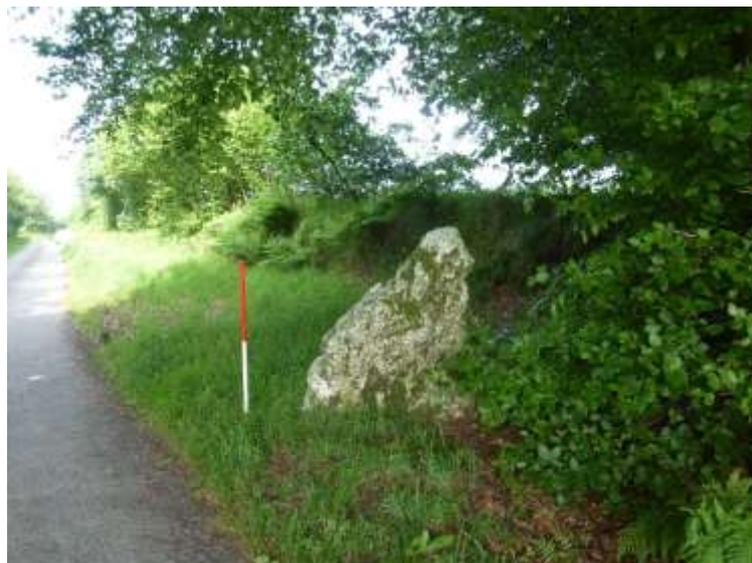
Unlikely to be a prehistoric standing stone. This tapering rough granite stone marks the Old Cleeve and Brompton Parish Boundary, and its provenance is uncertain. Similarly to the Devil’s Stone (MSO9261) its form seems to suggest that it is not a prehistoric monolith. While it was not included in the current survey, its status as a Grade II listed building, has led to its inclusion in the National Park’s Listed Building Condition Survey (Forthcoming).

MSO8857 – Naked Boy Stone.

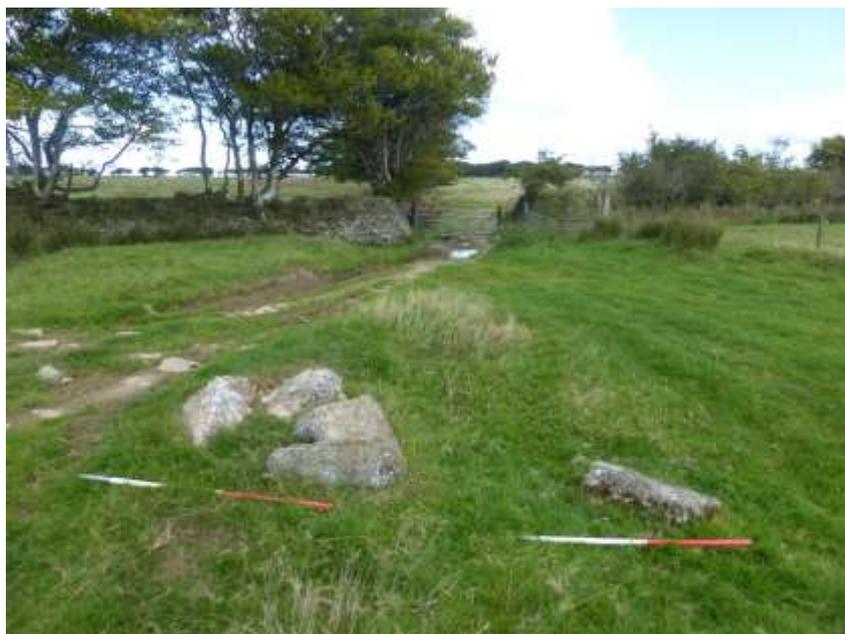
The site may have once been a series of standing stones but it is currently a clearance cairn, possibly placed to mark the parish boundary. However, the form of the stones appear to suggest that this site was unlikely once a stone setting. The improved pasture and trackway suggest little archaeological potential in the immediate vicinity for answering the question concerning the sites provenance.

MDE20562 – Five Stones East of Higher Westland Farm, Challacombe.

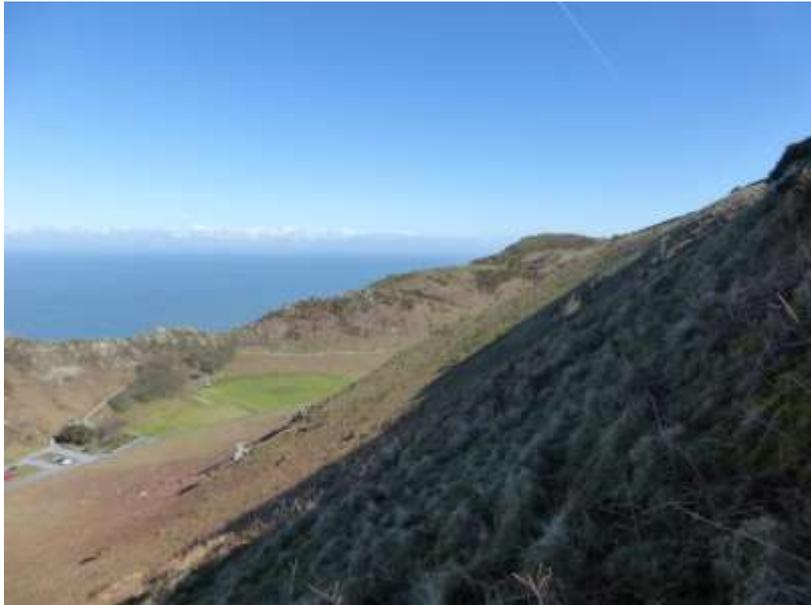
A duplicate record for the highly dubious standing stone in the Valley of Rocks (MDE8972). The other supplied grid references on the slopes revealed no other convincing prehistoric standing stones.

MDE1251 – The location of one of the additional grid references for this record.

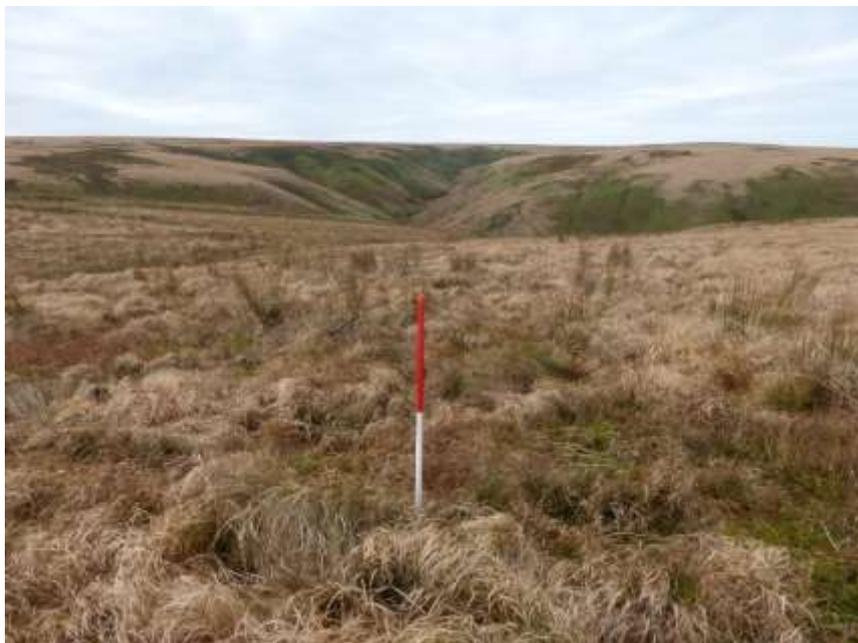
A small triggered stone was noted here during a survey in 1990. No stone was located during the current survey, although there are also suggestions this stone came from a nearby field bank.

MSO12243 – The recorded location of the stone looking up the Chains Valley.

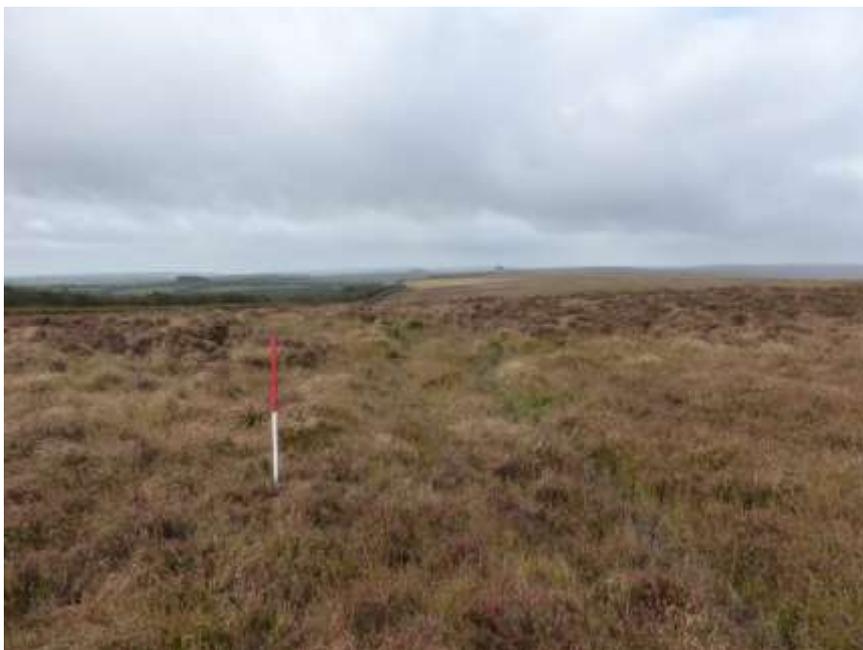
No stone could be located in the vicinity of the grid reference displayed on the HER. It is possible that the stone is one from the Madacombe Stone Row (MSO6883).

MSO6885 – The recorded location of the stone west of Alderman's Barrow.

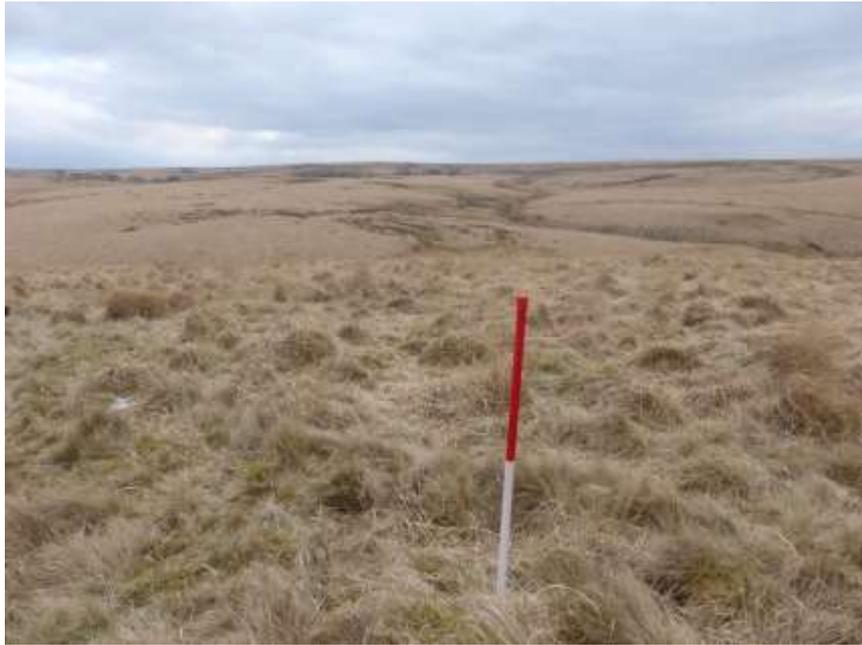
No stone could be located in the vicinity of the grid reference displayed on the HER. It could be lost under thick molinia and turf due to its small size.

MSO12247 – The recorded location of the stone on Trout Hill.

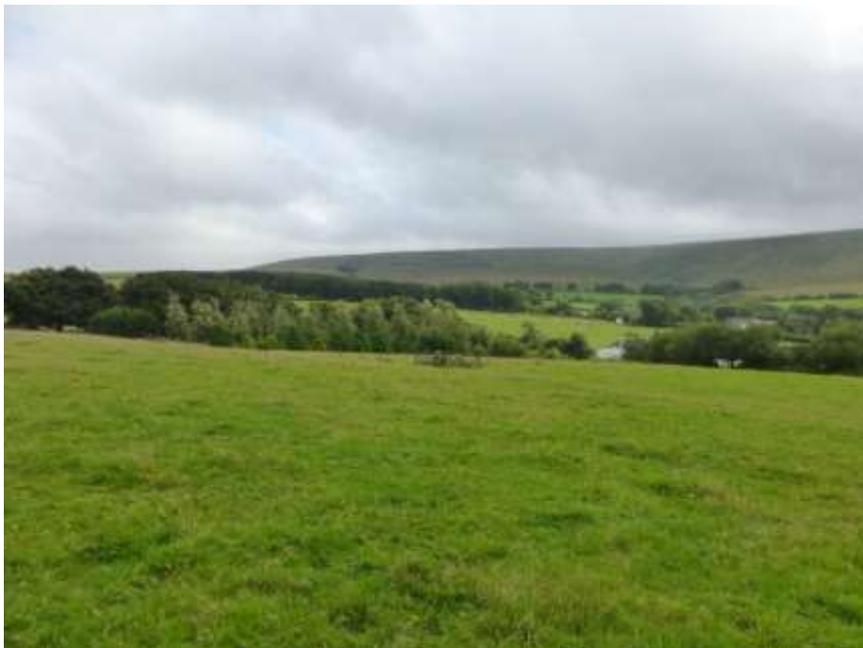
The re-recorded location of the Furzehill Stone Setting destroyed by Antell of Whimb (Chanter, Worth, 1905: 392). There was clearly no trace of a site situated within a field of improved pasture.

MDE21755 – The recorded location of the stone destroyed by Antell of Whimb.

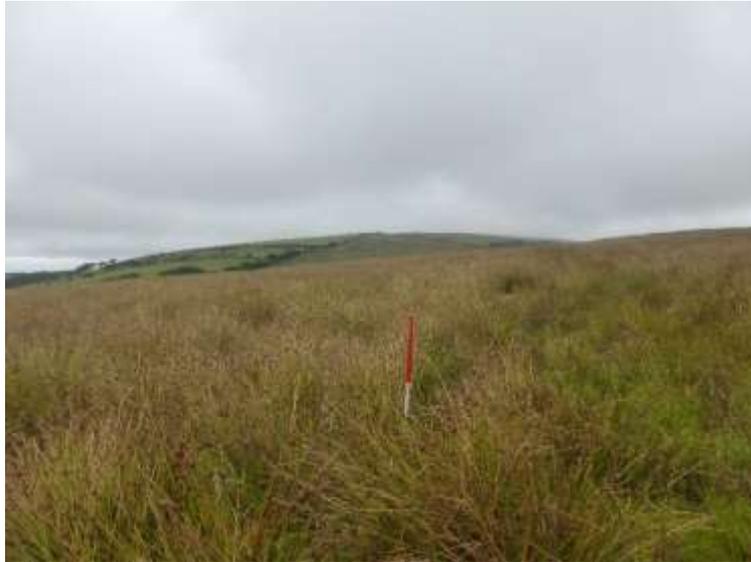
No setting could be found amongst the thick vegetation at the recorded location by the current survey and other recent surveys.

MDE1050 – The recorded location of the stone setting.

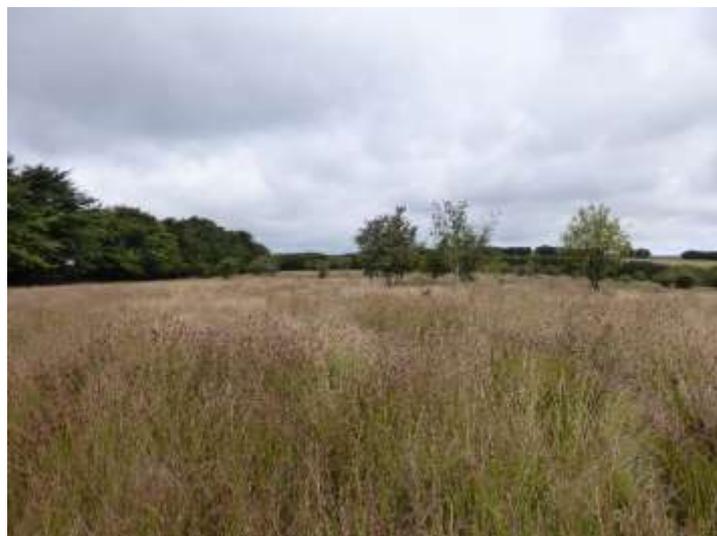
The site is likely destroyed or lost, no stones were found at the recorded grid reference which placed the site within an area where high levels of gorse had been removed (roots were still present).

MSO11968 – The recorded location of the stone setting.

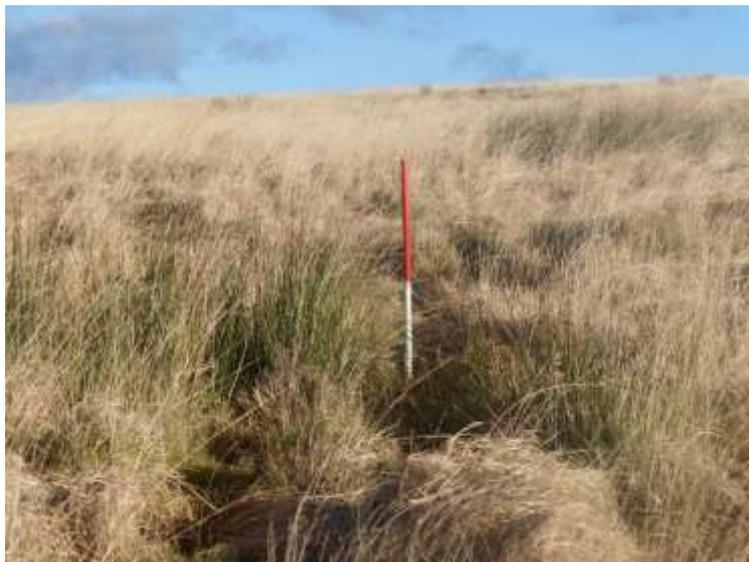
This site is recorded as a standing stone 0.3m tall with a noticeable split and it was once included as part of the Scheduled Swap Hill stone setting (MSO6873). No stone has been documented at this grid reference since 1981. The last three Scheduled Monument Condition Assessments had also failed to locate the site (Gent, Manning, 2015; Bray, 2009; Squires, 2005). The monument's location is covered in tussocks, rushes, and molinia, which could easily conceal a small stone. However, it may have also been one of the stones closer to MSO6873, with an incorrect grid reference. It is the opinion of the surveyor that it is unlikely upright in this location, and has either fallen or been incorrectly recorded.

MSO7150 – The recorded location of the standing stone.

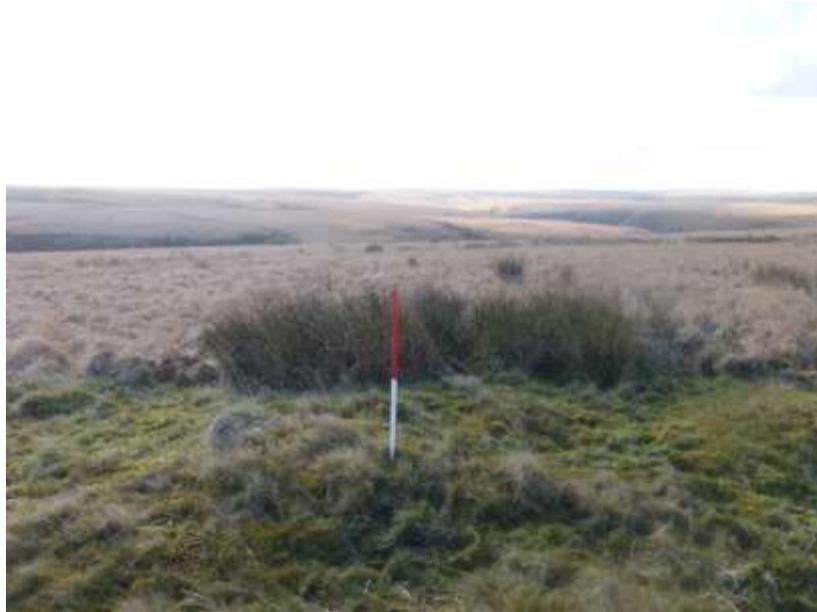
No stone was visible at the grid reference recorded on the HER. However, it has most likely been obscured by the thick molinia tussocks in the area.

MSO10119 – The recorded location of the stone at the centre of the barrow.

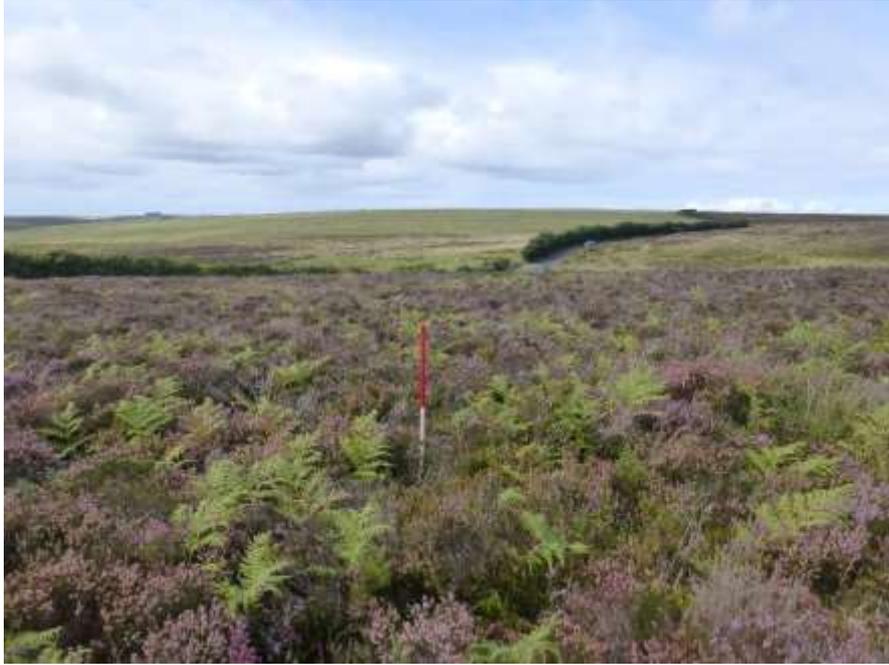
No stones were visible at the location recorded on the HER, and a thorough search was limited by the thick heather and bracken cover of the site. A historic record of a stone setting is available on the HER, with photographs, but there are fears that the site has been lost since this last record.

MSO7925 – The recorded location of the setting looking towards Porlock Stone Circle.

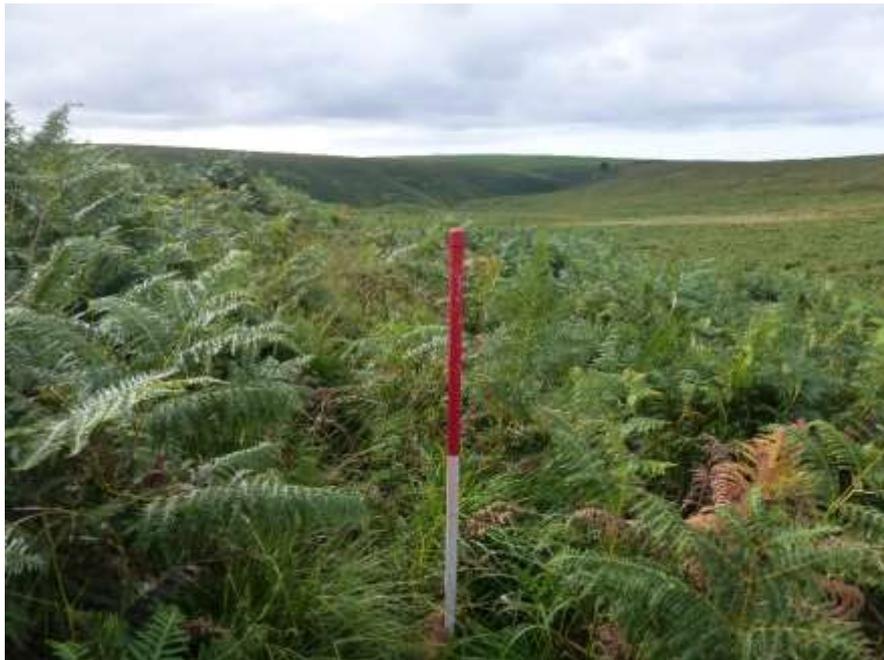
No stone was visible at the recorded location following two separate site visits (October, and August). It is likely obscured by the vegetation or tussocks on this hillslope, as there are no apparent threats to its condition, and it was recorded in the 2009 survey.

MEM9 – The recorded location of the stone looking west.

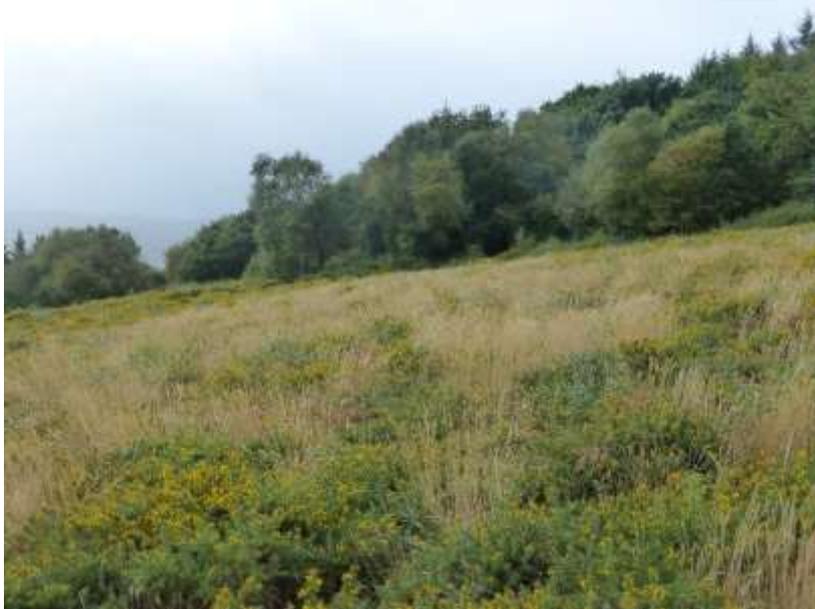
No stone was visible at the grid reference recorded on the HER. The location is within an area of thick gorse and the stone could be concealed underneath. The site was likely a boundary stone, marked on the 1st Edition Ordnance Survey map.

MEM22416 – The recorded location of the standing stone.

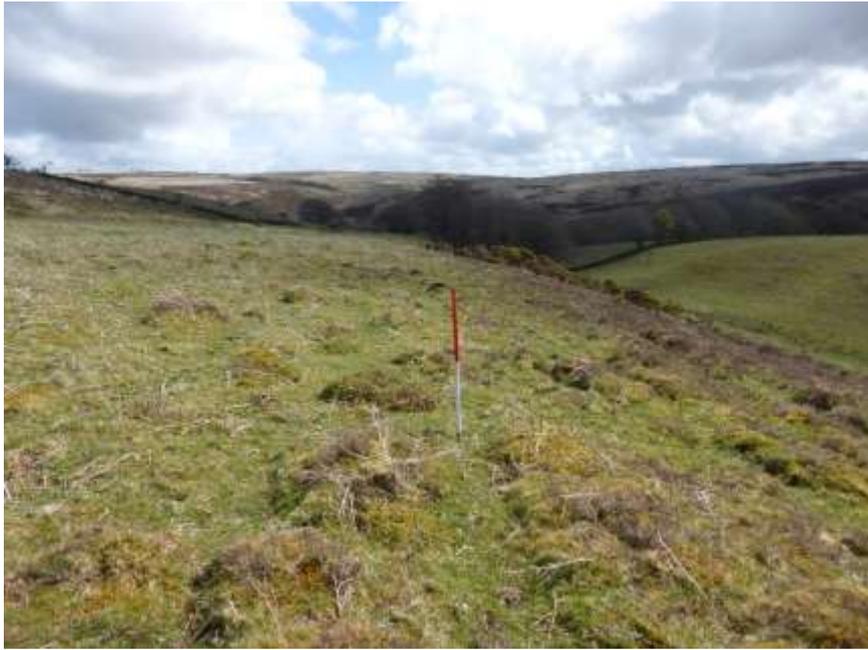
The site was overlooked by the surveyor, due to a limited description and imprecise locational information. However, several stones in that area were noted and photographed, which were likely part of the monument in question. It is unclear if it is truly a stone row as all stones noted were recumbent and close to a damaged cairn. However, the site is under little immediate threat at the present time.

MEM23034 – The recorded location of the site devoid of stones.

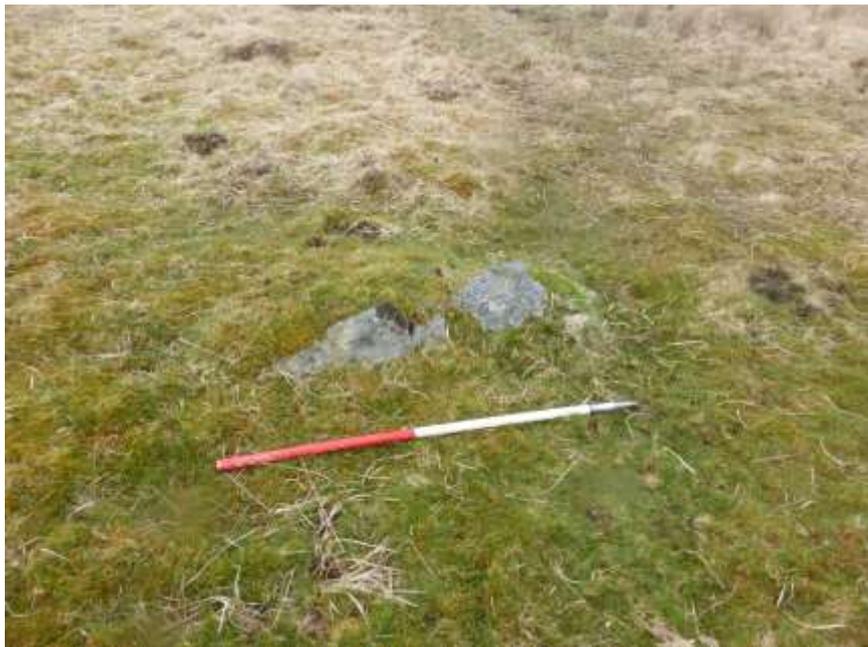
MEM23034 – One of the stones noticed which may form part of the Stone Row.

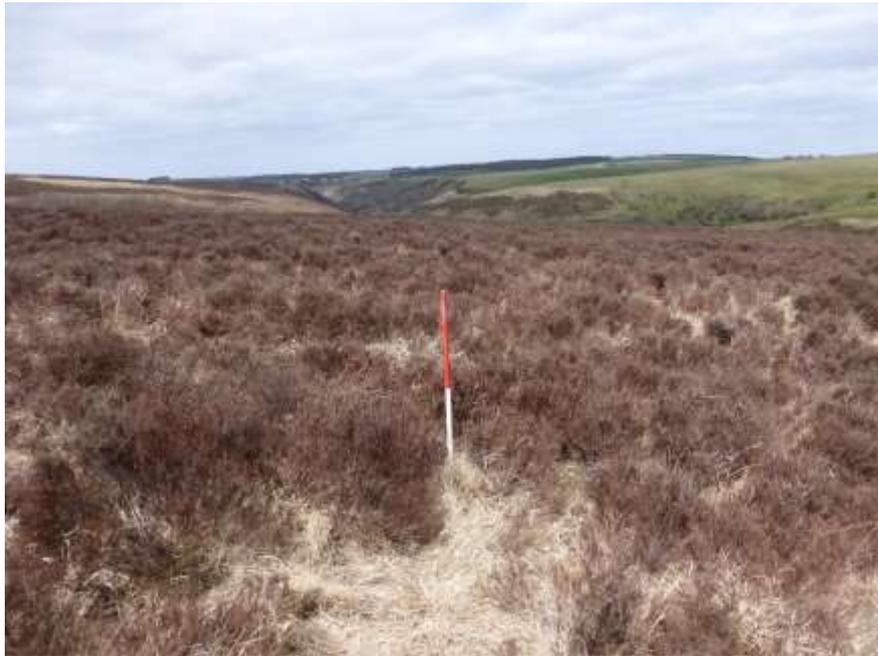
The stone could not be located in an area of thick molinia and heather. However, the size and shape of the stone would suggest it is now recumbent. It is unlikely to have been moved as it was discovered during the recent 2013 Dig Porlock survey.

MEM22436 – The recorded location of the stone looking northeast.

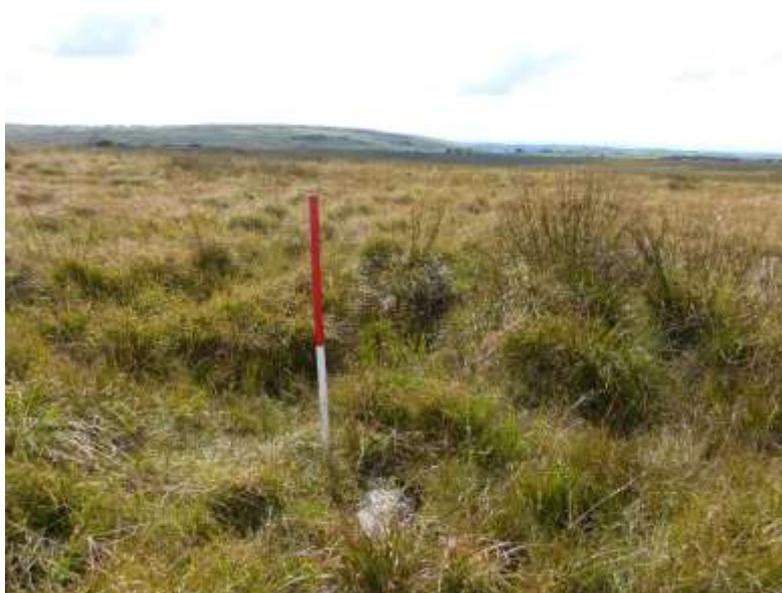
The only stone seen within the area of the record appears to be upcast from the drainage ditches or natural surface scatter. Previous photographs of the site may suggest that the stone is natural.

MSO10461 – A stone on the edge of a waterlogged drainage ditch.

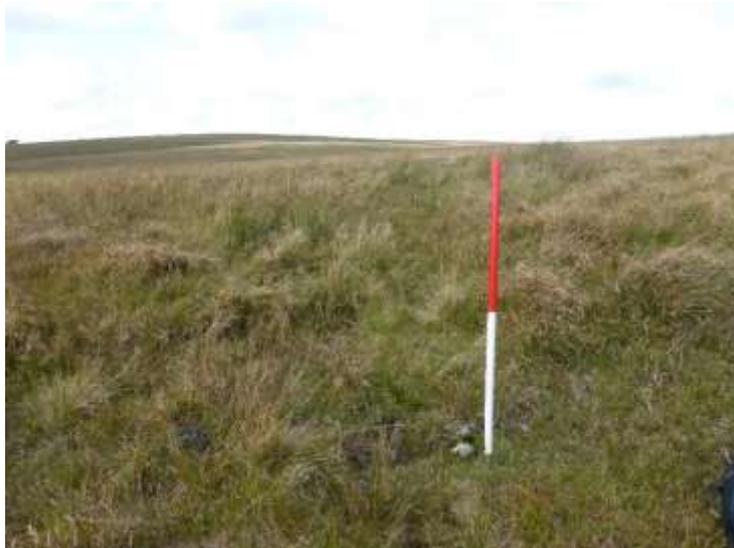
The only stones seen within the area of the record appear to be upcast from the drainage ditches or natural surface scatter. Previous photographs of the site may suggest that the stone is natural.

MSO10462 – Scattered surface stone.

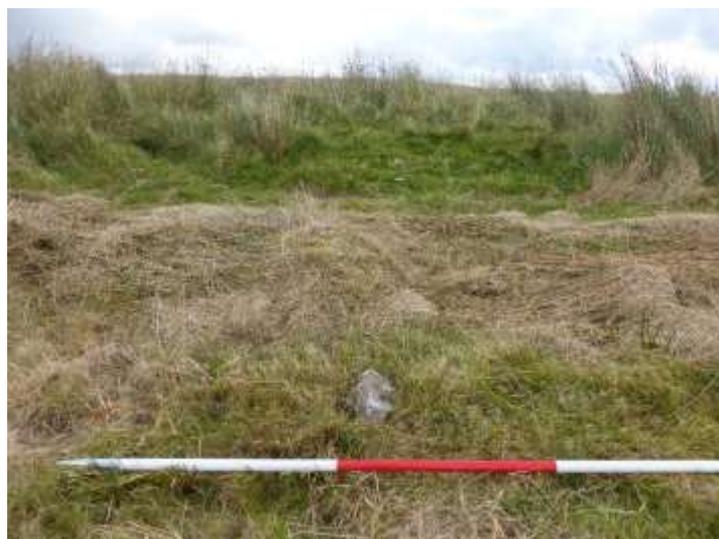
The only stone seen within the area of the record appears to be natural.

MSO10464 – A surface stone close to a field bank.

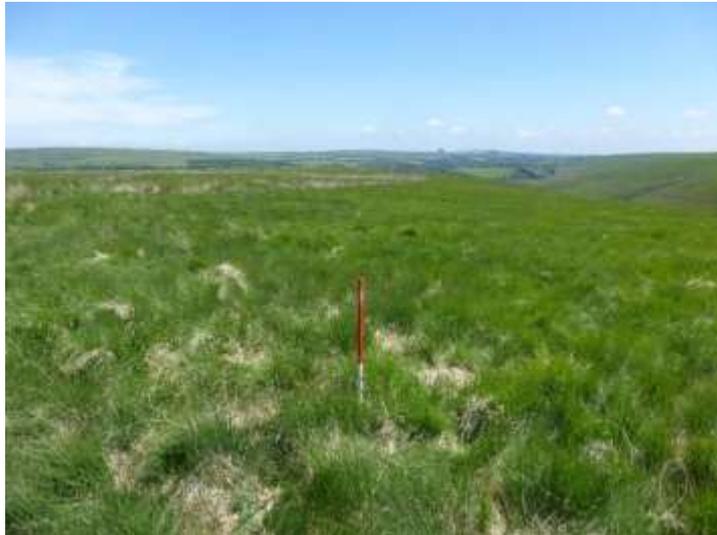
While it may possibly be natural, this stone is also recorded as prehistoric. No stone was located during the survey but site there appears to be little threat to the site.

MSO12229 – The recorded location of the site looking east.

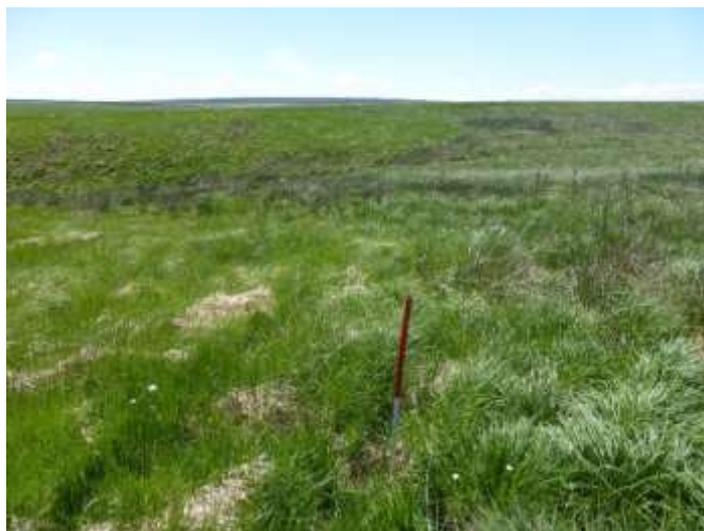
While it may possibly be natural, this site is also recorded as a stone alignment. No stones were located during the survey but there appears to be little threat to the site.

MSO12229 – The recorded location of the site looking west.
