Exmoor National Park  
Historic Environment Report Series No 14

# SELWORTHY CONSERVATION AREA: APPRAISAL DOCUMENT

Adopted March 2017

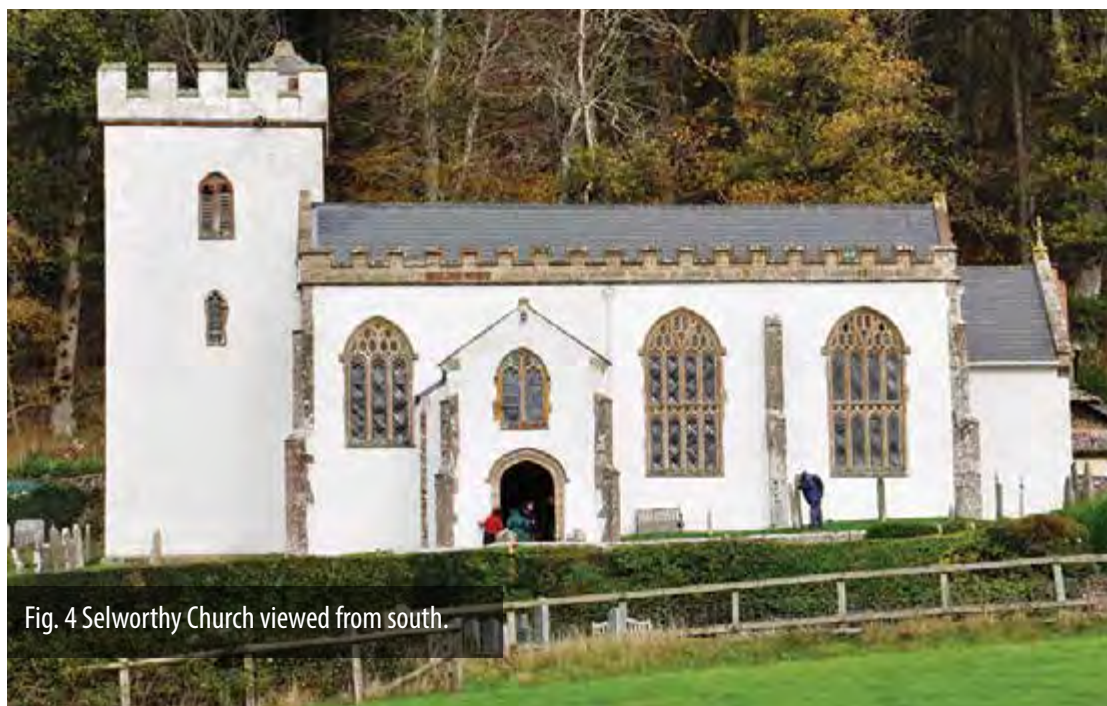
Fig. 4 Selworthy Church viewed from south.

There appears to never have been a manor house at Selworthy. The earliest surviving building is the Parish Church of All Saints (Fig. 4), which thanks to its elevated position and limewash, is the most prominent building in the village. Its earliest recorded fabric dates from the 14th century and, given the early origins of the settlement, it is possible that there was an even earlier church here. In its current guise it mostly dates to the 15th-16th century with the south aisle of 1538 identified by the architectural historian Nikolaus Pevsner as unsurpassed in the county. It is a compact low building of considerable interest in its own right but also has a high landscape value and is visible from the moorland to the south.

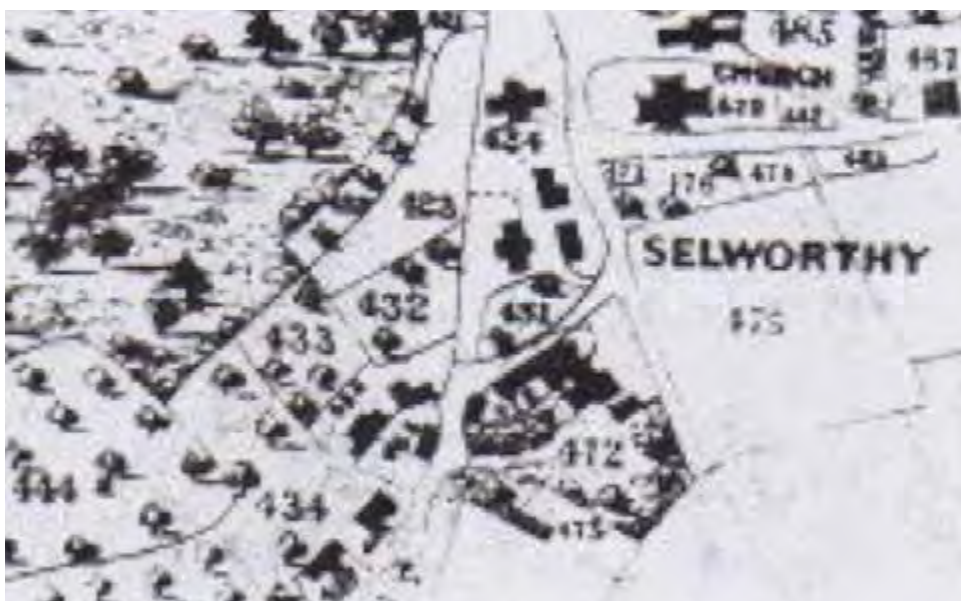
Fig 5 Extract  
from c.1840  
Tithe Map

The Holnicote estate remained with the Acland's until it was gifted to the National Trust in 1944. Later development has been very limited and restricted to the fringes of the village and outside of the historic core. The settlement pattern today is essentially the same as created by Sir Thomas Dyke Acland and depicted on the Tithe Map of c.1841 (Fig. 5).

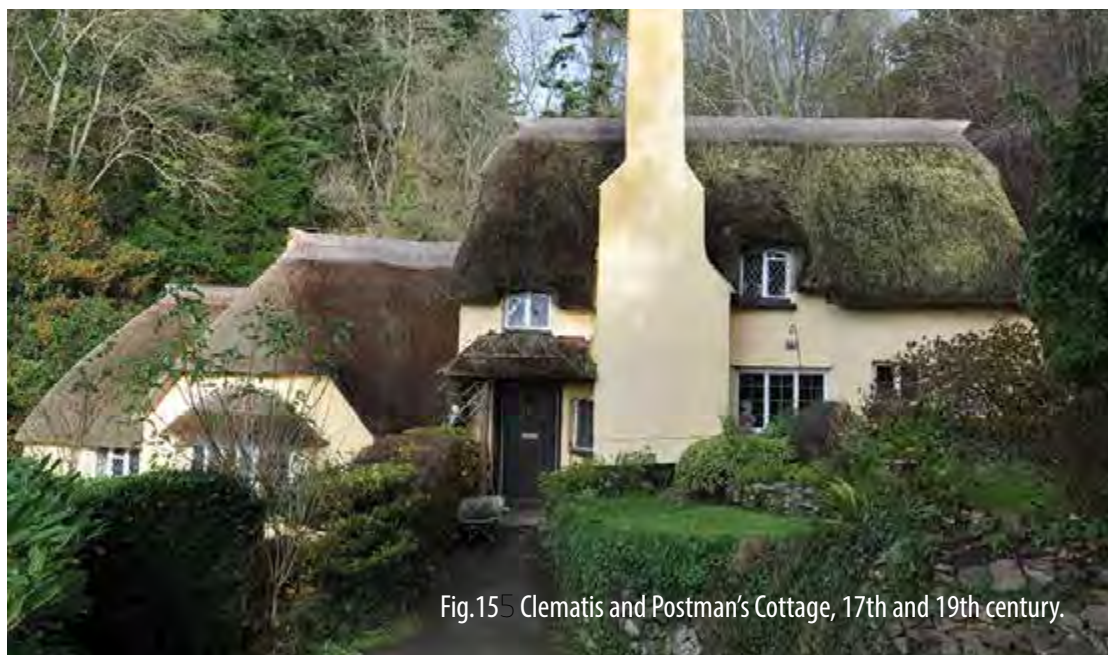
Fig.15 Clematis and Postman's Cottage, 17th and 19th century.

What ostensibly appears to be a homogeneous group therefore conceals a more complex picture. This is encapsulated in the pair of semi-detached cottages shown on the OS Map as **Clematis and Postman's Cottage** (Fig. 15). The upper cottage (Postman's) contains the hall and parlour and part of the cross passage of a late medieval hall house. The service end of the house has been replaced by a single-storey cottage built on a different axis in the early 19th century, which now houses the National Trust Shop/Information Centre.

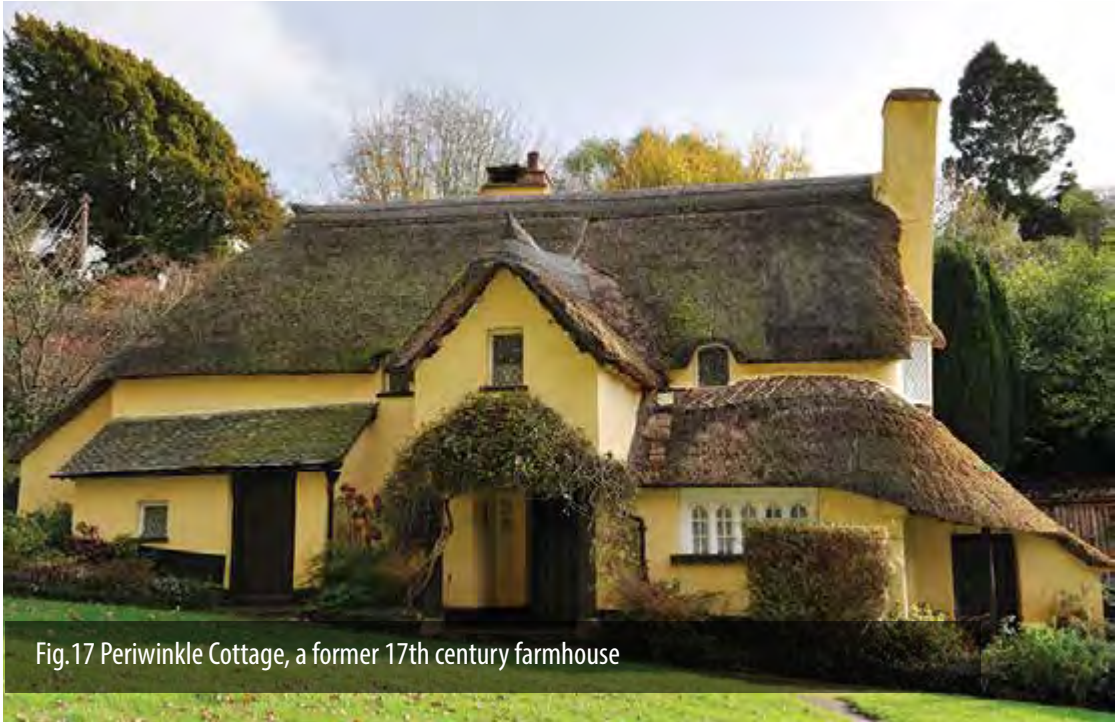
Fig.17 Periwinkle Cottage, a former 17th century farmhouse

Further down the Green, **Periwinkle Cottage Tea Rooms** (Fig. 16) is a 17th century farmhouse, of three bay cross-passage plan. The cross-passage doorway is sheltered by a two-storey picturesque porch was added in the early 19th century. The right outshot has a reset window with trefoil-headed lights, and decorative spandrels.

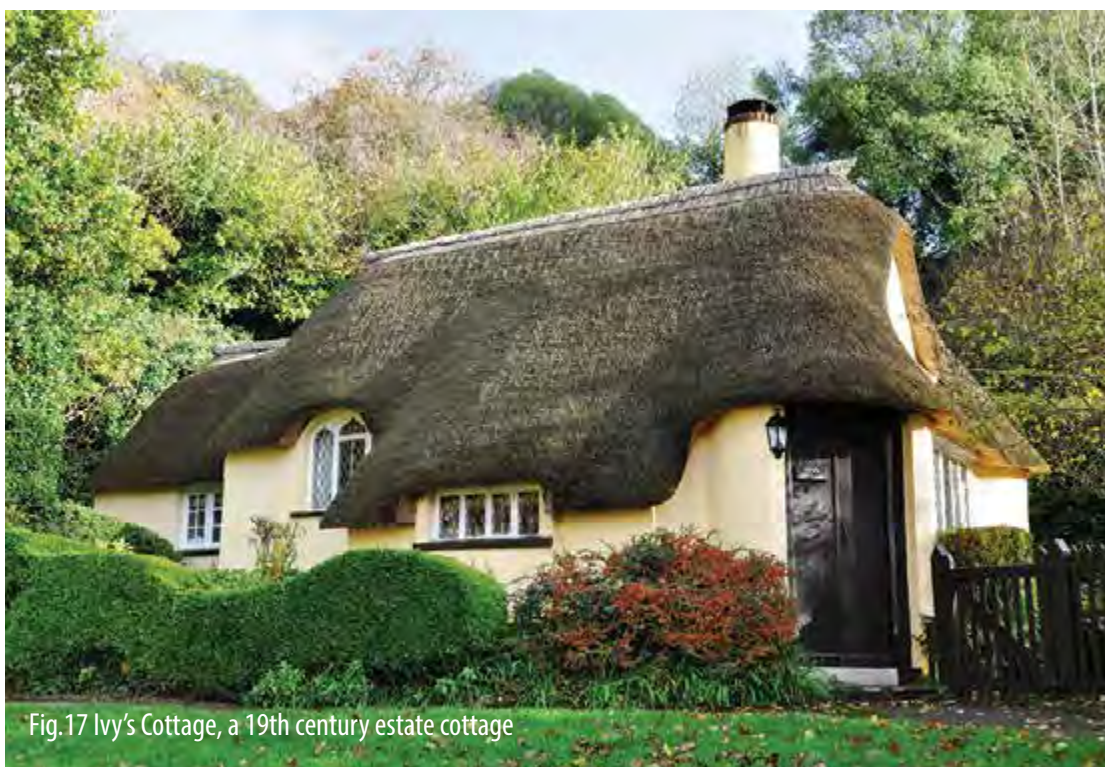
Fig.17 Ivy's Cottage, a 19th century estate cottage

To the south, **Ivy's Cottage** (Fig.17) is pure early 19th century and, along with Clematis, is one of the two additions built when the Green was formed. Like Clematis, Ivy's Cottage is single-storey and of irregular plan. It has an almost circular porch on the south-west corner and the ogee-headed features that typify 19th century Acland detailing.

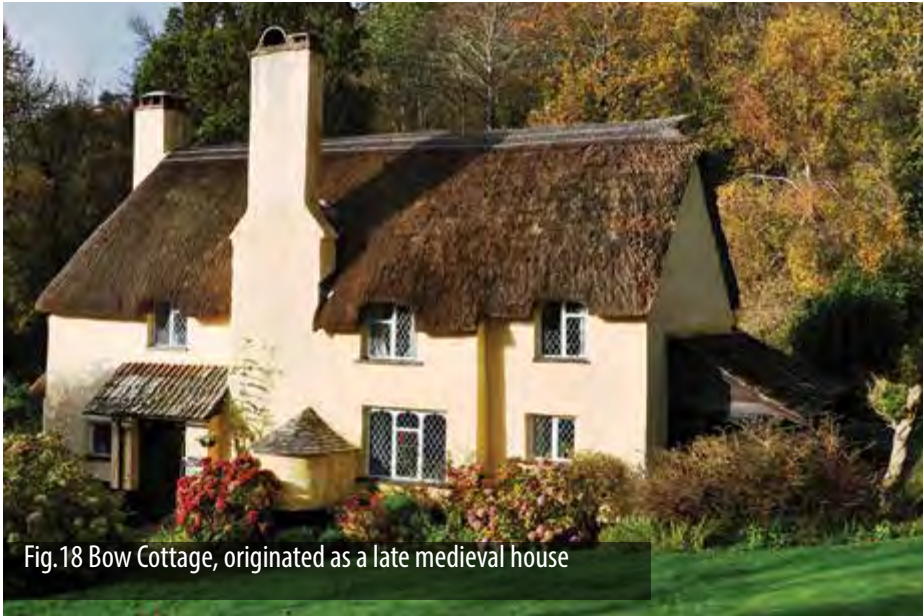
Fig.18 Bow Cottage, originated as a late medieval house

**Bow Cottage** (Fig. 18), opposite, has the same ogee headed design to the ground floor window next to the large front chimney stack. Like Perriwinkle and Postman's Cottage it originated as a three-bay hall house. The former hall, once open to the roof, was most likely ceiled and the front stack, and possibly the bread oven added before the end of the 16th century. The early 19th century picturesque additions include split oak trunks supporting a porch roof, and the usual embellishments of gothic and ogee- arched window frames, a bow window and leaded-light windows.

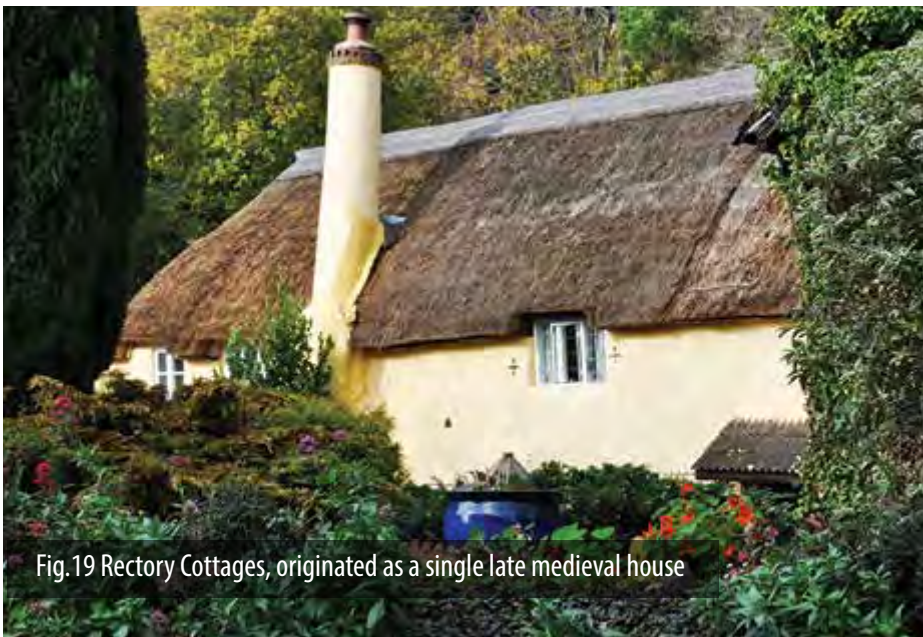
Fig.19 Rectory Cottages, originated as a single late medieval house

South of the Green, the cottages fronting the lane on the west side did not escape Acland's attention. At **Rectory Cottages** (Fig. 19) the Trust's survey discovered smoke-blackened thatch, indicative of a medieval open hall house. From the 17th century was a three-room house with a cross-passage. There is exposed cob on the rear elevation, and a heart and fleur-de-lys motif pargetted into the rendered front (Fig. 29) A projecting slate-roofed bay with a three-light wooden casement is probably an early-mid 20th century former shop front.

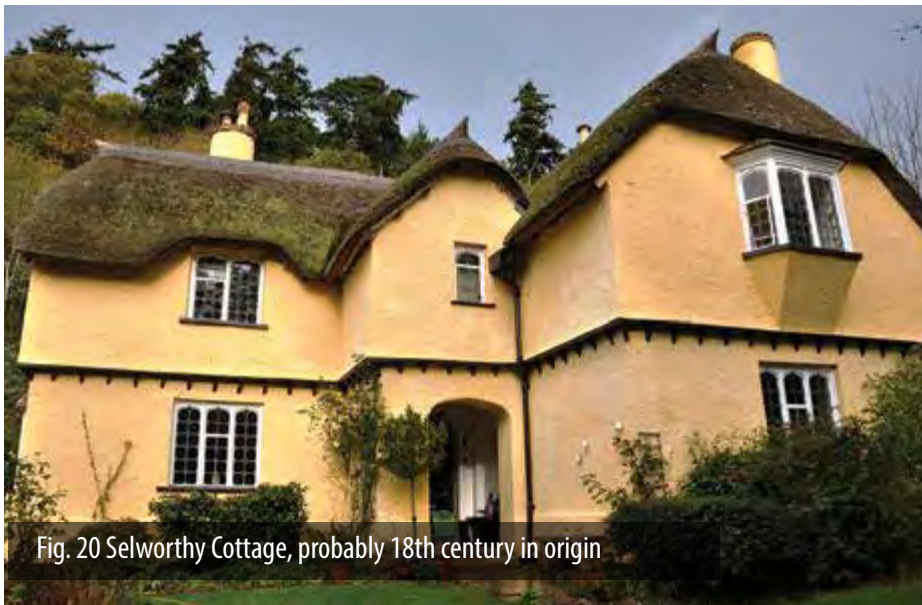
Fig. 20 Selworthy Cottage, probably 18th century in origin

**Selworthy Cottage** (Fig. 20) probably dates from the 18th century, but again was much modified in the early-mid 19th century with ogee-headed and lancet lights, a two-light oriel above the porch, and an ogee headed ribbed inner door added. Contrary to the list description's 17th and 18th century attribution, the Trust's vernacular building survey of Lower Cottage and Greenbanks (Fig. 21) suggests they are a planned pair of two-storey cottages built 1855-57, which places them slightly later than Sir Thomas' first phase of building. The large front stack is a particularly convincing archaic feature.

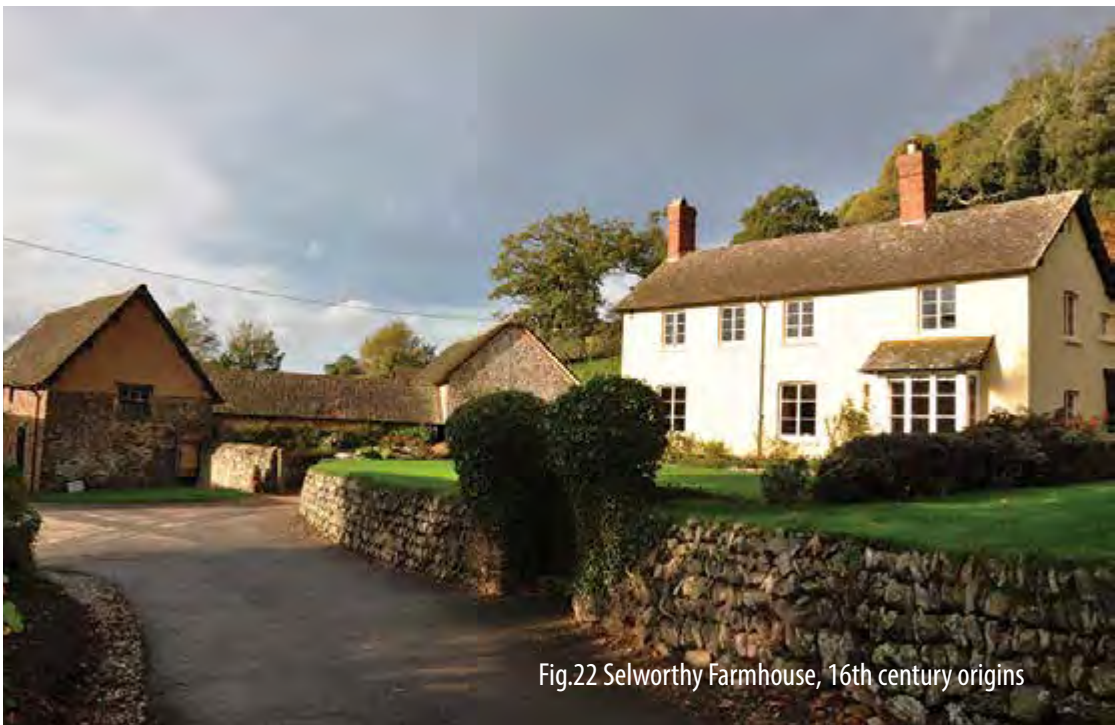
Fig.22 Selworthy Farmhouse, 16th century origins

**Selworthy Farm** (Fig. 22) which marks the south west corner of the Conservation Area, is substantially of 1883-4 and does not possess the picturesque features of the houses to the north. It does, however, incorporate an earlier farmhouse dating from the 16th century with jointed crucks and large stone jambs and quoins in a fireplace suggesting an early chimney, possibly one of the first in the area. The associated historic farm buildings to the west forming a rectangular plan around a cobbled yard are also of interest. The thatched barn, including a south-facing lean-to frontage with round section stone pillars, probably dates from the 18th century and the east range, a former cowshed and stable, is early 19th century. The remainder of the range is late 19th century.

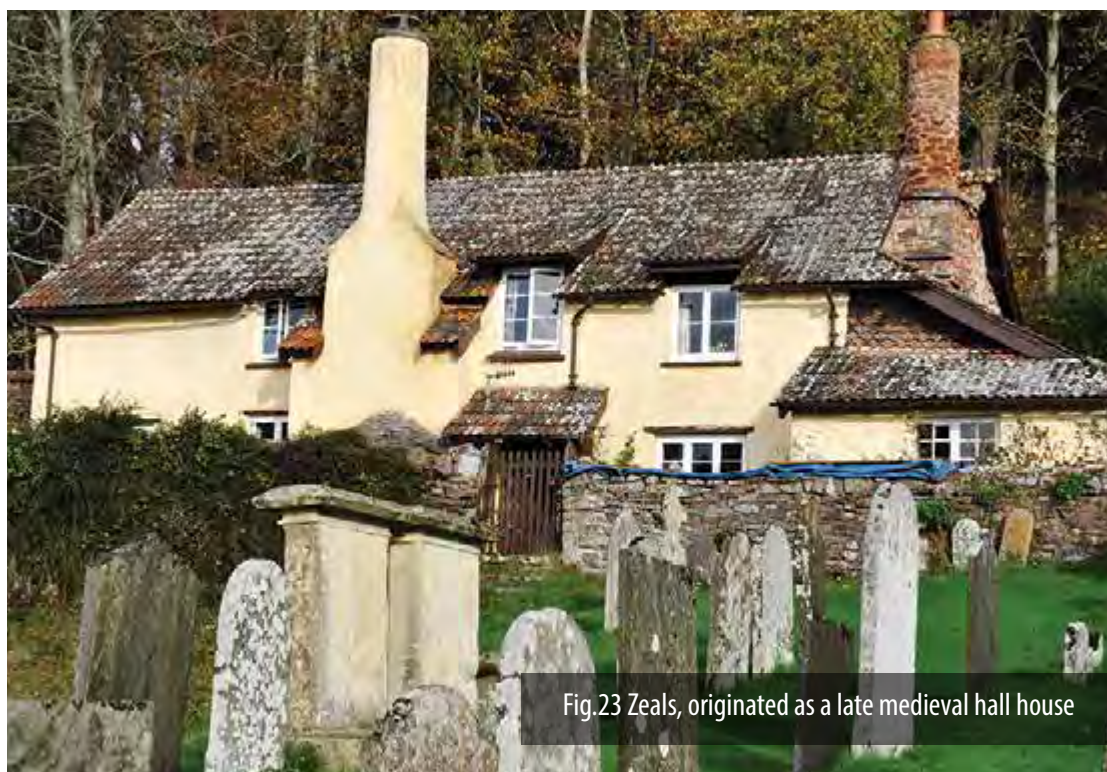
Fig.23 Zeals, originated as a late medieval hall house

The former farmhouse known as **Zeals** (Fig. 23), to the north of the church, also escaped the early 19th century picturesque treatment, its plain casement windows and Roman tiled roof suggesting a more prosaic later 19th century makeover of an earlier house. Internally, it reveals itself to be a late 15th-early 16th century farmhouse ceiled in the late 16th century. The original plan survives largely intact and it retains its timber plank and muntin screen and a rear stair turret.

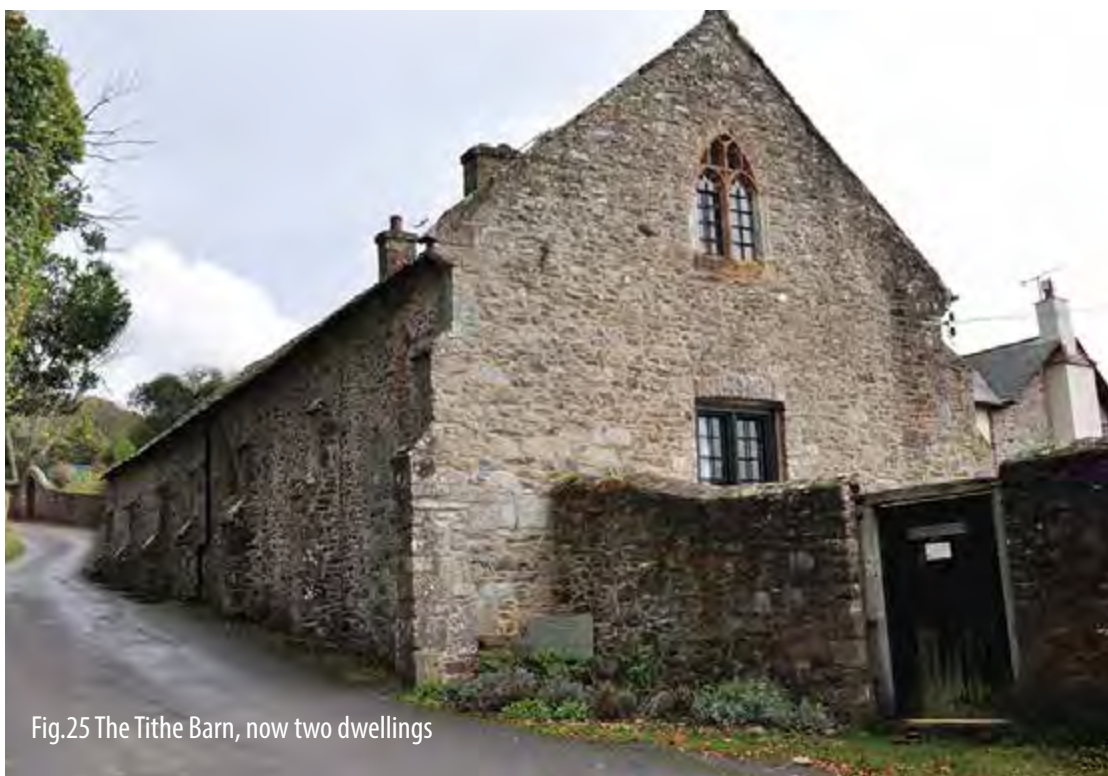
Fig.25 The Tithe Barn, now two dwellings

The buildings to the east of the lane are also largely devoid of the distinctive Acland picturesque flourishes. The Tithe Barn (Fig. 25) is believed to be one of the earliest buildings in the parish and its long unrendered stone north elevation parallel with the stream alongside the road, makes an important contribution to the character and appearance of the Conservation Area. Externally it is a mixture of agricultural and ecclesiastical. Built into the south wall at the west end of the Tithe Barn is a central moulded arch framing a blocked opening with carvings depicting a pig, a sheep and a sheaf of corn (Fig. 26). This is identified in the list description as a dole window, although it is set quite high in the wall. The west gable end has a 2-light cinquefoil headed window was moved from the church when the squire's pew was installed above the church porch in 1826. The south elevation has a more domestic character with 'Somerset' dormers at first floor level.

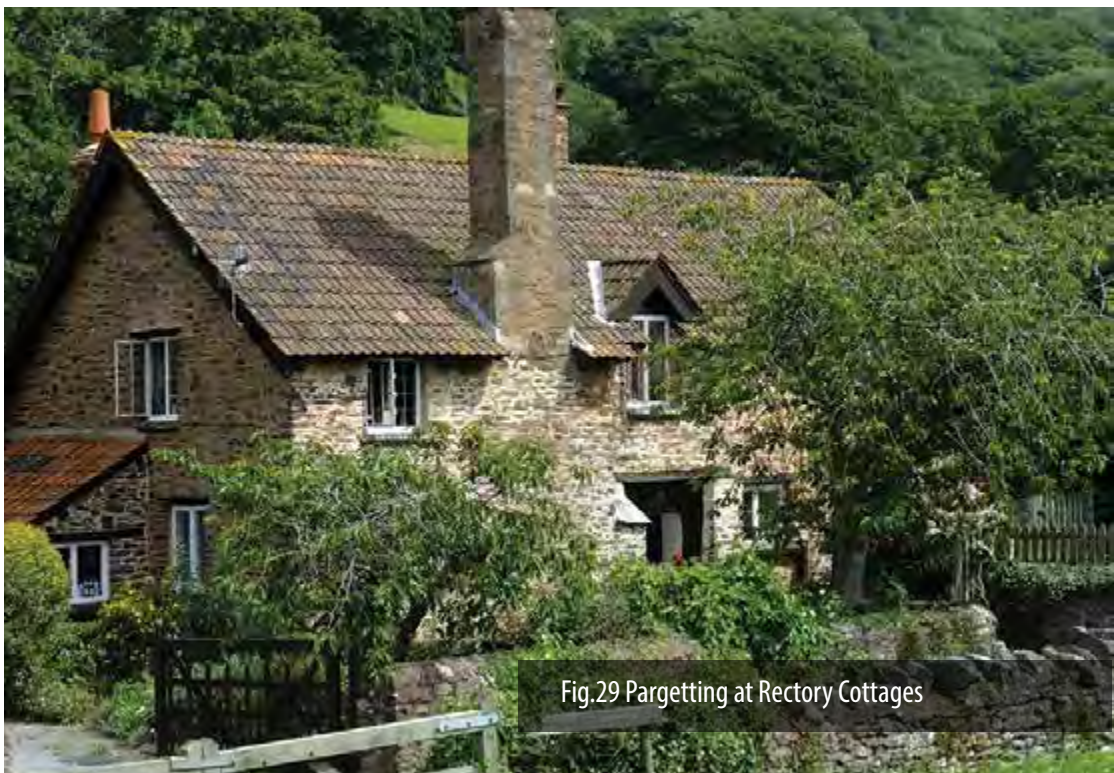
Fig.29 Pargetting at Rectory Cottages

In current and former farm buildings the stone is usually left exposed. The houses on the west side of the road and Zeals are rendered and finished with the estate yellow coloured limewash with a black tar-banded plinth. At Rectory Cottages there is a rare survival of pargetting decoration (Fig. 29).

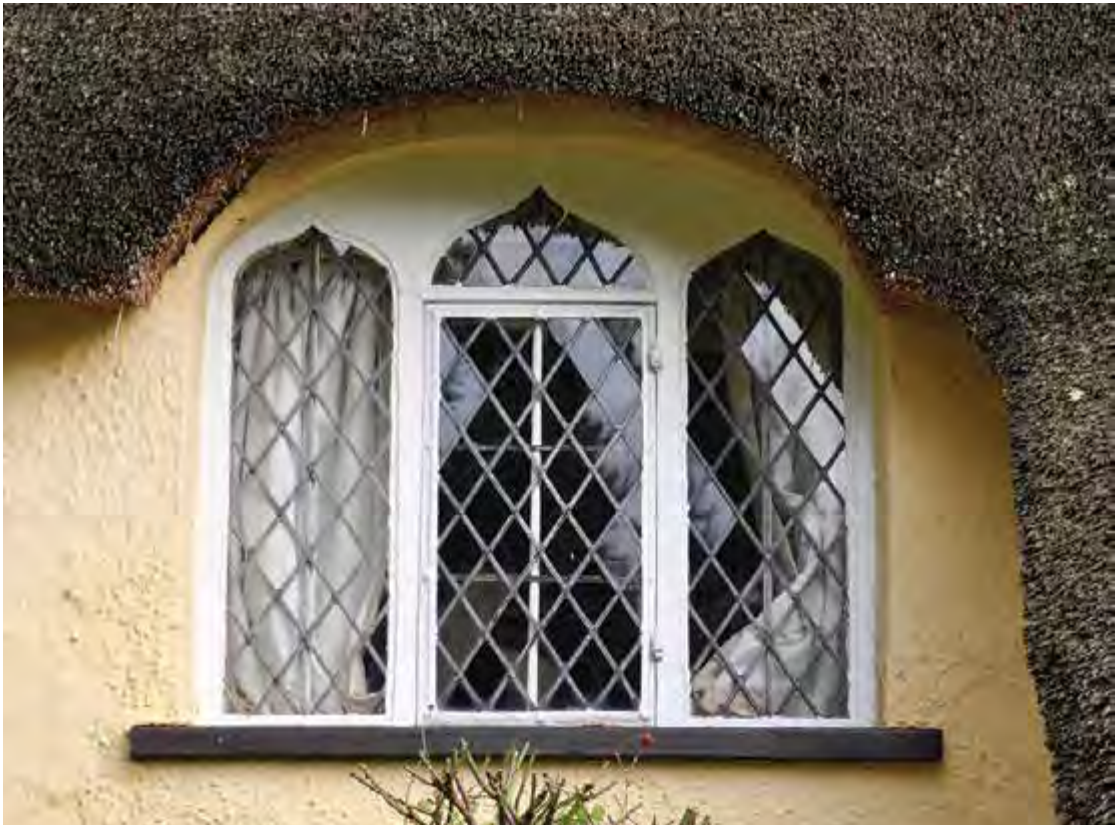
Fig.31 Ogee-headed windows, Ivy's Cottage

Historic windows in the Conservation Area are mainly a mixture of timber and metal casement with few, sash windows present. Some cottage windows have forged iron casements, and there is a range of leaded light glazing patterns. Frames are either plain rectangular or the characteristic ogee or gothic headed style. Oriel windows are another feature of the village and are found on at least three of the buildings, in this case they belong to the picturesque rather than vernacular tradition

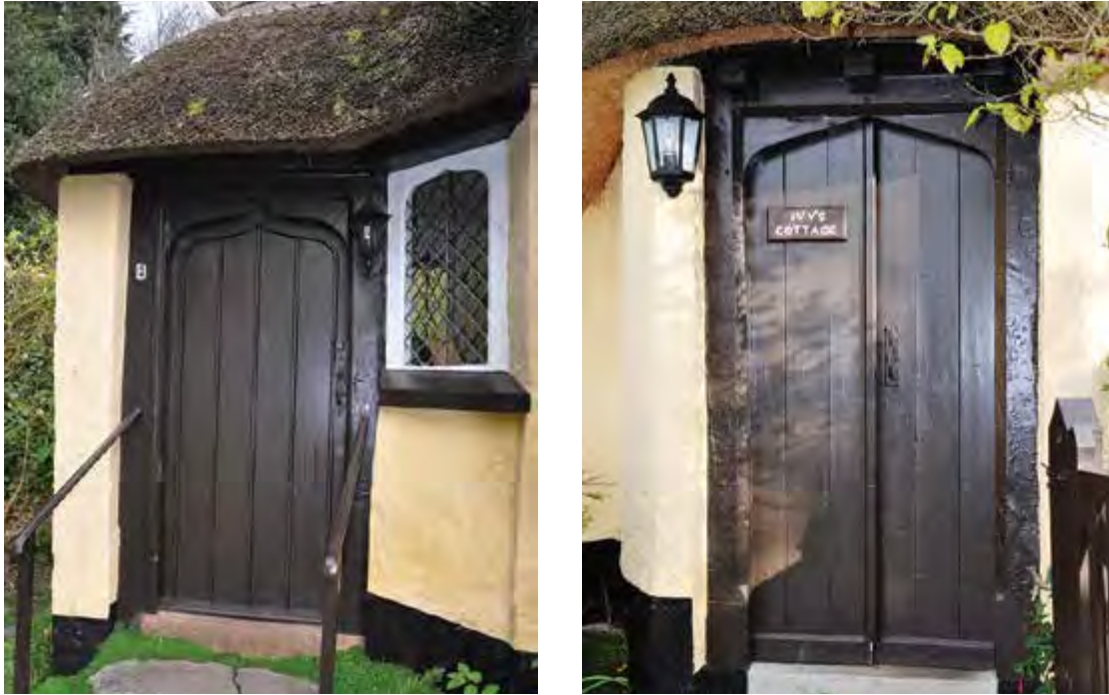
Fig.32 and Fig.33 19th century doors at Clematis (left) and Ivy's (right) Cottages.

Most doors are constructed in a traditional plank and ledged form (some with non-traditional fixed lights), and a few have examples of what may be termed rustic Arts & Crafts detail, for example use of diagonal boarding, and others with ribs or studs. Few openings of late medieval origin survive; their replacement is probably due to the early 19th century 'picturesque' alterations.

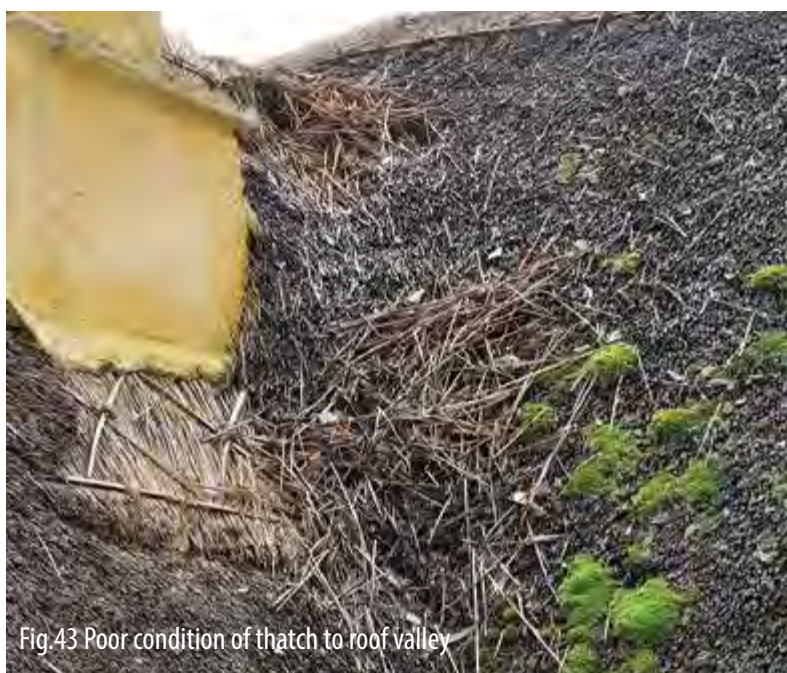
Fig.43 Poor condition of thatch to roof valley

19. Signs of a lack of maintenance such as poorly maintained gutters or joinery.	1. Not a problem at all	<b>2. A minor problem Some thatch in poor condition</b>	3. A noticeable problem	4. A significant problem

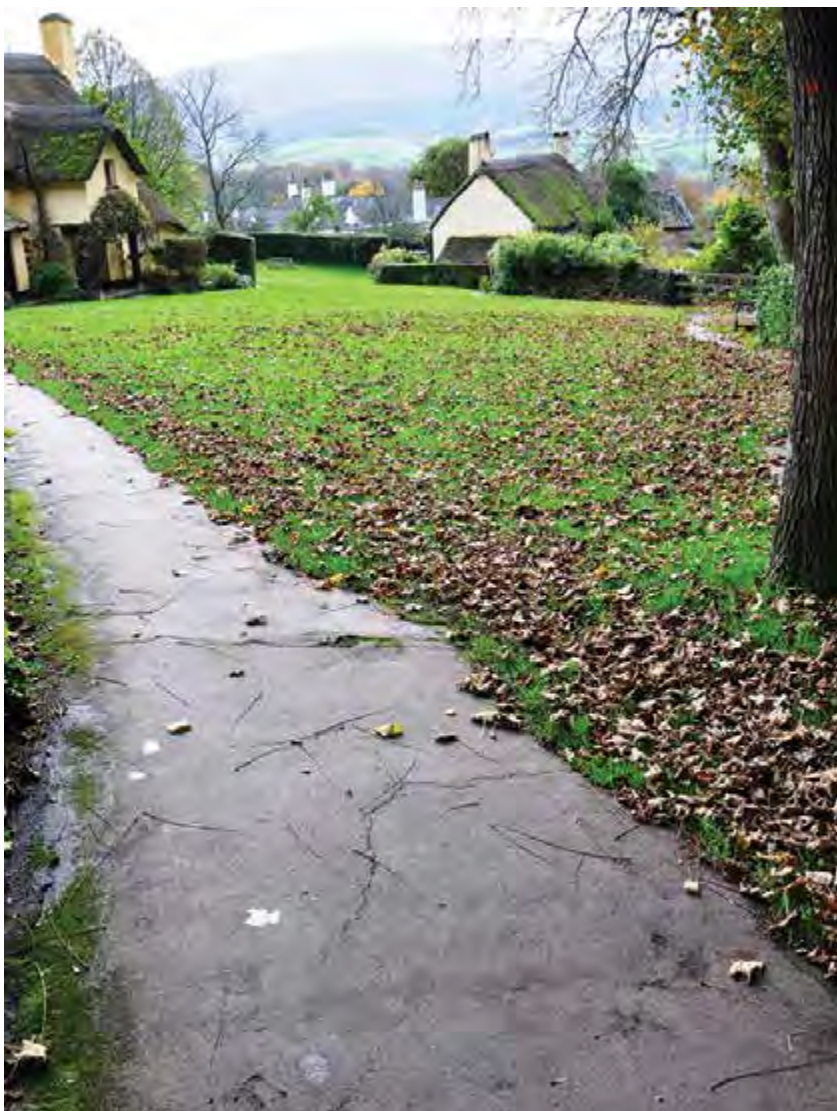
Fig.44 Tree root damage to path on the Green

20. The condition of the public realm:	<b>1. Not a problem at all</b>  <b>Limited damage to tarmac paths by tree roots</b>	2. A minor problem	3. A noticeable problem	4. A significant problem

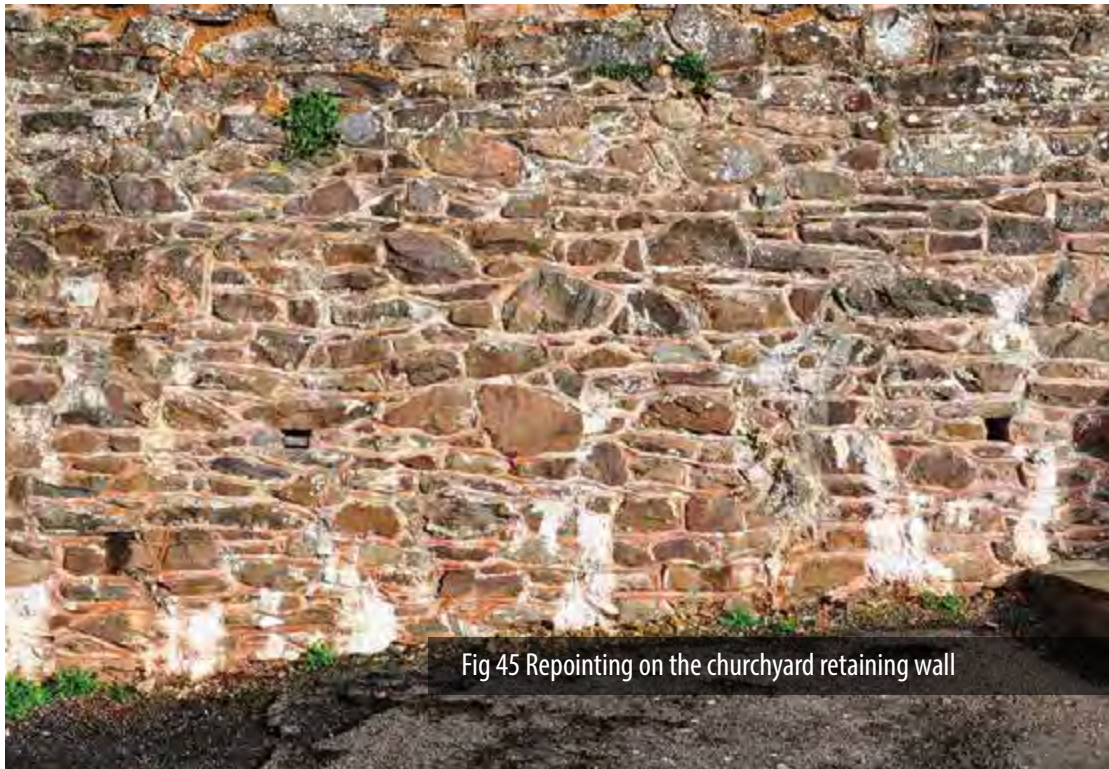
Fig 45 Repointing on the churchyard retaining wall

- Encourage re-pointing of stonework using suitable lime mortar mixes. Cement-rich mortars and raised or 'ribbon pointing' should be avoided. This is especially the case for some of the softer types of sandstone.
- Where appropriate, steps should be taken to re-discover supplies natural materials, preferably from their historic source or equivalent, and to encourage the development of skills in their use.
- More fully research the development of the early settlement, the sources of natural materials used in building construction, and whether former sources of stone or slate might become re-established. The initiative of the National Trust in producing wheat reed thatch from historic varieties grown locally is acknowledged.
