Exmoor National Park
Historic Environment Report Series No 21

WOOTTON COURTENAY CONSERVATION AREA: APPRAISAL DOCUMENT

Adopted 2018

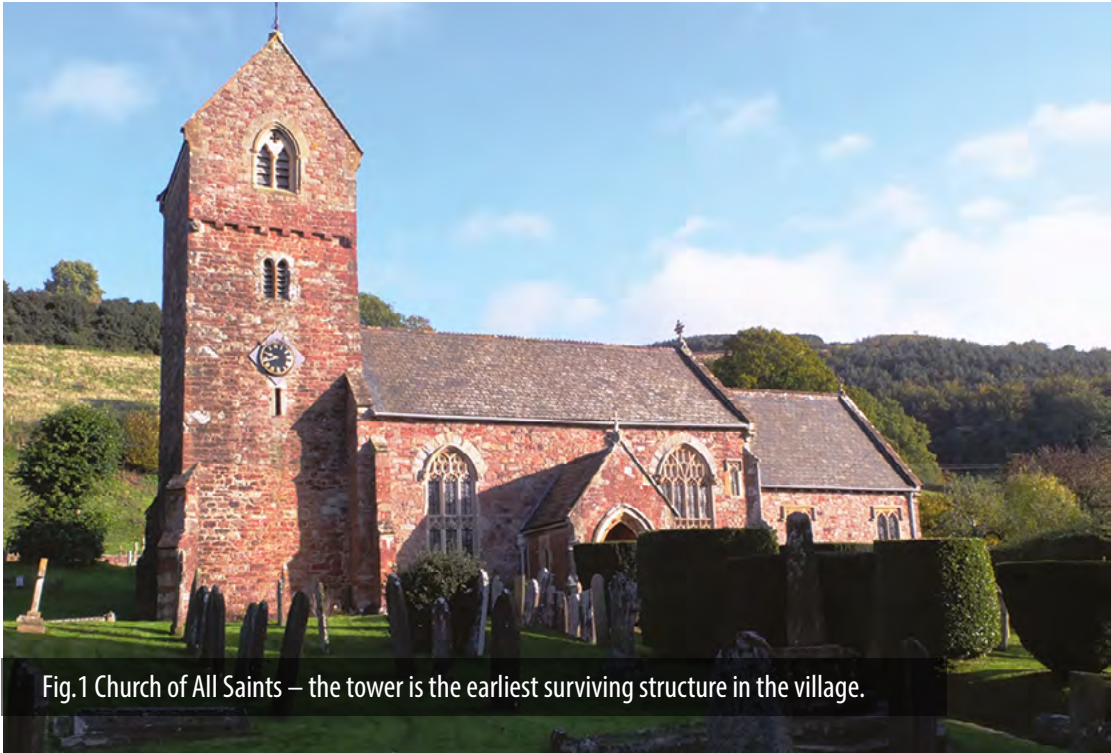
Fig.1 Church of All Saints – the tower is the earliest surviving structure in the village.

The only identifiable physical evidence of the mediaeval settlement at Wootton Courtenay is the parish church, which has its origins in the 13th century and the churchyard cross, which is some 200 years later in date.

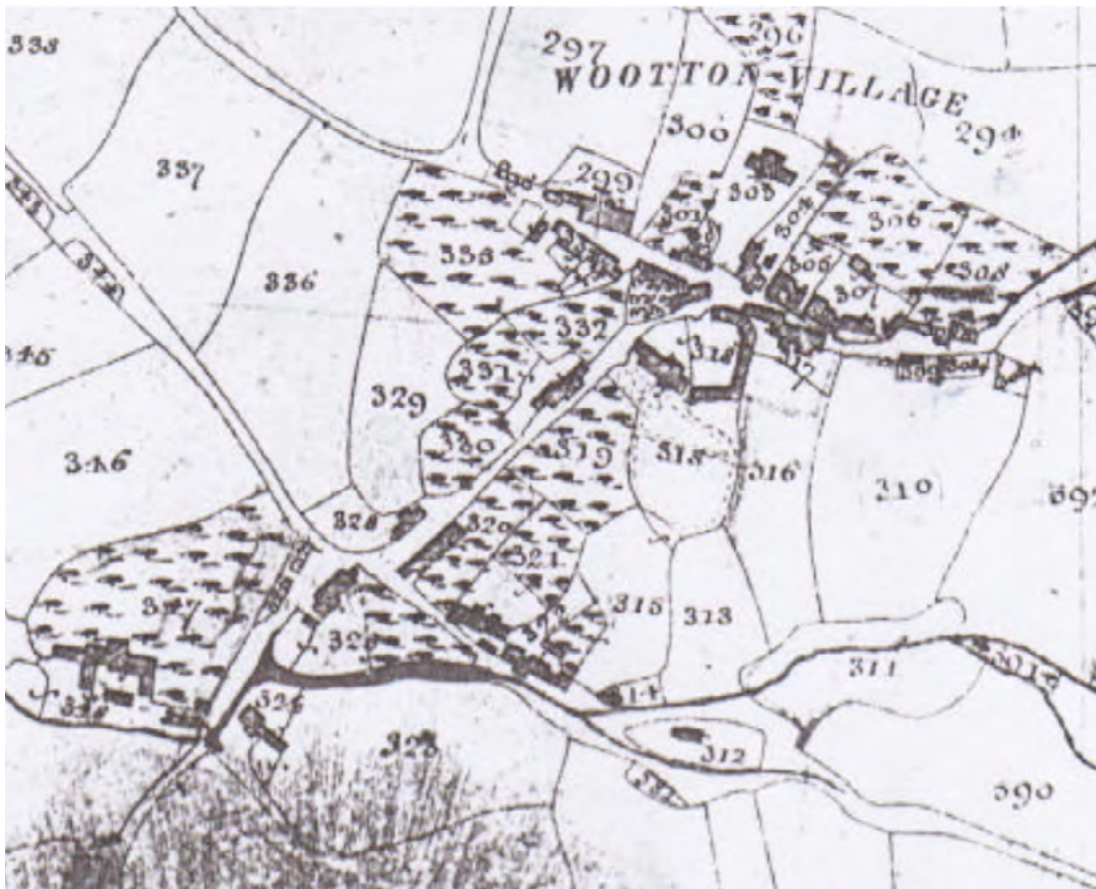
Fig. 2 Extract from Tithe Map of 1840.

The Tithe Map of c.1840 (Fig. 2) gives no indication of a regular field pattern of narrow strips leading back from the main street, normally indicative of burgage plots of larger medieval planned settlements. None of the domestic buildings are known to be earlier than the 16th century in date, but the possibility remains that some have medieval origins (see section 2.3).

Later development has followed this pattern, filling in gaps between buildings along the two principal lanes. The Tithe Map shows that the density of settlement in the village was quite low and while they has been some late-19th and 20th century additions, the historic core of Wootton Courtenay is very much intact. Away from here and outside of the Conservation Area, later building has followed the east-west lane through the village, with the bulk of the ribbon development on the east side.

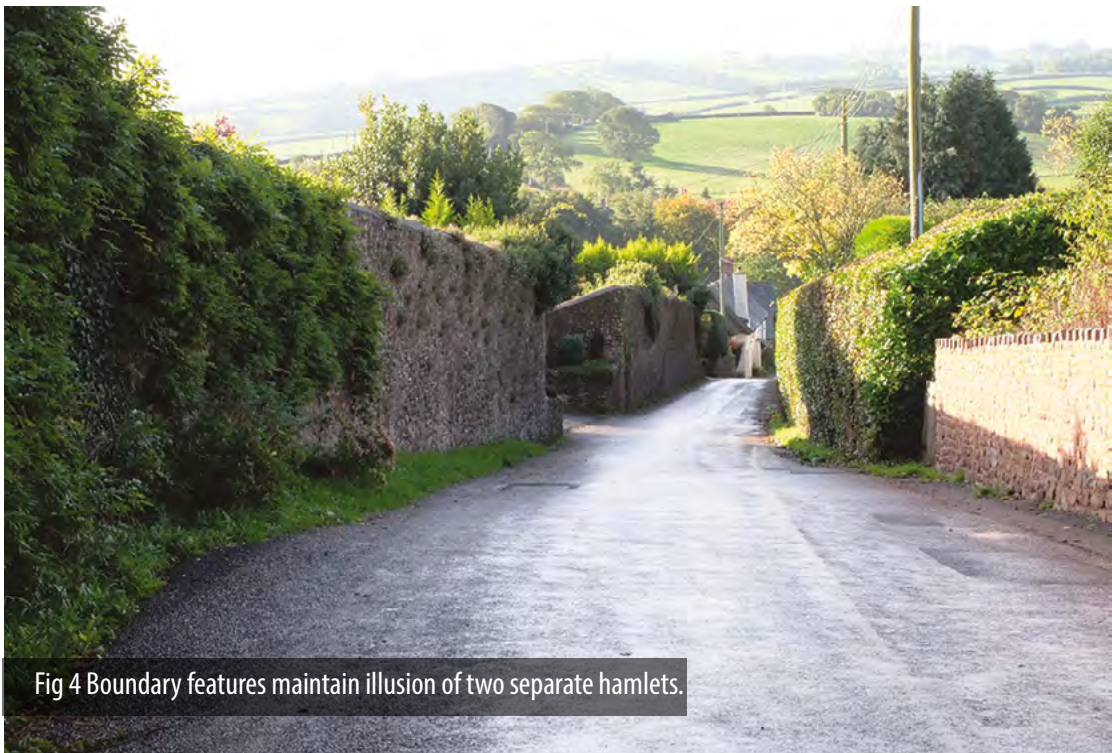
The present Wootton Courtenay Conservation Area includes most of the 19th century and earlier settlement which forms a loosely scattered linear pattern linked by sandstone walls. Wootton Courtenay can be divided into two zones: the main village centre spread out along both sides the east-west lane with its centre at the T-junction opposite the church; and the lower village along both sides of the lane leading south to the shallow river valley. Historically there has always been a gap between the two, formed on the east side of the lane by the extensive grounds of the rectory. Although this gap between upper and lower settlement has been partially filled by modern the development, the nature of this and the presence of the high walls and hedges down the lane means that the illusion is maintained.

Fig 4 Boundary features maintain illusion of two separate hamlets.

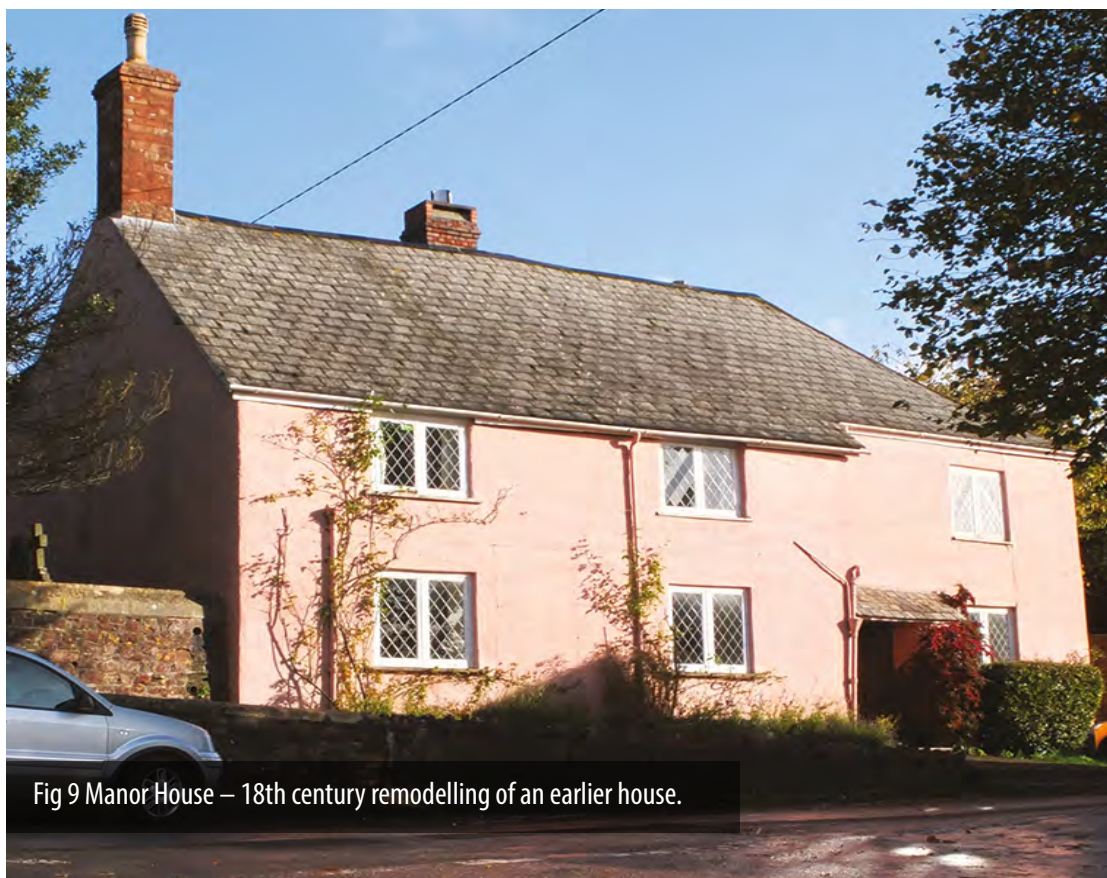
Fig 9 Manor House – 18th century remodelling of an earlier house.

Adjoining the church yard is **Manor House** (Fig. 9). Built of rendered stone and cob with a slate roof, it was originally a three-room and cross-passage plan dating from the early-mid 17th century, but was remodelled and extended with a cross-wing added in the mid-18th century marked by the inscription 'M H 1763' under the eaves.

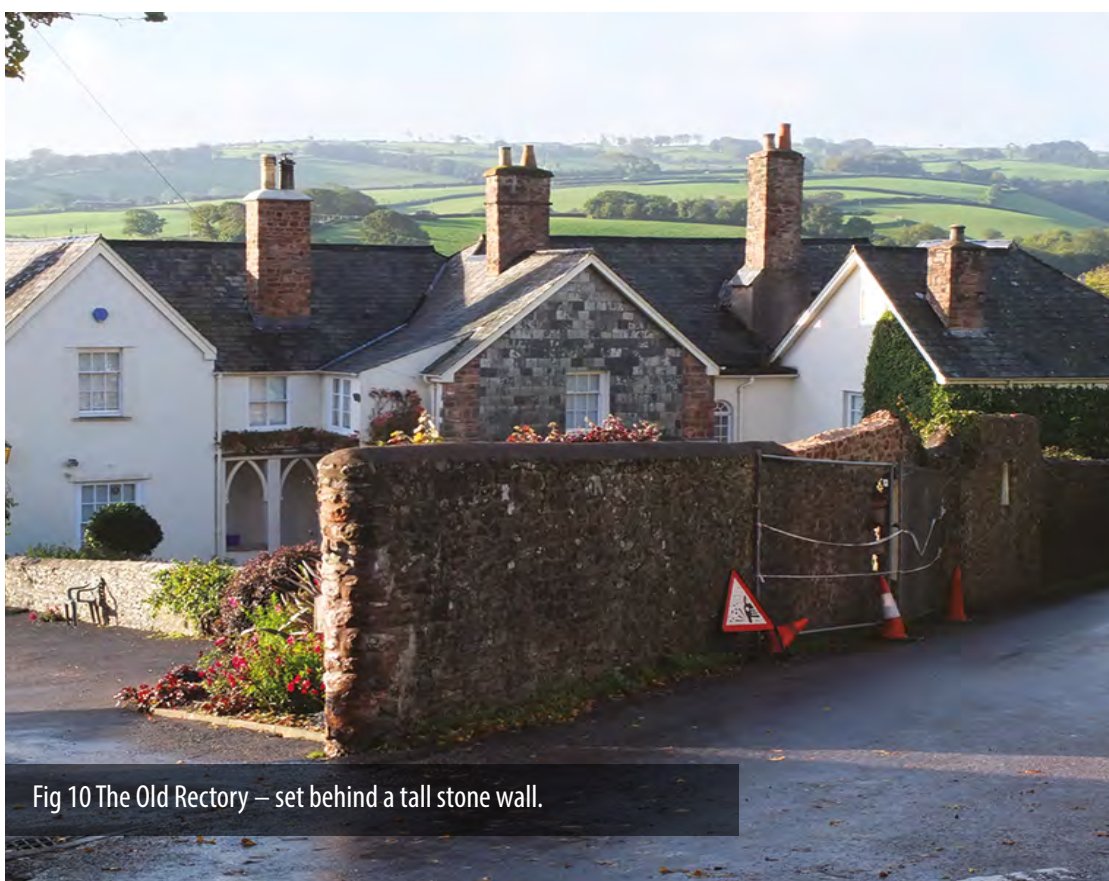
Fig 10 The Old Rectory – set behind a tall stone wall.

Opposite the church and down the hill slightly, the **Old Rectory** (Fig. 10) is still the largest house in the village, despite having part of its east wing demolished in the 20th century. Set behind a high stone wall, outwardly it appears early-mid 19th century, but has 16th century origins, the main evidence for which is in the roof structure which has collar beam trusses with arched braces, and chamfered purlins with windbraces. The house is built of red sandstone, and part roughcast rendered with slate roofs and some slate-hung frontage detail. There are several tall stone stacks, including a prominent lateral one on the north frontage. To the east of the house are the remnants of a long range of outbuildings that formerly swept around three sides of the yard.

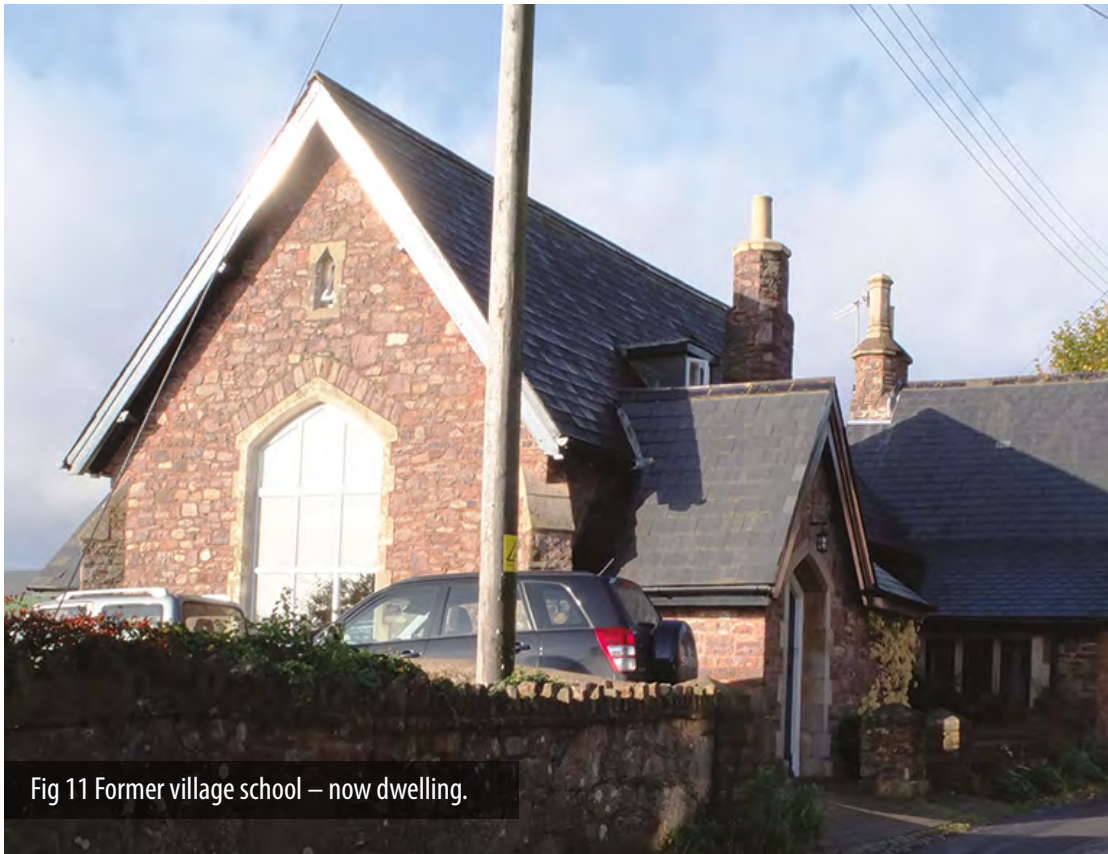
Fig 11 Former village school – now dwelling.

To the east and fronting the lane is the former **school and schoolhouse** (Fig. 11). Built as a National school in 1859, it was enlarged in 1867 and is now a dwelling. It is constructed of squared stone, mainly single-storey with steep low-swept gabled slate roofs, first-floor flat roofed dormer. Its gothic-revival style detailing includes the pointed triple arch windows to the right gable.

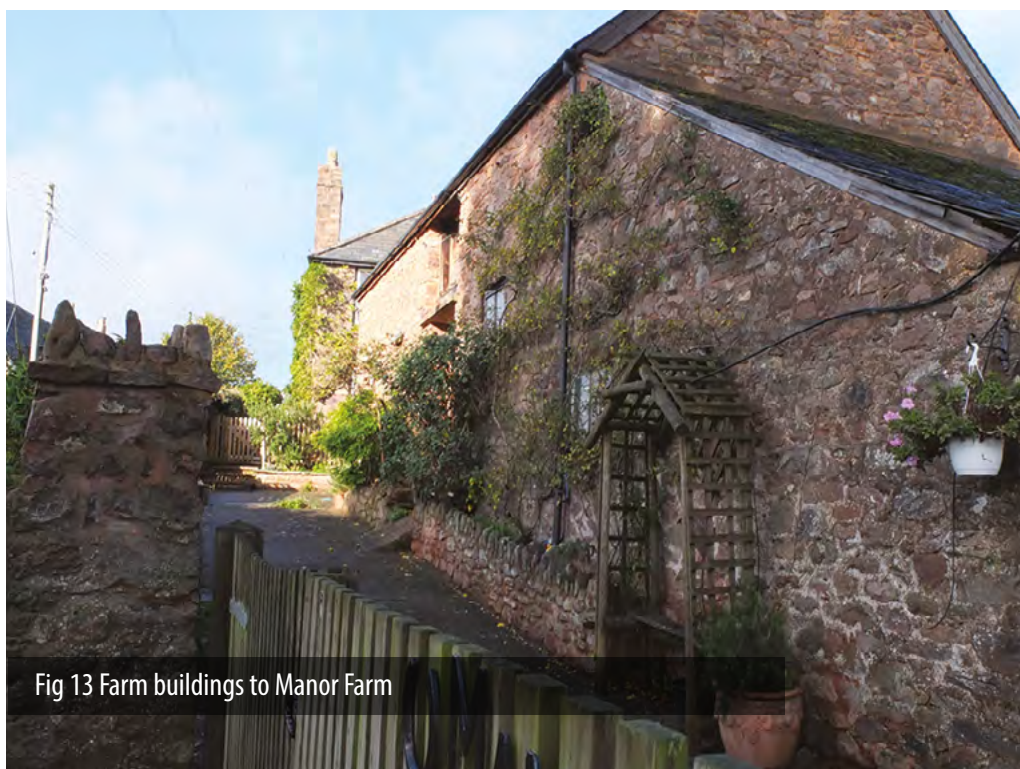
On the opposite side of the road is **Manor Farm** (Fig. 12). Built of exposed stone and slate, its tall squared stone front lateral stack might date it to the 17th century. The large timber casement windows are probably 19th century, as is the walled garden with crenellated gate piers and the fine collection of farm buildings to the east.

Fig 13 Farm buildings to Manor Farm

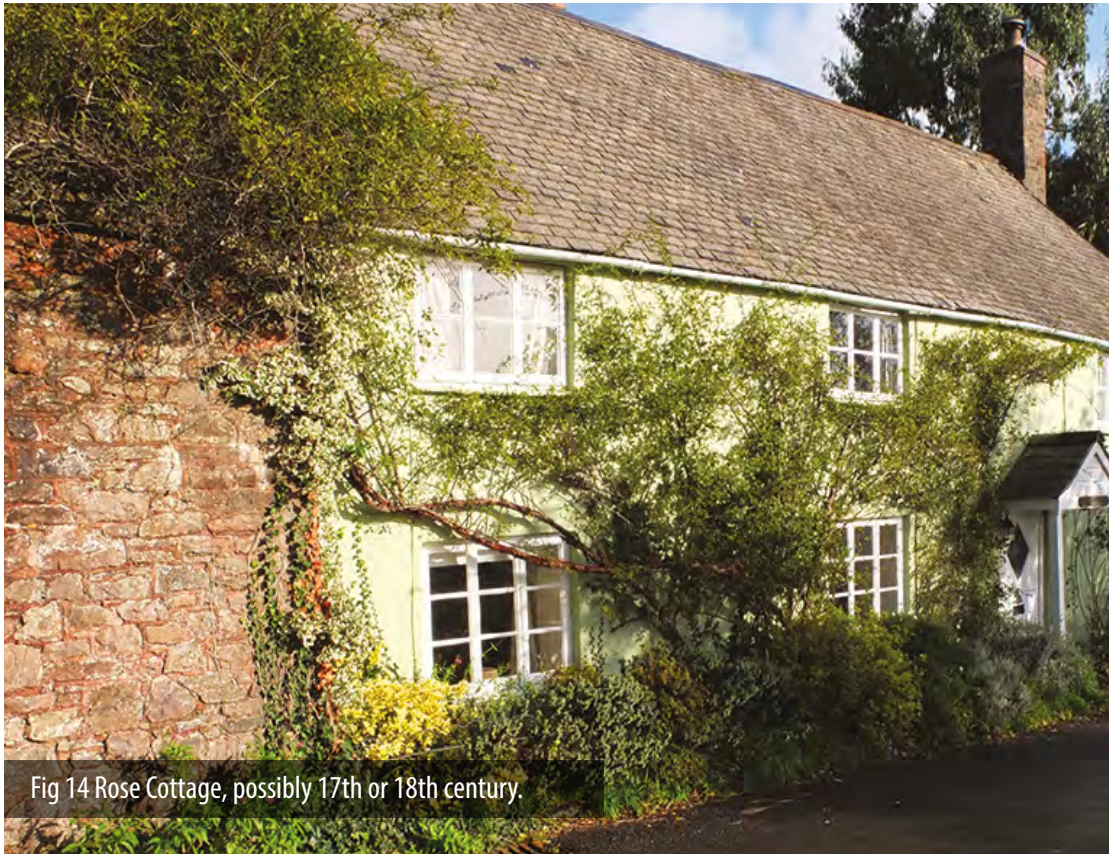
Fig 14 Rose Cottage, possibly 17th or 18th century.

Beyond is **Rose Cottage** (Fig. 14), rendered with a slate roof, and again a tall square-section lateral stack, but to the rear. It is possibly of 17th or 18th century origin, but has more recent embellishments, for example the gabled trellised porch, and casement windows.

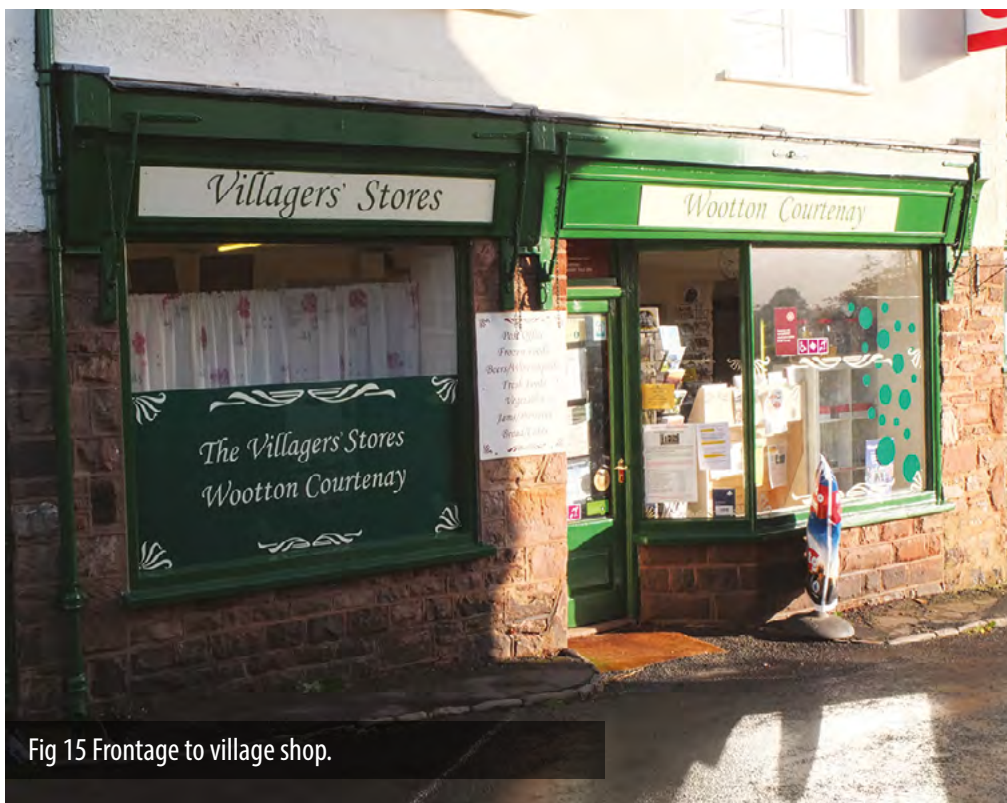
Fig 15 Frontage to village shop.

On the west side of the church the houses are more densely packed. **The Village Shop** (Fig. 15) retains original fascia detail with segmental arched heads to the windows above. It forms part of a group that includes a garage workshop, providing a visible focal point to the village. Attached to the rear of the shop and abutting the churchyard is **Jasmine Cottage** (Fig. 16) a tall 2 ½ storey building of exposed stone with a slate roof. Its top floor dormers are now joined by solar PVs.

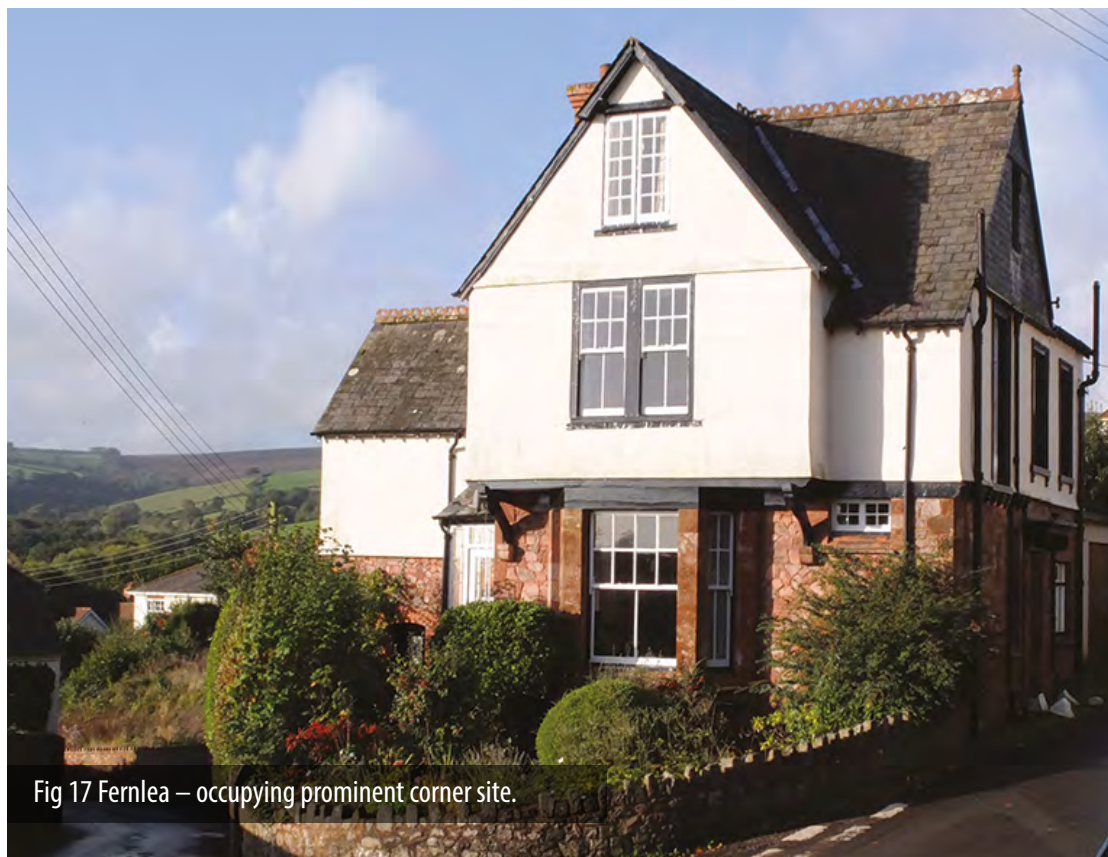
Fig 17 Fernlea – occupying prominent corner site.

Opposite the shop and occupying a corner site is Fernlea (Fig. 17) a substantial late-19th- early- 20th century gabled house in Arts and Crafts style with exposed stone ground floor, rendered upper floors, and mainly sash windows.

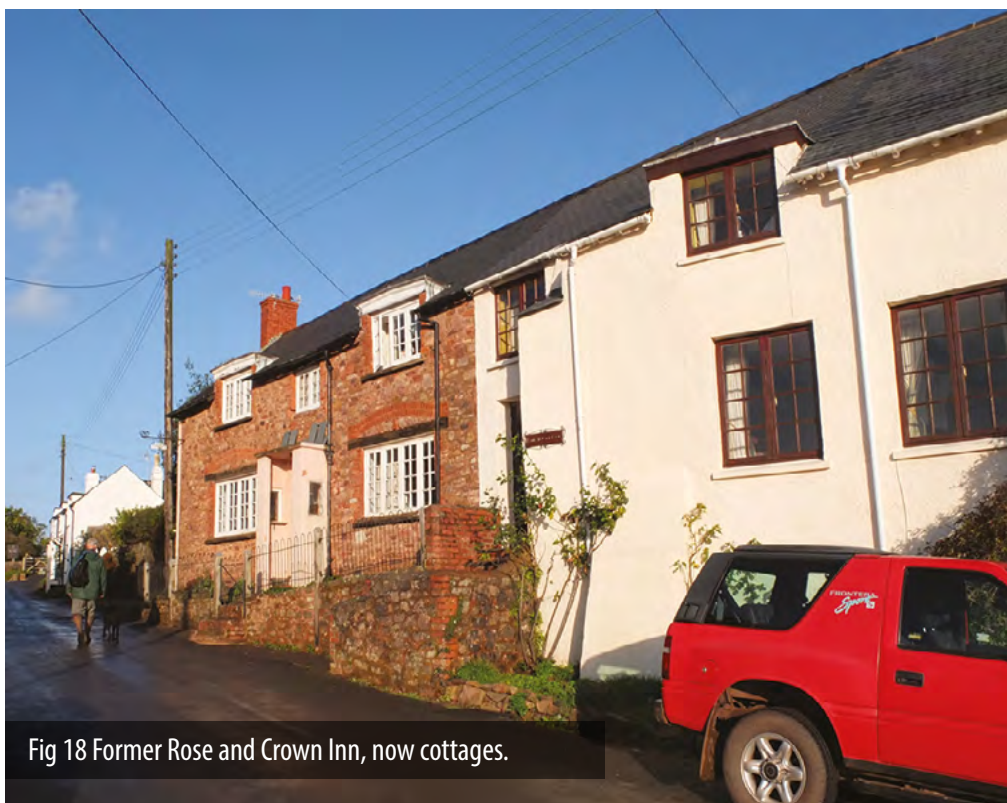
Fig 18 Former Rose and Crown Inn, now cottages.

Pound Cottage and **Stag Cottage** (Fig. 18) are marked on the 1st edition OS map as the 'Rose and Crown Inn'. They are slightly angled to the road, and probably date from the late 17th to 18th century. The former is rendered with steps up, the latter has exposed stone with a brick relieving arch and wrought iron railings, and there are timber casement windows to both. Opposite and set straight on to the road are a pair of attached cottages, **Pear Tree Cottage** and **Wreford** (Fig. 19) Although they occupy a site which has cottage shown on the 19th century and later OS maps and the former has a lateral stack externally they have the appearance of late-20th century houses.

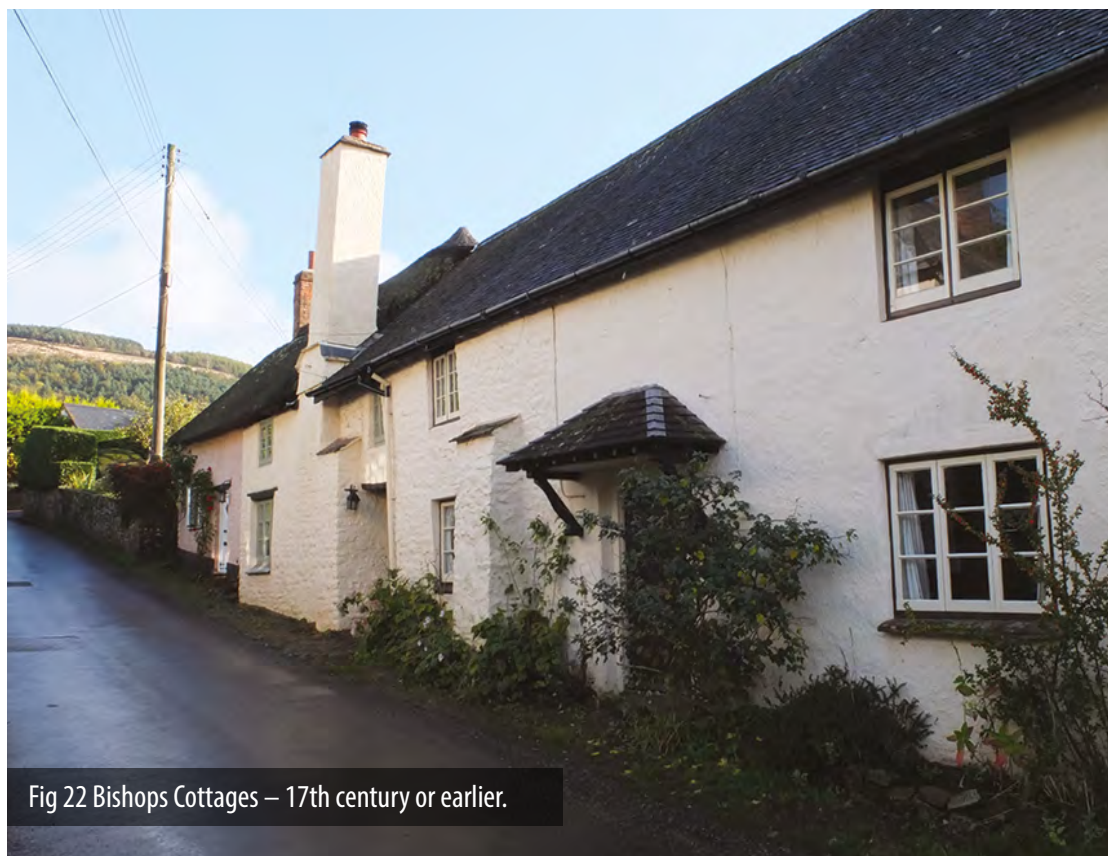
Fig 22 Bishops Cottages – 17th century or earlier.

Opposite, **1-4 Bishops Cottages** (Fig. 22) may have originated as a single house in the 17th century, or possibly earlier, and been extended later. The row includes a front projecting stack with rounded shaft and small casement windows with timber lintels. The cobbled pavement and a hipped porch on timber brackets to No 3 enhance the understated vernacular detail. The upper end of the row is thatched.

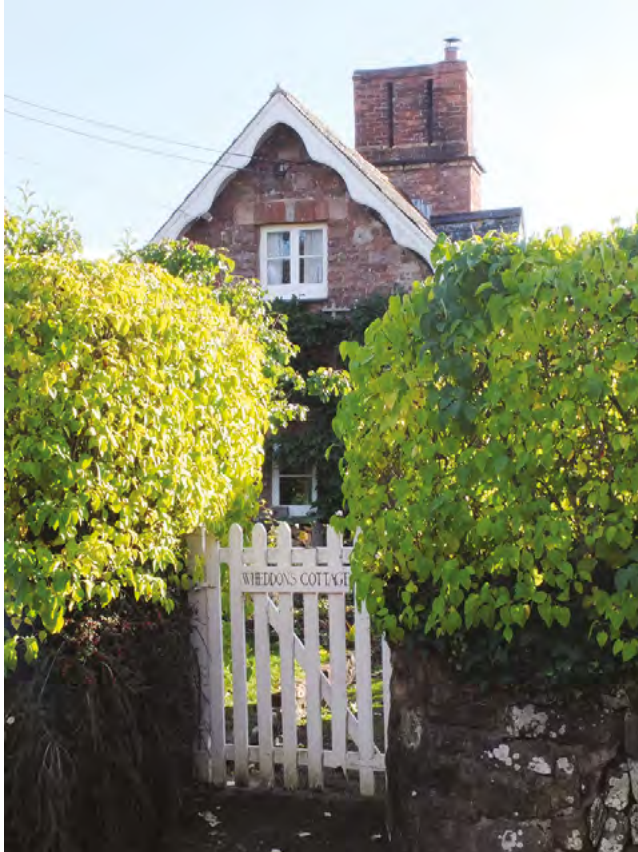
Fig 23 Wheddon's Cottage – mid-19th estate-style cottage.

From Bishops Cottages a narrow lane follows the flow of the river east. At the corner is **Wheddon's Cottage** (Fig. 23) and **Bradlea**, a pair of estate-style cottages built of worked stone, with a central stone stack with linked triple brick flues, and ornamental barge-board. They are probably mid-late 19th century as they are absent from the Tithe Map but appear on the 1st edition OS map.

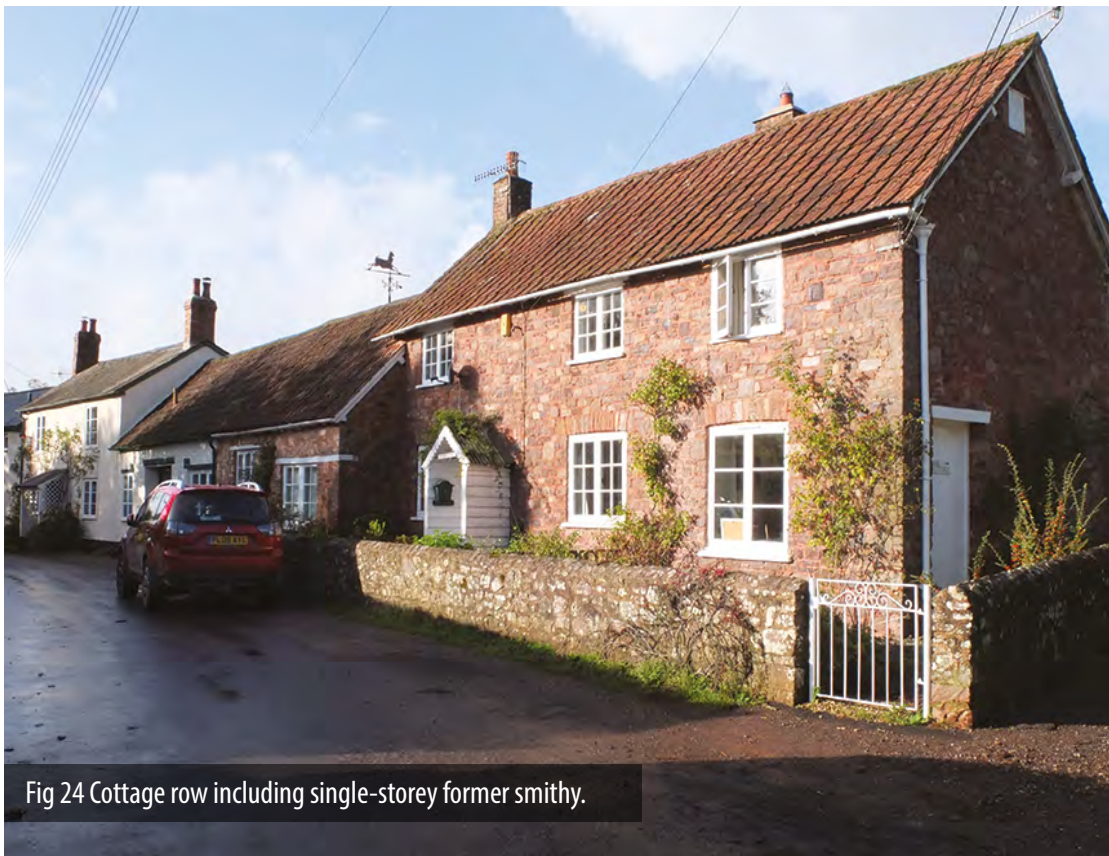
Fig 24 Cottage row including single-storey former smithy.

Back on the main lane there is another short cottage row (Fig. 24). At the north end at the corner of Butt's Lane, **Vine Cottage** is a two-storey cottage, with exposed stone walls and Roman tile roofs with a door in the gable end. **Woodbine Cottage** is a part of the same building but extends into the single-storey range to the south that projects forward and is probably part of the former smithy. The other part of this single storey range belongs to **Forge Cottage**, the largest in this row, which is rendered with a slate roof. The group is mostly 18th-19th century.

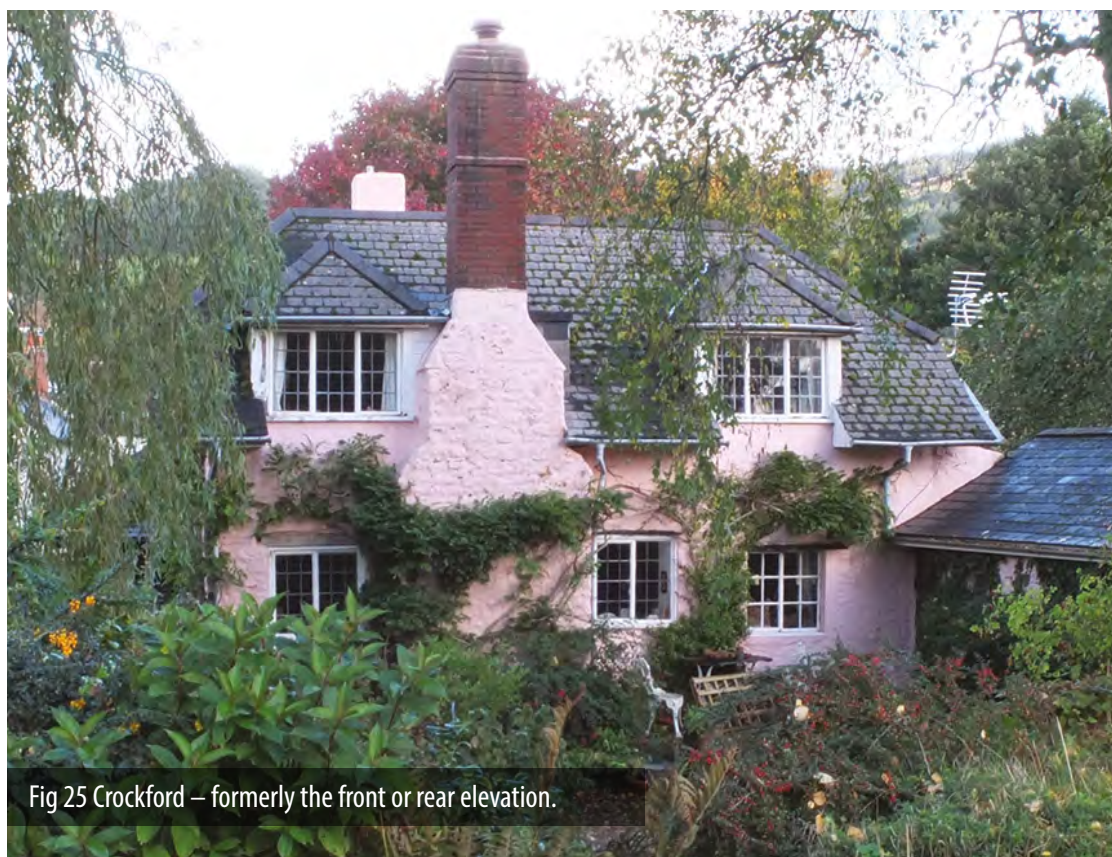
On the east side of the river is **Crockford** (Fig. 25). It currently fronts the lane but the shouldered lateral stack on the south wall, which could have been on the front or back, indicates that it was originally orientated on a east-west axis. Although it was originally 17th or 18th century it has been greatly extended in subsequent years.

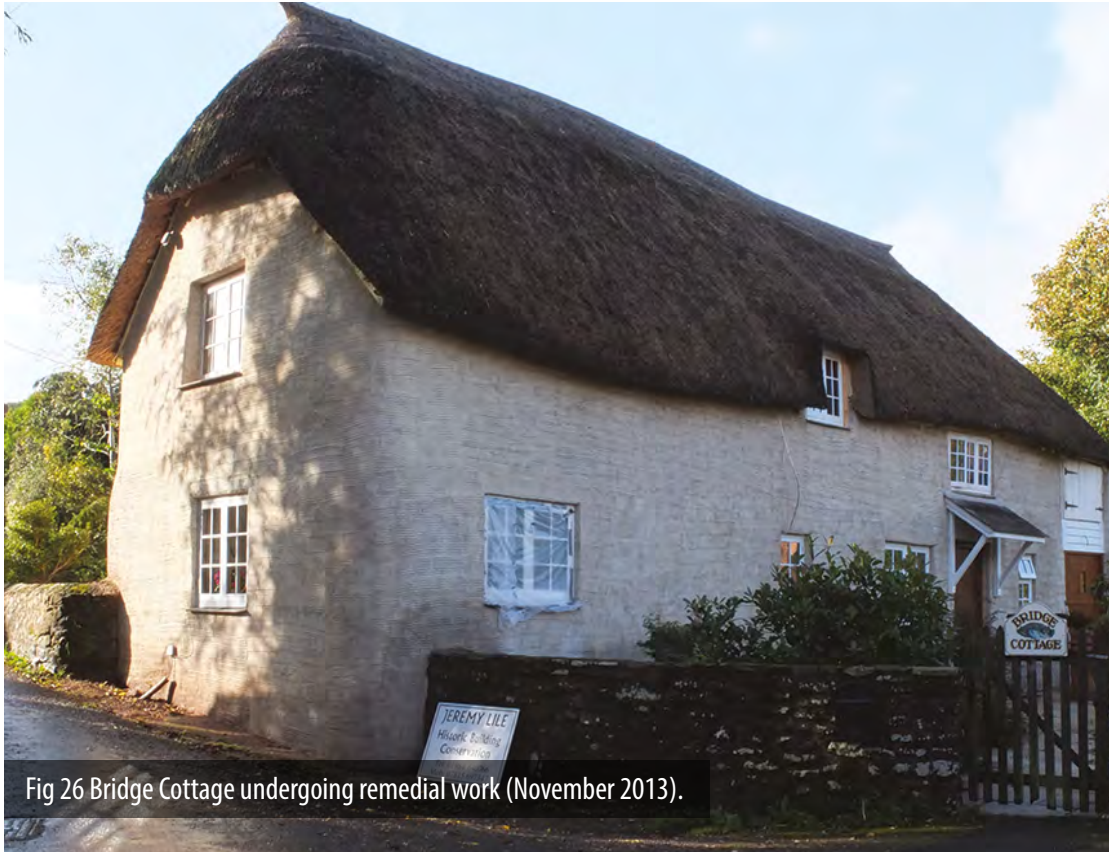
Fig 26 Bridge Cottage undergoing remedial work (November 2013).

On the other side of the lane, **Bridge Cottage** (Fig. 26) is probably contemporary with Crockford but has been far less altered. It has two large rear lateral stacks and may have began life as two single-cell dwellings with an attached farm building. It is constructed of stone rubble and cob with a thatched roof.

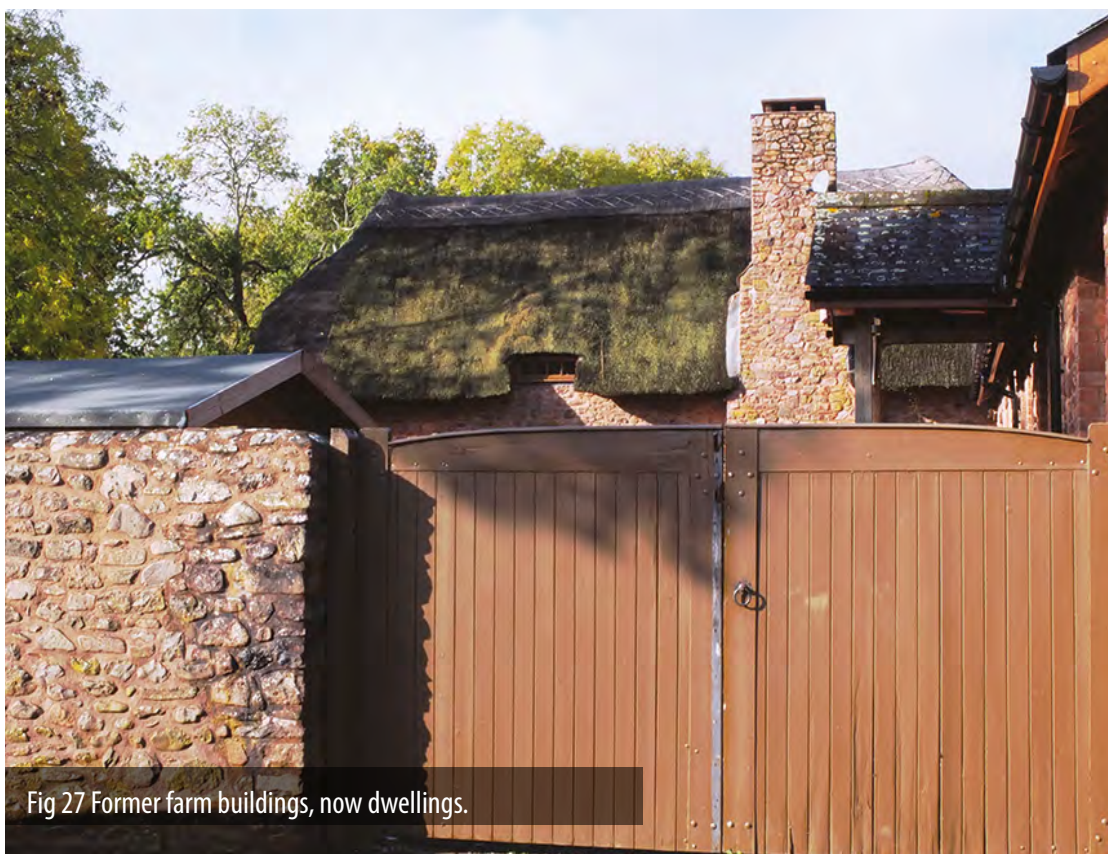
Just to the west of the lane are the L-shaped restored remnants of a farm building group, probably 18th century in origin but converted to domestic use in 1988 and now known as **The Old Parlour** and **Hanny Cottage** (Fig. 27).

Fig 27 Former farm buildings, now dwellings.

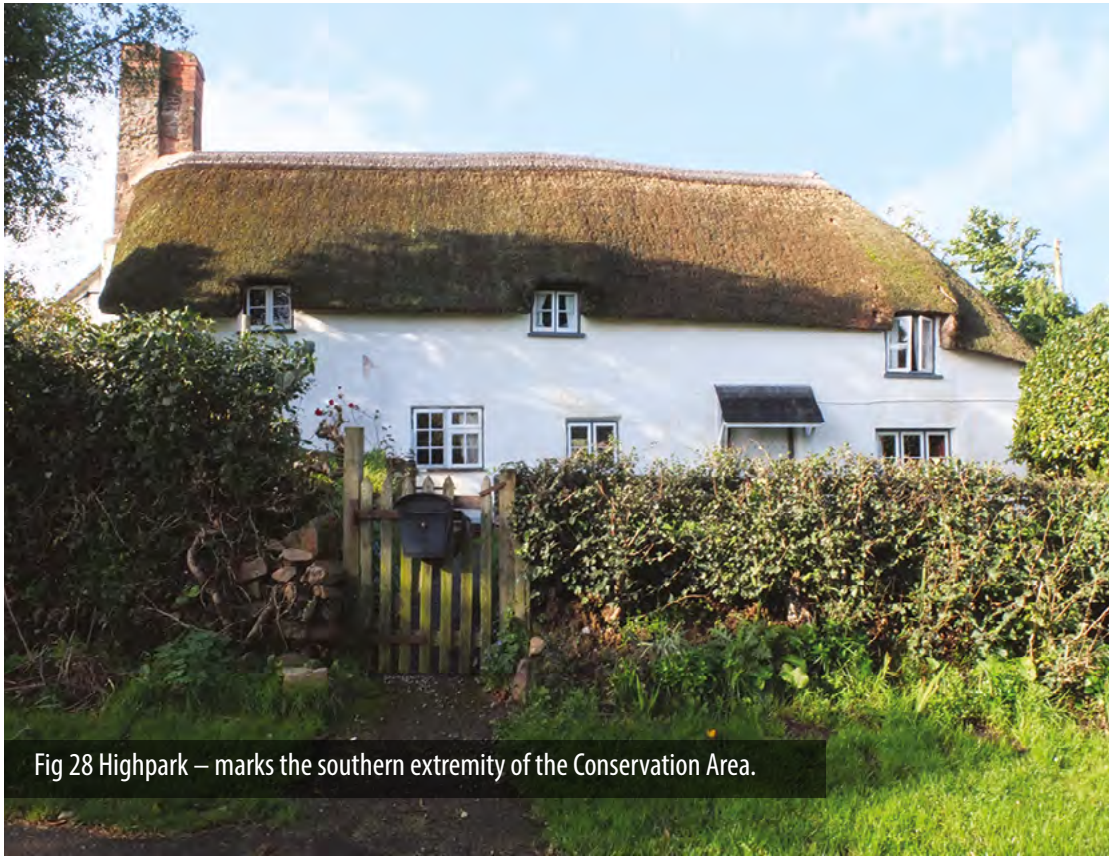
A short distance up the hill from the valley bottom is **Highpark** (Fig. 28), another thatched and rendered stone rubble and cob cottage. It dates from the late 17th century and was enlarged in the 18th century to two dwellings, but converted back to a single dwelling in the 20th century. An unpublished Vernacular Architecture Group report (1983) suggests this was originally a two-cell dwelling, with the rear wall of one unit demolished and a circular pier inserted to form a linyay.

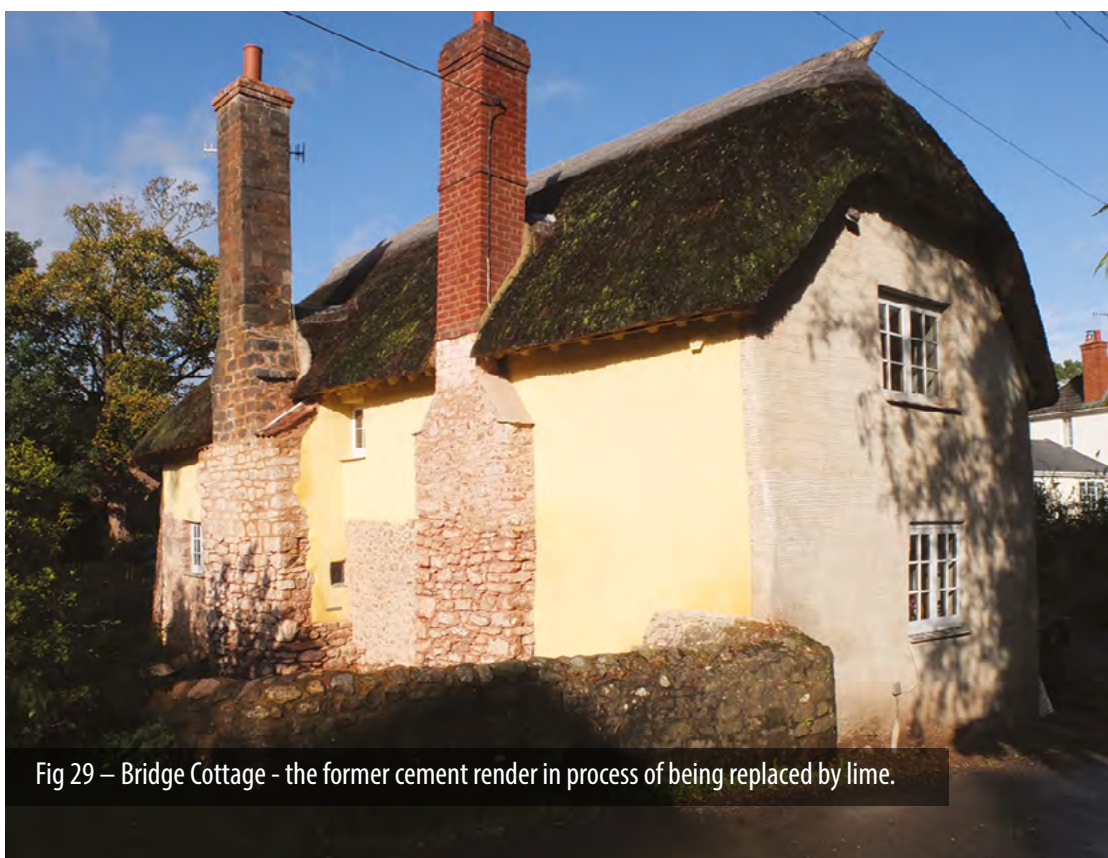
Fig 29 – Bridge Cottage - the former cement render in process of being replaced by lime.

The use of stone for building is widespread and includes all the main buildings, for example the parish church and former village school. Here the stone is usually worked, and sometimes ashlar. The farm outbuildings are of stone rubble as are most of the cottages, although these are typically covered by render, which was traditionally lime although this has been replaced in many cases by cement. Slate hanging is rarer but does occur at the Old Rectory and Fernlea.

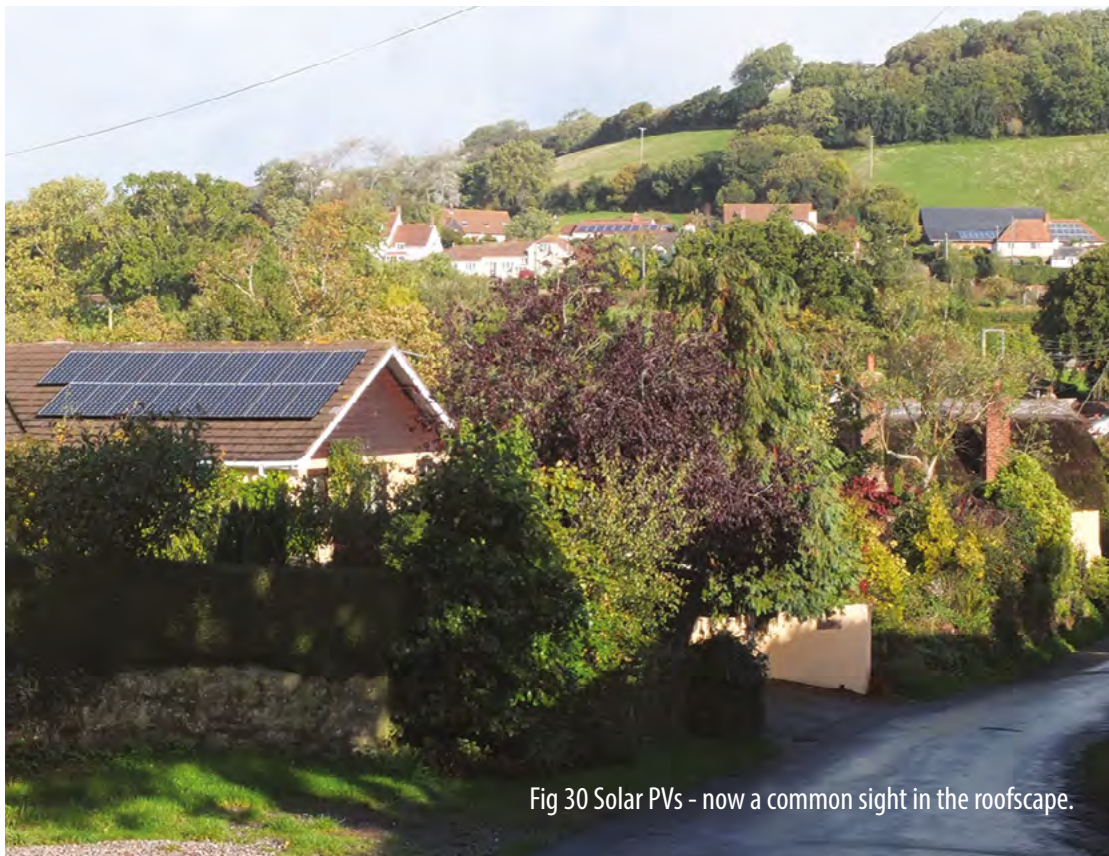
Fig 30 Solar PVs - now a common sight in the roofscape.

One very noticeable change since the last appraisal is the number of buildings sporting solar photo voltaic panels on their front elevation roofs. This is not surprising given the village's south facing aspect.

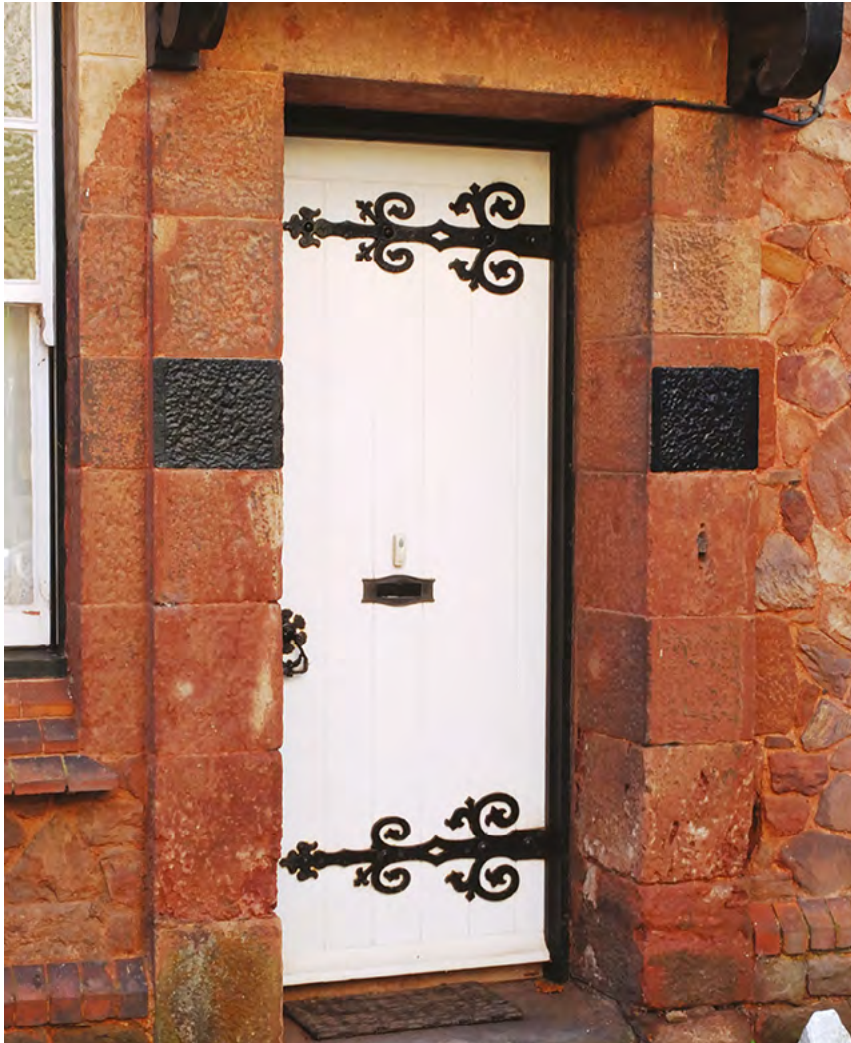
Fig 31 Arts and Crafts doorway at Fernlea.

Most doors are constructed in a traditional plank and ledged form, some with fixed lights, others with decorative Arts & Crafts detail (Fig. 31). The relatively few panelled doors with fanlights above are more commonly found in houses dating from the late 18th to early 20th century. A few of the earlier openings have large oak frames, and are jointed with pegs or chamfered with stops. An example is the entrance at the Manor House (Fig. 32) although the original ovolo-moulded doorframe has been altered in a later restoration.

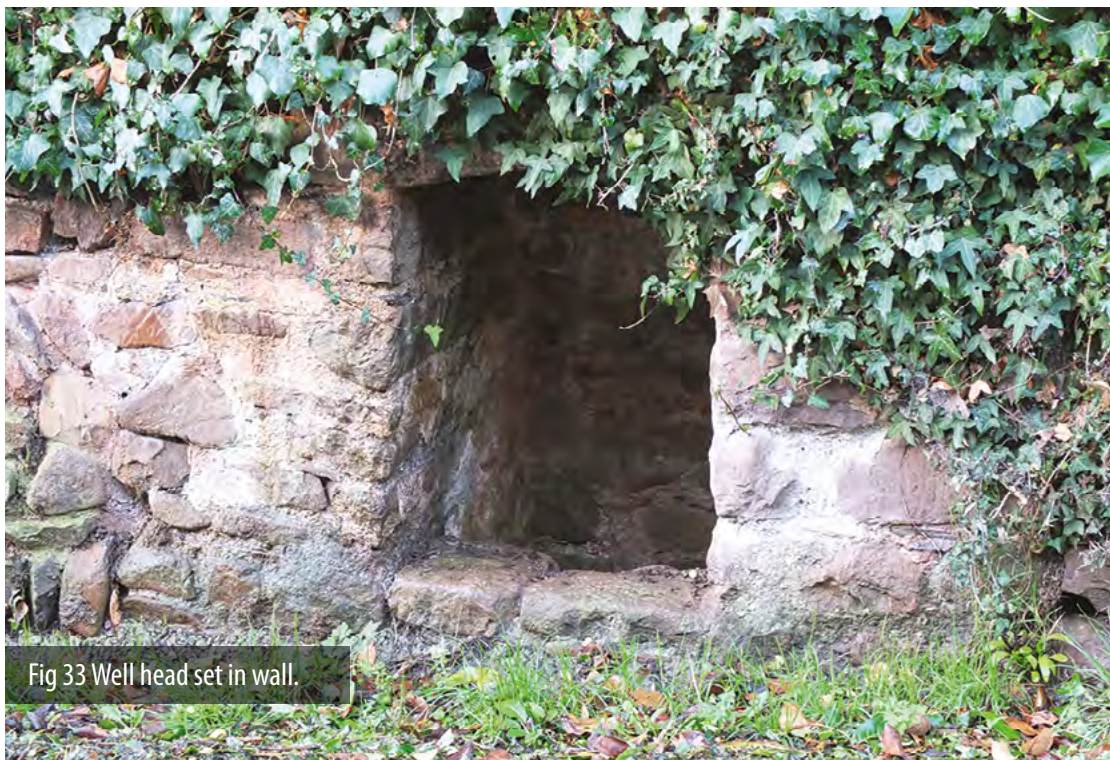
There are a number of wells in the village shown on the early OS maps with a visible example surviving on the lane down to the lower village (Fig. 33).

Fig 33 Well head set in wall.
