Exmoor National Park
Historic Environment Report Series No 21

WOOTTON COURTENAY CONSERVATION AREA: APPRAISAL DOCUMENT

Adopted 2018

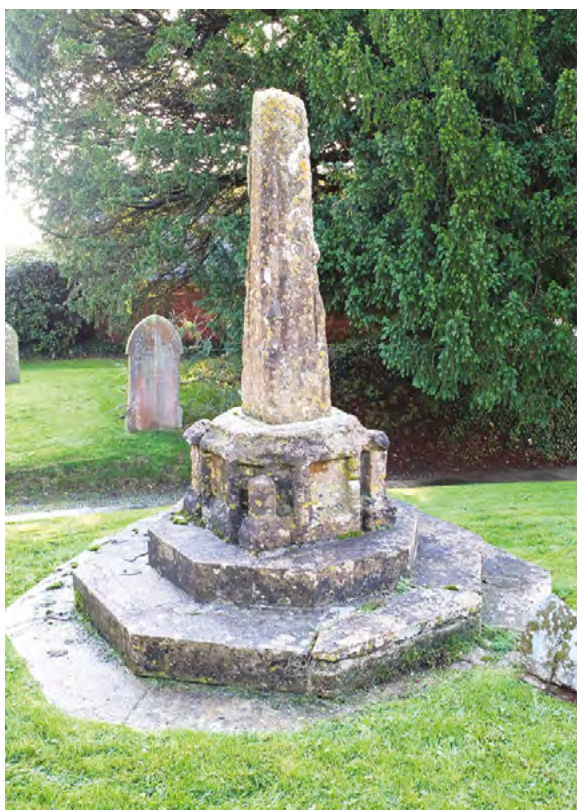
Fig 34 Medieval churchyard cross – the plinth is 19th century.

Within the churchyard are the remains of a churchyard cross (Fig. 34) built of Ham Hill stone, and dating from the early 15th century but subjected to a heavy mid 19th century restoration. There is also an early 17th century headstone. Both this and the cross are listed in their own right.

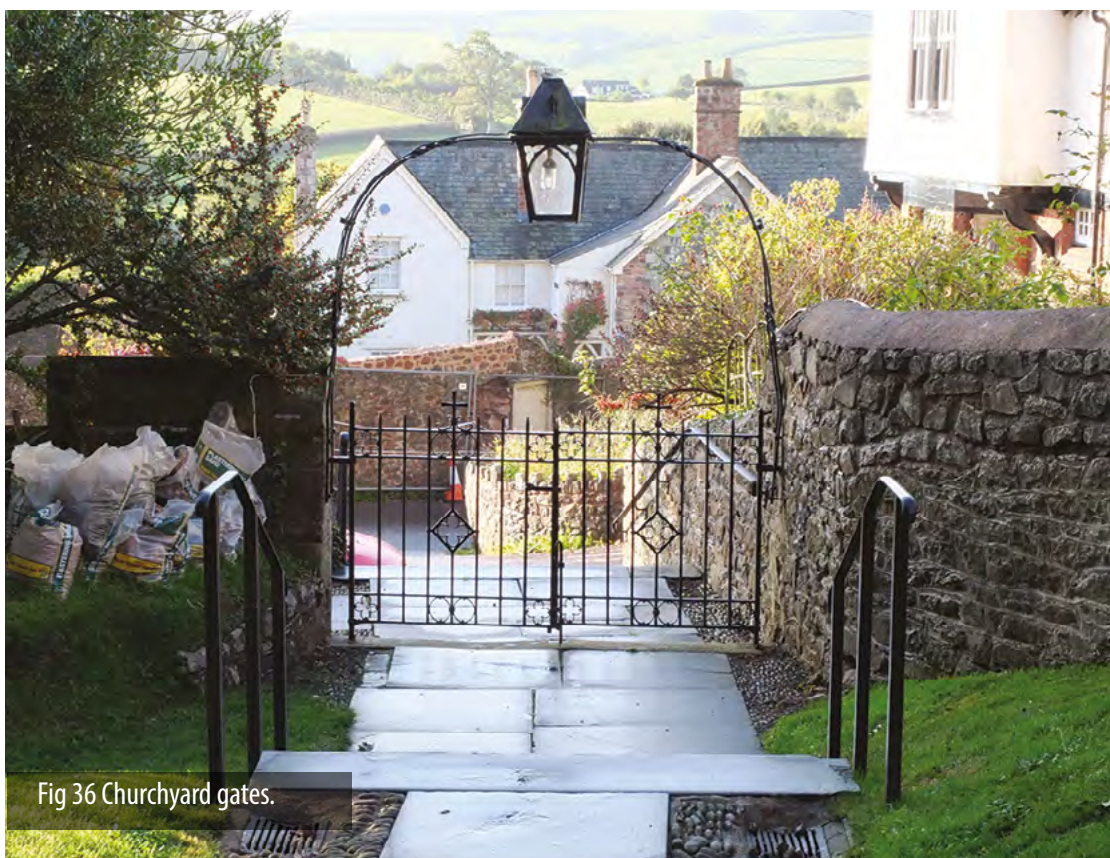
Metal railings and gates also form boundary features in a few locations within the Conservation Area. They are mainly of plain wrought iron design, and date from the mid-late 19th century onwards. The ornate churchyard gates (Fig. 36) with overthrow and lantern are, for example, of no great age but do form an important role in marking the formal entry to the consecrated ground.

Fig 36 Churchyard gates.

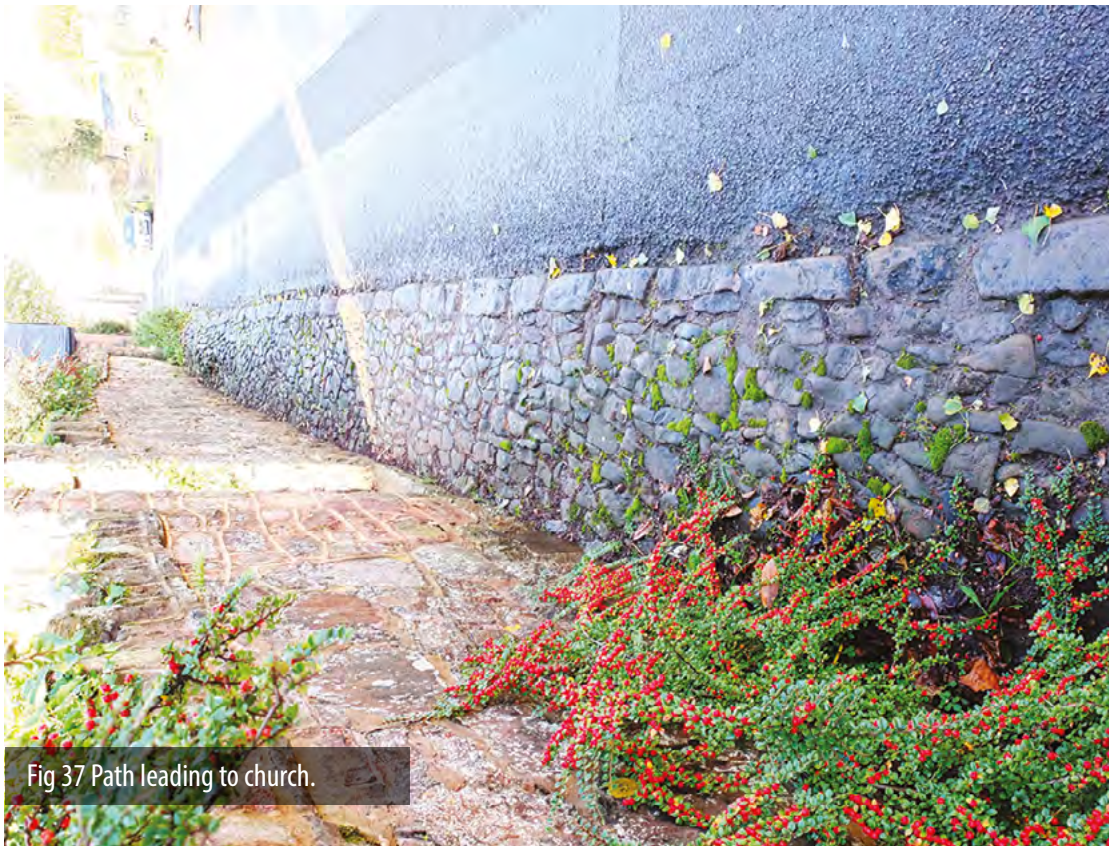
Wootton Courtenay has a significant number of surfaces that are paved, cobbled and kerbed in natural stone. The best examples are in the higher part of the village, including the churchyard where the centre of the path has been replaced by paving slabs (Fig. 37) and an exceptional 100 m intact length east of the former village school (Fig.38). Although much consists of small blocks of local hard sandstone randomly laid, there are smaller areas where slate, brick and waterworn cobbles are used.

Fig 37 Path leading to church.

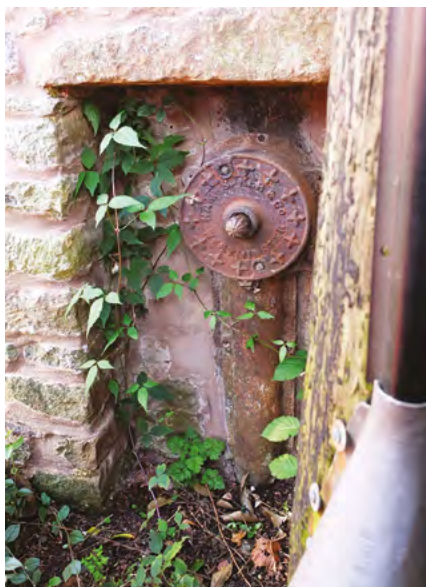
Fig 39 Hydrant to rear of telephone kiosk.

Two hydrants manufactured by Ham Baker & Co, probably in the late 19th-early 20th century, survive, one behind the K6-type telephone kiosk near the church (Fig. 39) and the other next to Pound Cottage.

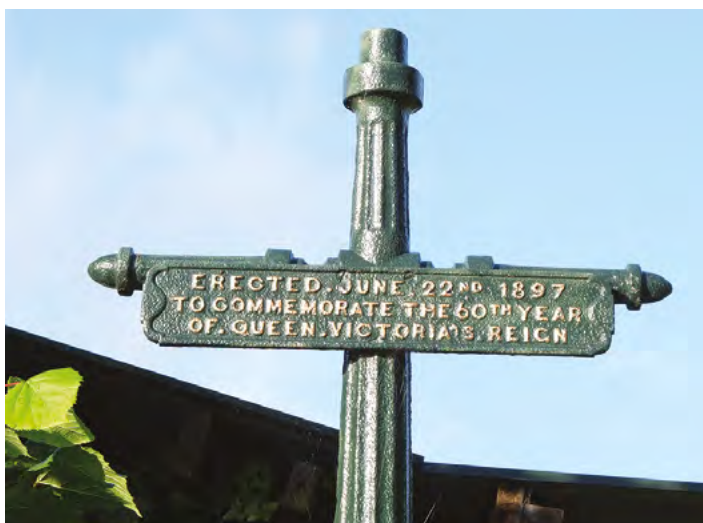
There is also an 'ER II' post box set in the wall near the post office. Opposite is the village noticeboard which celebrates the Silver Jubilee of 1977 – a timber bench near the church records the Coronation of 1953. An earlier royal event is commemorated within the churchyard where there is a cast iron lamp standard erected for Queen Victoria's Diamond jubilee (Fig. 40) although this does not appear to have been its original position.

Fig 40 Lamp standard in churchyard.

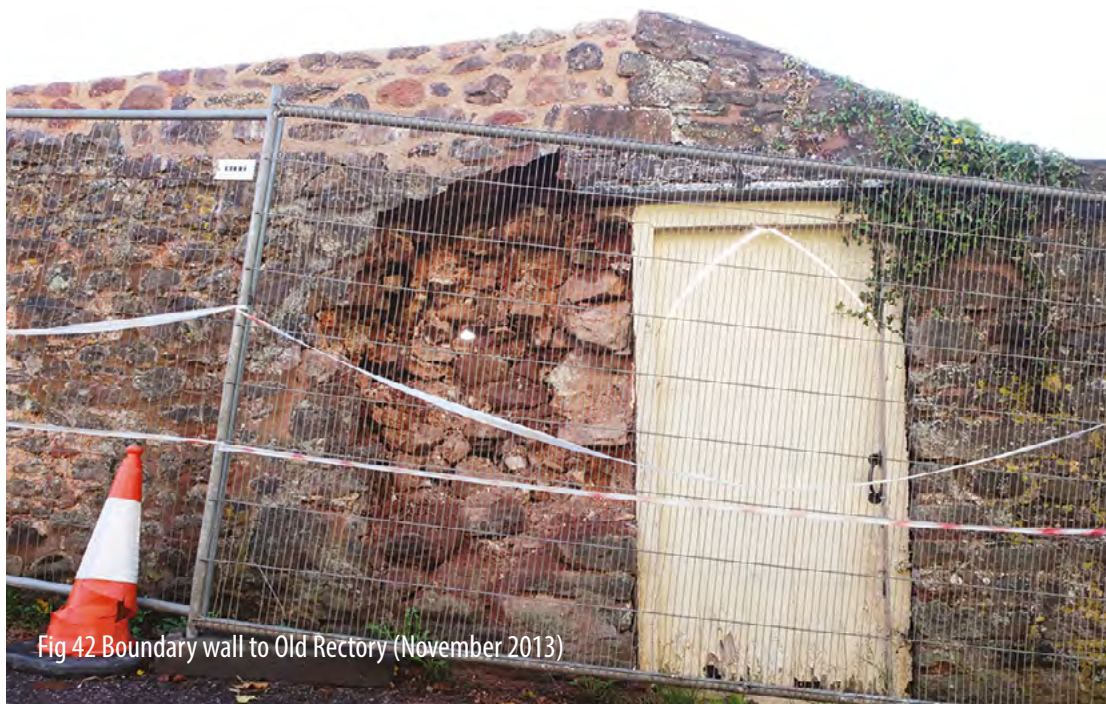
Fig 42 Boundary wall to Old Rectory (November 2013)

Some localised deterioration of stonework is noted, especially the condition and structural integrity of some boundary walls. At the time of inspection, the wall to the Old Rectory was in need of repair (Fig. 42). The churchyard is generally very well kept but some individual graves are in need of maintenance (Fig. 43).
