Exmoor National Park
Historic Environment Report Series No 20

DULVERTON CONSERVATION AREA: APPRAISAL DOCUMENT

Adopted 2019

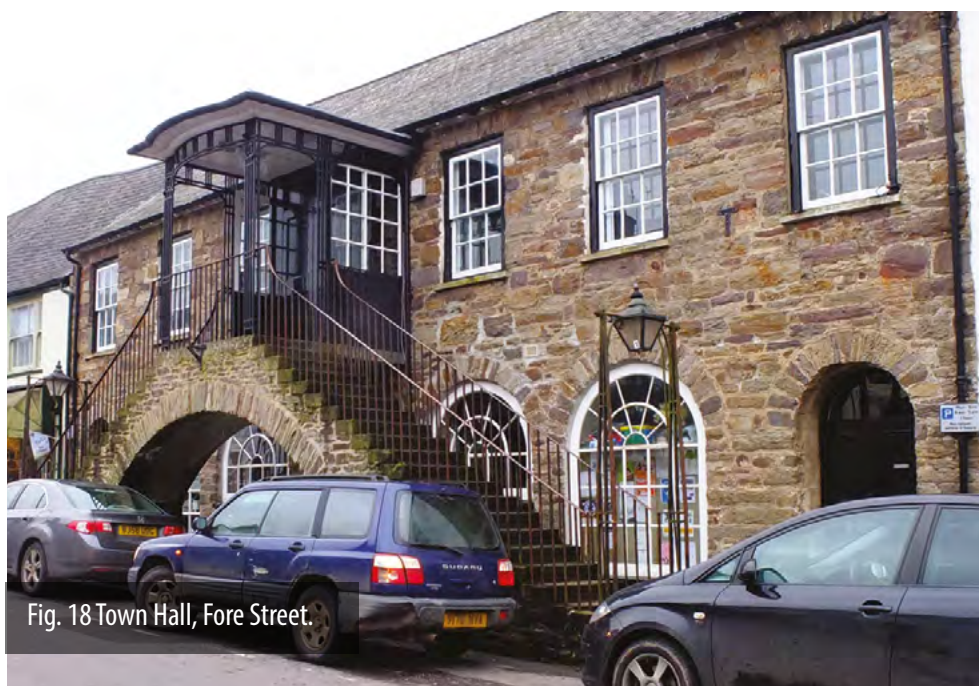
Fig. 18 Town Hall, Fore Street.

Standing at the centre of a small island between Fore Street and High Street is the **Town Hall** (Fig. 18), a former market house and now a public hall over shops. The original market house on this site dated to around 1760, the current building is from 1866 and has a seven-bay stone front. Its most notable feature, the arched staircase with twin arms leading to a central upper porch with veranda and ironwork has a lightness of touch reminiscent of Regency style but was actually added in 1930 by the architect Sir A.E. Richardson.

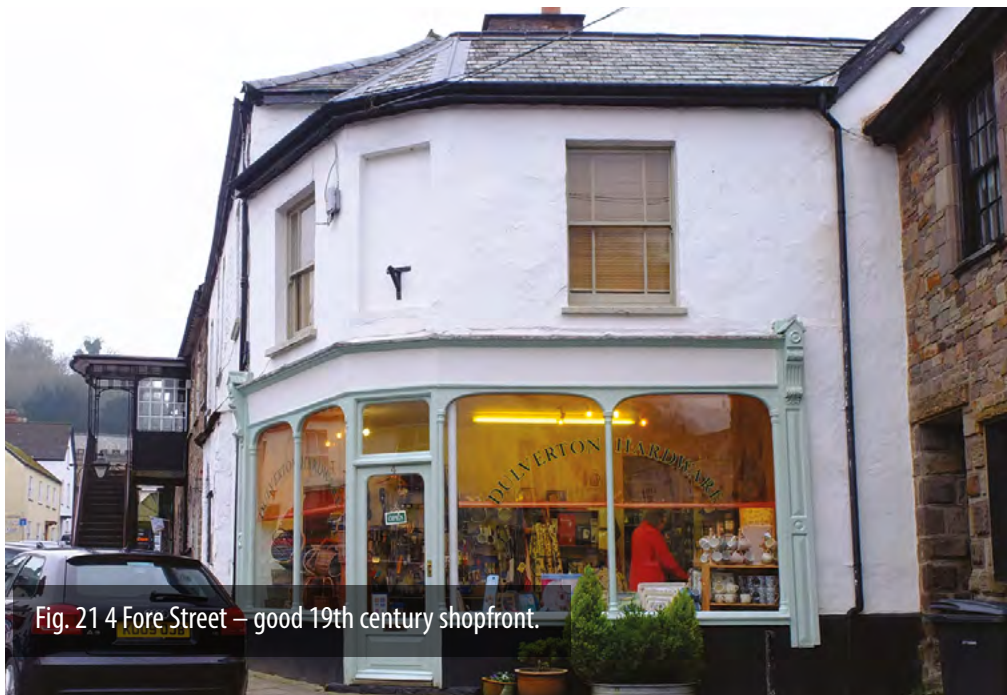
Fig. 21 4 Fore Street – good 19th century shopfront.

Back on Fore Street, **No.4 (Dulverton Hardware)** (Fig. 21) occupies a corner site and has a good late 19th or early 20th century shopfront with the entrance on the splay and ornate pilasters and consoles flanking the display windows and fascia.

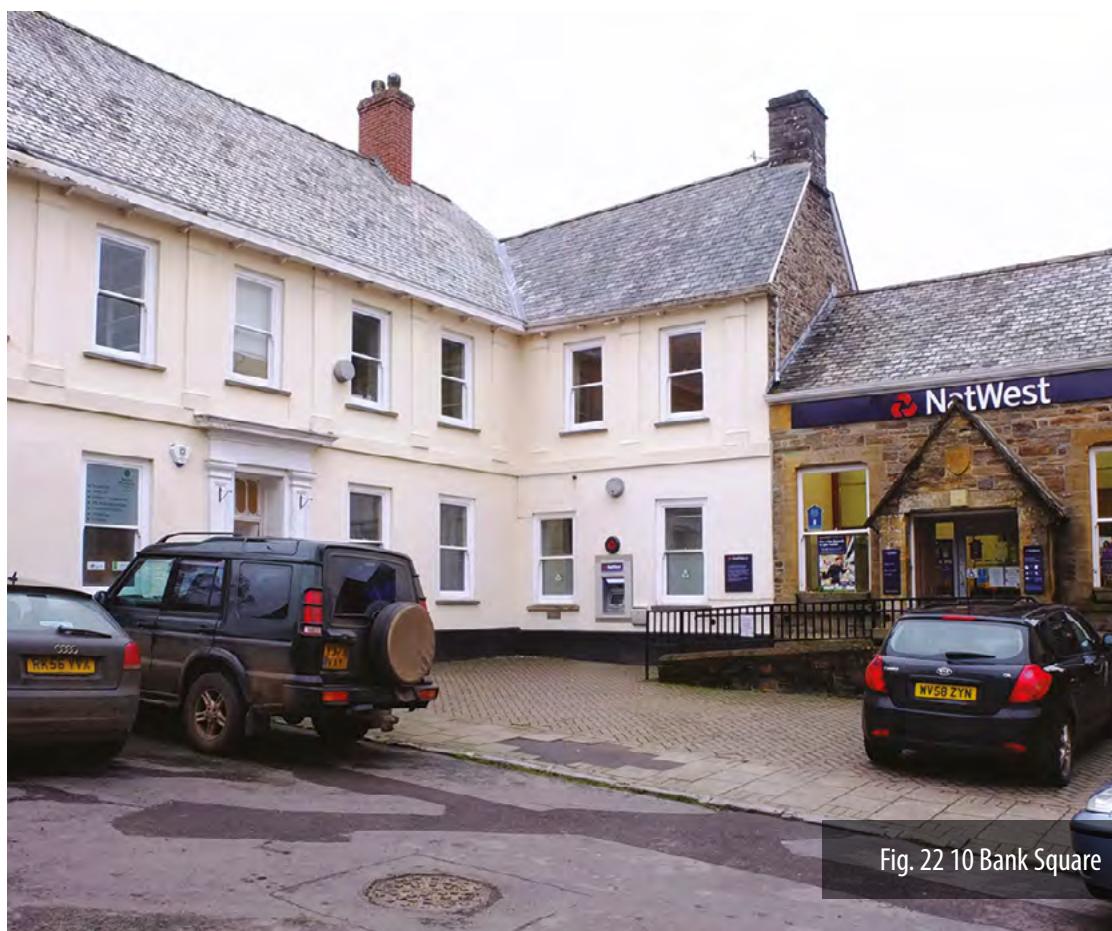
Fig. 22 10 Bank Square

North of the cross-roads, at the top of Bank Square and closing the view is **No 10** (Fig. 22) a 5-bay house. It probably dates from the early 19th century and is stuccoed with an imposing Classical entrance, including panelled door and four-light patterned glazing above. The plain sash windows are later in date, and the first floor has flat pilasters between bays rising from a plat band. It was formerly a bank in the 19th century until this function transferred to the building to its right.

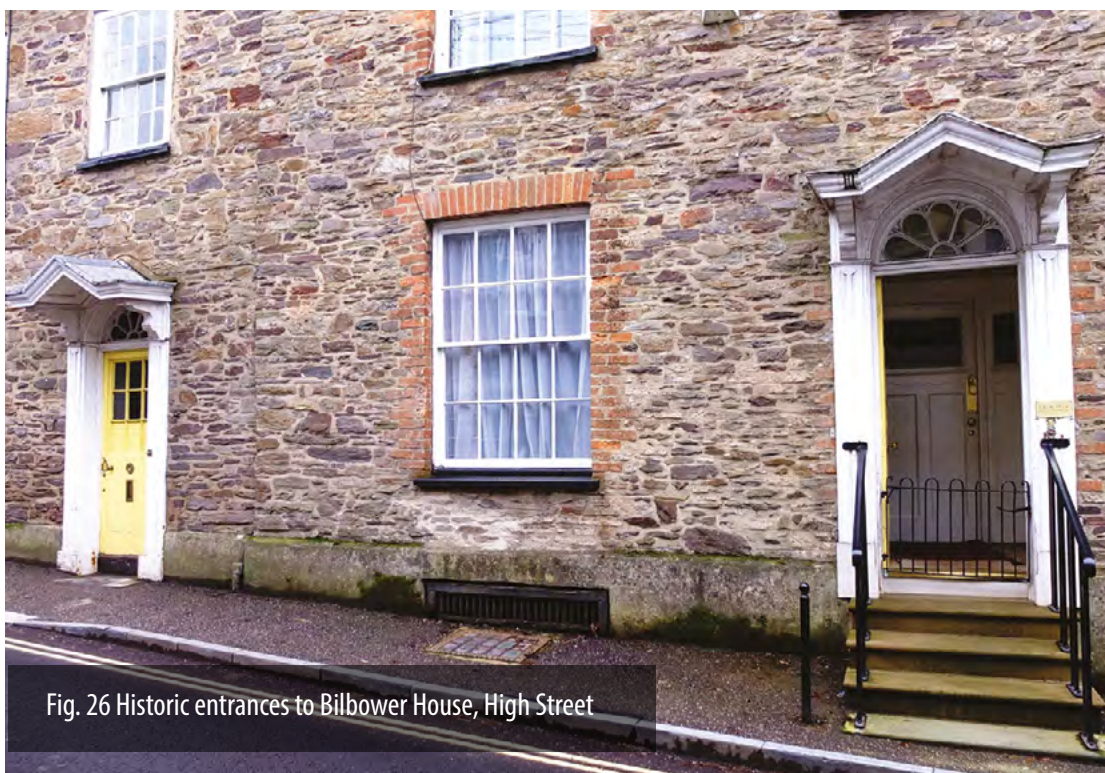
Fig. 26 Historic entrances to Bilbower House, High Street

The upper part of the High Street, from Union Street to Vicarage Hill, contains a number of notable buildings. On the south side, **Bilbower House (Nos 50-52)** (Fig. 26) is two houses and part of a row and of late-18th/ early-19th century date. Built of local stone rubble with slate roofs, one half was rebuilt in the late 19th century with brick surrounds to window openings. Both have good quality fluted pilaster doorcases with fanlights (Fig. 77) and half-glazed and panelled doors respectively, the lower house is fronted by a short flight of stone steps with a wrought iron handrail.

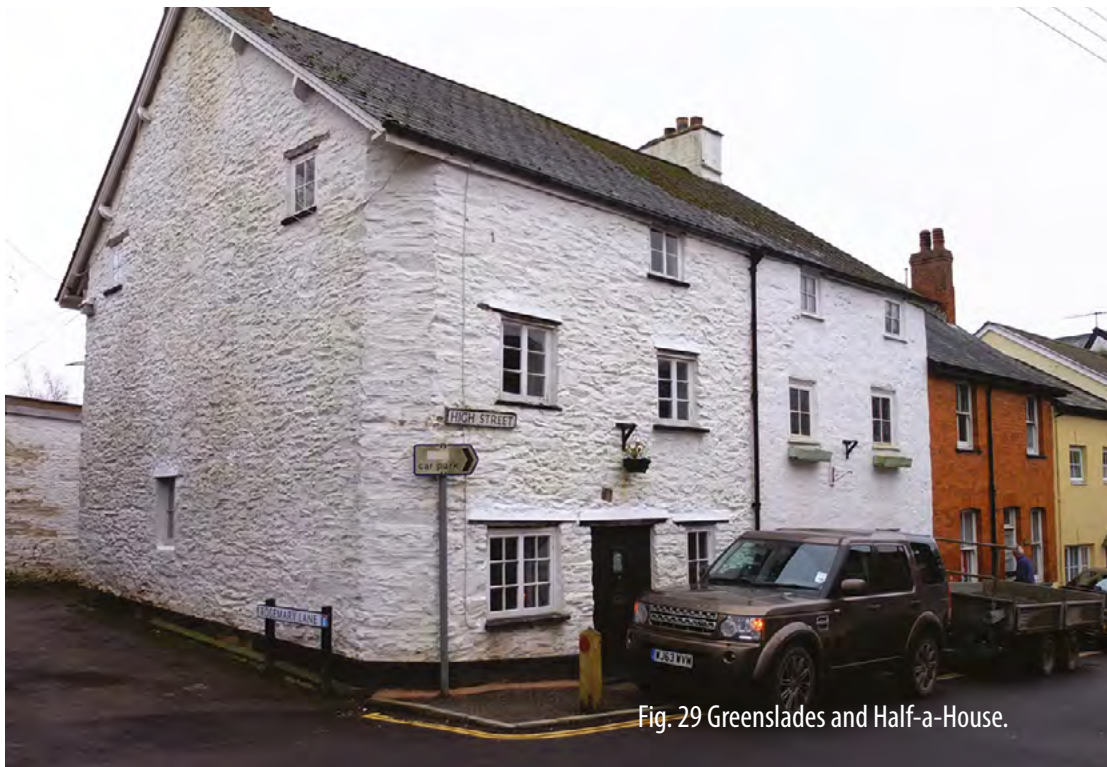
Fig. 29 Greenslades and Half-a-House.

Further up the hill at the junction with Rosemary Lane is **Greenslades** (Fig.29) and an adjoining cottage, probably 18th century or earlier. The irregular three-storey frontage of painted stone rubble has small three-light casement windows with timber lintels. Off Rosemary Lane, **Chypleighs** (Fig. 30) is an early 19th century cottage, roughcast over rubble and possibly adapted from an earlier two-cell and cross-passage plan dwelling with stone stacks at either end. There are pointed gothic arch openings; the windows are casements with divided tracery heads, and the door of vertical plank construction.

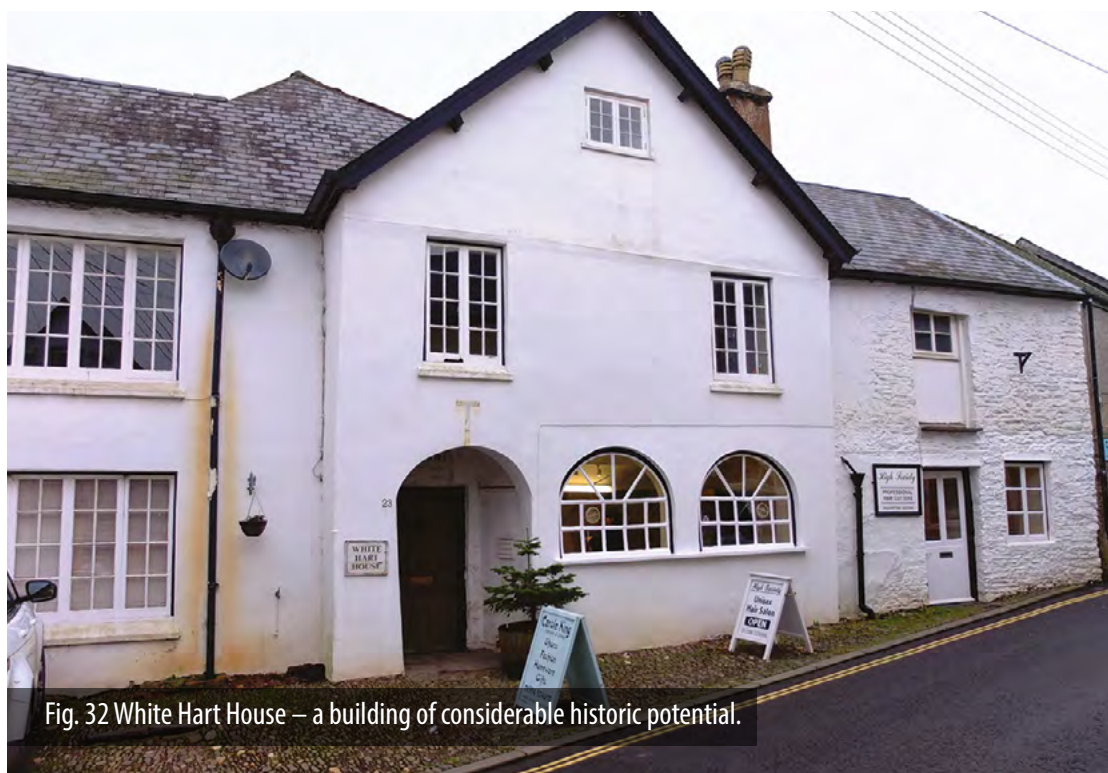
Fig. 32 White Hart House – a building of considerable historic potential.

Another building of interest, **White Hart House (No. 23)** (Fig. 32) is located on the island between Fore Street and High Street and forms a 'C-shaped' range around a small front cobbled courtyard. Its two storey frontage to the High Street has a large gable containing an attic storey. The ground floor has a deep semicircular arched entrance porch and adjoining round-headed windows with radial glazing bars. An internal inspection by Richard Parker has revealed the building to date to the 15th or 16th century and raises the intriguing possibility that it may have originated as a market house or guildhall.

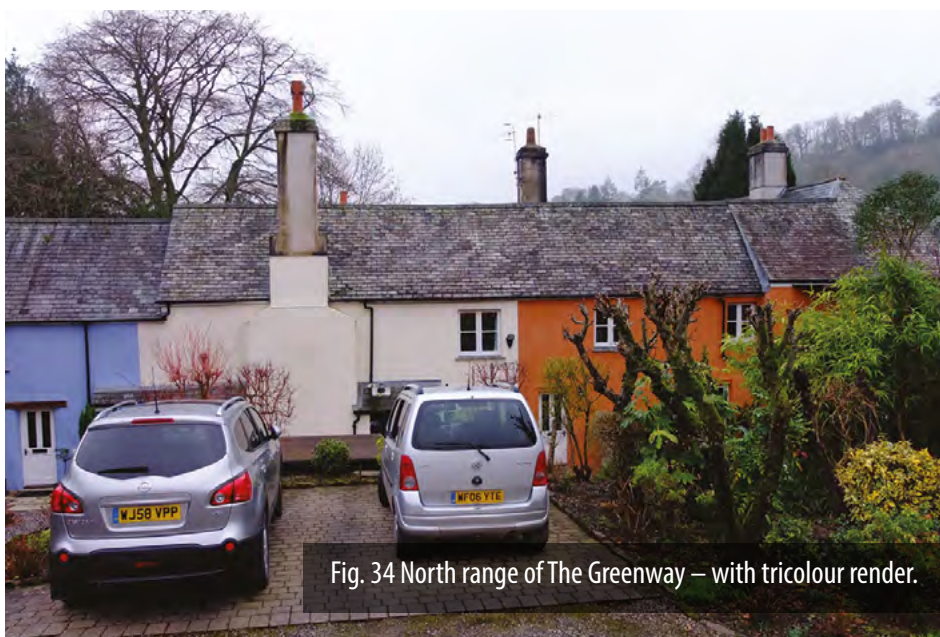
Fig. 34 North range of The Greenway – with tricolour render.

On the opposite side of the High Street and down a narrow lane is **The Greenway** (Fig. 34), a late 18th –early 19th century fronting of an earlier house. It is rendered over rubble and has a hipped slate roof. Its main south-facing two-storey 5 bay range is in Regency style with ground floor 15- pane sashes reaching to ground level and similar first floor windows of 12-panes. There is a central semicircular headed entrance with panelled reveals and above the door a fanlight with radiating bars. The interior is said to retain significant period detail, for example, panelled shutters to windows, a stick baluster stair, and segmental-headed doorway also containing a fanlight.

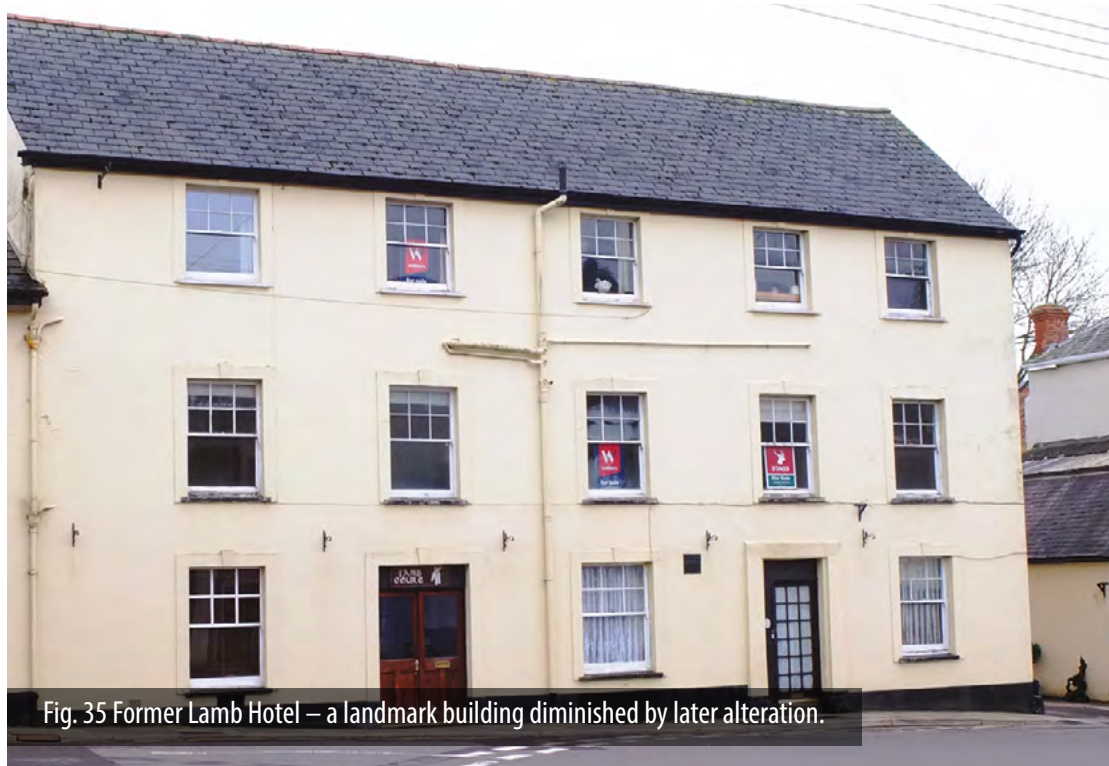
Fig. 35 Former Lamb Hotel – a landmark building diminished by later alteration.

Back on the High Street and a prominent town centre building, the **Lamb Hotel (now Lamb Court)** (Fig. 35) is an imposing 3-storey 5-bay building probably dating to the late 18th century. The former hotel and outbuildings to the rear were converted into flats in late 1980s resulting in the loss of much of its character, including the 4 large chimney stacks and the impressive ionic porch that was admired by the architectural historian Pevsner.

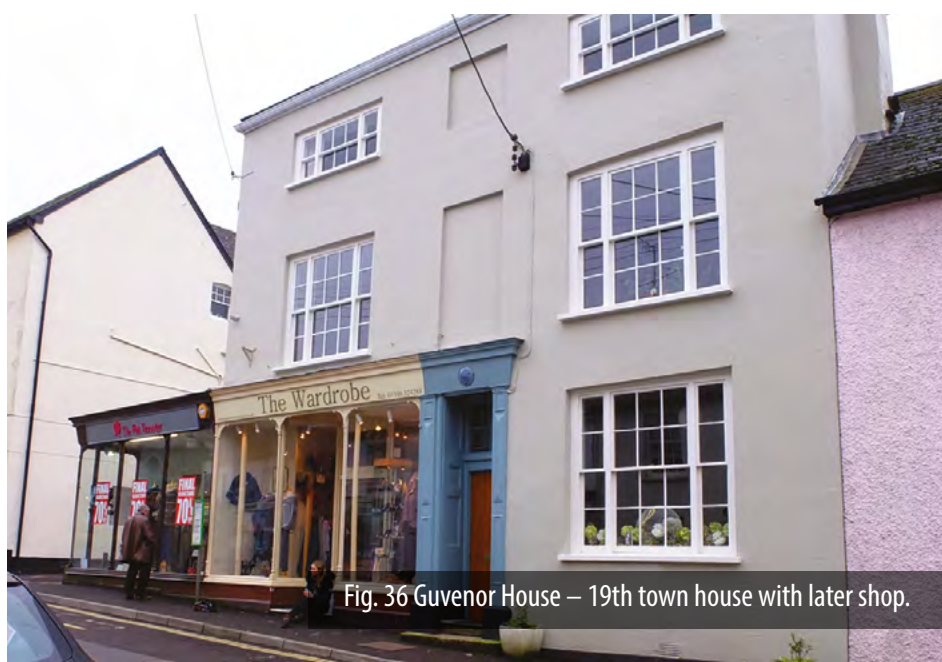
Fig. 36 Guvenor House – 19th town house with later shop.

The adjacent **Guvenor House (No. 18)** (Fig. 36) is also a large three-storey building, in its current guise it is a substantial town house of c.1800 with a later shop window inserted in its three-bay symmetrical façade with a blind centre bay and tri-partite sash windows to the first floor. An internal inspection, however, suggests it may be a remodelling of a 17th century building. The shopfront is also of interest and has panelled reveals and lozenge pattern in flanking pilasters.

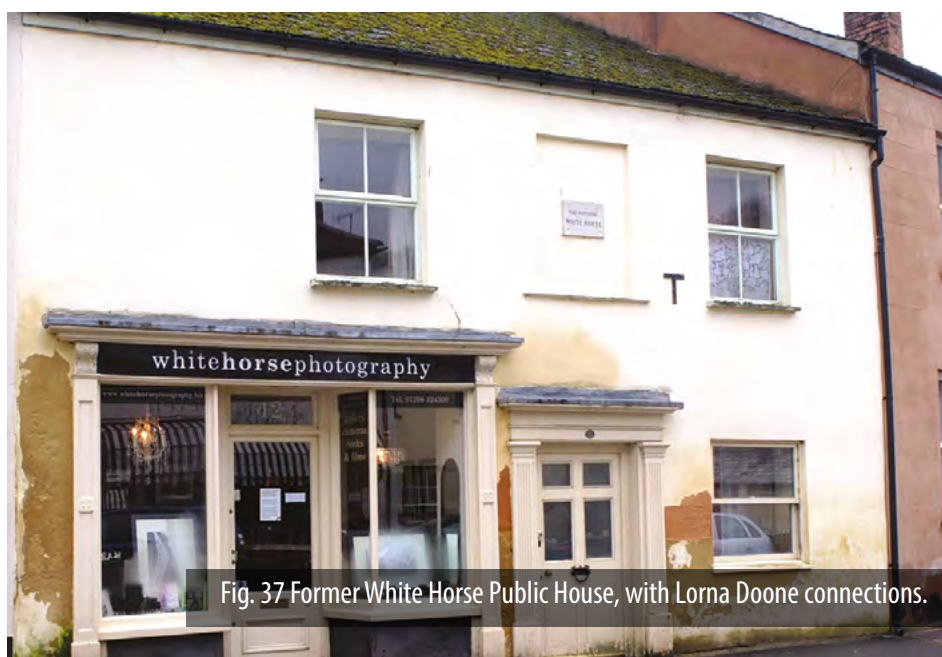
Fig. 37 Former White Horse Public House, with Lorna Doone connections.

The remainder of the buildings on the High Street as it heads west towards the Barle are two storey. **No. 12** (Fig. 37) is described on a wall plaque as 'The historic White Horse' and is probably of 18th century origin or earlier, but with a mid-late 19th century frontage including a shop-front with central recessed entrance door and cornice supported by curved console brackets flanking the fascia. Adjoining is a six-panel door (the upper four glazed) within a heavy door-case with fluted pediments and flat hood with cornice above.

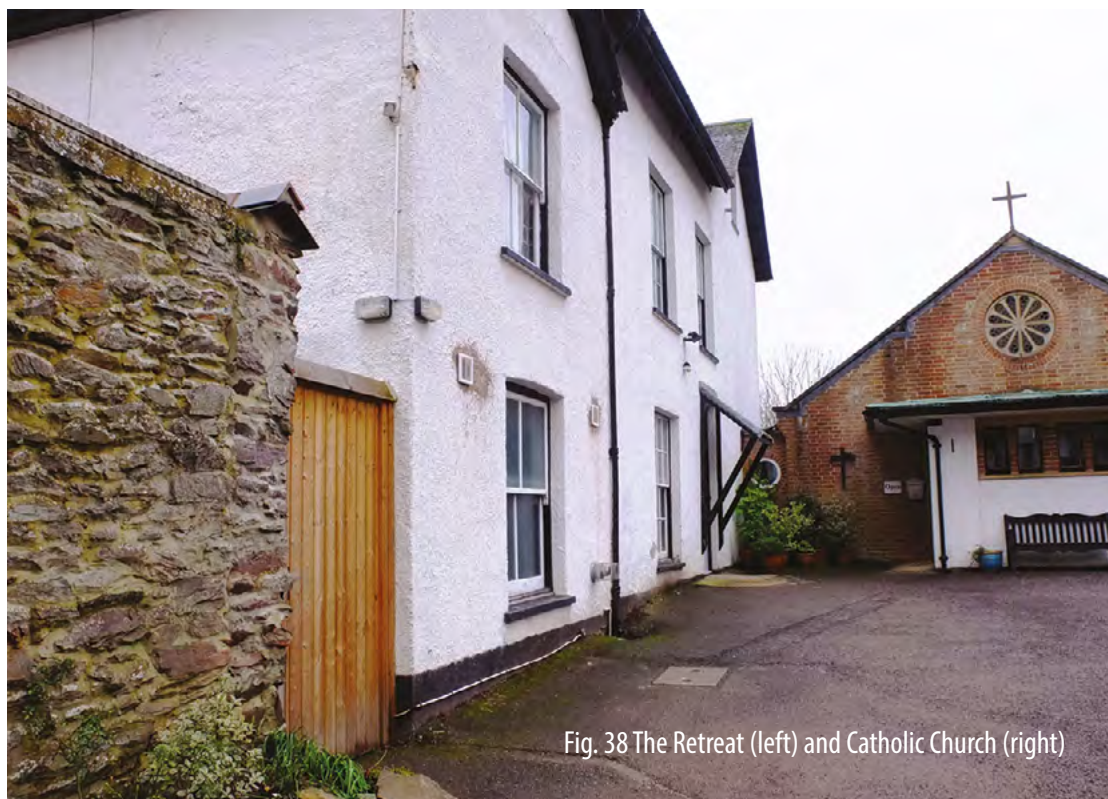
Fig. 38 The Retreat (left) and Catholic Church (right)

The **Catholic Church** was formerly the stables to the adjacent the large 19th century house known as **The Retreat** and were converted to a church in 1955 (Fig. 38). Both are set back off the main street frontage.

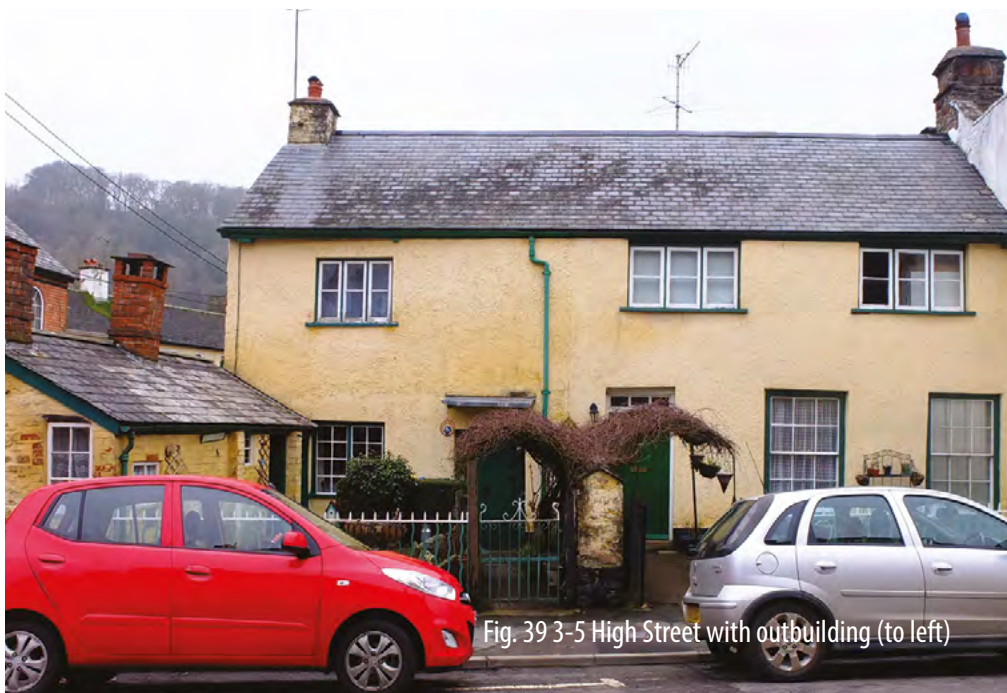
Fig. 39 3-5 High Street with outbuilding (to left)

On the north side of the street and set back slightly, **3 and 5 High Street** (Fig. 39) were formerly a single house, probably 17th century or earlier and three rooms with cross-passage. The listing details suggest an original hall to which a rear lateral stack was added, probably in the 17th century. The original house was remodelled, extended and divided in the early-mid 19th century with two surviving 12-pane sash windows and later 19th - early 20th century casements with horizontal glazing bars. No. 3 has a single storey outbuilding projecting forward with a mono-pitched roof and twin stacks.

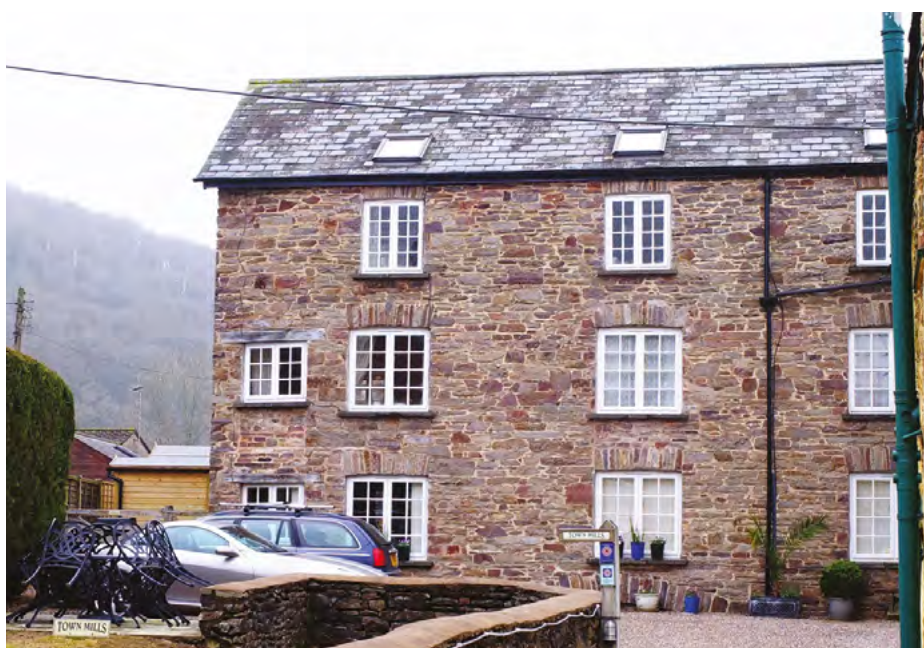
Fig. 40 Town Mills

To the rear, **Town Mills** (Fig. 40) is one of the 19th century grist mills, almost certainly with earlier origins. It is of three-storeys, with a transverse wing across the leat. Predominantly built of local sandstone rubble there is some timber panel infill and segmental arched openings with six-light casement windows.

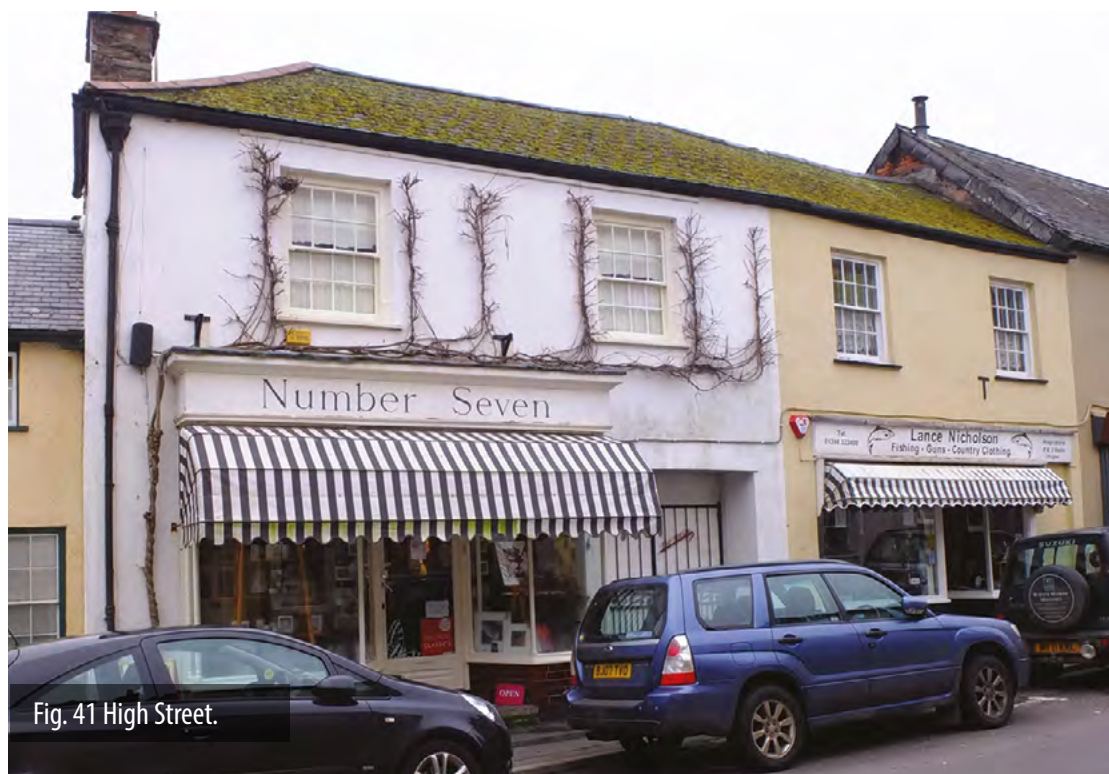
Fig. 41 High Street.

The remainder of the lower end of **High Street**, has a well-proportioned sequence of late 18th and 19th century two-storey frontages with a number of traditional shop-fronts, and first floor sash windows with narrow glazing bars, especially its south facing elevation. **Nos 7 and 9** (Fig. 41) are fairly typical and represent a 19th century rebuilding of an 18th century building.

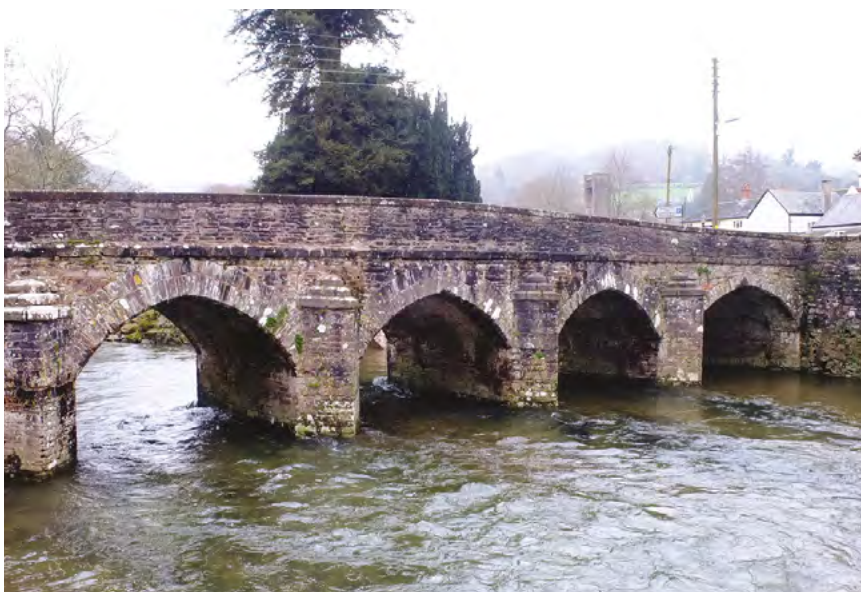
Fig. 42 The Barle Bridge

The Barle Bridge marks the western entry to the town. It is built of local stone rubble with ashlar string course and coping and spans the river in five arches with pointed cutwater buttresses between a four-centre central arch. It is medieval in origin, but was repaired in 1624, and widened in 1819 by John Stone. It has had to be repaired after flood damage on many occasions, notably in 1866, 1952 and 2012.

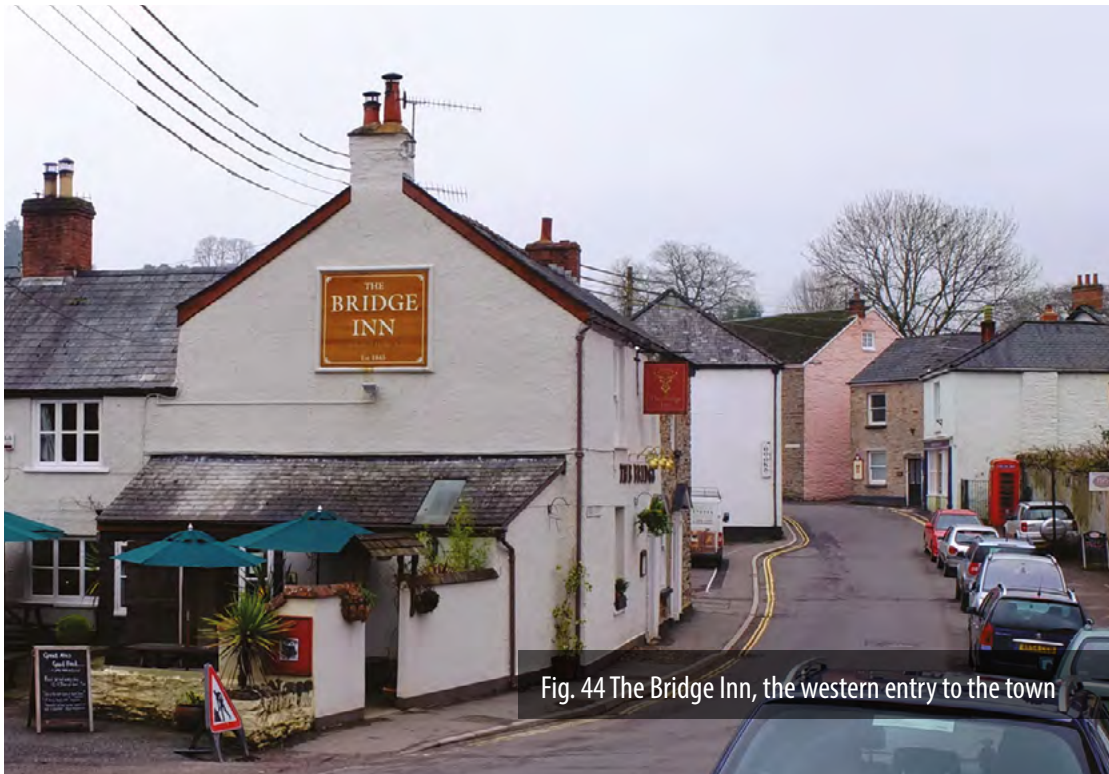
In Bridge Street, **Bridge Inn** and **Bridge Cottage** (Fig. 44) are both early-mid 19th century (the date of 1845 is marked out in pavement cobbles at the front). Built of stone rubble, the former occupies a prominent corner plot. Both have broken pedimented door-cases on the Bridge Street frontage, one with a round-headed arch, the other elliptical arch, both have fanlights with radial bars.

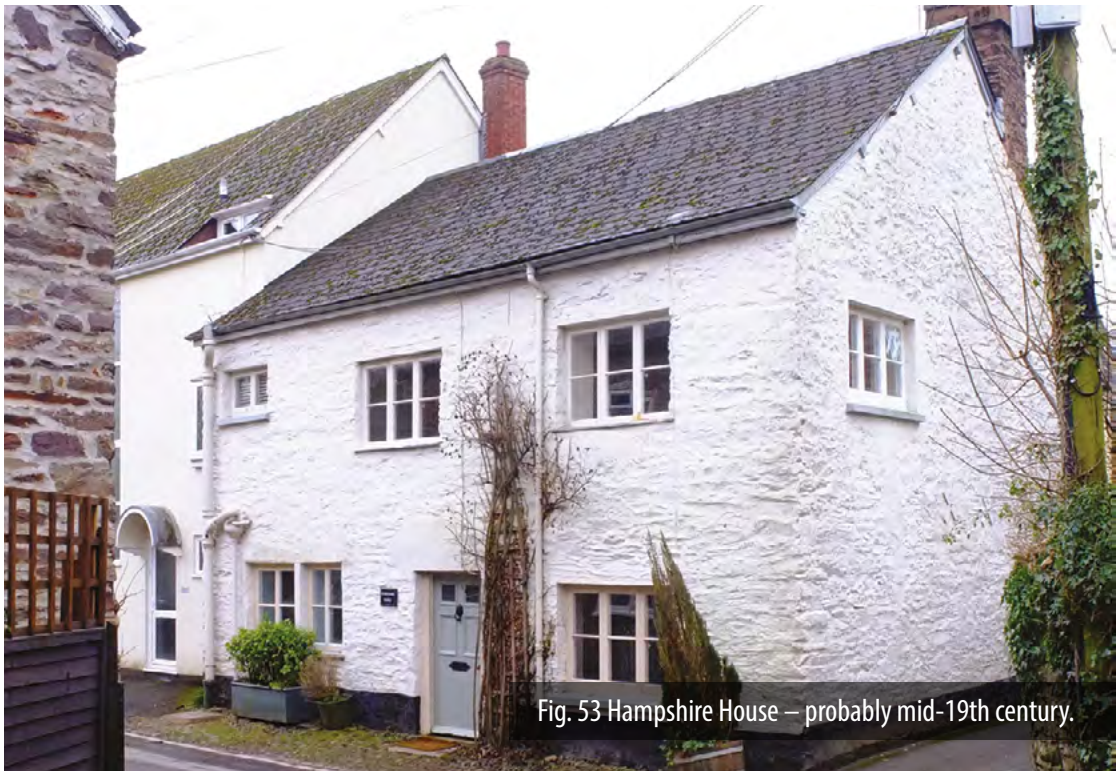
Fig. 53 Hampshire House – probably mid-19th century.

Chapel Street has a number of cottages, mainly dating to the mid-19th century. **Hampshire House** (Fig. 53), is representative of these with a painted stone rubble frontage and cobbled forecourt. The six-panel entrance door has two fixed lights and the timber casement windows each have a single horizontal glazing bar. Nos. 11-13 opposite have a modern plaque with a date of 1660. Others retain good detailing, such as the rustic porches at **Myrtle Cottage** (Fig. 76) and **Poolston Cottage**.

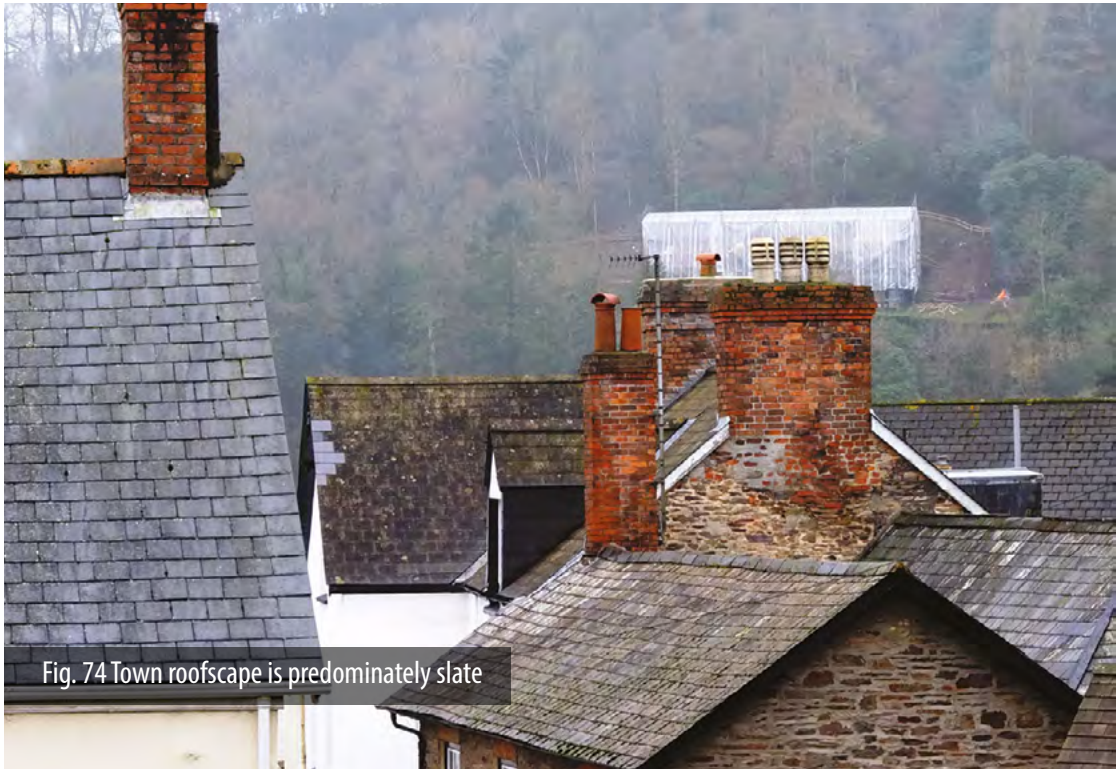
Fig. 74 Town roofscape is predominately slate

Traditionally thatch would have been a more prevalent form of roofing material, but from the late 18th century slate was more commonly used, especially in towns where there was the ever present risk of fire spreading. Today Welsh slate predominates, but a significant proportion has either been turnerised or has been replaced by varieties of artificial slate. More recently, imported natural slate has appeared. Evidence of local slate, which originated mainly from the Brendon Hills where a few slate quarries flourished until the early 20th century, is scarce in the town. From the late 19th century onwards, the main alternative to slate was the red clay double-Roman tiles, sourced from the Bridgwater area. Plain tiles also began to be used on new buildings from this time, but are less commonplace.

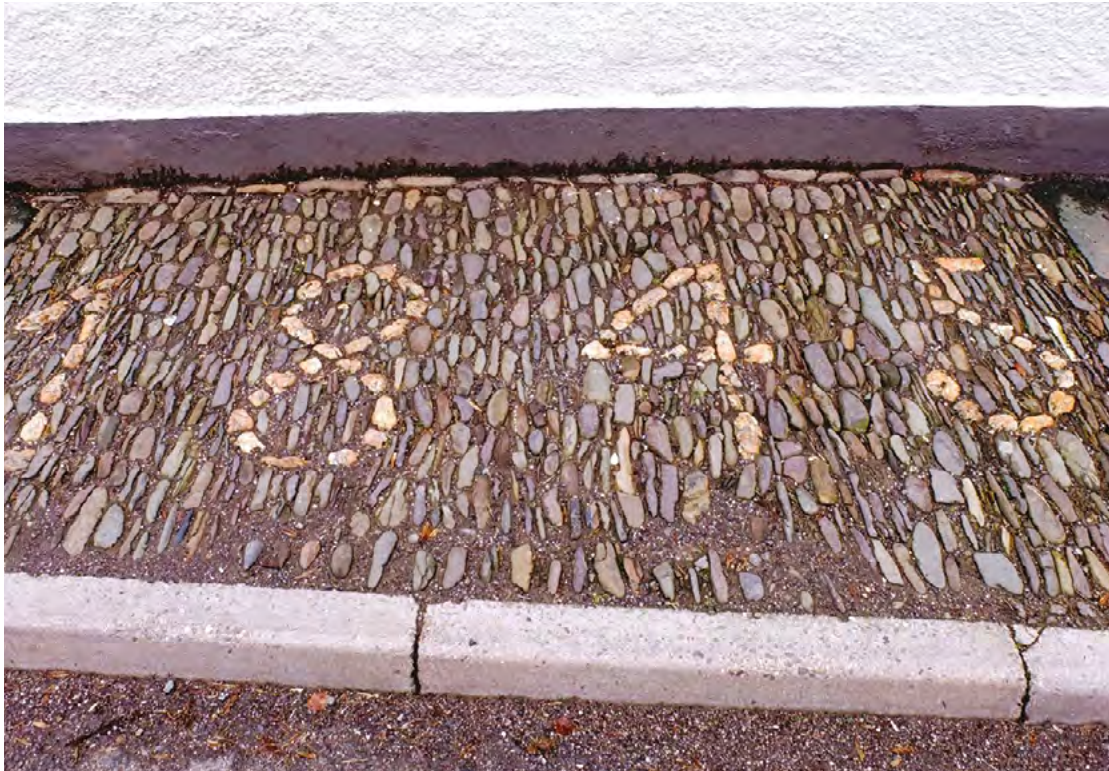
Fig. 80 Decorative cobbles show date outside the Bridge Inn.

Dulverton has many examples of paved or cobbled surfaces using natural stone. Most noteworthy is Church Lane, which probably dates from the time the terrace of cottages was built. The passage between the library and information centre is paved with York stone and is bordered by rounded cobbles. There are numerous examples of cobbled forecourts to houses, such as at White Hart House. In some locations the cobbles are a more marginal feature adjoining asphalt. There are other locations where surfaces consist of gravel or loose chippings, and where there is potential for a paved or cobbled surface to survive below or be added.
