Exmoor National Park
Historic Environment Report Series No 10

BOSSINGTON AND WEST LYNCH CONSERVATION AREA: APPRAISAL DOCUMENT

Adopted 2019

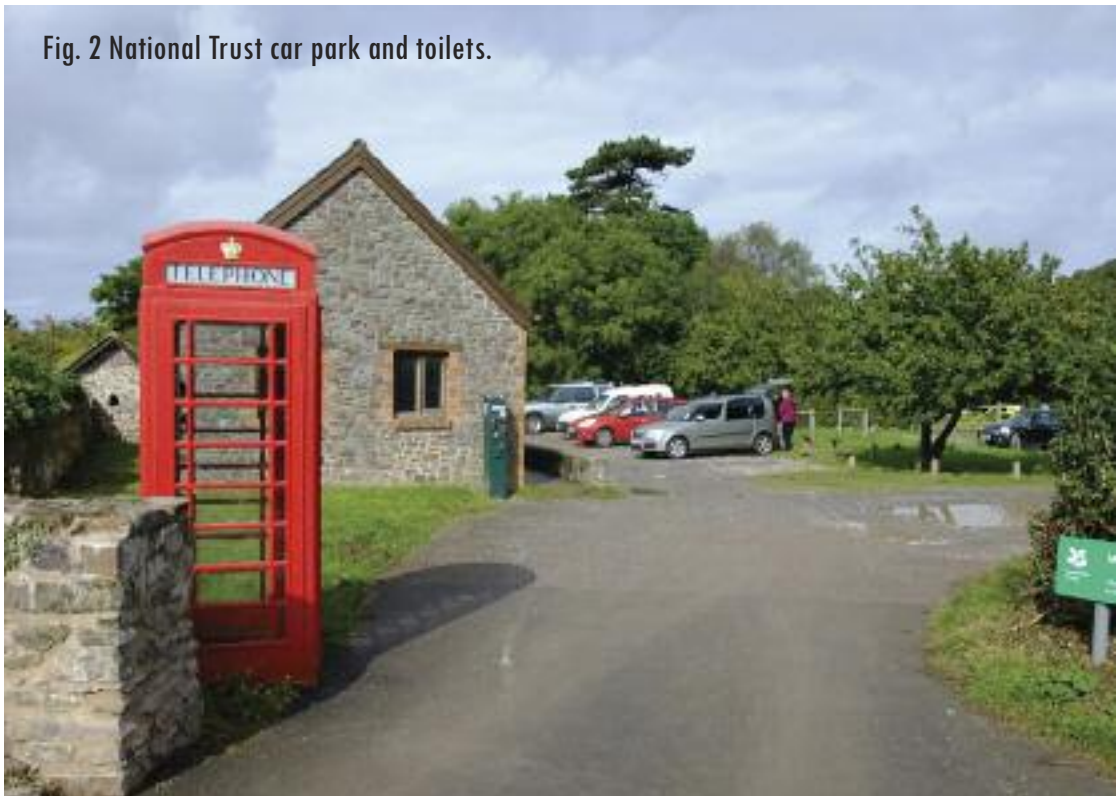
Fig. 2 National Trust car park and toilets.

The picturesque qualities of the settlements, the relatively easy accessibility and proximity to the sea, mean that Bossington and West Lynch have long been popular with tourists. The National Trust Car Park and toilet block in local vernacular materials (Fig. 2) also make Bossington a base for outdoor activities in the surrounding countryside.

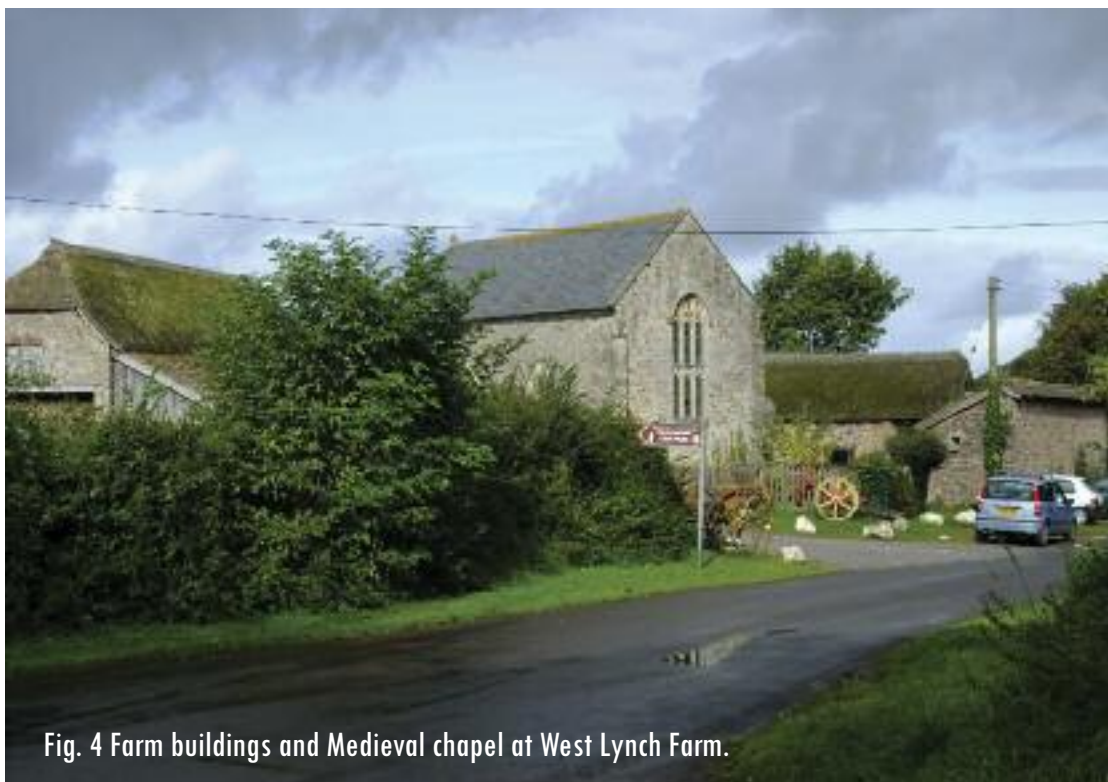
Fig. 4 Farm buildings and Medieval chapel at West Lynch Farm.

The buildings at West Lynch Farm (Lower Lynch) are tightly grouped to the south of the farmhouse creating, in effect, two partly enclosed yards, with the medieval chapel forming the south-west part of the east yard. The farmhouse is

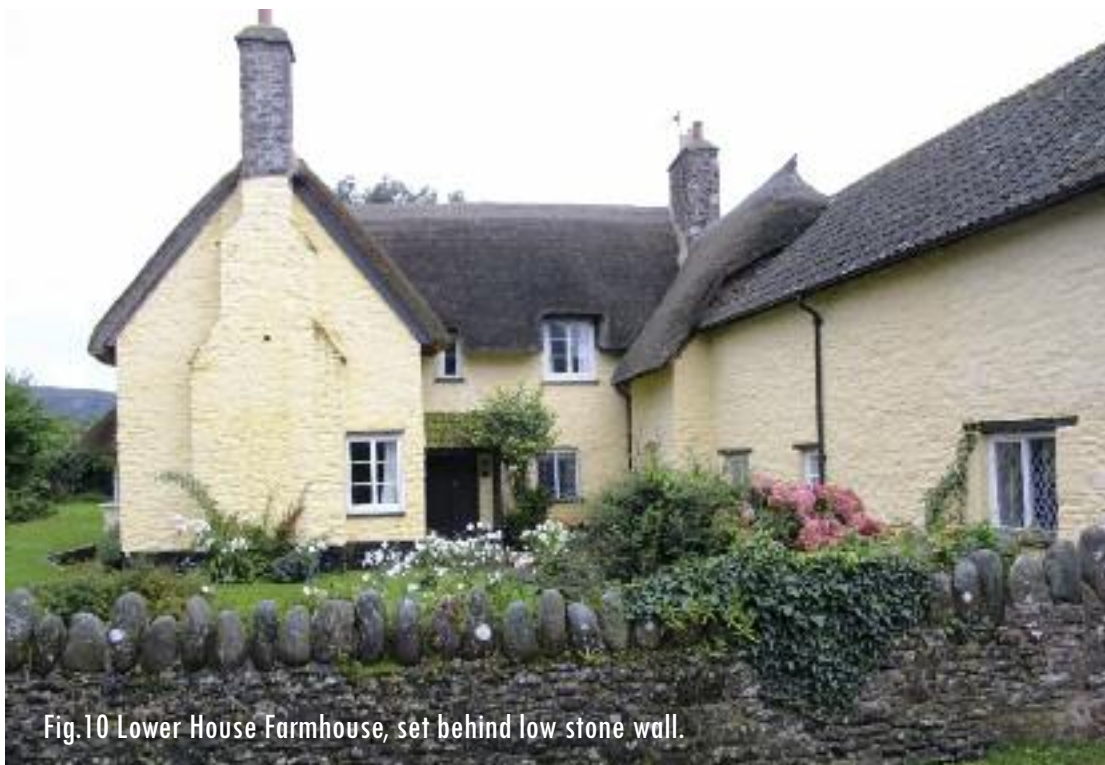
Fig.10 Lower House Farmhouse, set behind low stone wall.

At the north-west Conservation Area boundary is **Lower House Farm**. The farmhouse (Fig. 10) originally dates to the 16-17th centuries, and was altered and extended in the late 19th century, when most of the farm outbuildings were added. The current L-plan probably derives from the original two-cell south-west front with an adapted former agricultural wing addition. Windows are mainly 19th century leaded light casements, and there is a diagonally boarded double-door entrance.

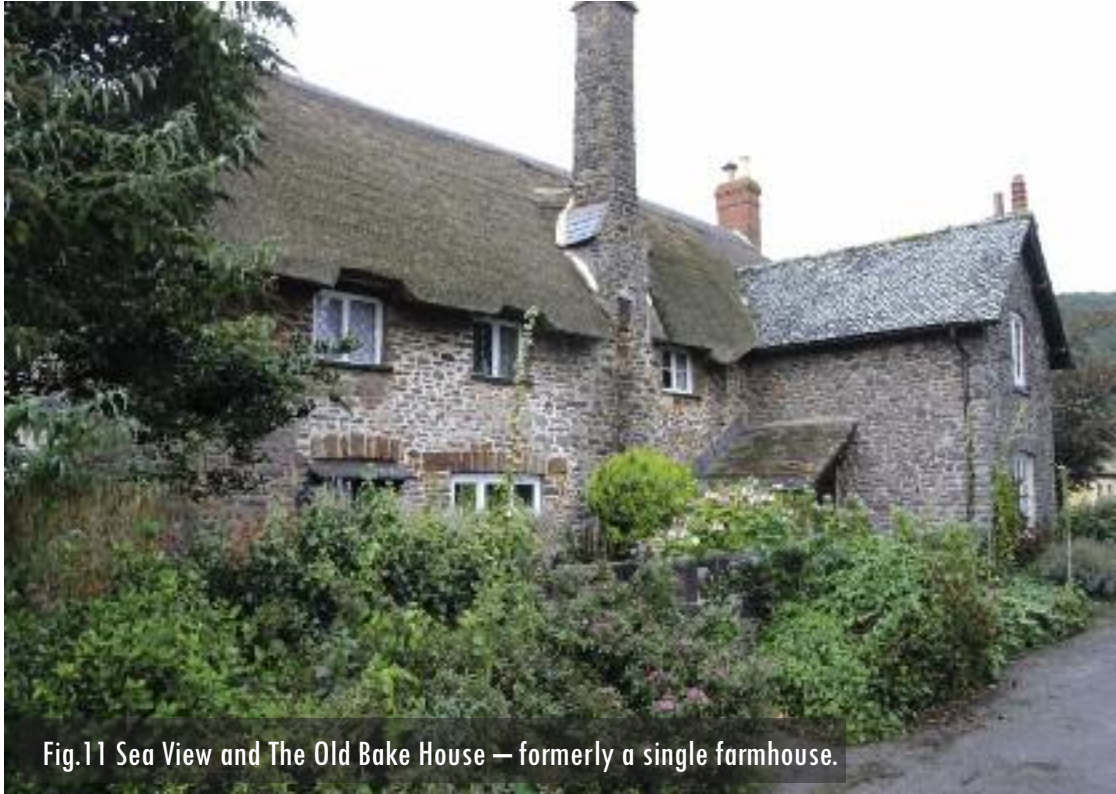
Fig.11 Sea View and The Old Bake House — formerly a single farmhouse.

Opposite is **Sea View** and **The Old Bake House** (Fig. 11), a former farmhouse, probably 17th century, but enlarged mid 19th century to form two cottages. The original plan is three-bay with cross-passage, enlarged to L-plan. There are many vernacular features, including a large stack rising from the eaves centre with slate-roofed projecting bread oven.

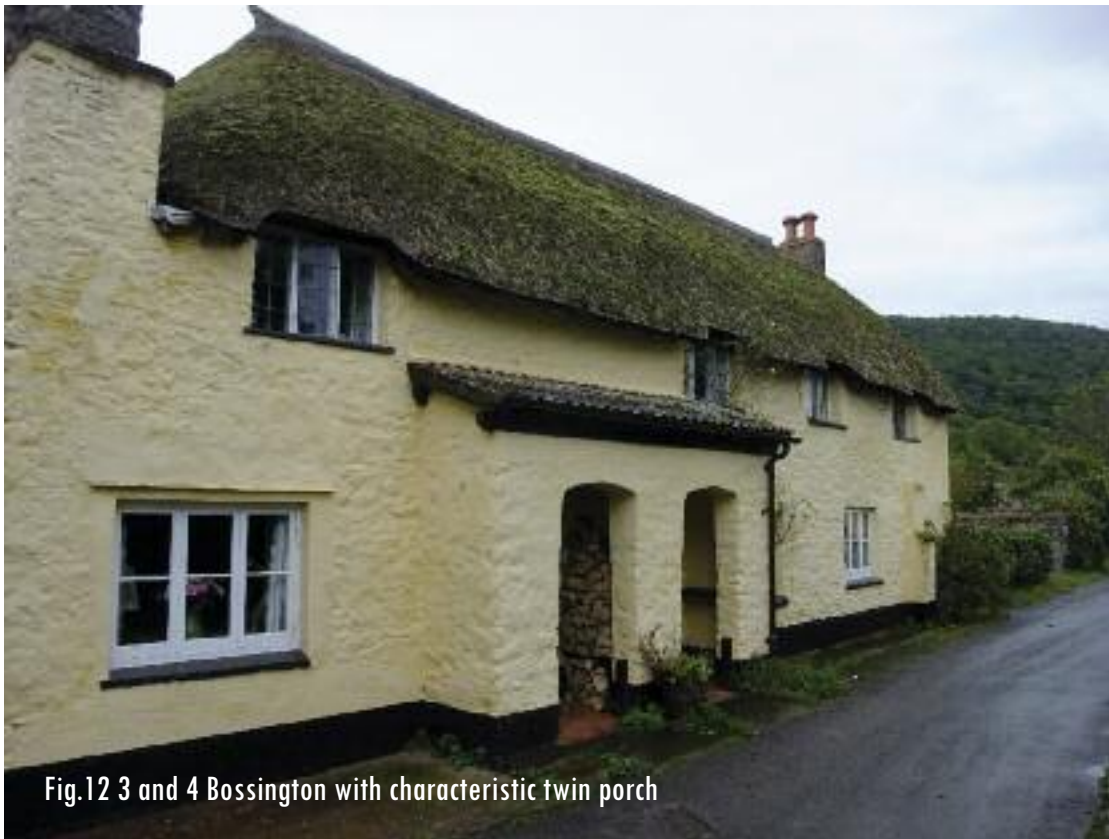
Fig.12 3 and 4 Bossington with characteristic twin porch

Nos. 3 and 4 Bossington (Fig 12) are a semi-detached mirrored pair of the early 19th century thatched cottages, with roughcast rendered stacks. There are other plain vernacular features, for example first floor leaded iron casement windows, and double Roman tiled porch with semicircular-headed openings and plank and ledge doors.

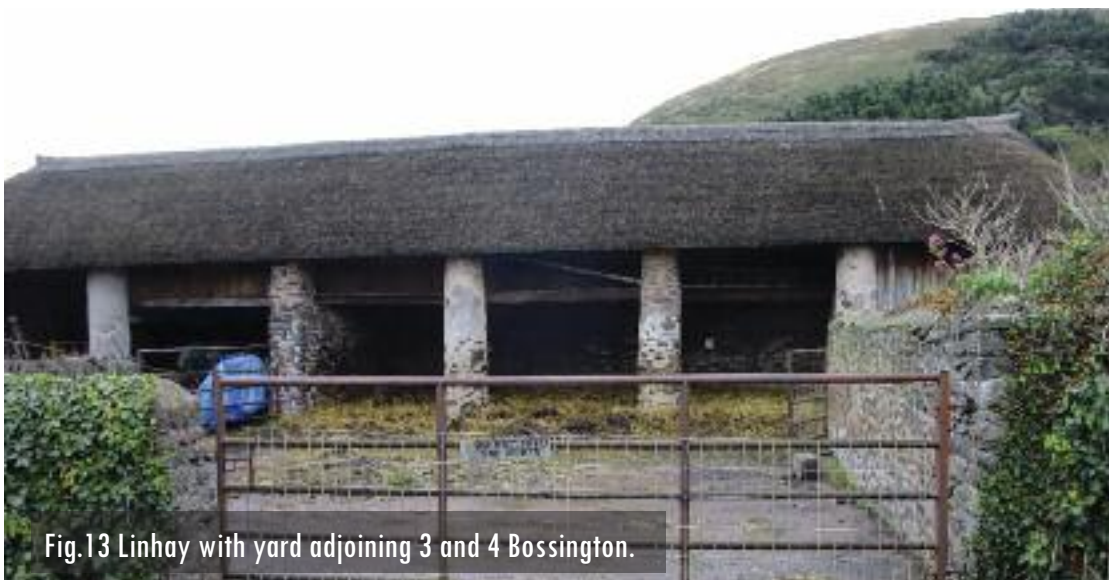
Fig.13 Linhay with yard adjoining 3 and 4 Bossington.

Immediately adjoining, and set back behind a stone wall forming a small yard, is a thatched two-storey linhay (Fig 13), probably 18th century. The mainly open-fronted six bay elevation is partitioned by rendered circular piers, a typical local vernacular feature.

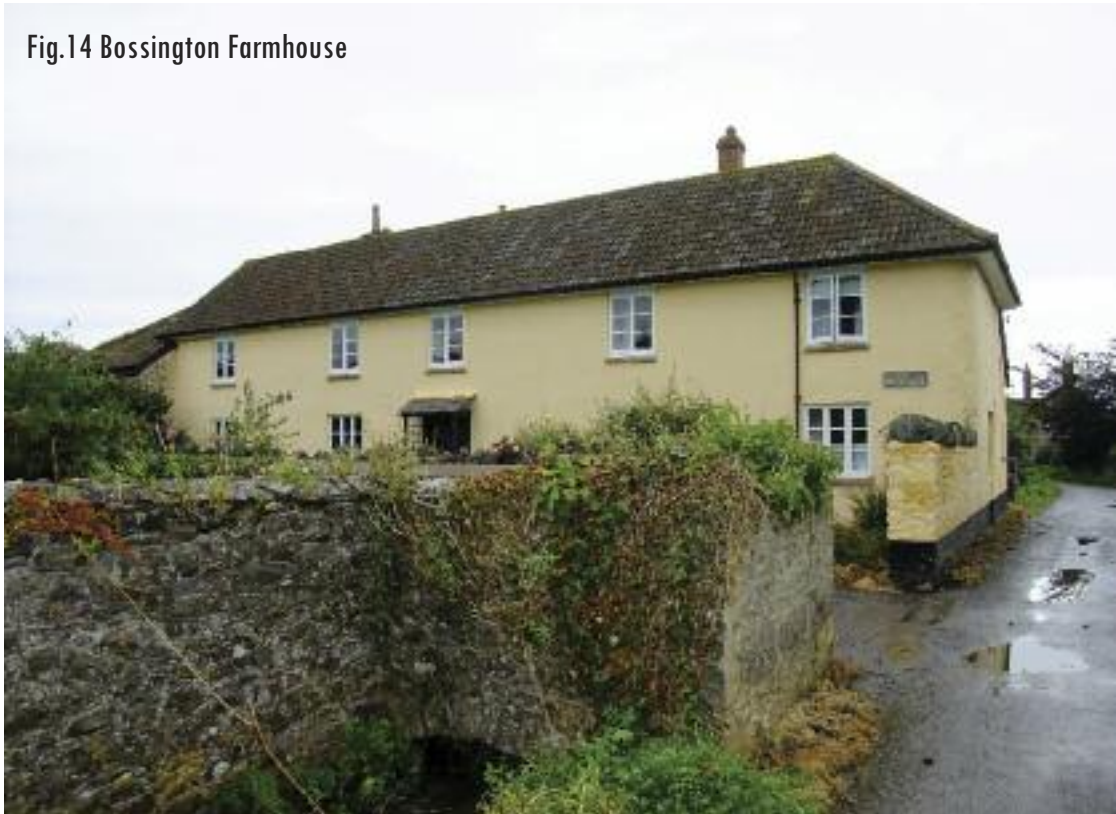
Fig.14 Bossington Farmhouse

The linhay may have belonged to **Bossington Farm**, opposite. The farmhouse (Fig. 14) and its outbuildings grouped around a cobbled yard form an attractive ensemble ranging in date from c.1800 to the latter part of the 19th century. Behind the farm and accessed via a lane leading to Porlock, **Caversham** and **Hillview** (Fig. 15) appear externally to be 19th century estate cottages with paired porches, but actually consist of a single late 16th century two or three bay house with cross passage and rear semi-rounded stair turret. It was divided into the present cottage pair in the mid-19th century. On the opposite side of the road are two farm buildings, probably mid 19th century (Fig.43).

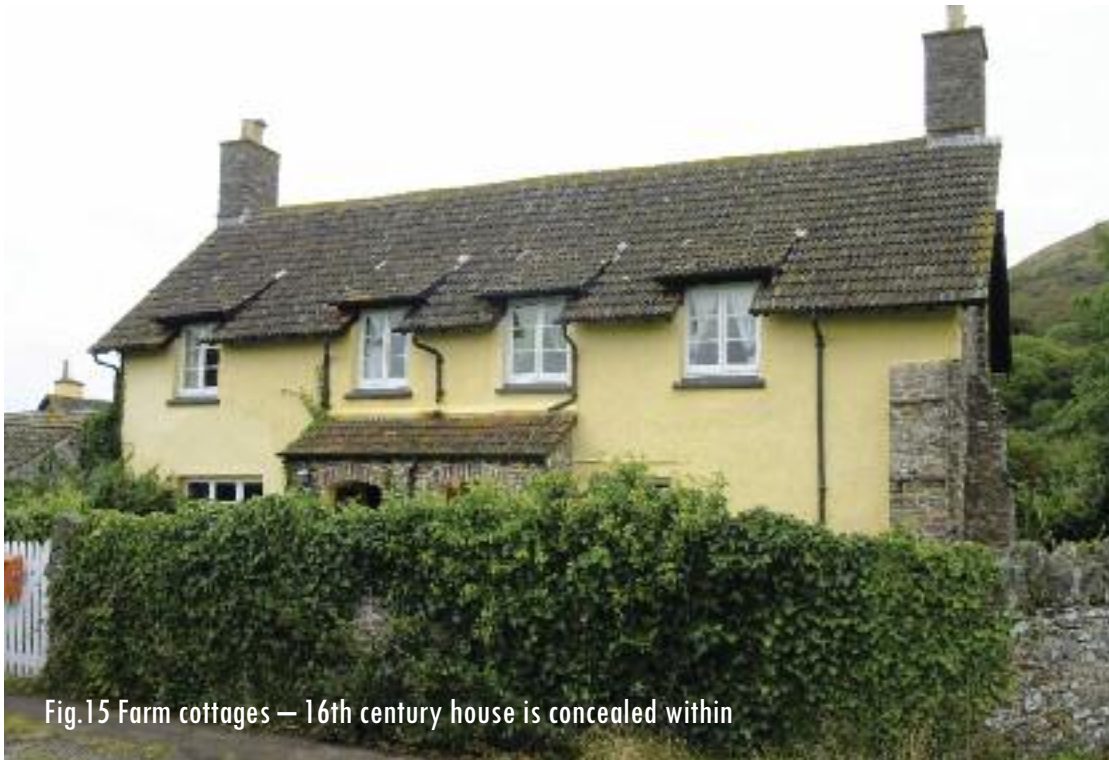
Fig.15 Farm cottages — 16th century house is concealed within

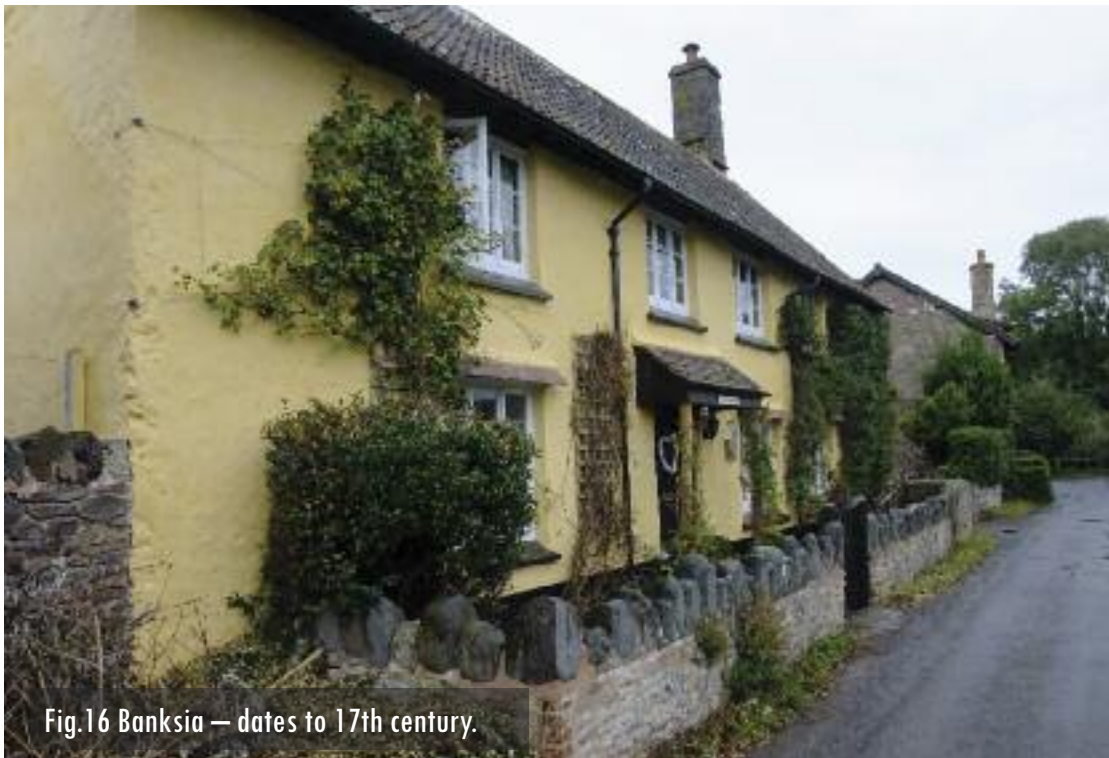
Fig.16 Banksia — dates to 17th century.

Back on the main street, **Banksia House** (Fig. 16) is a typical 17th century house with good quality late 18th - early 19th century internal features such as a dog-leg open string flight of stairs, and several panelled doors.

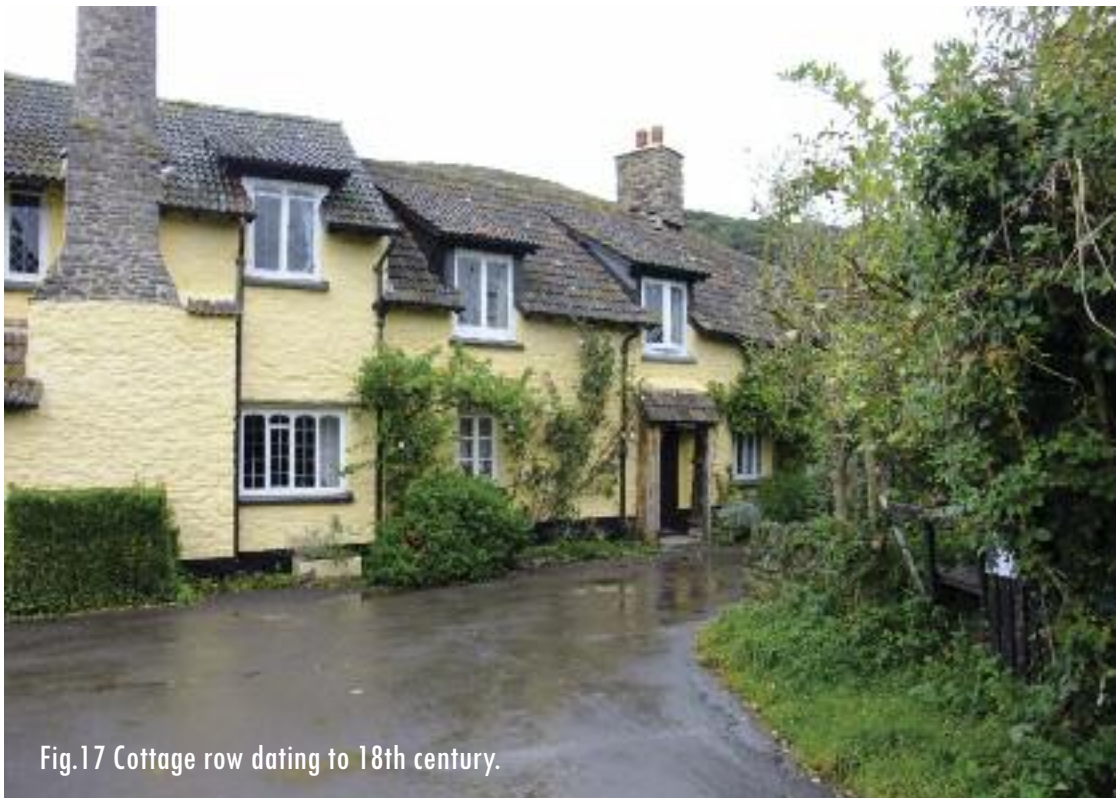
Fig.17 Cottage row dating to 18th century.

Next is a curving row of three cottages, **Myrtle Cottage**, **Rose Cottage** and **Wayside** (Fig. 17) from the 18th to 19th century. Openings follow local traditional patterns, and include one four light casement window with ogee-heads and leaded lights, and plank and ledged doors. Wayside has a right gable end with decorative barge-boards and diagonally boarded timber infill over a three-bay veranda with splat balusters, and supported on shaped ground floor brackets (Fig. 18). This incongruous mid 19th century feature is similar in style to an even more ornate one at Cloutsham Farm, several kms away, but also part of the Holnicote estate.

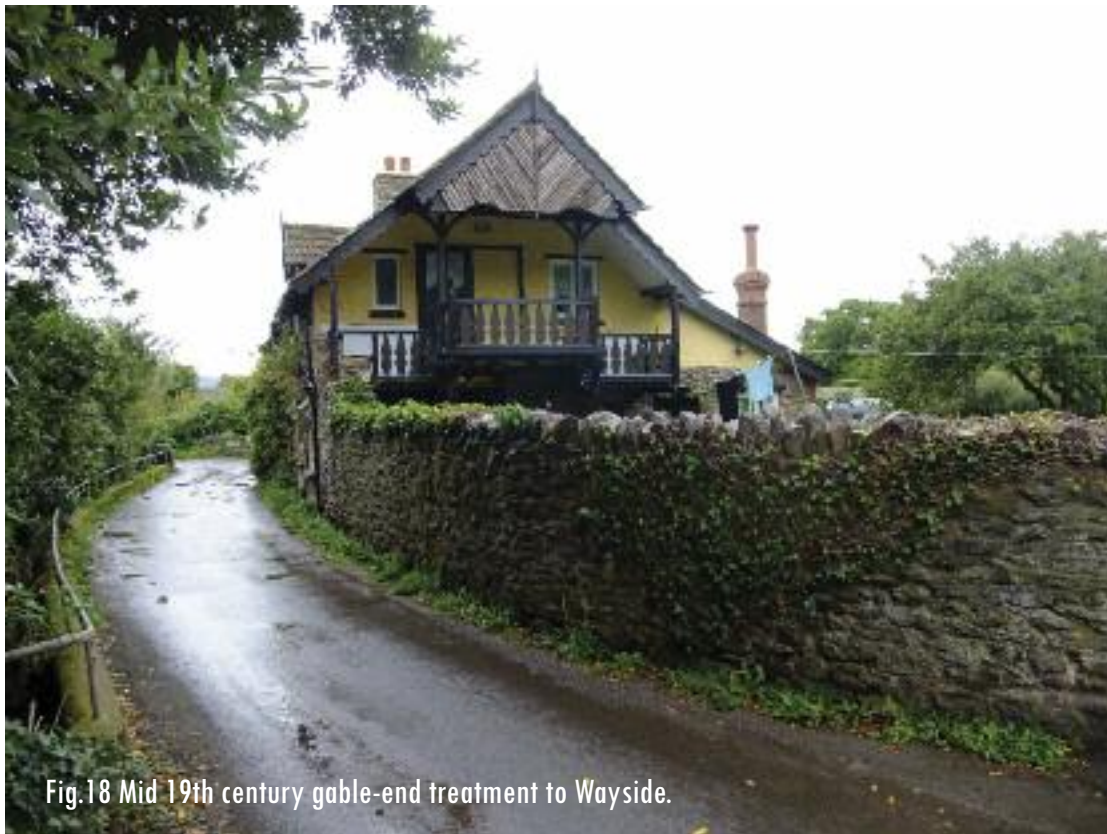
Fig.18 Mid 19th century gable-end treatment to Wayside.

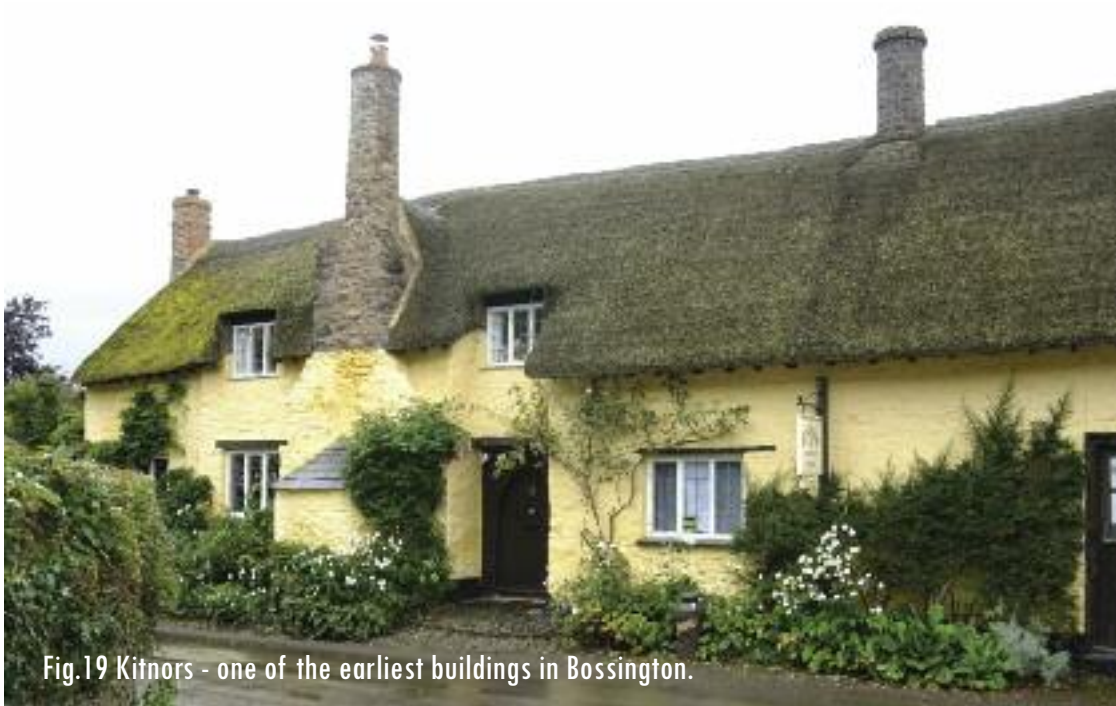
Fig.19 Kitnors - one of the earliest buildings in Bossington.

The remaining cottages form part of a visual entity, and are one of the most complete expressions of vernacular form and detail in the locality. **Kitnor's** (Fig. 19) was originally a late 15th – early 16th century open hall house (there is evidence of smokeblackening in the roofspace), three bay with cross-passage. The external front stack and first floor supported by beams, with rear stair turret were added in the late 16th century. There were further 18th century alterations including the addition of axial stacks, and a 19th century outshot addition under a catslide roof to the north-west. Two stacks have circular shafts, the front with a semicircular projecting bread oven with slate roof. Windows are mainly 19th century two or three light casements. The chamfered pointed arch doorframe may be 16th century.

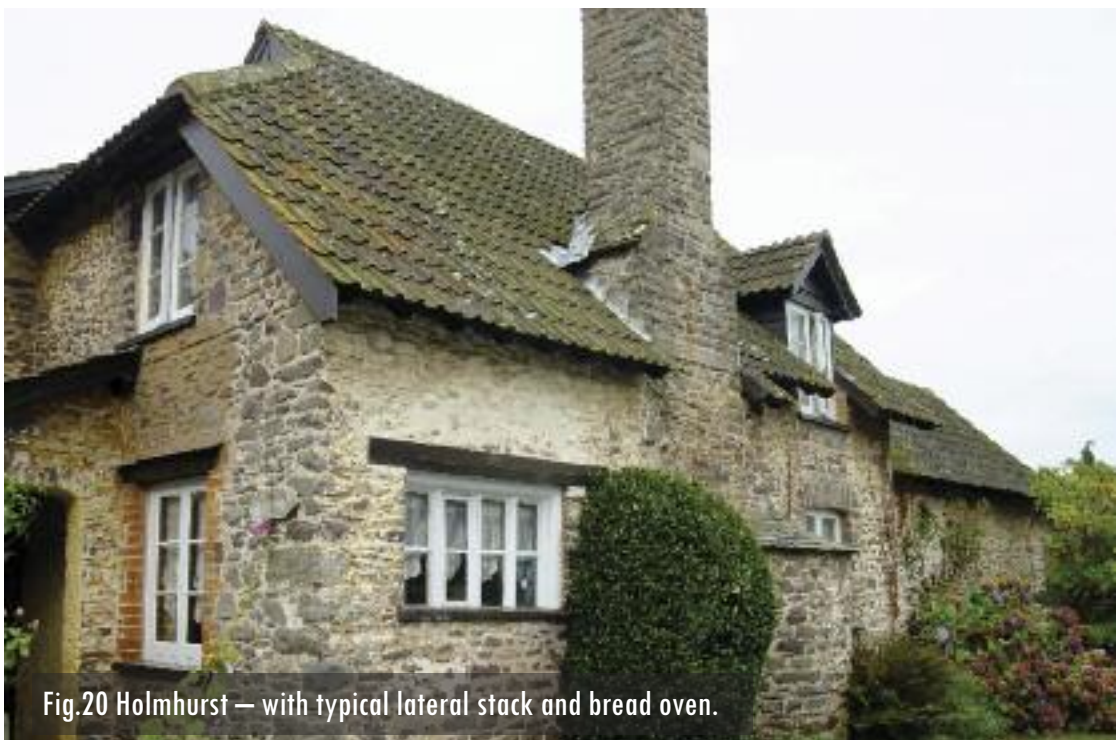
Fig.20 Holmhurst — with typical lateral stack and bread oven.

Next on this side is **Holmhurst** (Fig. 20), originally 17th century, again three-bay and cross-passage, but much altered in the mid-late 19th century. The walls are exposed stone rubble with some brick dressing and a double Roman tiled roof

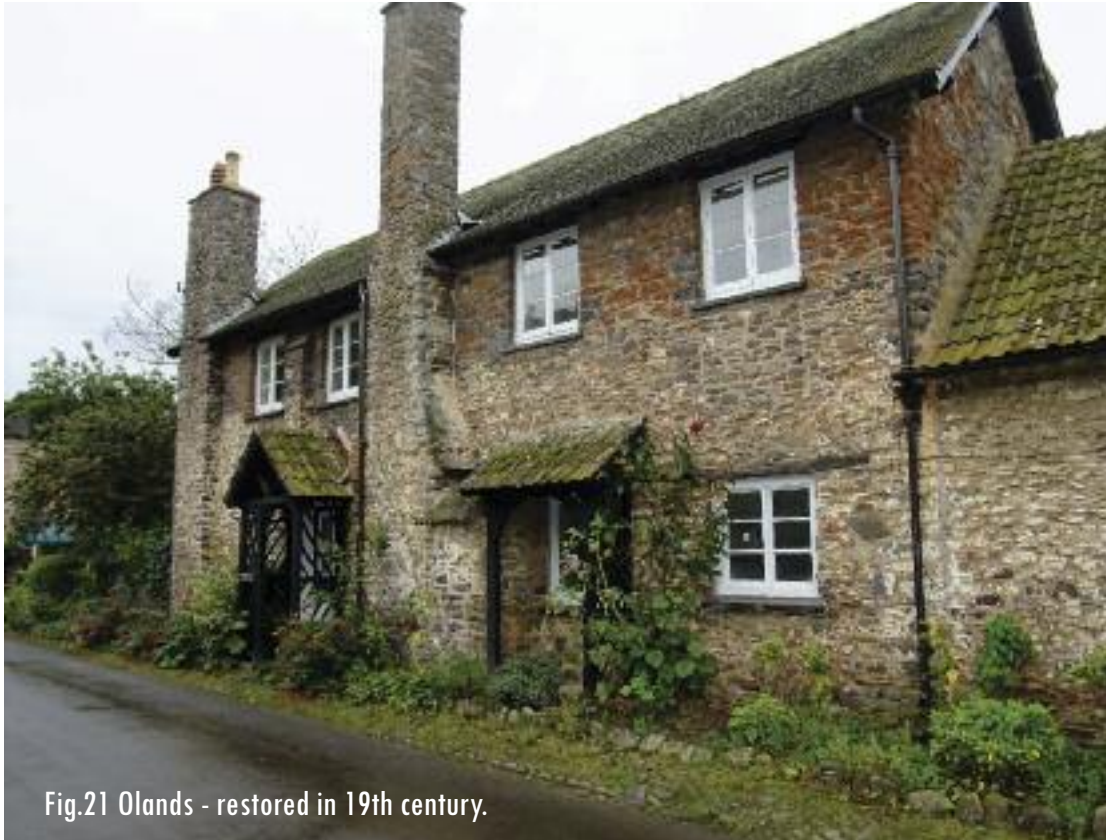
Fig.21 Olands - restored in 19th century.

Adjoining, **Olands** (Fig. 21) is a former semi-detached cottage pair, probably 17th – early 18th century and now a single dwelling, and largely rebuilt in the late 19th century. There are two rustic porches, one with gabled, the other with pentice roof. The listing details refer to an ‘interesting example of 19th century restoration with attractive front and utilitarian rear elevation.’

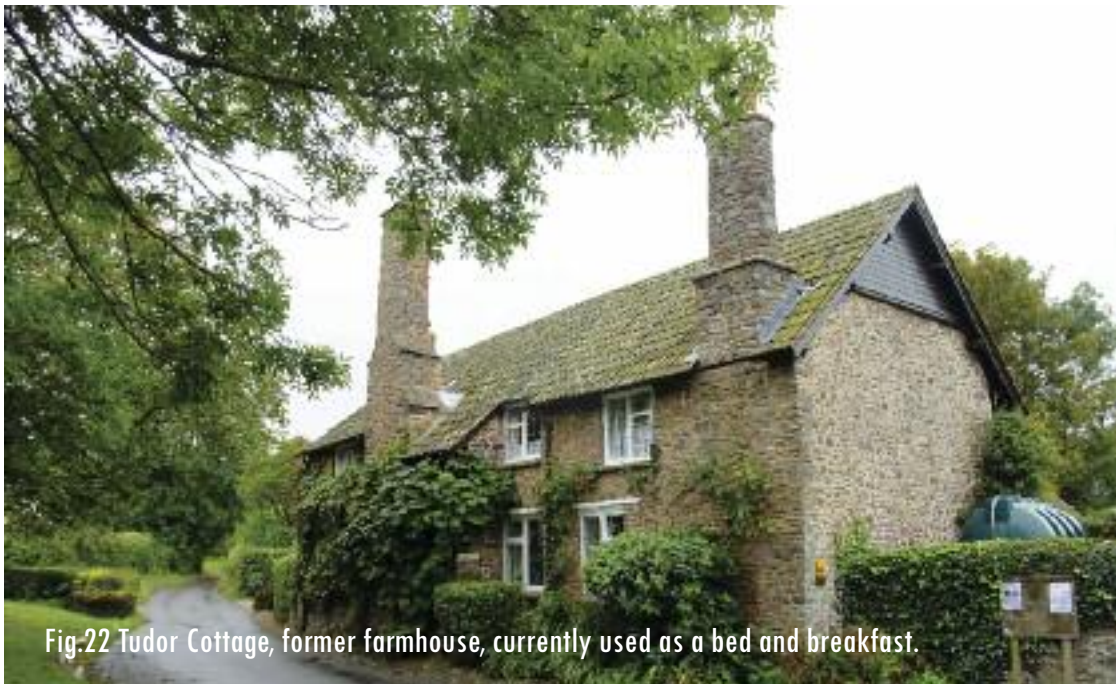
Fig.22 Tudor Cottage, former farmhouse, currently used as a bed and breakfast.

Tudor Cottage (Fig. 22), a former 16th –17th century farmhouse, probably originally three-bay with cross-passage. It subsequently became two dwellings, but has reverted to a single dwelling. Features include a three-light ovolo moulded mullioned window, probably 17th century, and some early 19th century leaded light iron casement windows.

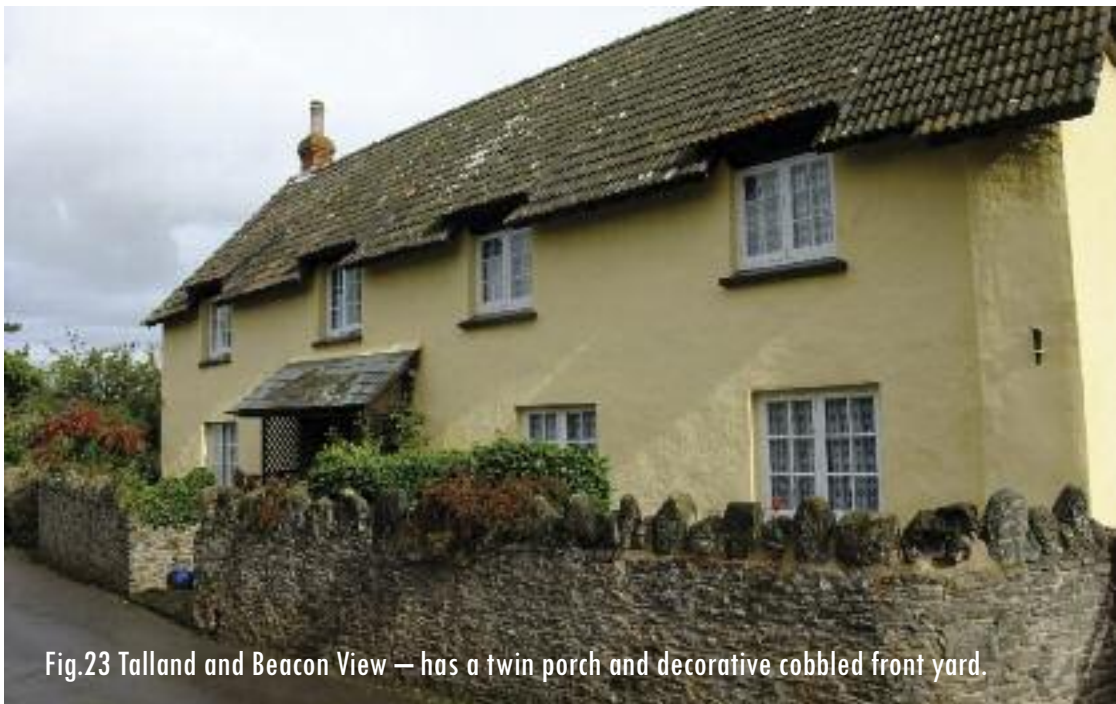
Fig.23 Talland and Beacon View — has a twin porch and decorative cobbled front yard.

On the opposite side of the street, **Talland** and **Beacon View** (Fig.23) although unlisted are an important element of the street scene immediately north-east of Kitnors being part rendered, part exposed stone, with decorative 19th century embellishments, for example patterned cobbles, and gothic-style arched entrance doors with diagonal ribs (Fig. 36).

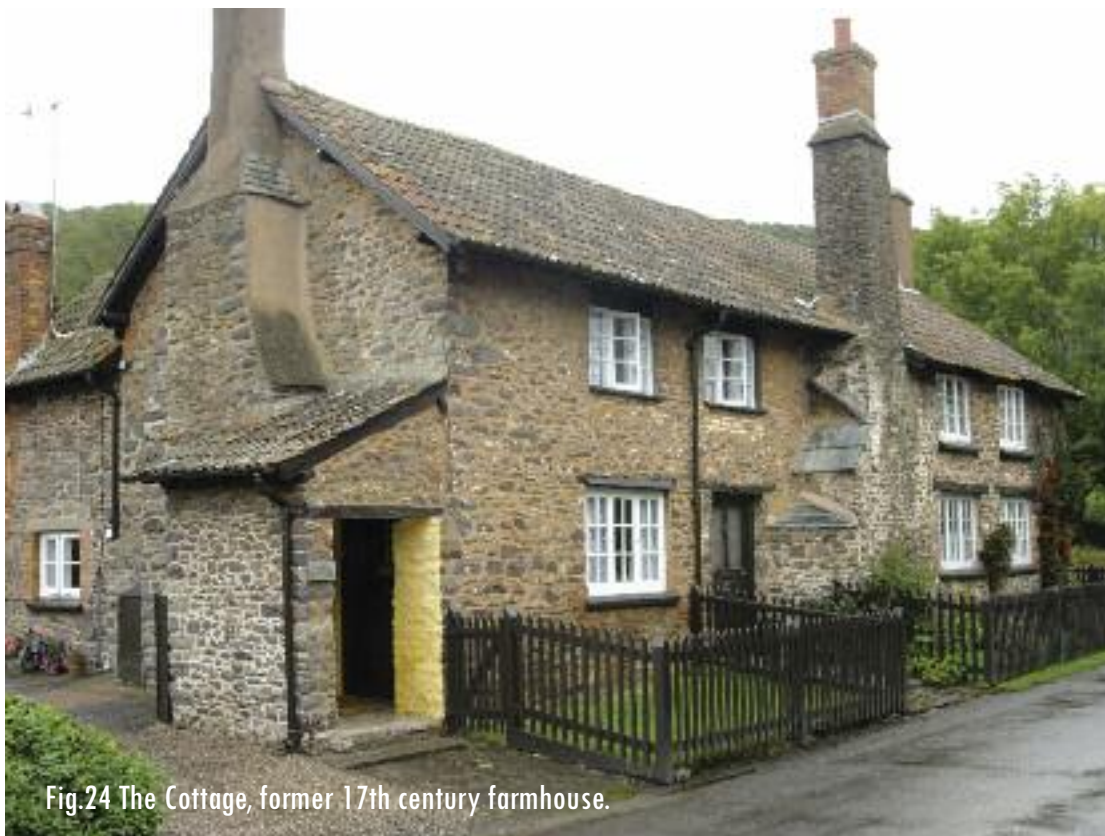
The Cottage (Fig.24) is another a former farmhouse, 17th century, but much altered. It was converted to two dwellings in the late 19th century but appears to have reverted to a single dwelling since the last Conservation Area Appraisal. Built of red sandstone rubble with a double Roman tiled roof, there is an external stack at the left gable with renewed circular chimney, and the remains of a lateral stack with a rebuilt brick chimney. The slate roofed bread oven projection in the angle is typical of the locality. Most casement windows and the ribbed plank doors are probably early 20th century replacements.

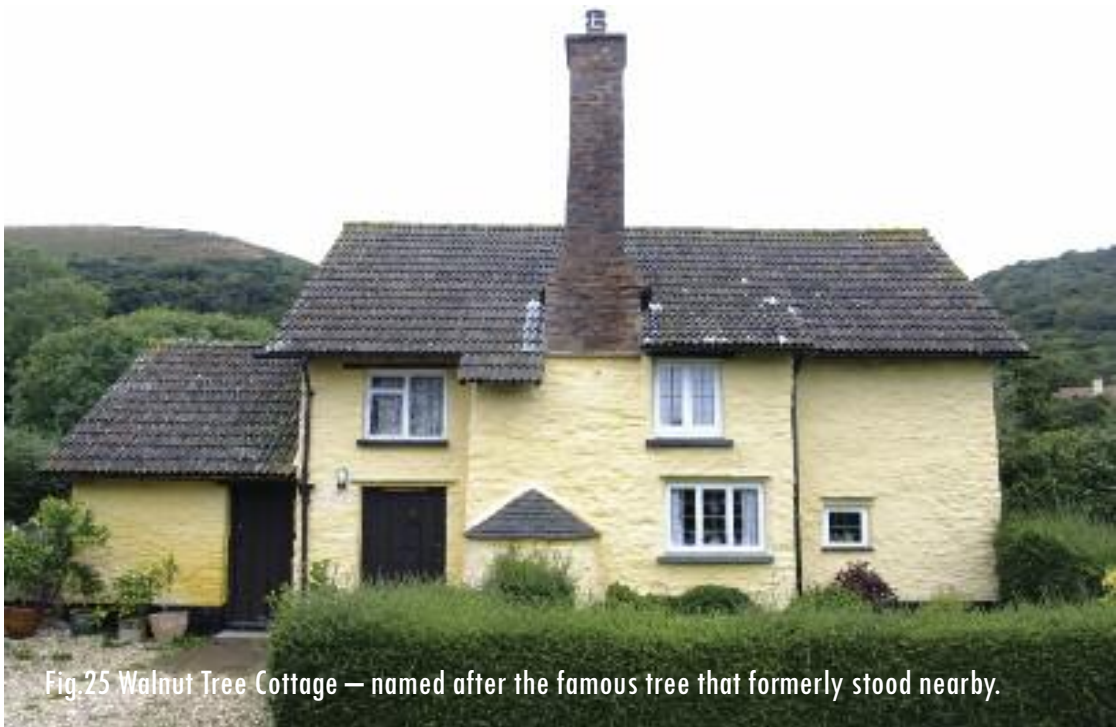
Fig.25 Walnut Tree Cottage — named after the famous tree that formerly stood nearby.

Slightly set apart at the south end of the village is **Walnut Tree Cottage** (Fig.25). Predominantly 17th century, but altered mid 19th century, with tall front lateral stack and bread oven projection.

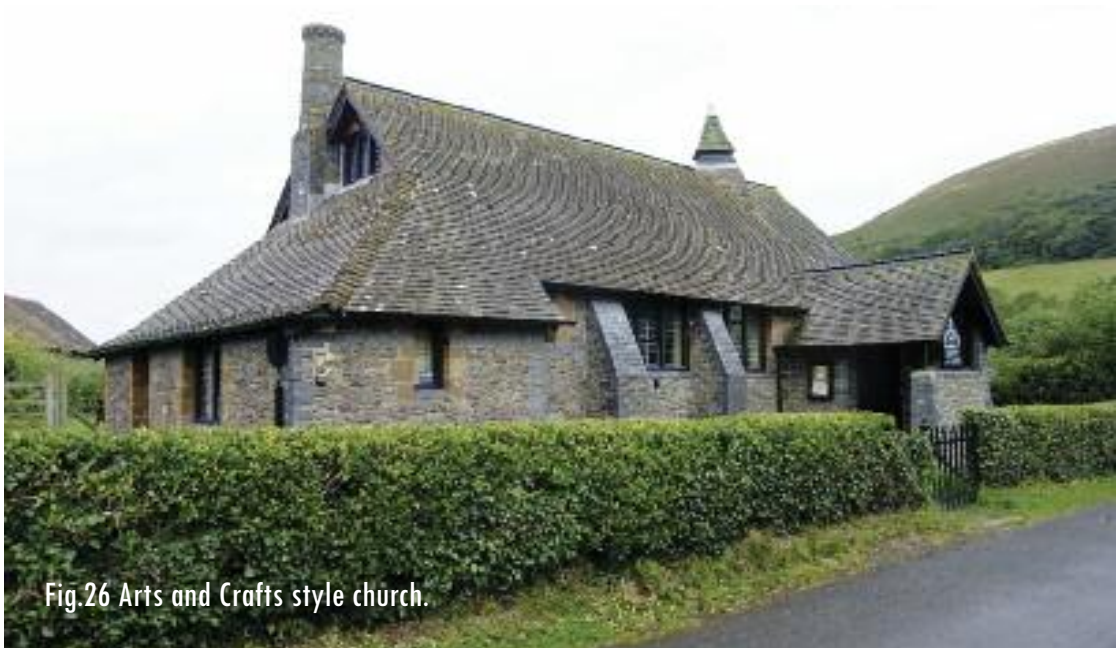
Fig.26 Arts and Crafts style church.

In an even more isolated position on the lane to Porlock is **Bossington Methodist Church** (Fig.26), an early 20th century building in an Arts & Crafts style, including raked buttresses. There is an eclectic mix of materials with red sandstone random rubble, blue glazed bricks for some quoins and dressed sandstone for others. Above is a small bell cage and spire set on a truncated

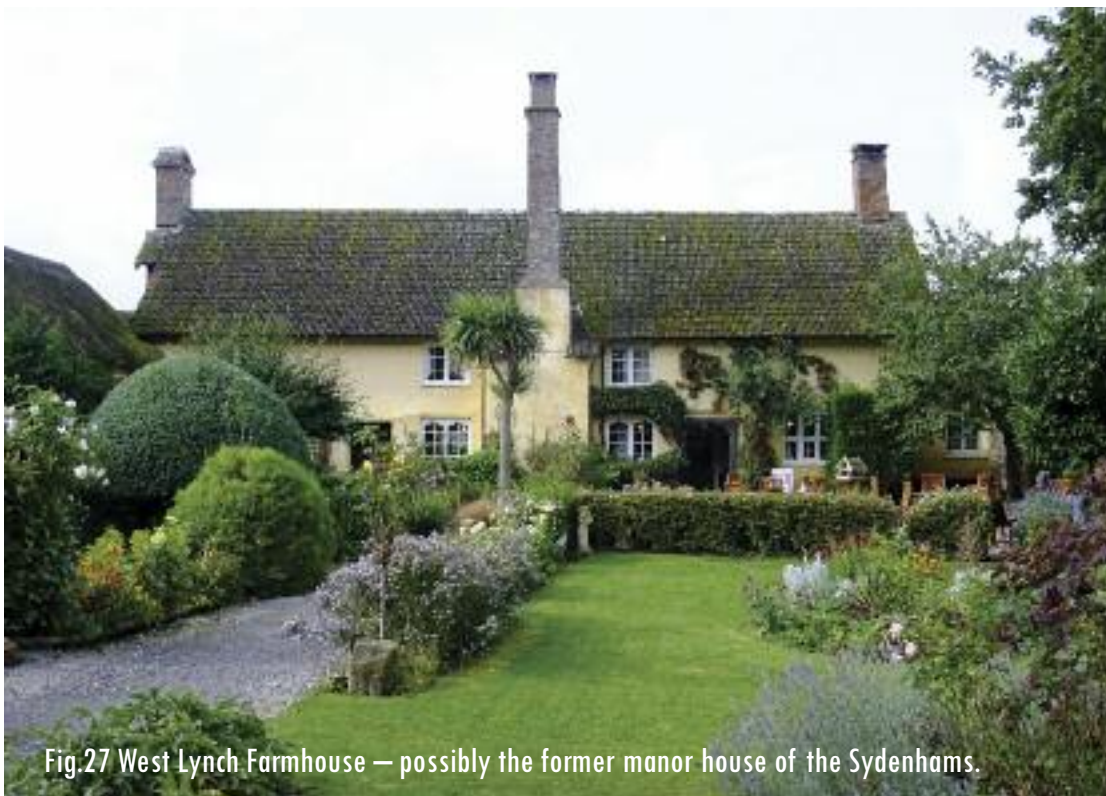
Fig.27 West Lynch Farmhouse – possibly the former manor house of the Sydenhams.

West Lynch Farm has an excellent collection of historic farm buildings. The farmhouse (Fig. 27) dates from the 16th century or earlier. There are five jointed cruck roof trusses, three with smoke-blackening, indicating an original open plan hall house. The heavy pegged door frame with semi-circular chamfered head and adjoining timber mullion and transom with four-centre arch head and floral decoration to spandrels is possibly late 15th – early 16th century. The tall front lateral stack with circular stone shaft, rear stair turret and ceiled interior were probably added in the late 16th –early 17th century.

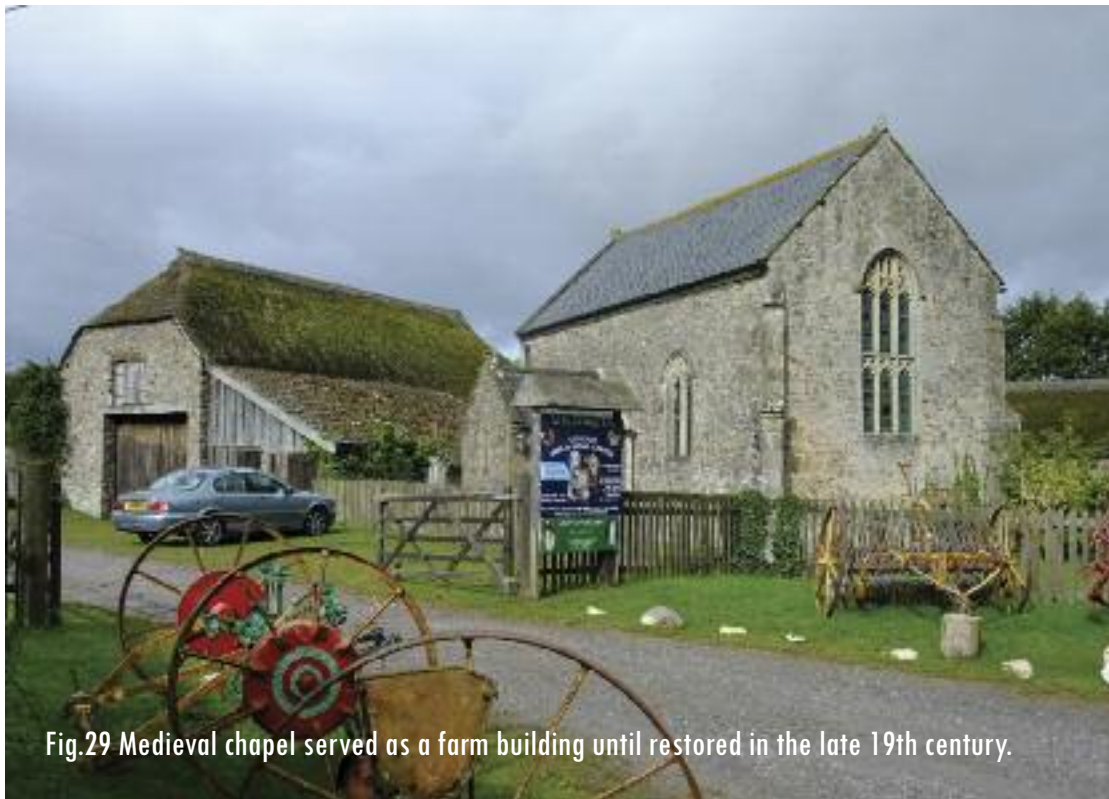
Fig.29 Medieval chapel served as a farm building until restored in the late 19th century.

Within the West Lynch Farm complex there is also **Lynch Chapel** (Fig.29), a remarkably complete early 16th century chapel, possibly serving the former manor of the Sydenhams, although it was reputedly established by an Abbot of Atheleney. For a period the chapel had become a barn, but Sir Thomas Dyke Acland, refitted and restored it as a Chapel of Ease in 1884-5 installing the fine east window of three lights with transom bars which resemble windows at Doverhay manor, and at Porlock and Selworthy churches. Inside, there is a wagon roof, panelled dado and a 17th century gallery with plain balusters.

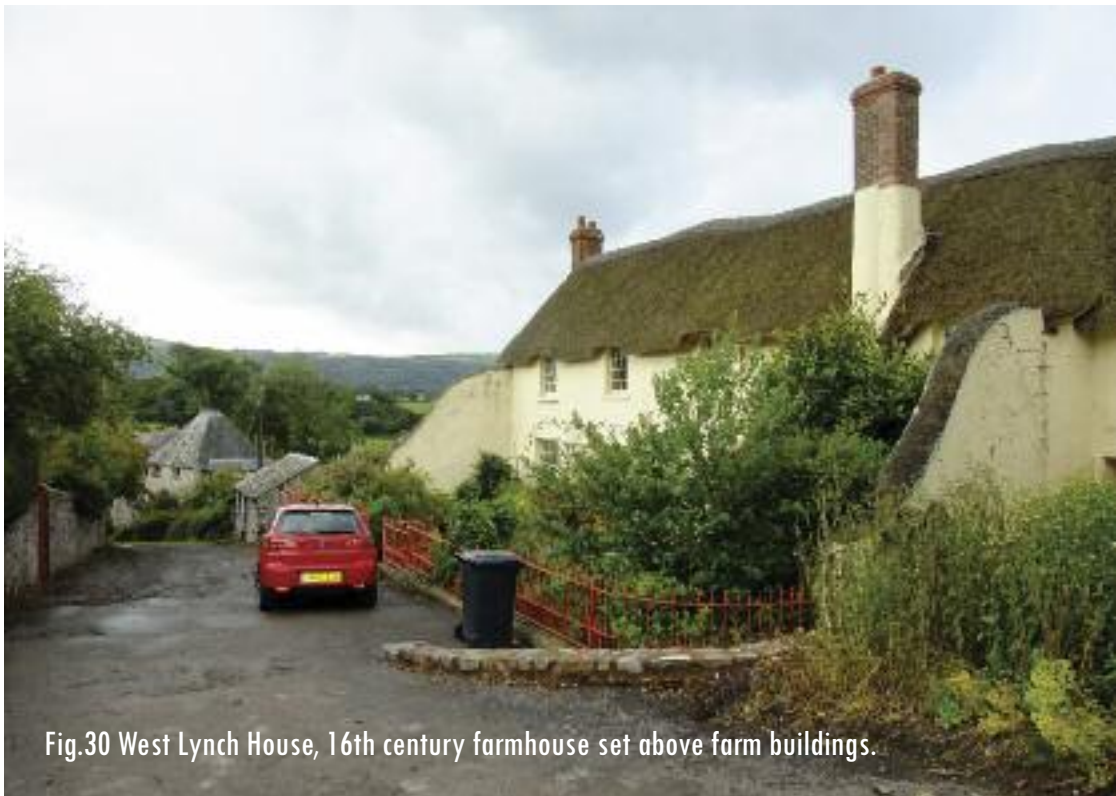
Fig.30 West Lynch House, 16th century farmhouse set above farm buildings.

East of the river, **West Lynch House** (Fig 30) is a former farmhouse dating from the late 16th– early 17th century, but substantially altered, including re-fenestration, probably in the early 19th century when this became the owners' house of the Clarke's Mill complex further down the hill. At the lower end of the associated outbuildings is a former malt-house and traction engine house, probably dating from the early 19th century (they are shown on the 1841 Tithe Map). Built of stone rubble with brick dressings, the malthouse has a steeply pitched pyramid roof with circular vent at the apex and is set above the hexagonal traction house adjoining. Opposite are remnants of the former mill itself, now **Gate Cottage** (Fig. 32) and **West Lynch Stables**, which were formerly linked until bisected by the driveway to Lynch in the early 20th century.

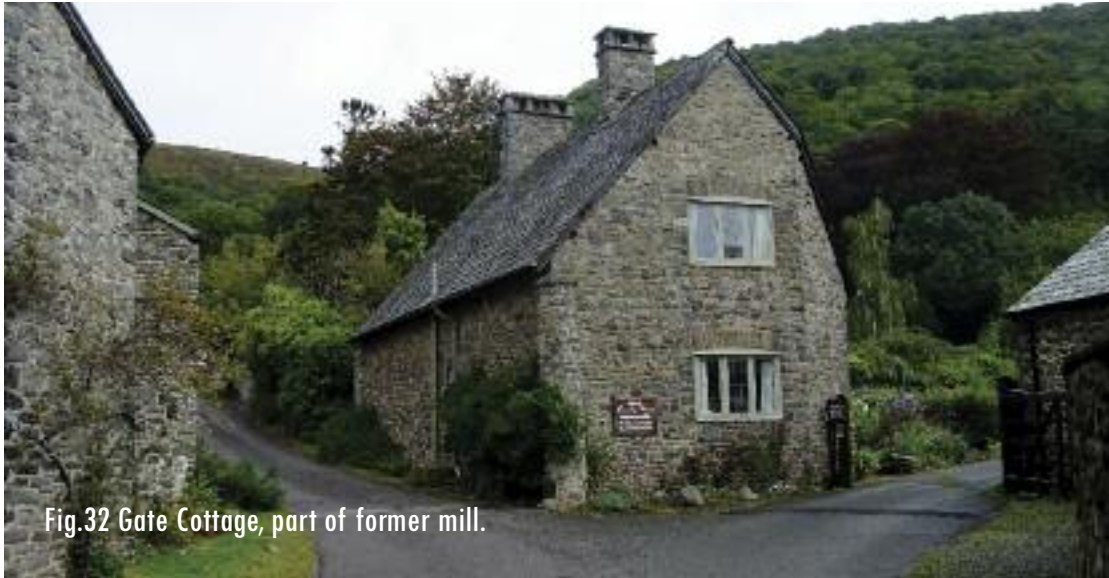
Fig.32 Gate Cottage, part of former mill.
