Exmoor National Park
Historic Environment Report Series No 10

BOSSINGTON AND WEST LYNCH CONSERVATION AREA: APPRAISAL DOCUMENT

Adopted 2019

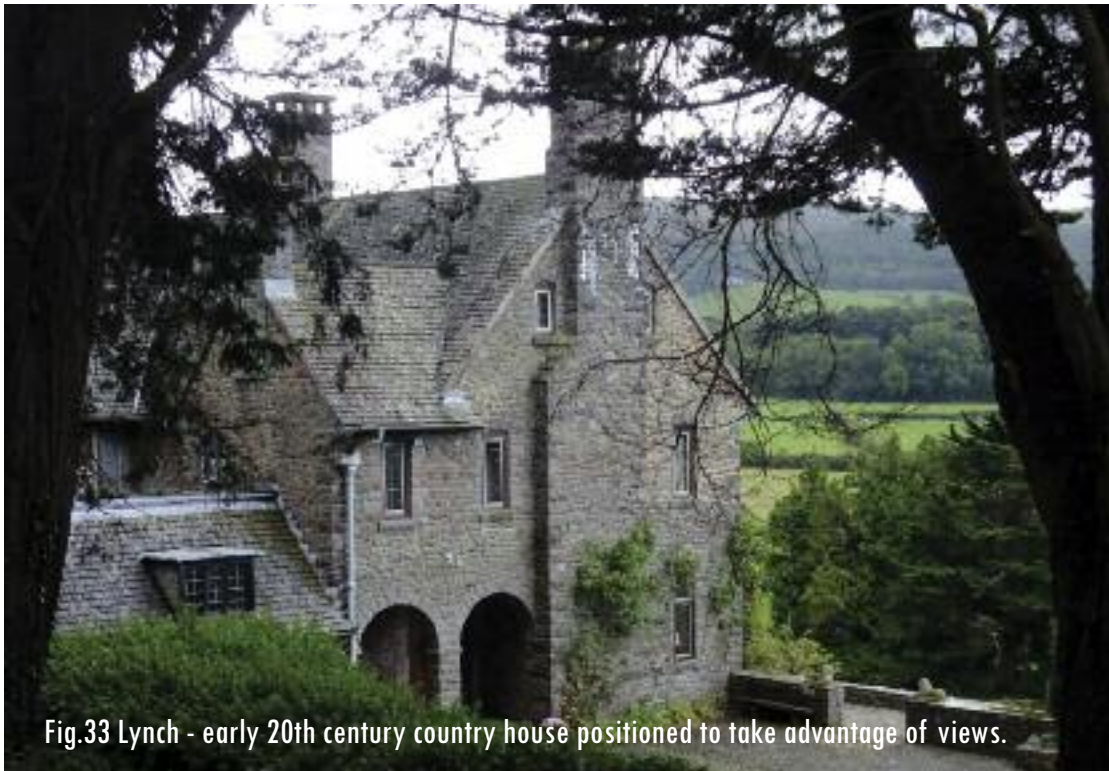
Fig.33 Lynch - early 20th century country house positioned to take advantage of views.

To the south, the early 20th century house known as **Lynch** (Fig. 33) is the largest dwelling in the Conservation Area. This substantial stone and slate house built in the Arts & Crafts tradition is set prominently into the hillside with a long seven bay frontage with four tall axial stone stacks, and two rear lateral. The centre three bays have recessed ground floor windows in semicircular arched openings. The stone transom and mullion windows have leaded lights. There are extensive outbuildings and former lodges (converted to holiday homes) in a broadly similar style to the main house. All have casement windows with rectangular leaded lights, and solid timber doors. There are also extensive stone walls and stone cobbled areas. This small estate is a late example of extensive use of local building materials when supplies were still obtainable.

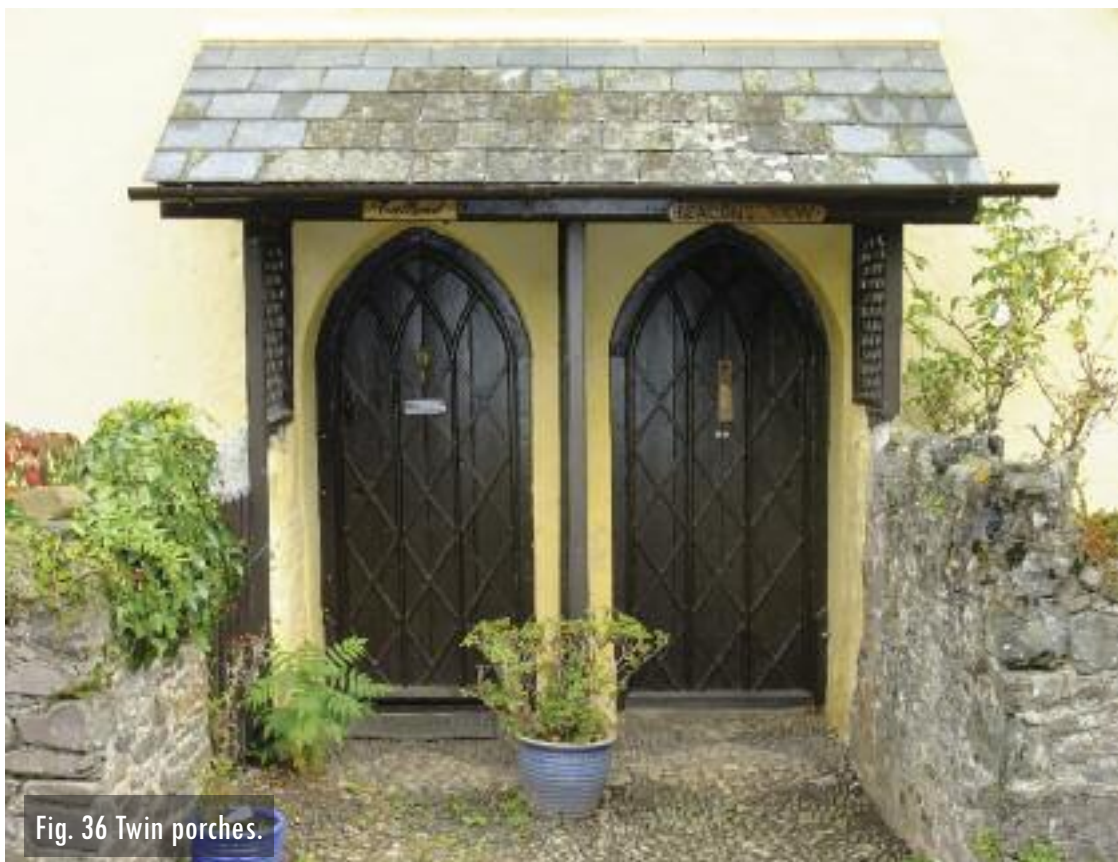
Fig. 36 Twin porches.

fixed lights, and a few have examples of what may be termed rustic Arts & Crafts detail, for example use of diagonal boarding, and others with ribs or studs. Among the semi-detached dwellings, twin porches are a common feature. Some openings of late medieval origin survive - these had massive oak

On the opposite side of the street, **Talland** and **Beacon View** (Fig.23) although unlisted are an important element of the street scene immediately north-east of Kitnors being part rendered, part exposed stone, with decorative 19th century embellishments, for example patterned cobbles, and gothic-style arched entrance doors with diagonal ribs (Fig. 36).

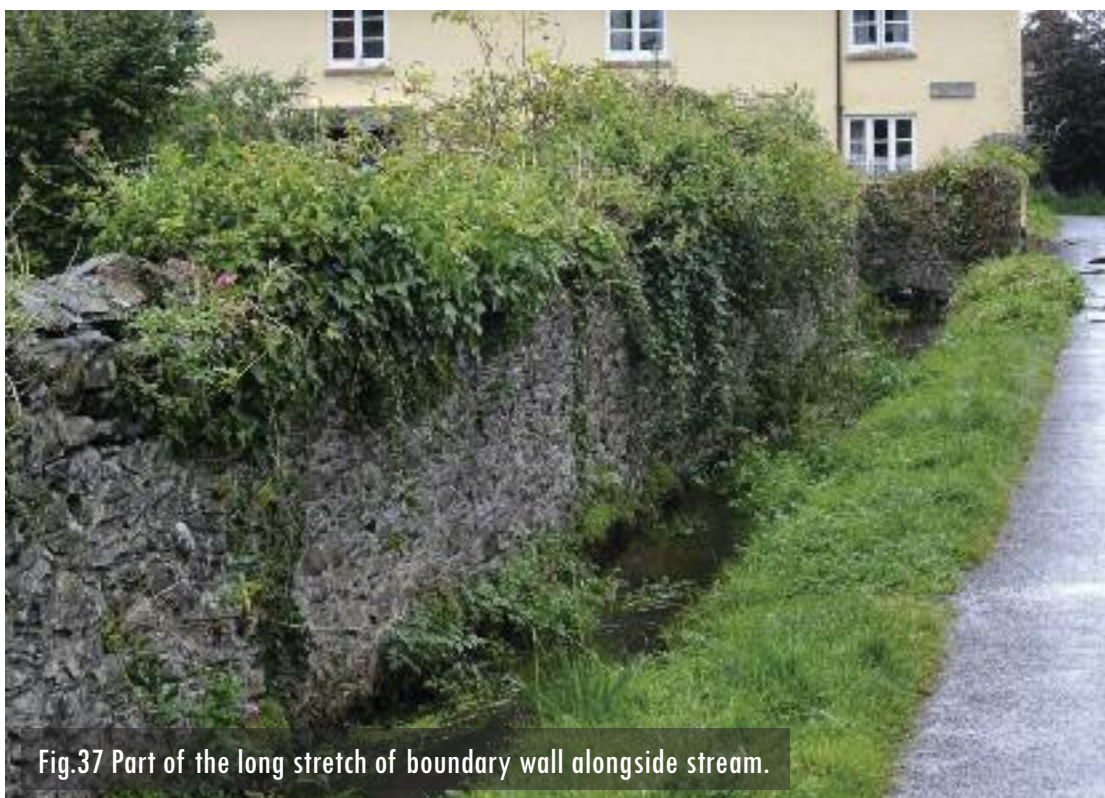
Fig.37 Part of the long stretch of boundary wall alongside stream.

There are long stretches of boundary or retaining walls built of local sandstone rubble, usually roughly coursed and infilled with mortar. An alternative, occasionally evident as a support to earth banks, is the locally distinctive dry-stone pattern known as 'dyking'. This adds a pleasing contrast but as a retaining feature to hedgerow banks, it can be prone to deterioration as a result of root spread when not regularly maintained.

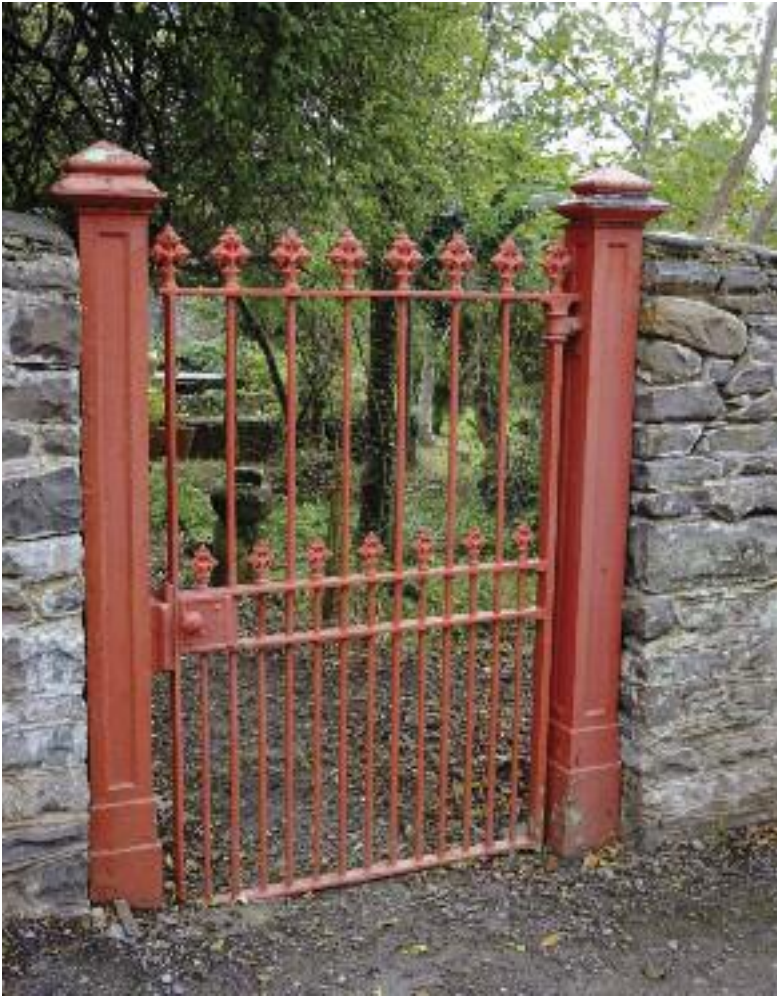
Fig.38
Decorative
gate at West
Lynch House.

Timber is the most common material for gates and fences. Iron gates are relatively rare, but there is a good 19th century example at West Lynch House (Fig. 38), as well as set of railings at the front of the farmhouse.

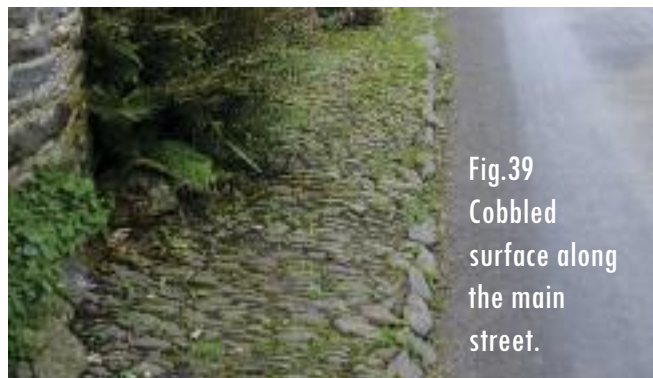
Fig.39
Cobbled
surface along
the main
street.

Bossington has several locations where surfaces are cobbled. The best examples is along the frontage of cottages extending southwards from Kitnors, where small blocks of local sandstone have been used, laid end on.

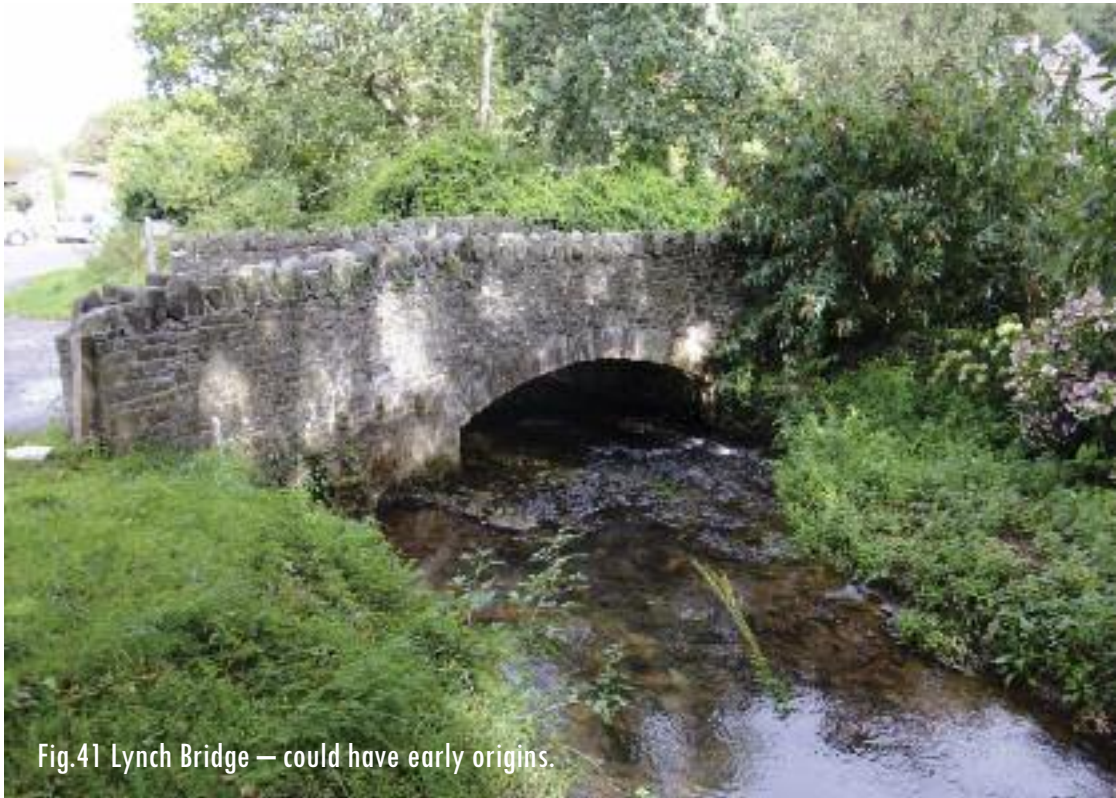
Fig.41 Lynch Bridge — could have early origins.

Lynch Bridge (Fig. 41) gives access to the buildings on the east side of the Aller and must be at a relatively early river crossing place. Further west, Green Bridge crosses the wider Horner Water and has a boundary stone (Fig. 42) (re)set into the parapet marked 'PP SP' (Porlock Parish - Selworthy Parish).

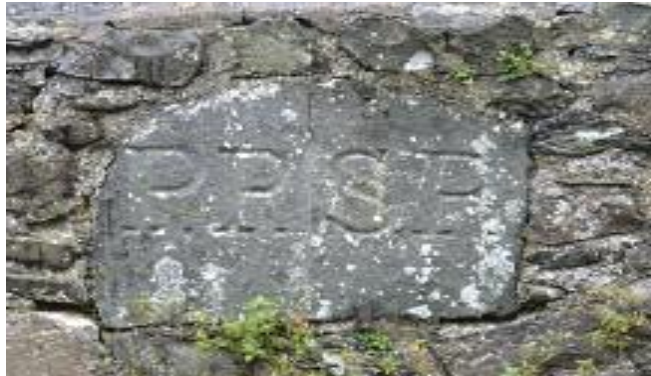
**Fig.42
Boundary stone,
Green Bridge**

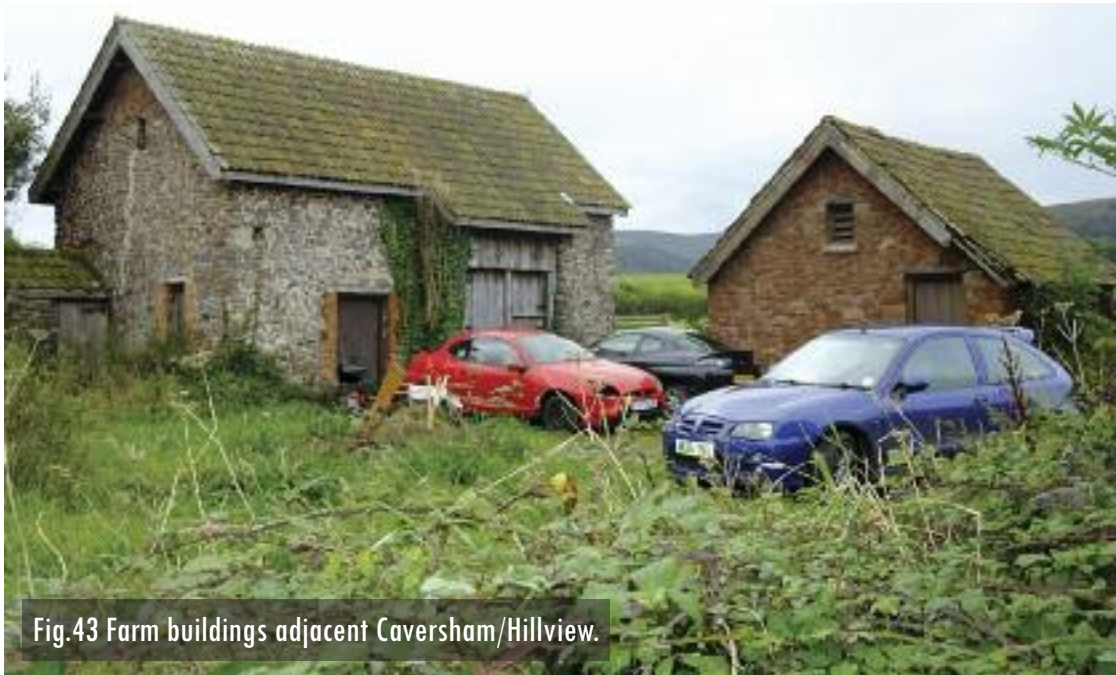
Fig.43 Farm buildings adjacent Caversham/Hillview.

There are some outbuildings, for example on the other side of the road from Caversham/Hillview, which appear to be redundant in terms of agricultural use and look underused and are undoubtedly in need of some renovation and repair. This situation is unchanged from the 2004 Appraisal. Some outbuildings at Lower House Farm are also in poor condition.
