Exmoor National Park  
Historic Environment Report Series No 9

# ALLERFORD CONSERVATION AREA: APPRAISAL DOCUMENT

Adopted March 2017

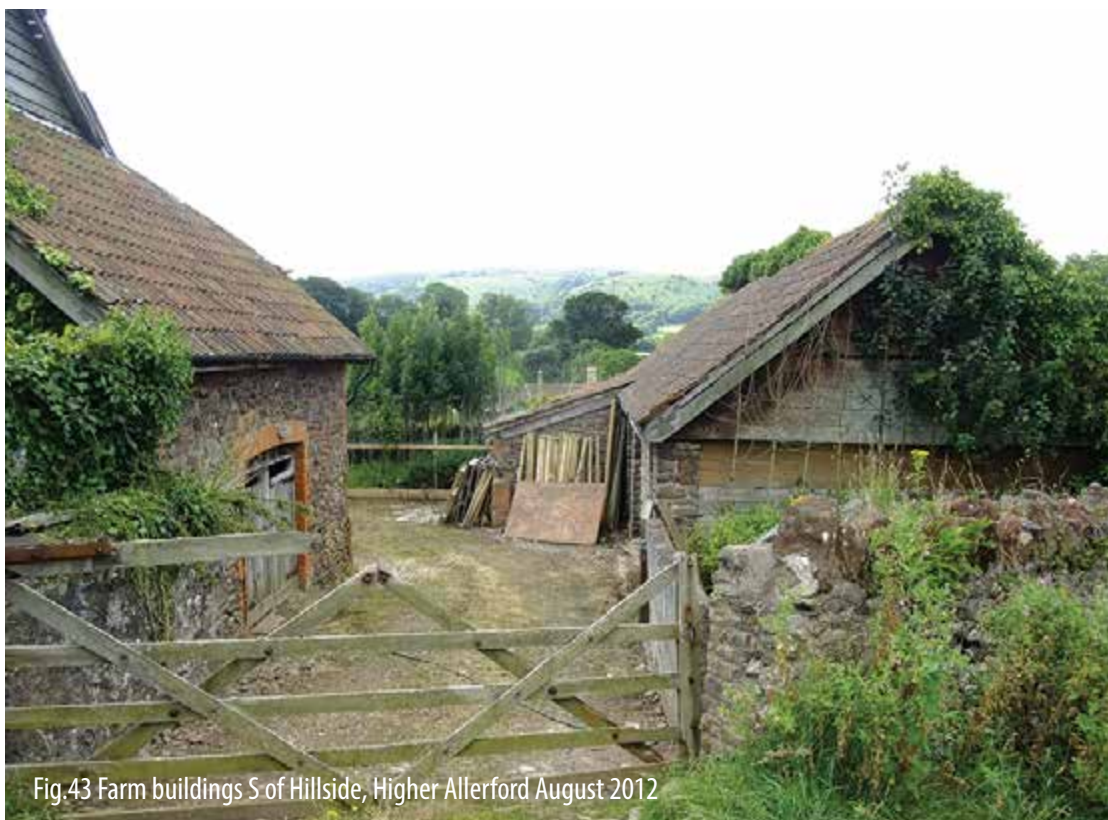
There are outbuildings at Lower and Higher Allerford that appear to be redundant in terms of their original agricultural use. The thatched linnhay at Stoates Farm, Lower Allerford (Fig.42), at the time of survey, has some roof damage and a temporary tarpaulin cover. This building is regarded as being 'at risk'. The farm buildings south of Hillside, Higher Allerford (Fig.43) look underused but appear to be in fair structural condition although they are undoubtedly in need of some repair. This situation is unchanged from the 2004 Appraisal.
