Exmoor National Park  
Historic Environment Report Series No 16

# EXMOOR FARMSTEADS CONSERVATION AREA: APPRAISAL DOCUMENT

Adopted 2018

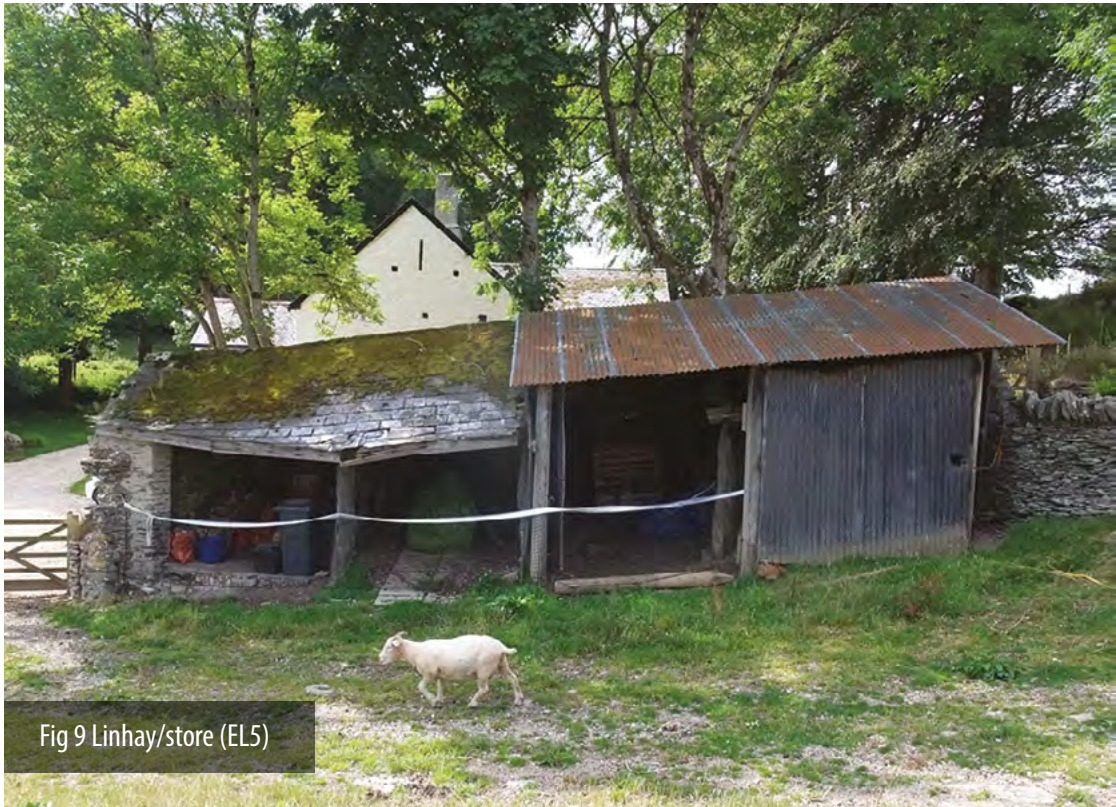
Just to the south are two detached agricultural buildings. The larger is two-storey, probably a former **stable with hayloft above** (EL3). The other is possibly a former **implement shed** (EL4), the blocked former entrance noted in 2005 has since had window inserted. Just north of the farmhouse is a small single storey **linhay/shed** (EL5) built up against a boundary wall. It is in a dilapidated state with its corrugated iron roof supported by wooden posts and stone orthostats.

Fig 9 Linhay/store (EL5)

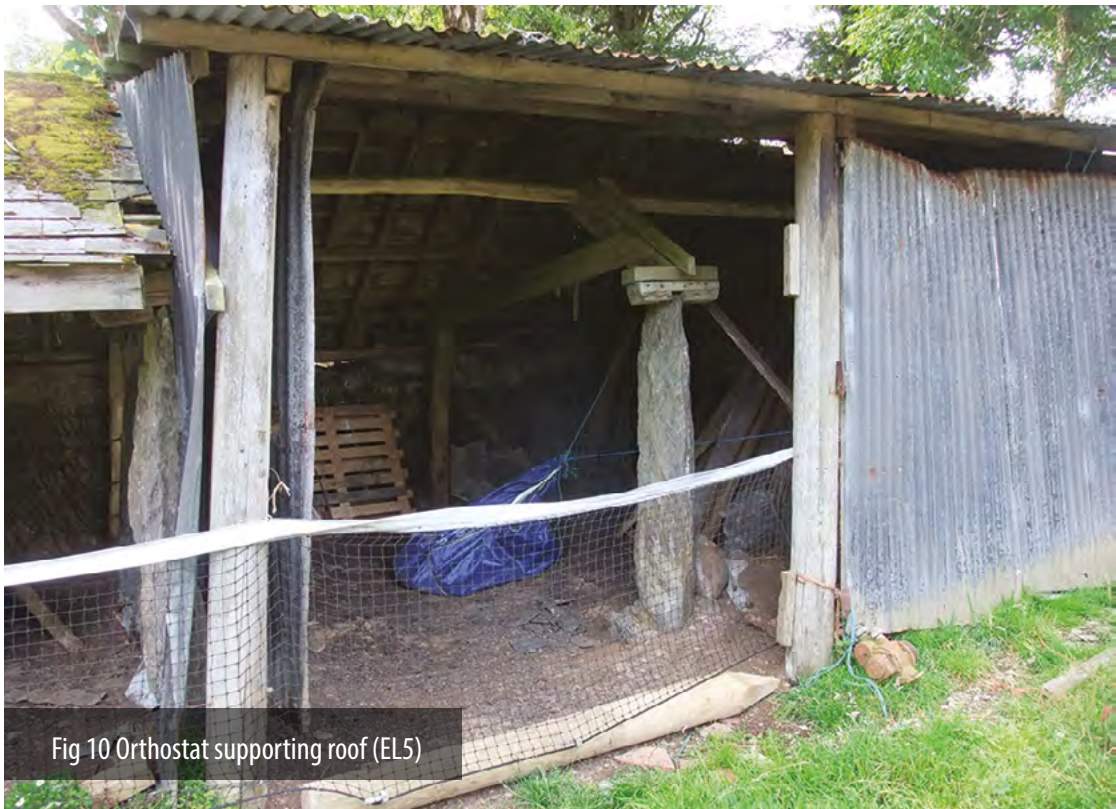
Fig 10 Orthostat supporting roof (EL5)

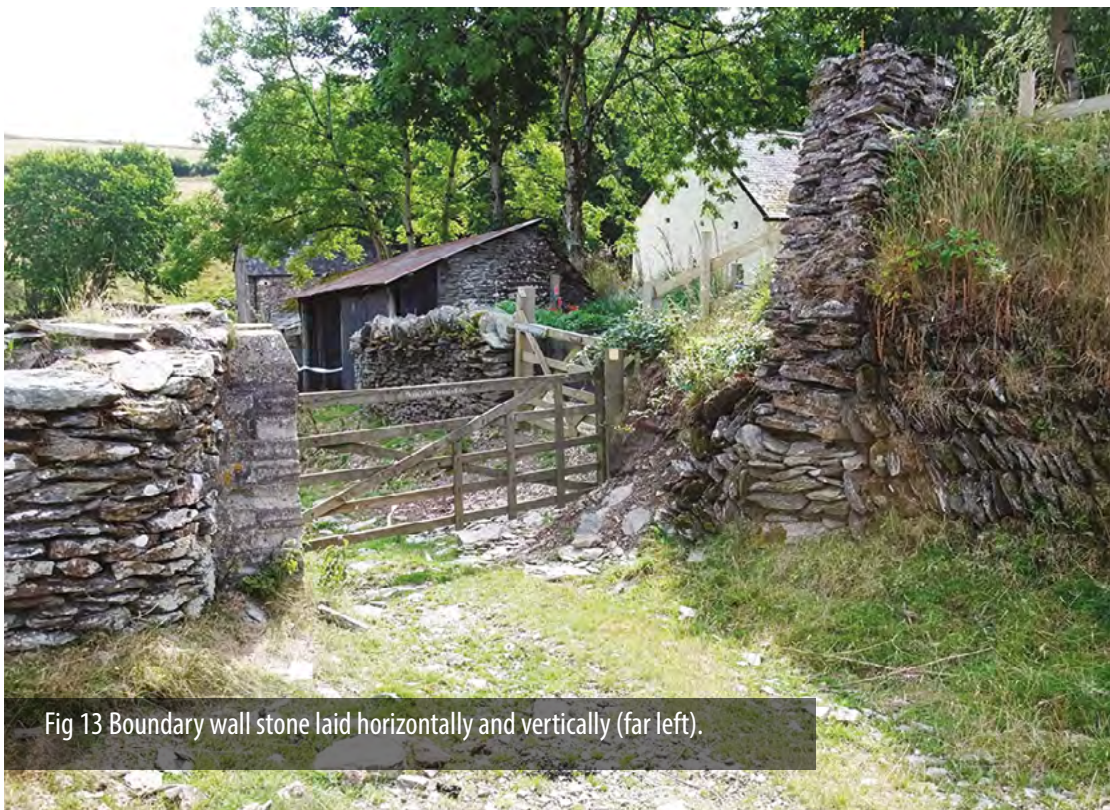
Fig 13 Boundary wall stone laid horizontally and vertically (far left).

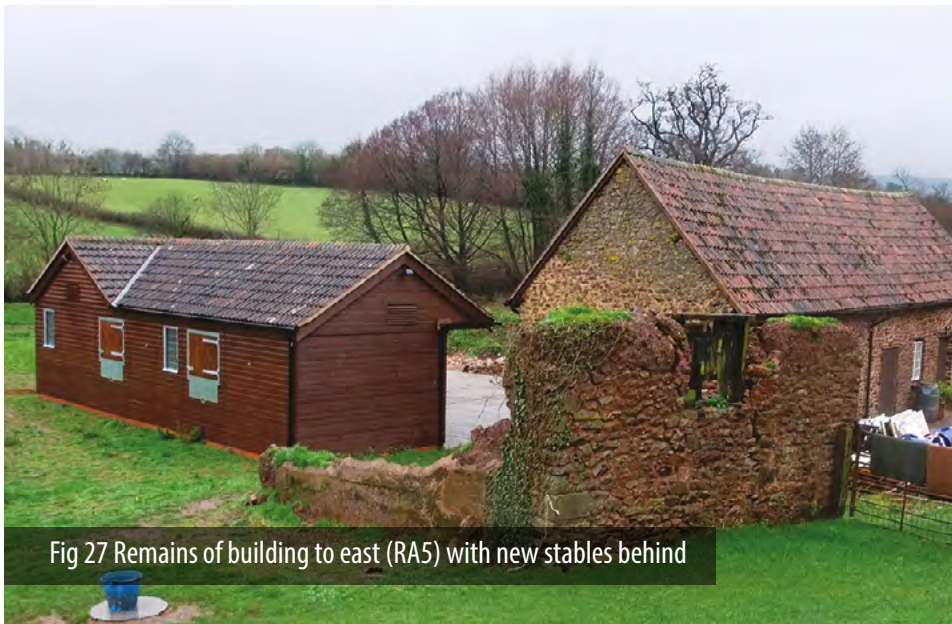
Fig 27 Remains of building to east (RA5) with new stables behind

At the time of this current survey the condition of some curtilage listed buildings was of concern. Principally, the western building (RA5) is now derelict and with exception of the north gable is beyond repair. The south wall of wagon shed (RA8) has racked, caused by the spread of the roof, but could be effectively repaired.
